Hobbs E-4 Junction Box NMOCD Case #: 1R428-71

Stage 1 Abatement Plan

**Hobbs E-4 Junction Box
NMOCD Case #: 1R428-71**

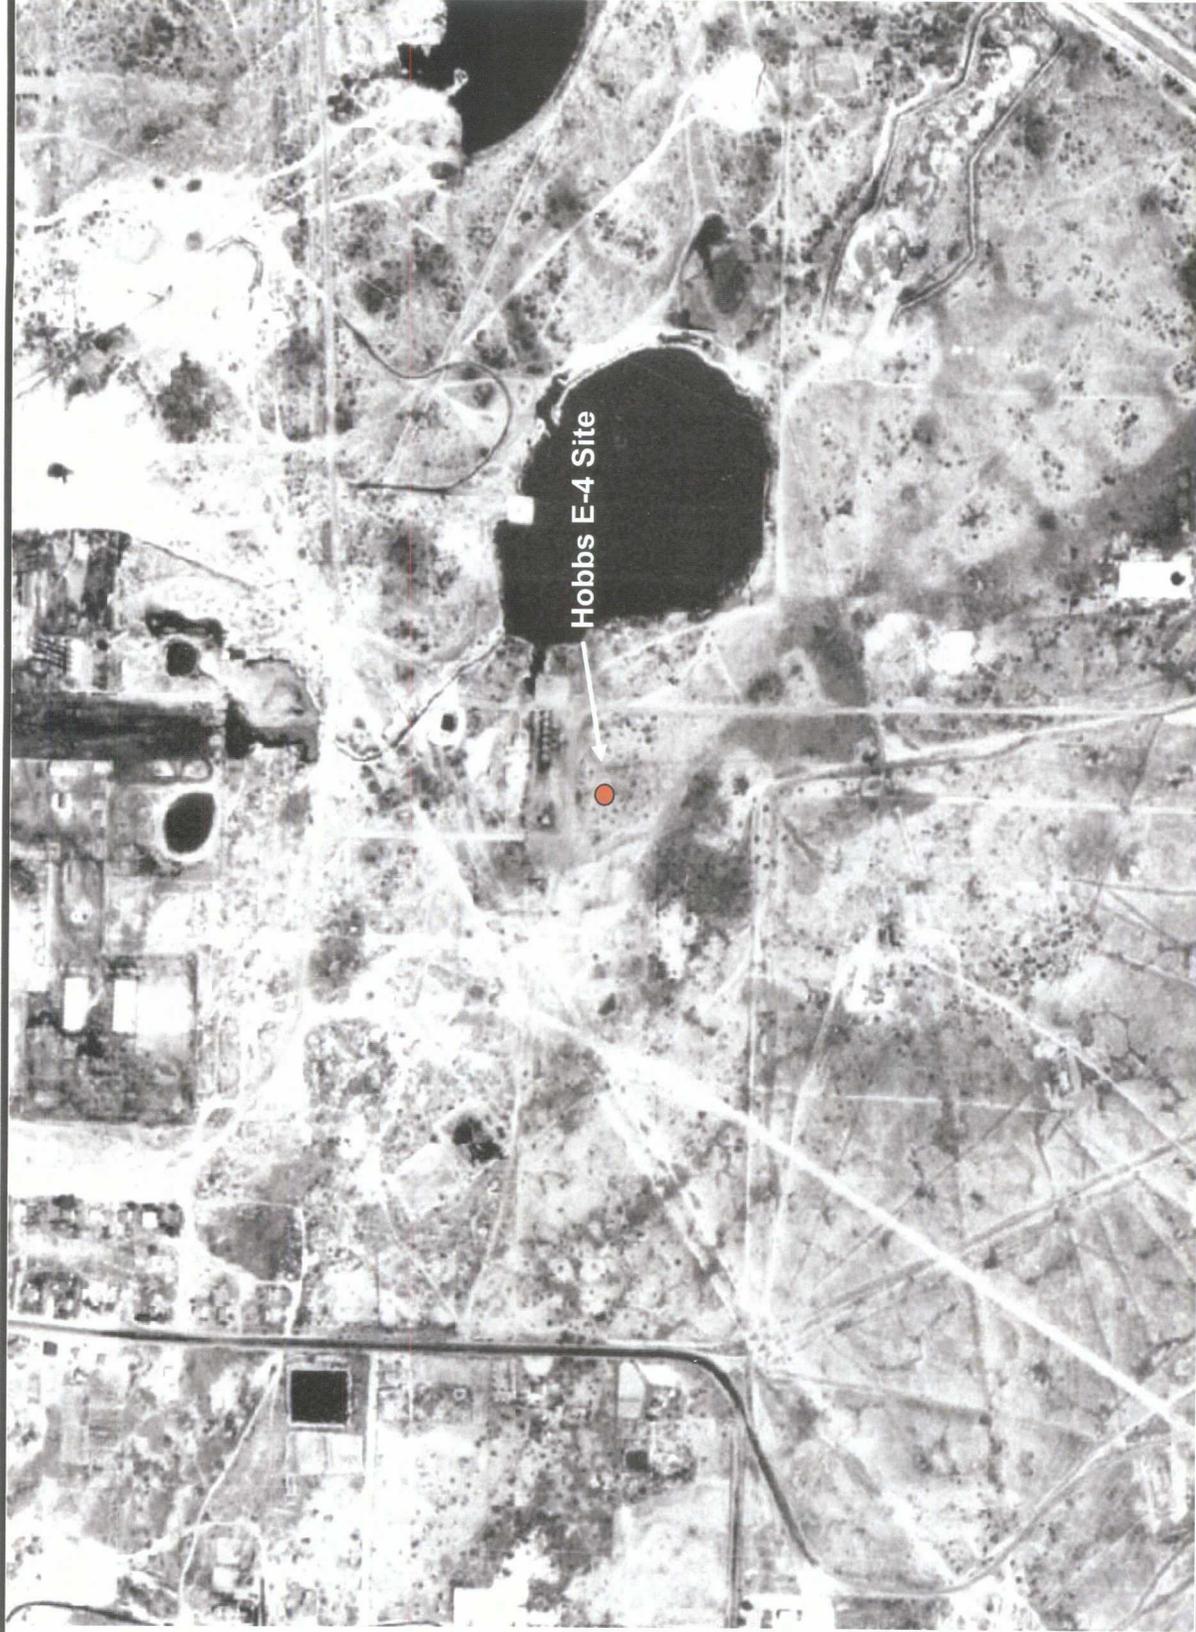
Plate 2A

Plate 2 is a series of aerial photographs that indicate the location of the E-4 site relative to the surrounding oil and gas production operations and livestock activities from 1954 to the present. Of particular concern is a series of tanks located across the lease road to the north approximately 150 feet from the present-day Hobbs E-4 site.

1954 Aerial Photograph

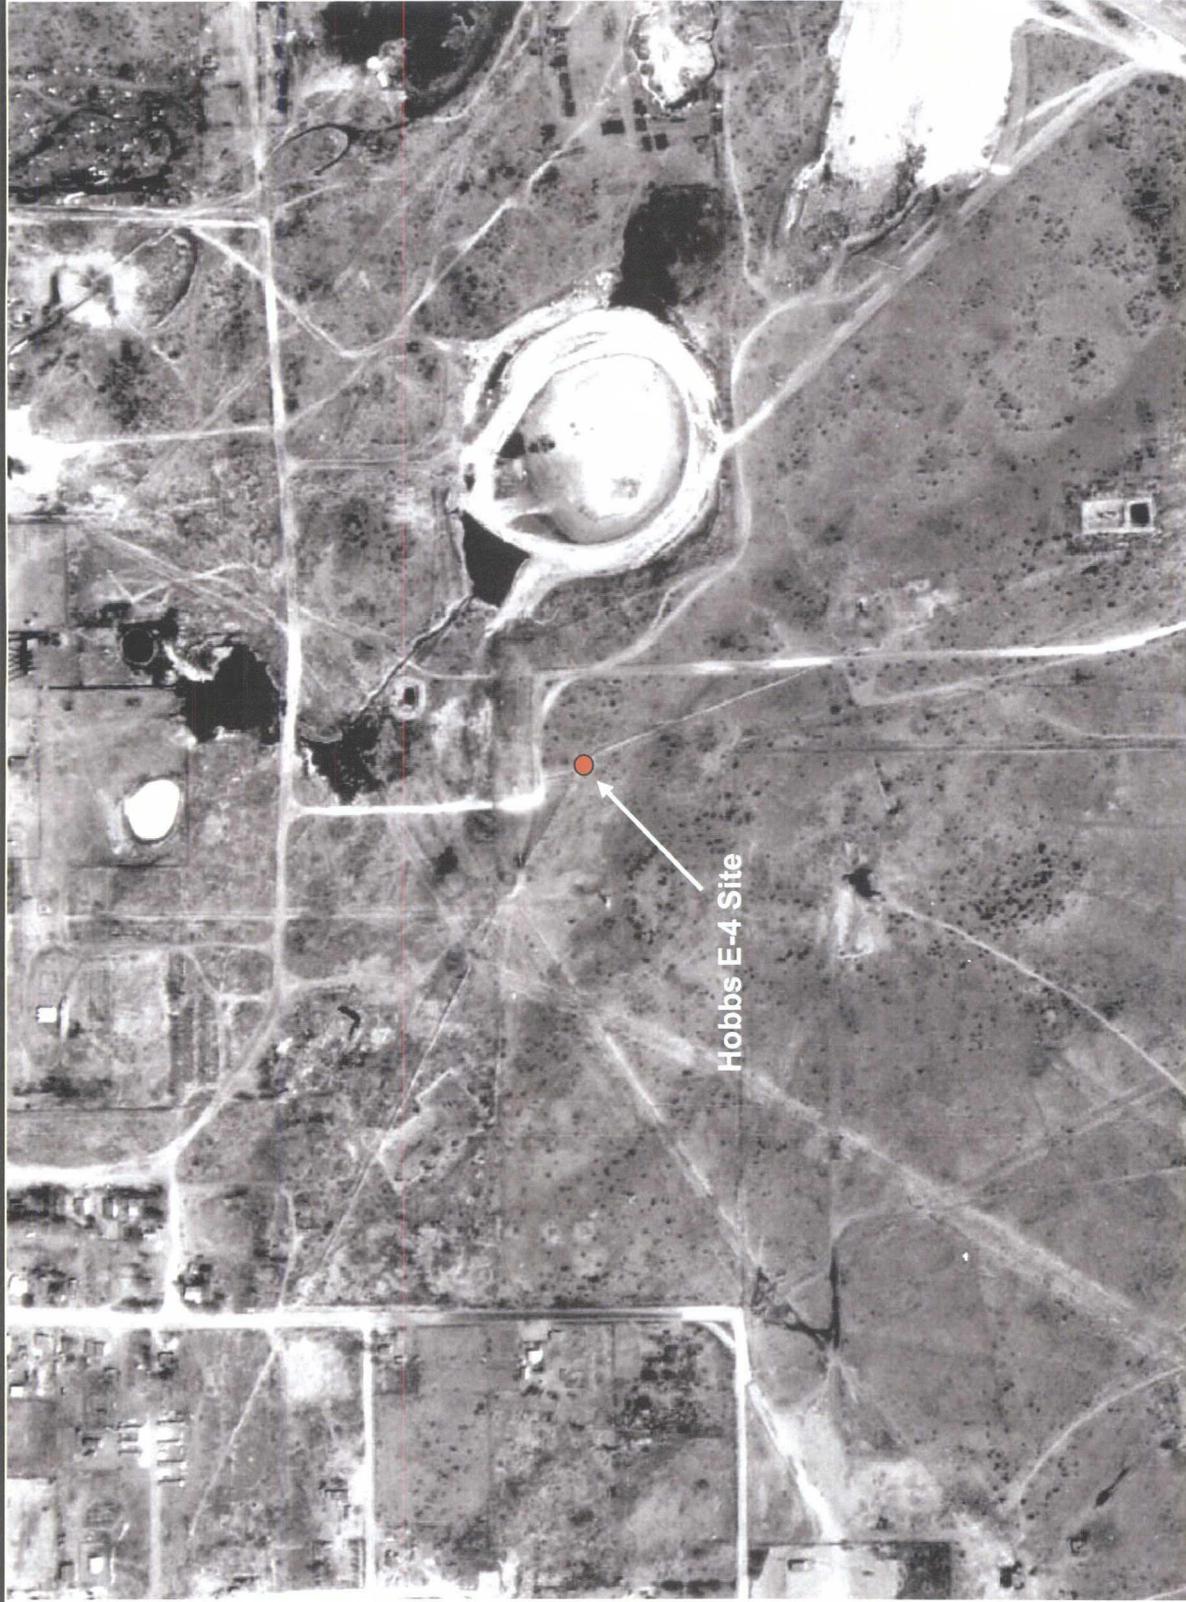
Plate 2B

1967 Aerial Photograph

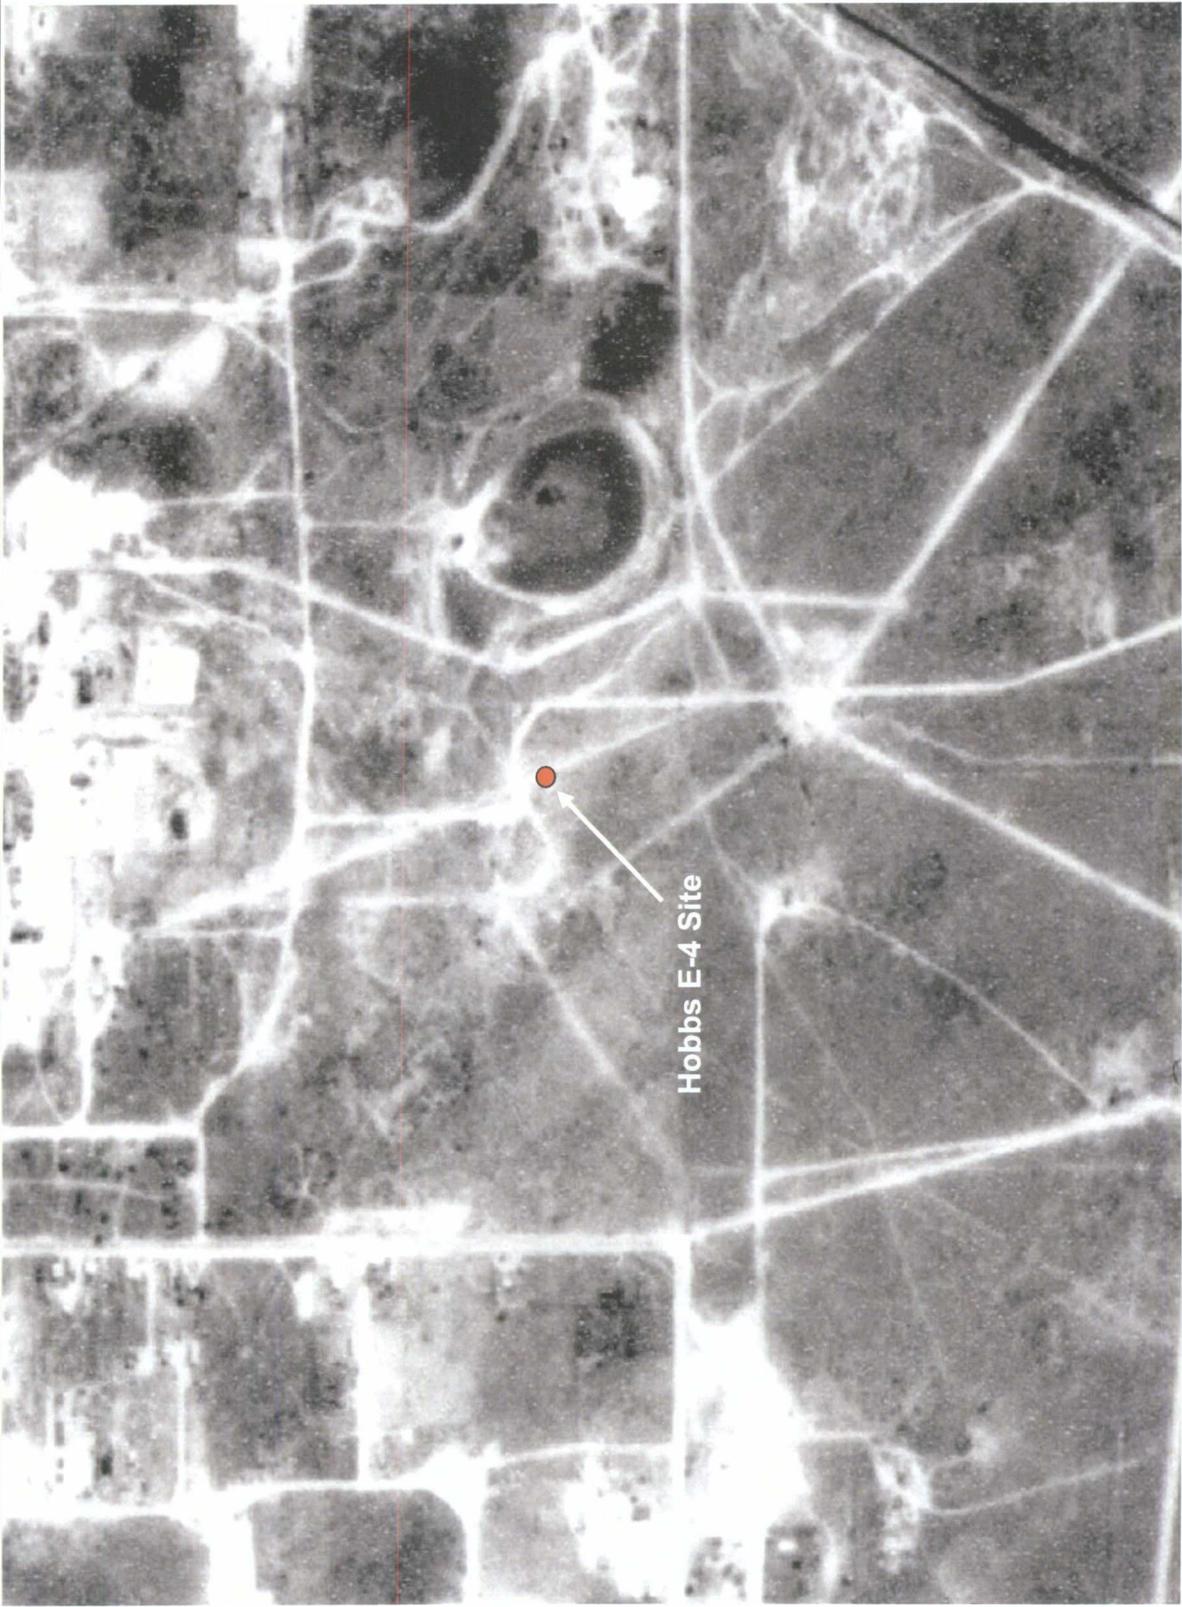
Plate 2C

1977 Aerial Photograph

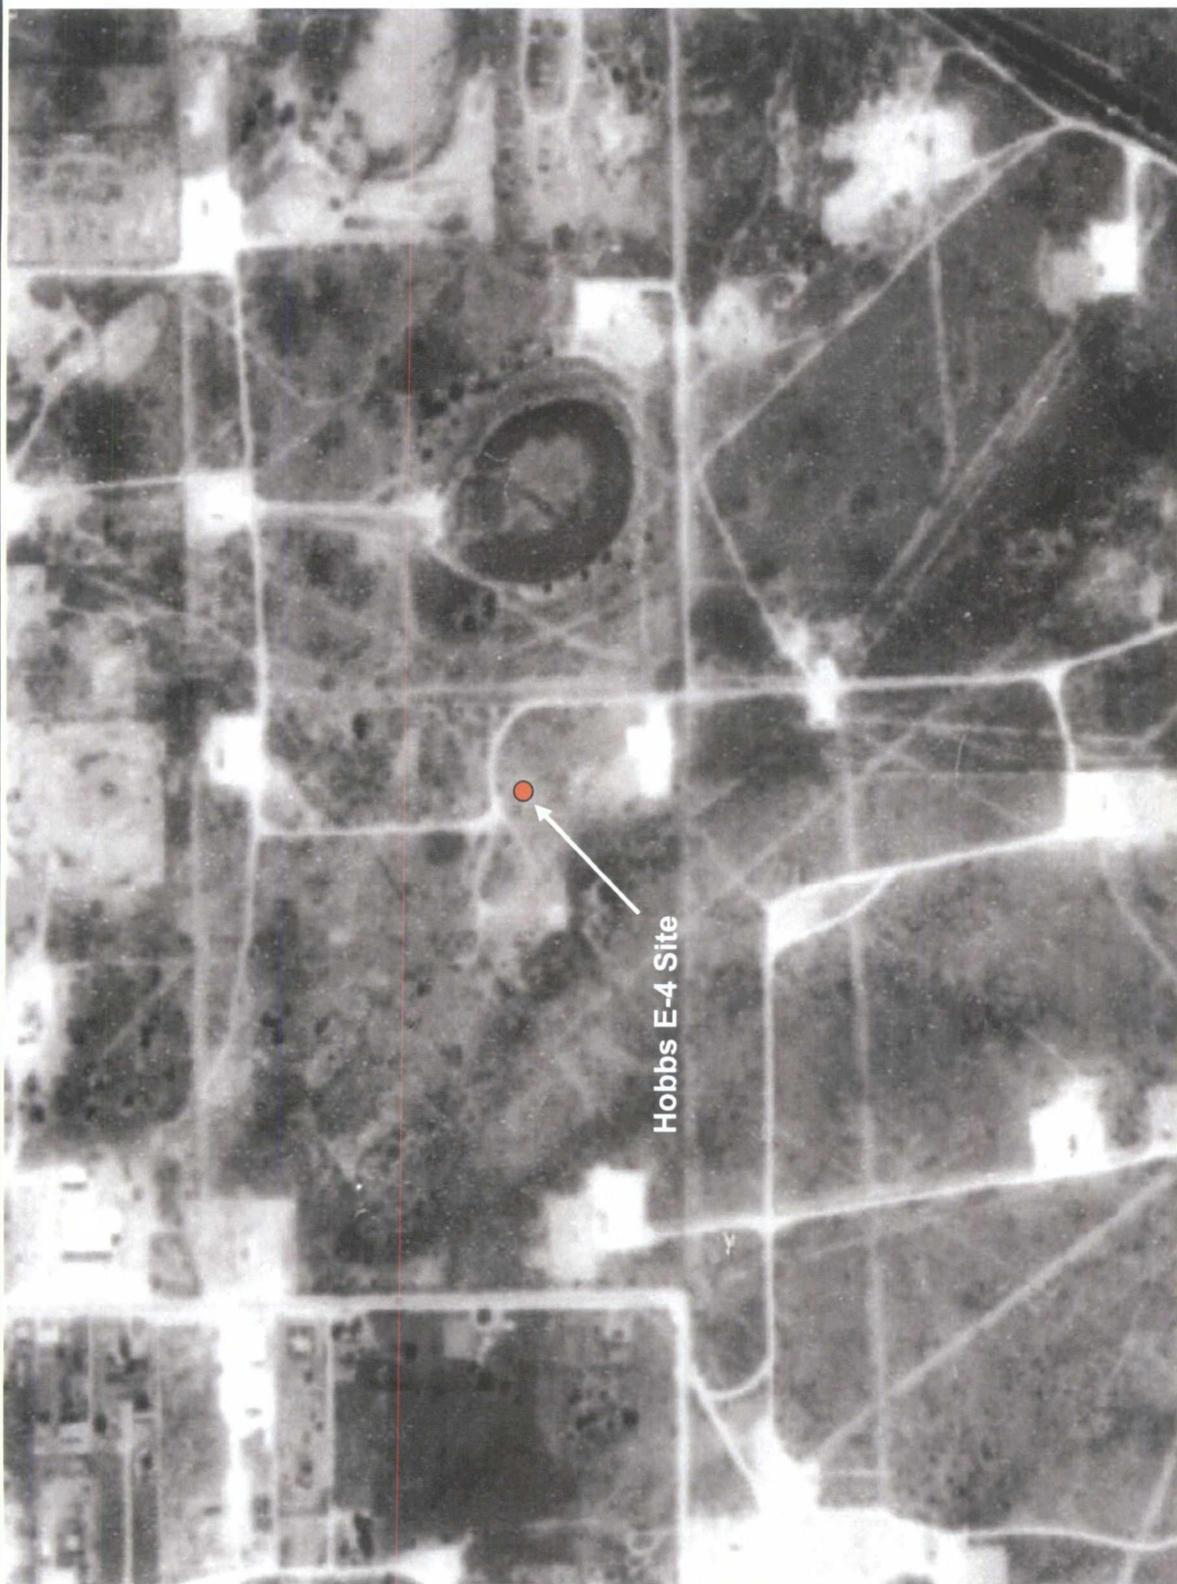
July 2008

Hobbs E-4 Site

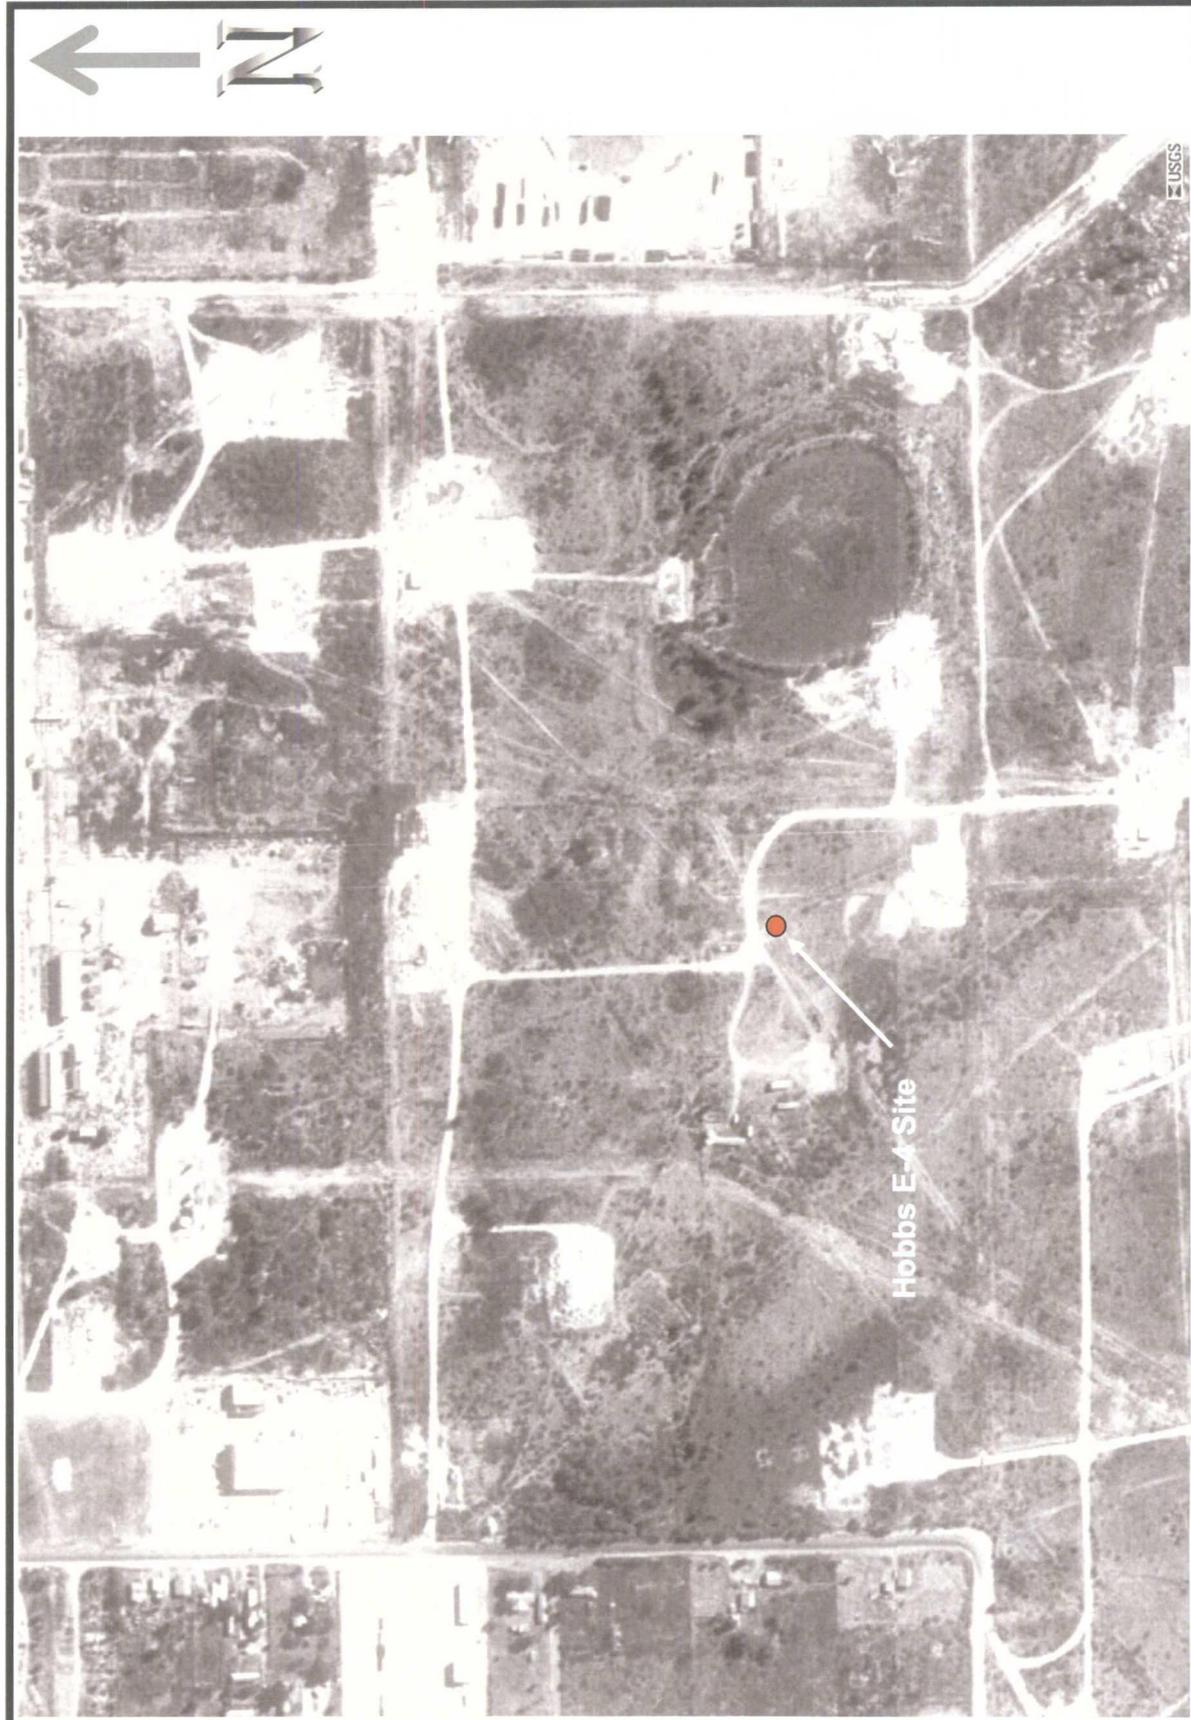
1997 Aerial Photograph

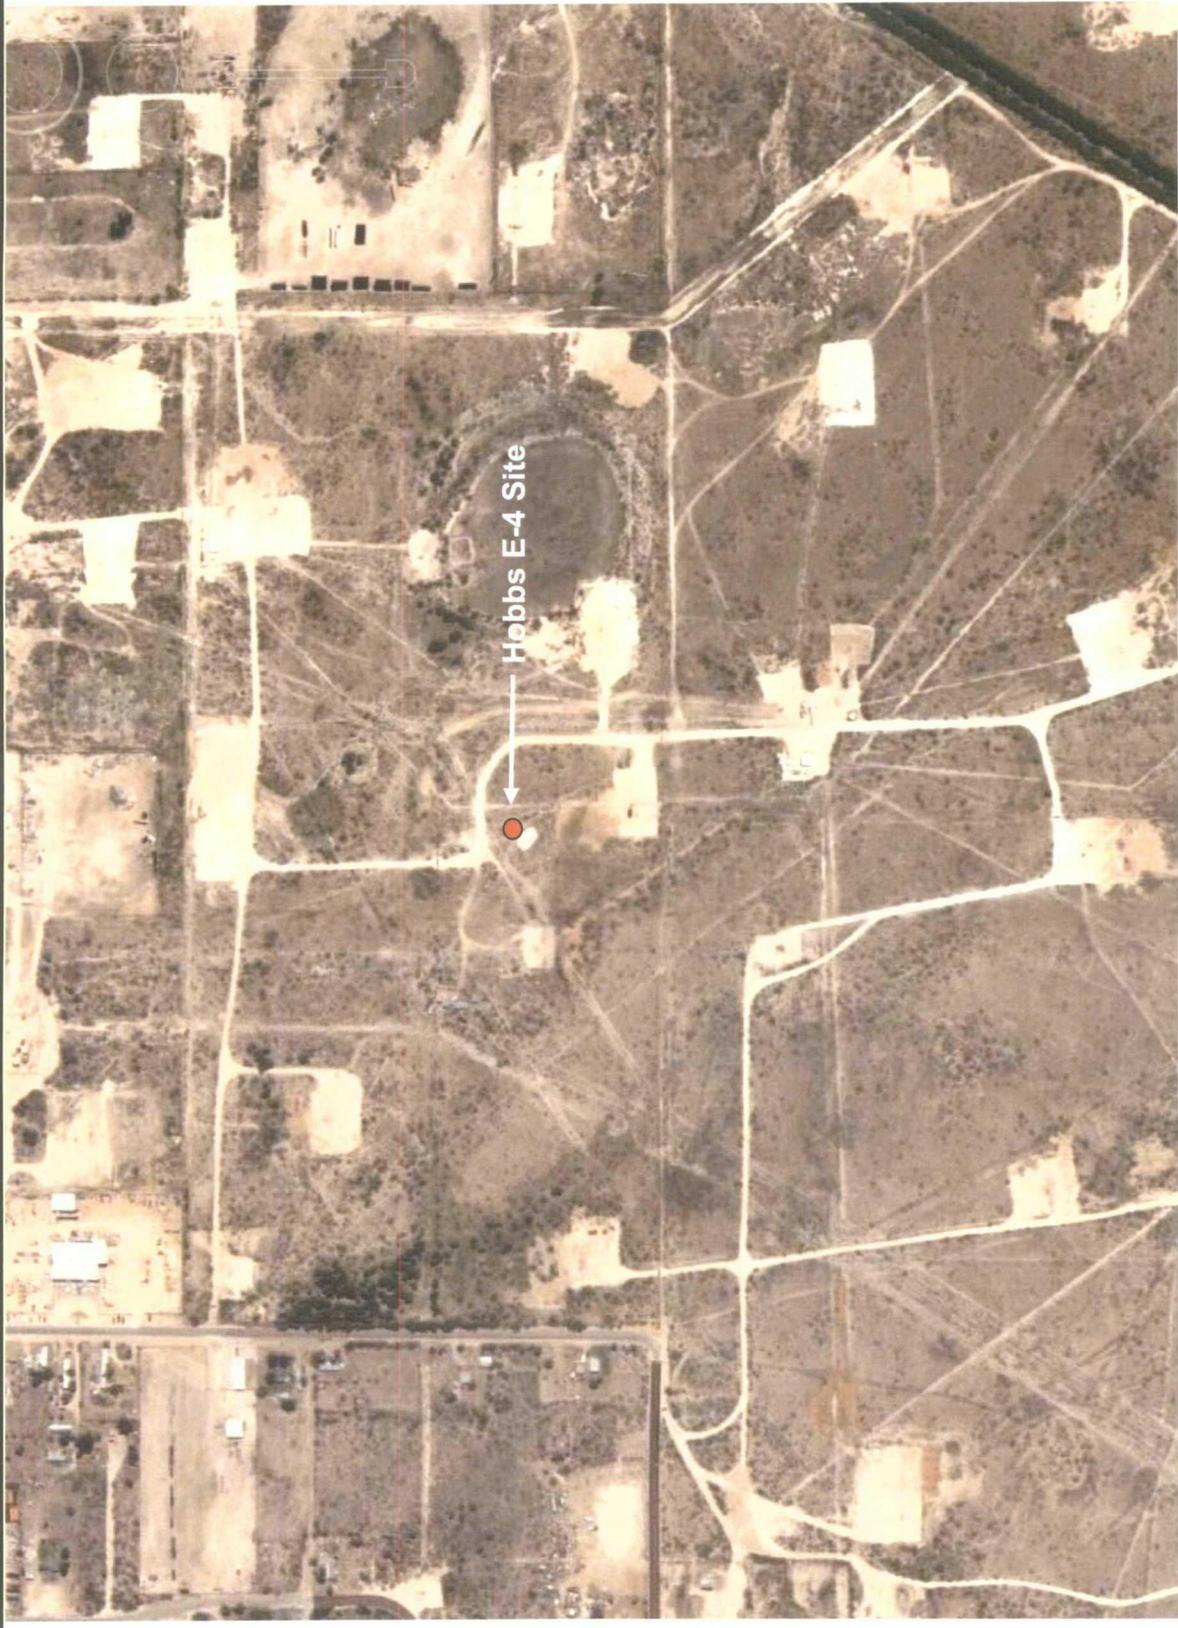
Plate 2F

Current Satellite Image

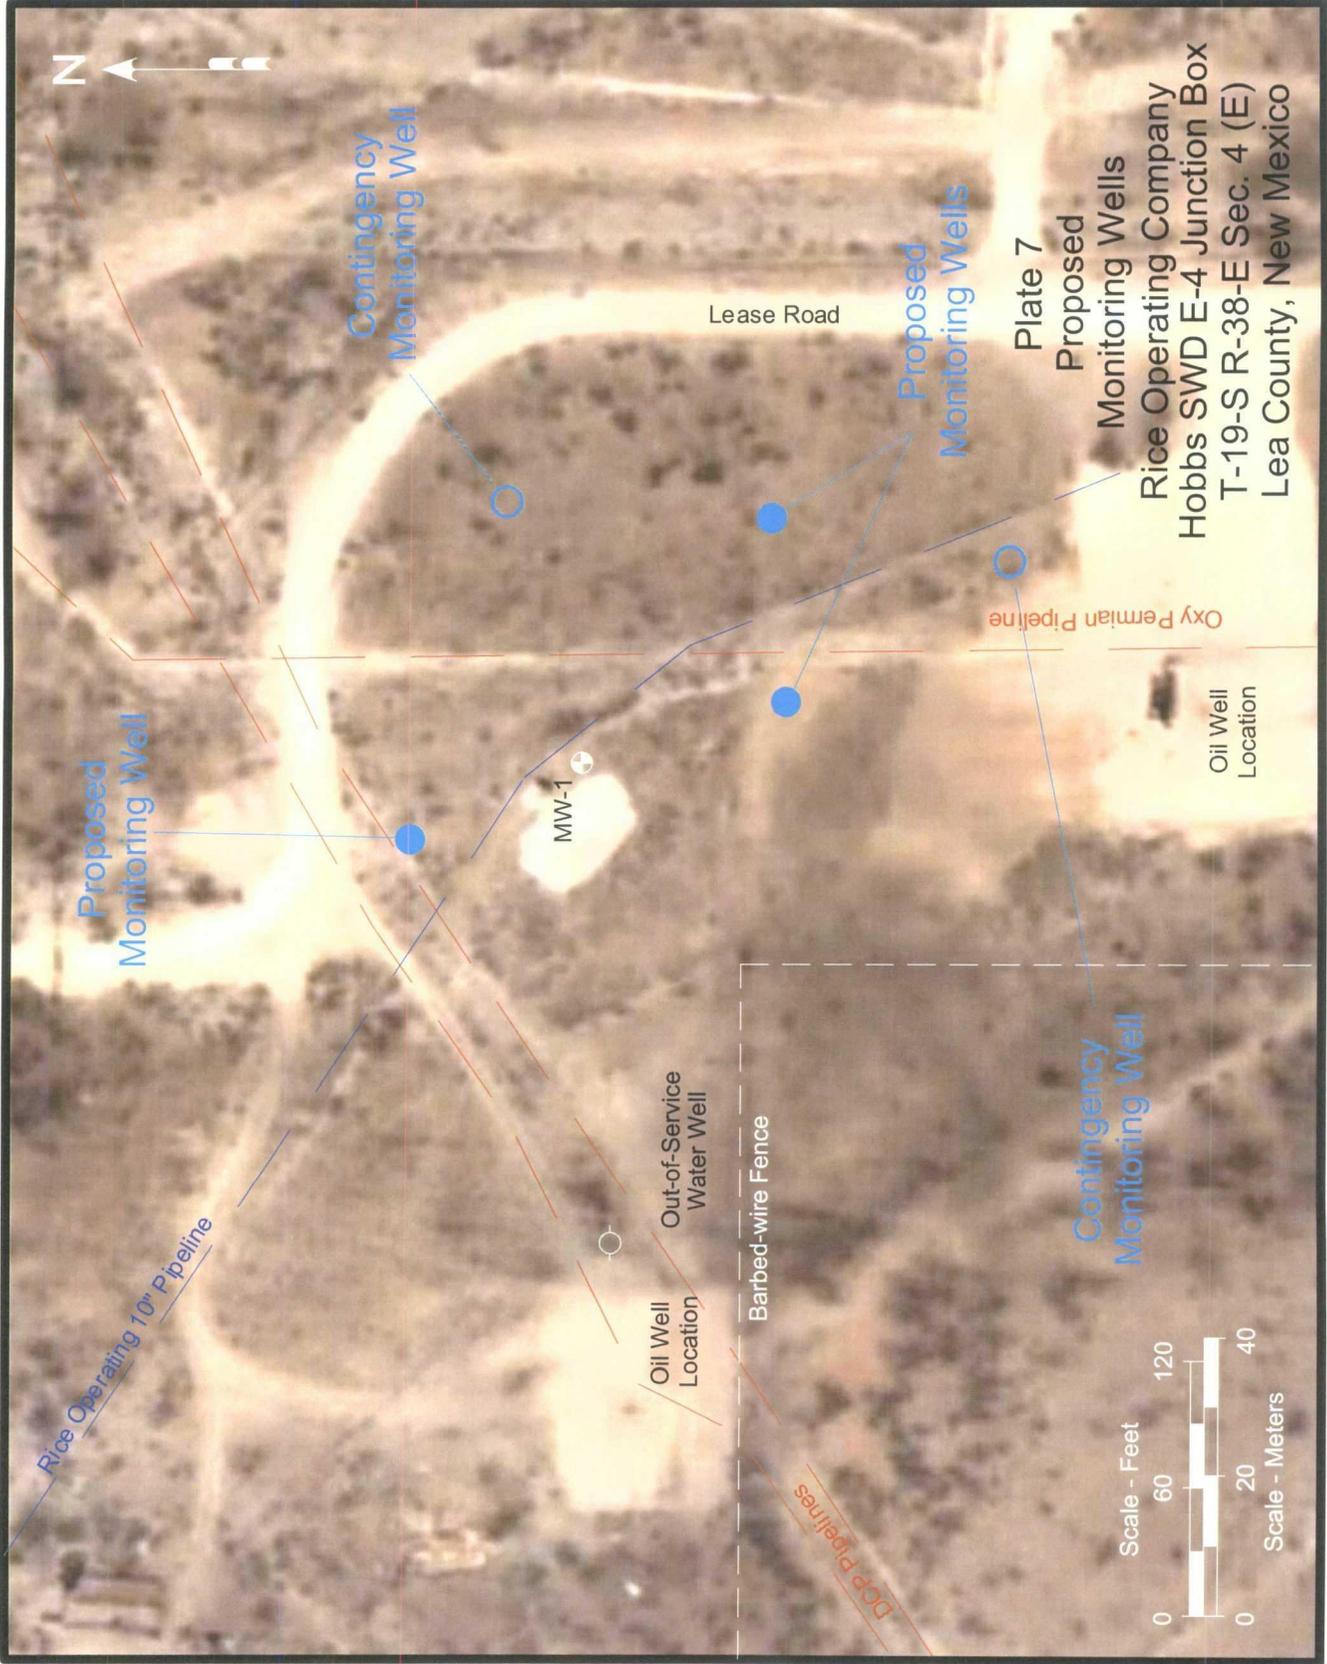
Plate 7
Proposed
Monitoring Wells
Rice Operating Company
Hobbs SWD E-4 Junction Box
T-19-S R-38-E Sec. 4 (E)
Lea County, New Mexico

In late 2008, ROC and Hicks Consultants will install at least three additional monitoring wells to complete the delineation of the hydrocarbon-impacted ground water plume as shown on Plate 7.

ROC and Hicks Consultants recommend that a sufficient number of additional monitoring wells be installed in the area surrounding the site to fully delineate the horizontal extent of the hydrocarbon-impacted ground water. Once delineated, ground water monitoring will be conducted on a quarterly bases for 2 years to determine the plume stability relative to potential receptors. The first annual ground water monitoring report will be prepared and submitted following the spring 2009 sampling event. Recommendations for further corrective actions or remediation will be provided in a Stage 2 Abatement Plan based on the results of the ground water monitoring program.
