**RE: Phase I and II Remediation, Former Enersource Facility, Monument, Lea County,
New Mexico**

WORK PLAN for PHASE II REMEDIATION

Former Enersource Facility, Monument, New Mexico

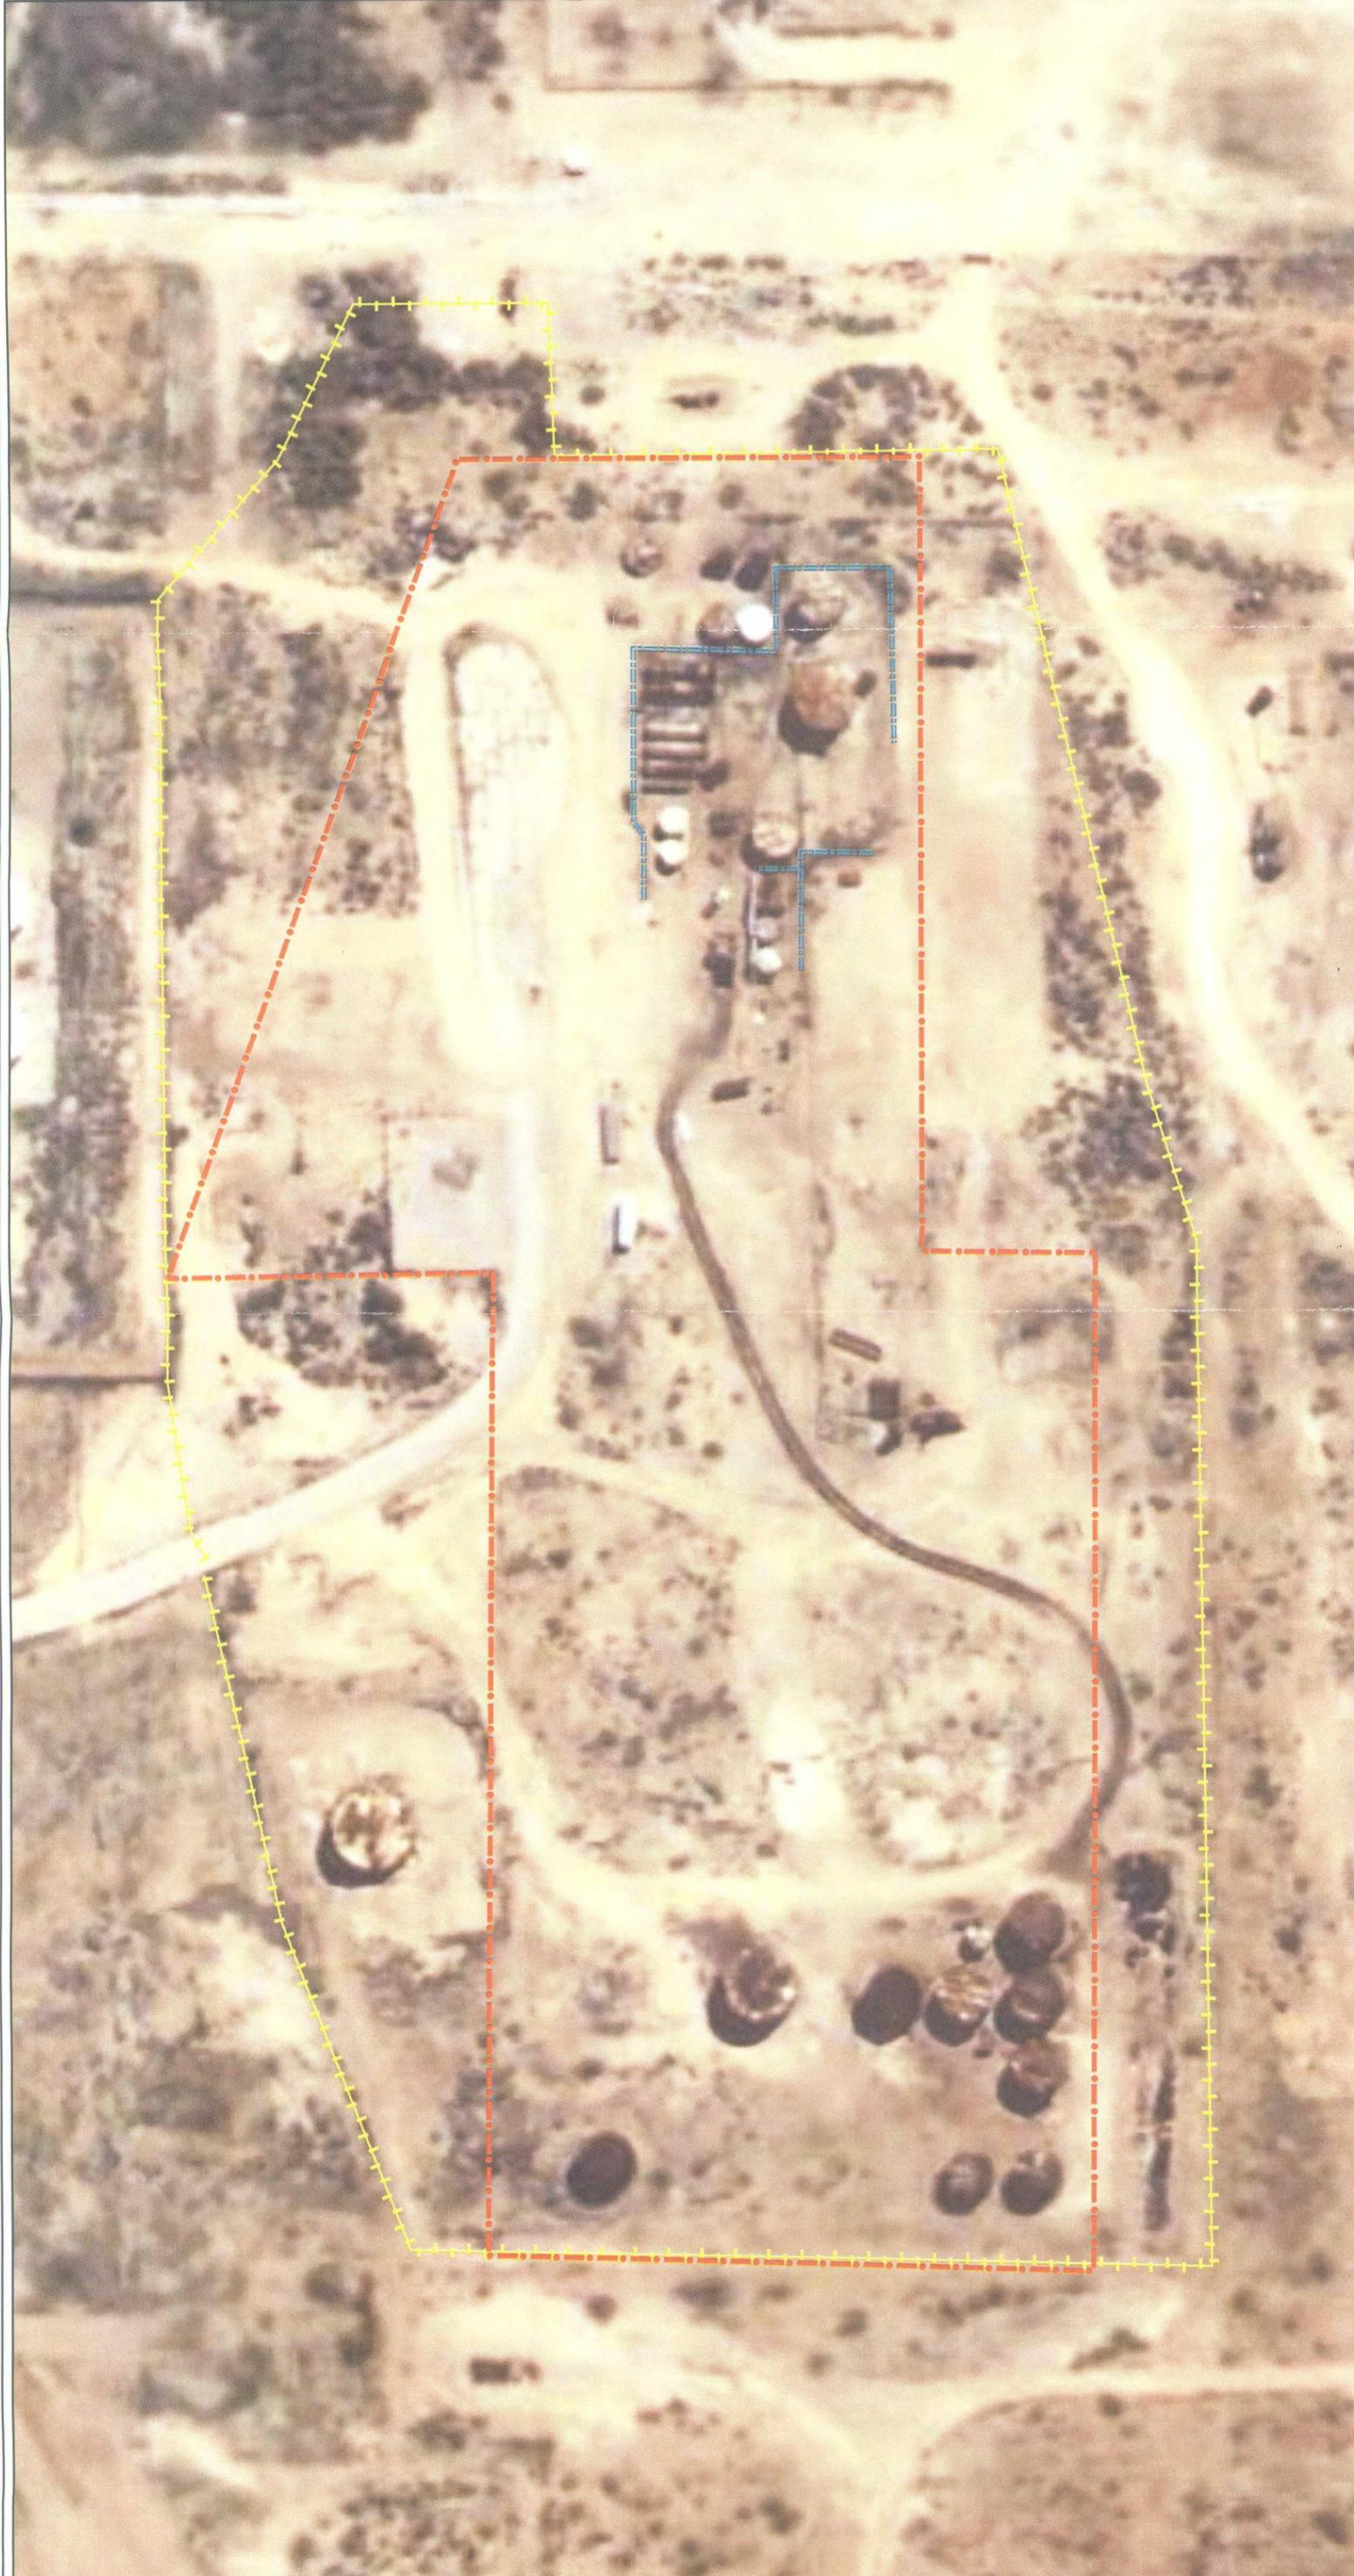
Figure 2
 Site Plan - 2005 Aerial Photograph
 Enersource Site - Monument, NM

Source(s): 2005 aerial photo - MapTech.

Land in the area is used for oil and gas exploration/production and cattle ranching. The Versado Gas Processing Plant (remediation permit # 1R-281) is located immediately adjacent to the northern property boundary. El Paso Natural Gas operates a facility within 500 feet of the eastern property boundary. Numerous oil/gas wells, pump jacks, and storage tanks are in the vicinity. The estimated property boundary and the fenced area believed to have been used by Enersource operations are illustrated on Figure 2.

INTERA was contracted in 2006 to test the existing ASTs and fluids/sludge for naturally occurring radioactive materials (NORM) and subsequently remove these materials from the Site. The tanks illustrated in Figure 2 and some underground piping were removed from the Site and disposed of at an off-Site facility in the summer of 2006. During the removal action, soil samples were collected at eight (8) locations from a depth of 3.25 feet below ground surface across the site and the samples were analyzed for total petroleum hydrocarbons (TPH), diesel range and motor oil range organics (DRO and MRO), and chlorides. Locations of tanks, samples, and analysis results are illustrated on Figure 2.

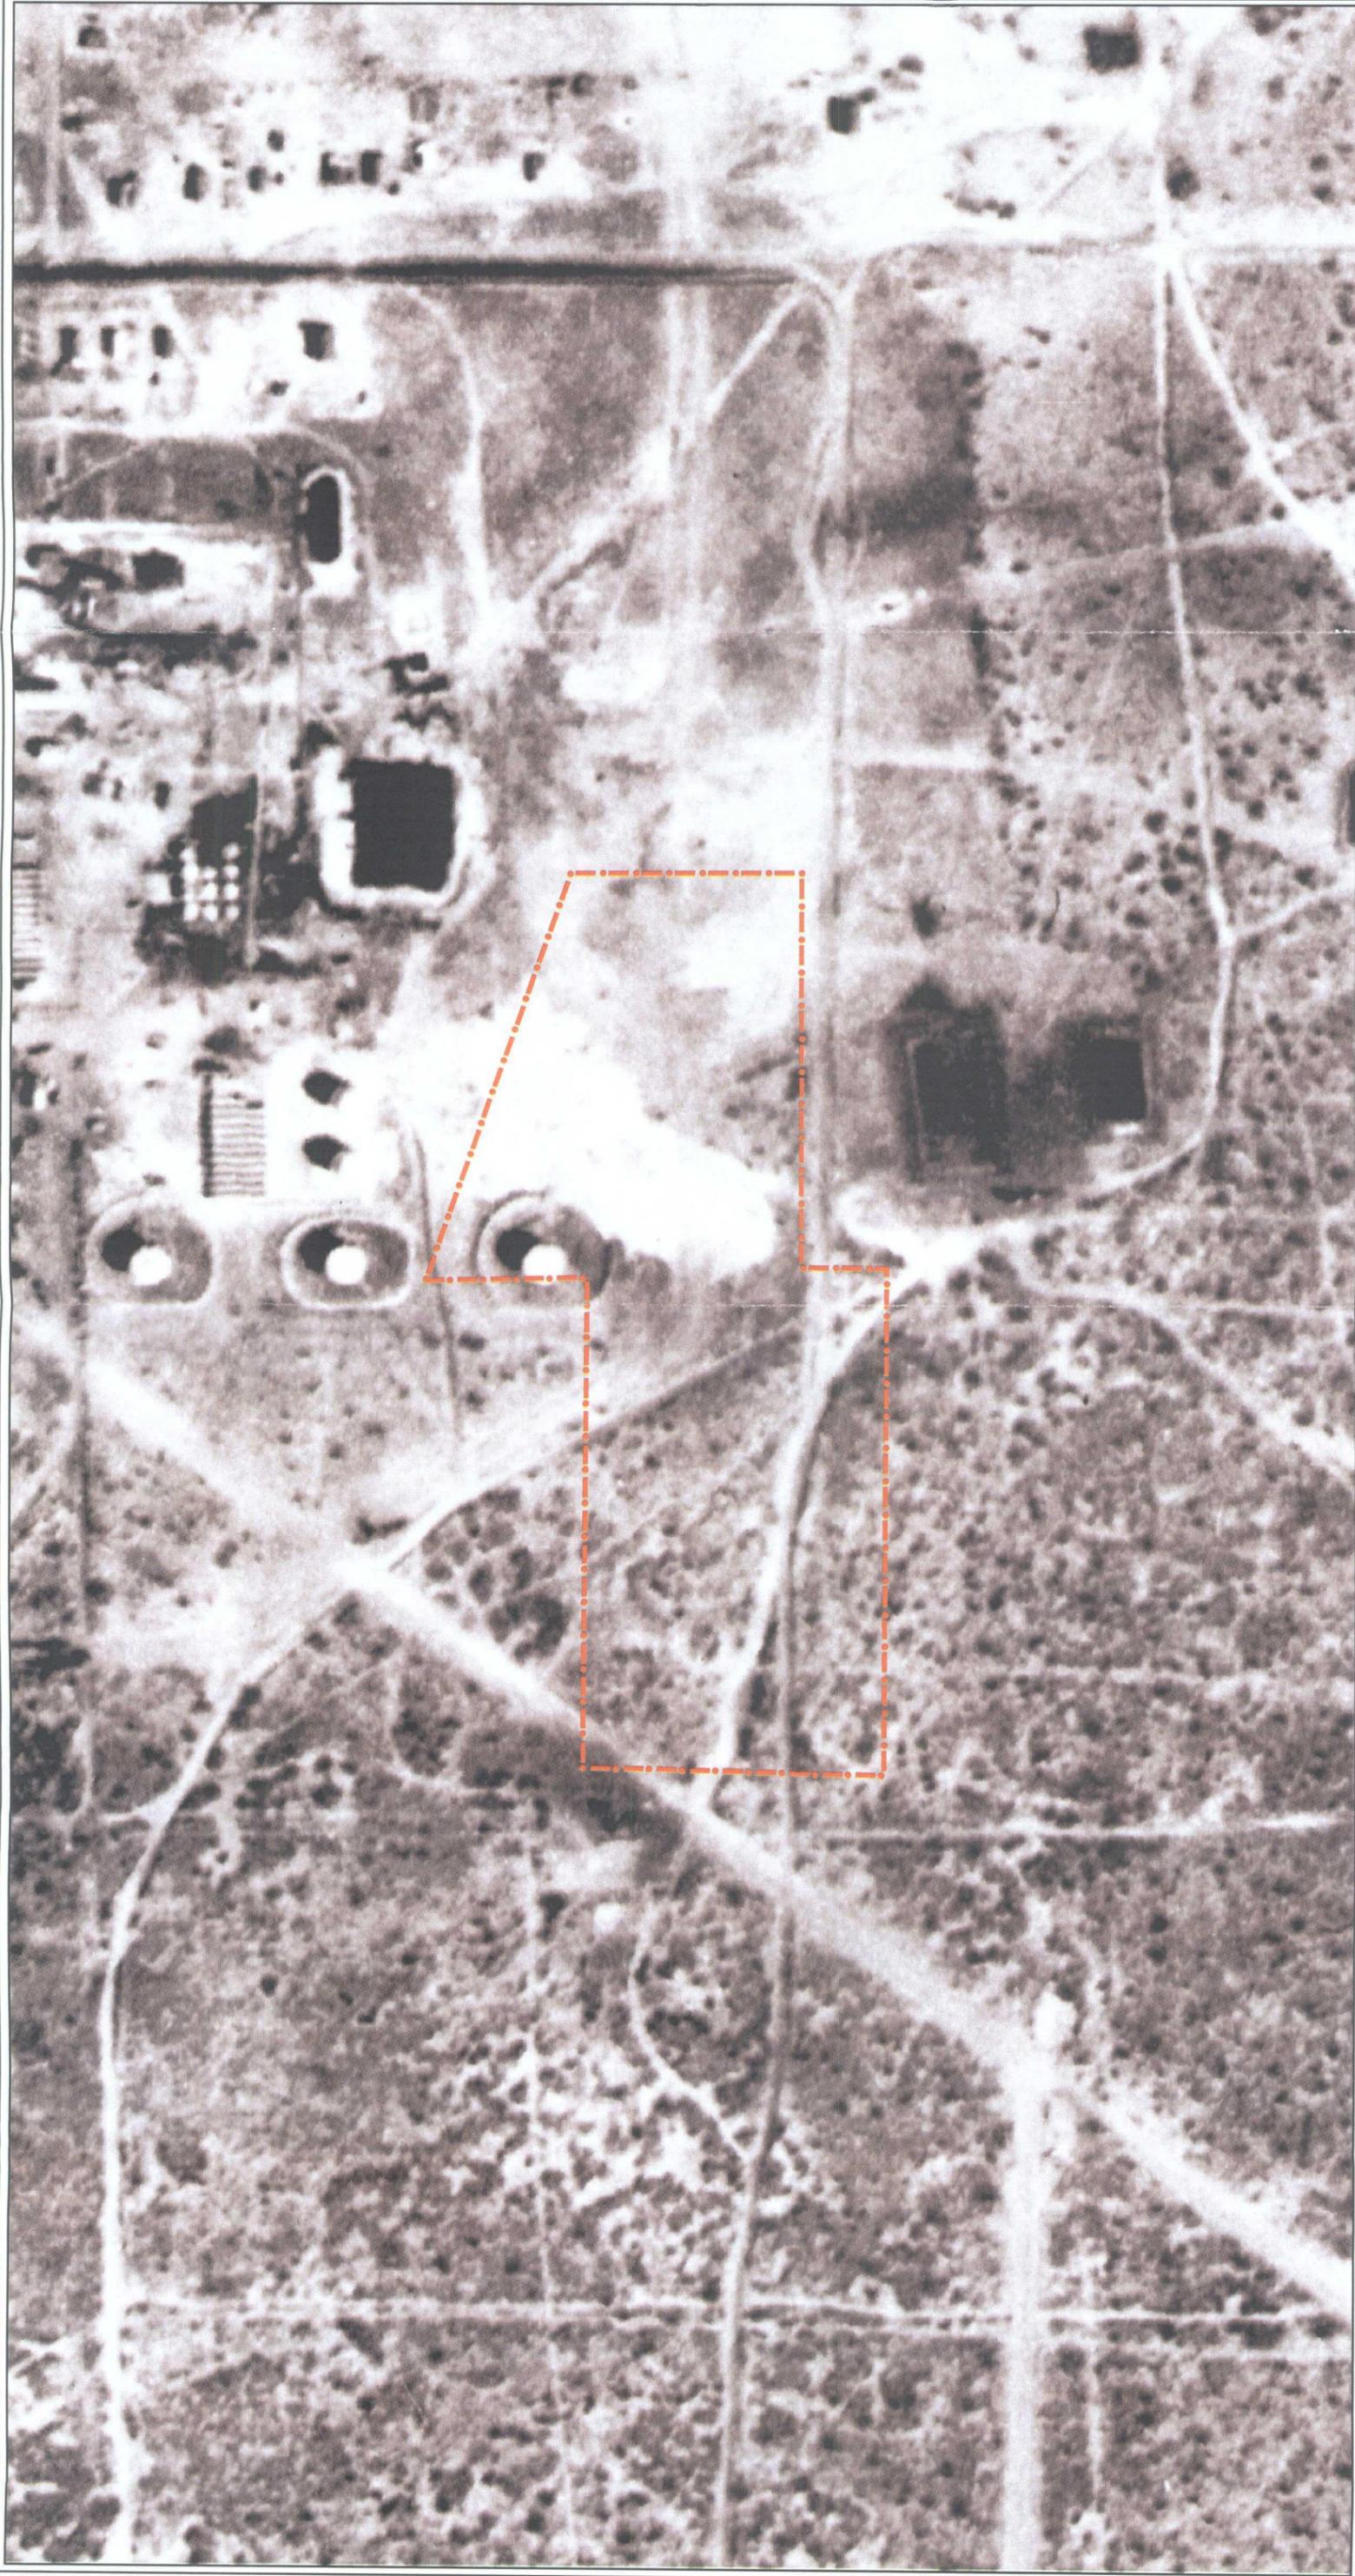
Figure 3
1949 Aerial Photograph
Enersource Site - Monument, NM

Source(s): 1949 aerial photo - Earth Data Analysis Center.

Based on historical aerial photographs taken in 1949, 1966, and 1978 (see Figures 3 through 5), it appears that major development at the Site occurred after 1949. The aerial photograph taken in 1949 (Figure 3) reveals one large tank that straddles the Site boundary, but, with the exception of some roads, the remainder of the Site is undeveloped. The 1966 (Figure 4) and 1978 photographs (Figure 5) show numerous (> 25) above ground tanks located within or slightly

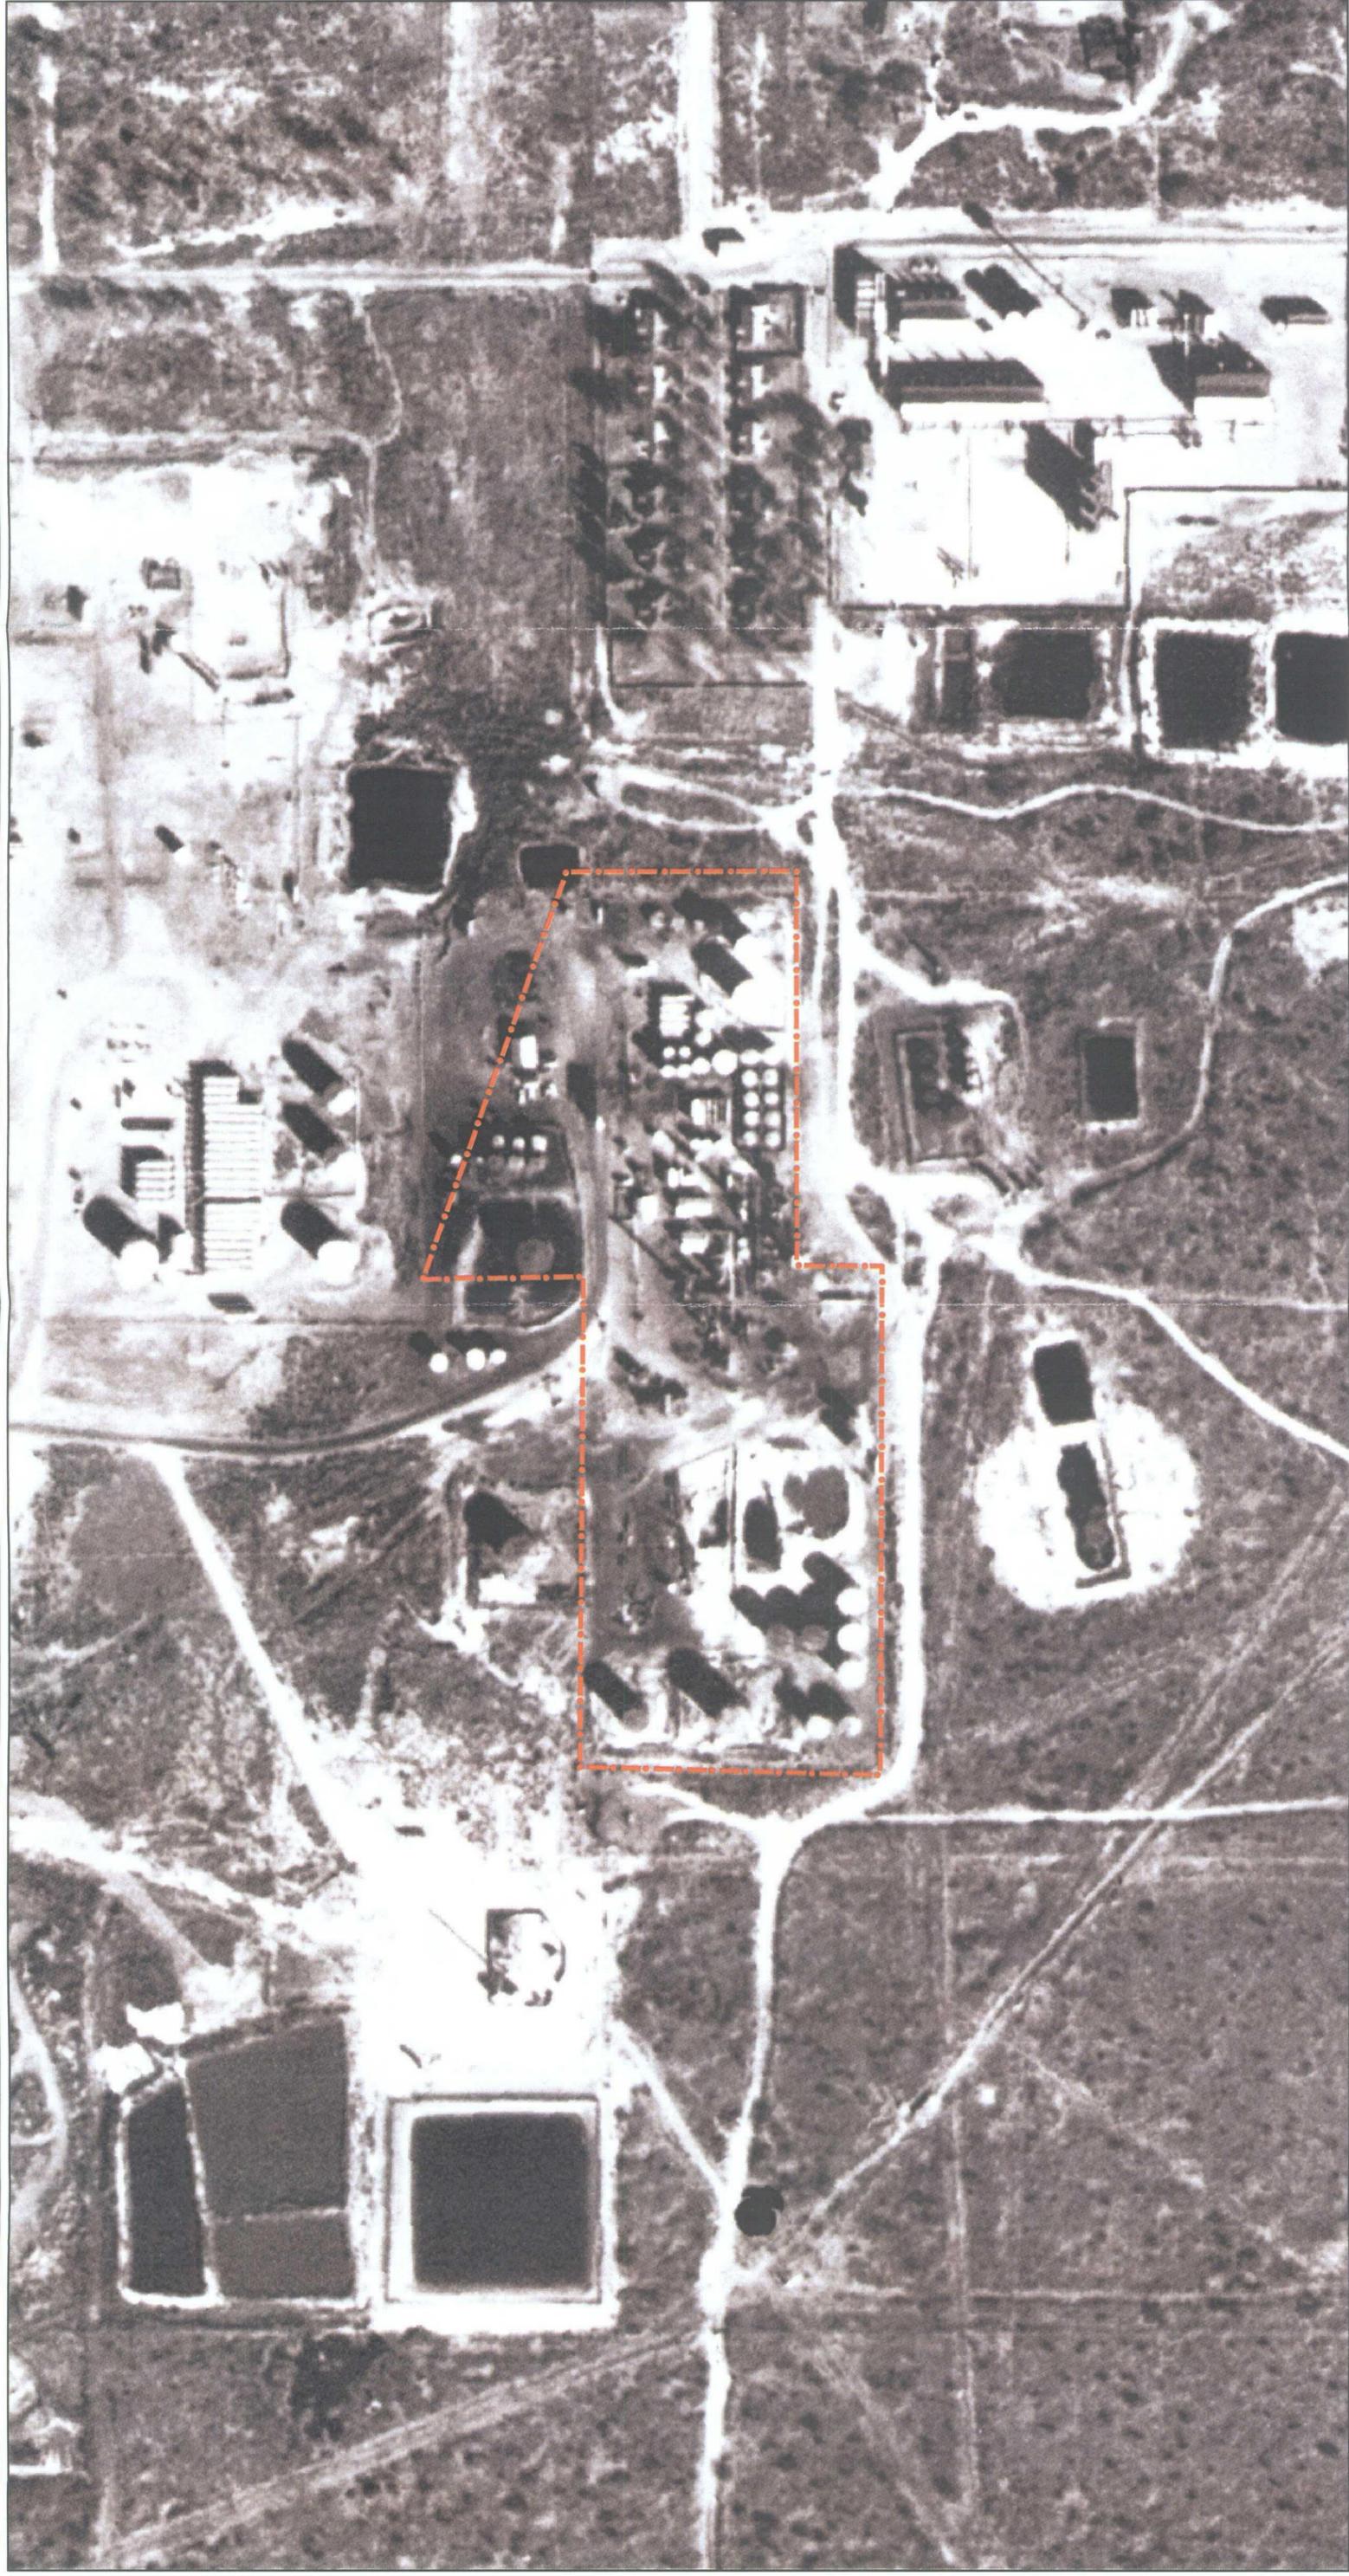
Figure 4
1966 Aerial Photograph
Enersource Site – Monument, NM

Source(s): Aerial photo – Earth Data Analysis Center

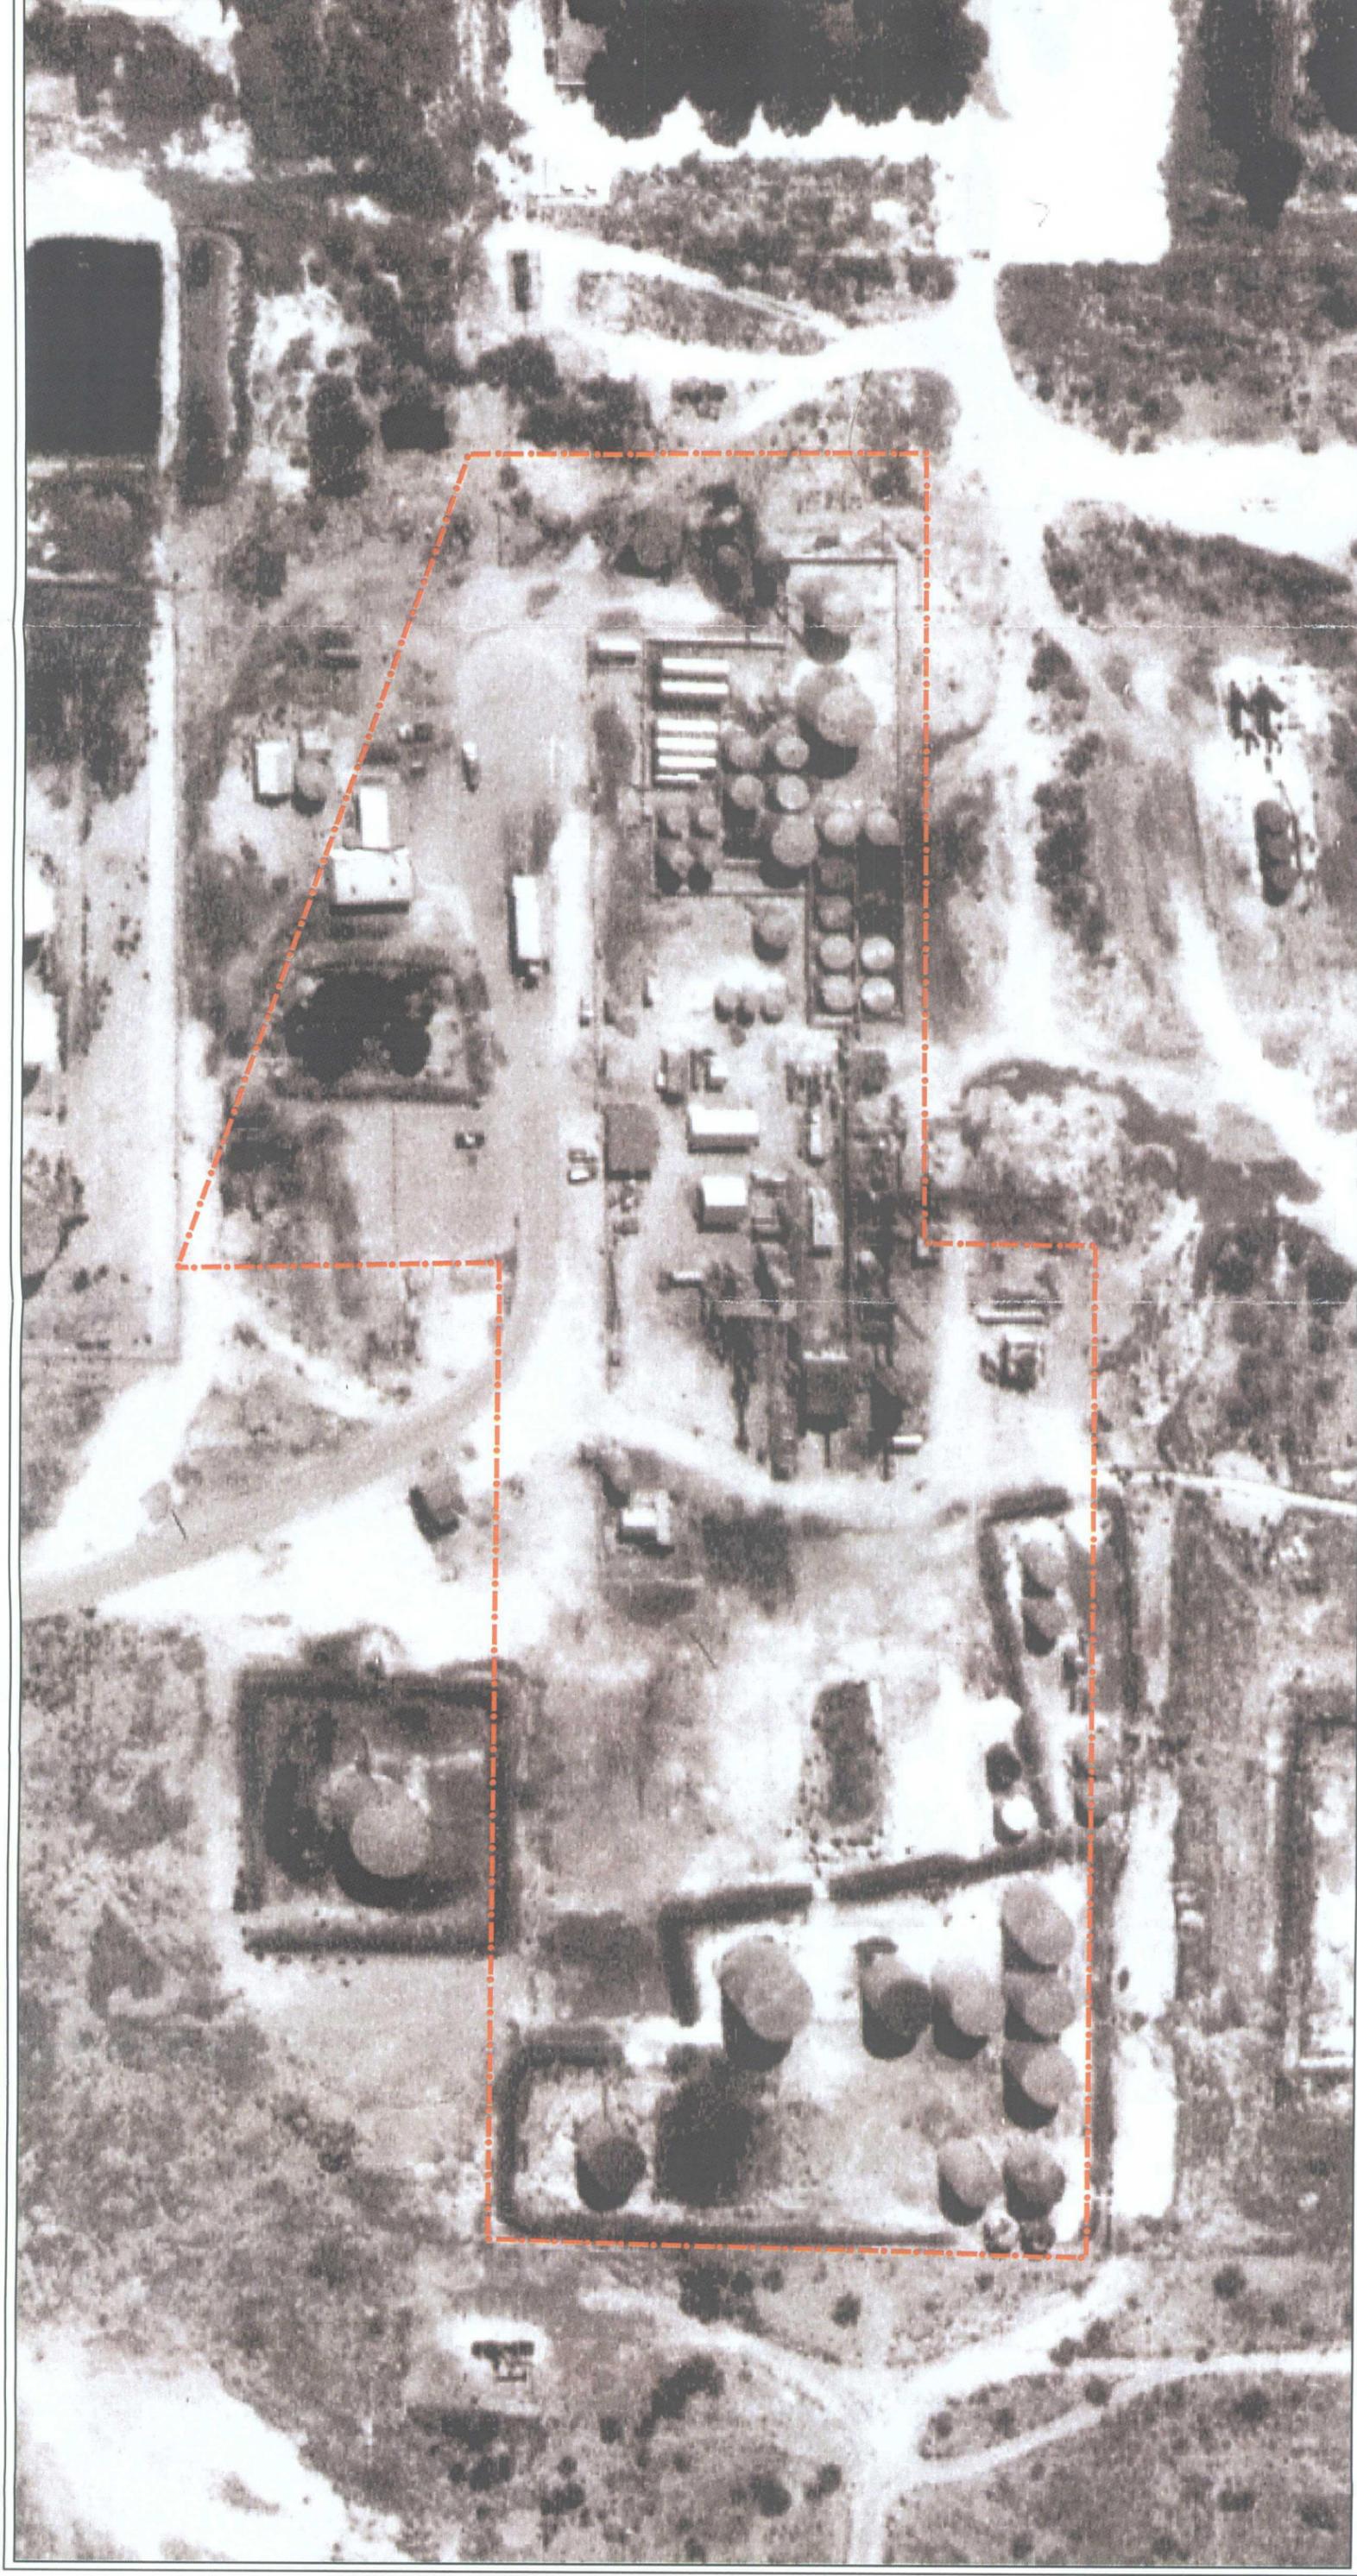
Source(s): 1978 aerial photo - Earth Data Analysis Center.

outside the property boundary. The tanks are arranged into an eastern and a western cluster. The tank sizes within the western cluster are, in general, larger than the tanks in the eastern cluster. The two clusters of tanks are separated by a central area that contains buildings and, based on the shape of the shadows, tall narrow structures. Mr. Larry Parker, a long time resident of Lea County, stated that the Site was used as a jet fuel refinery during this time period. Therefore, these tall, narrow structures formerly located in the central part of the Site may be cracking or distillation towers. Given the larger tank sizes, the western part of the property was probably used for crude storage; and the eastern cluster was used for product storage. A tractor trailer truck can be seen in the 1978 aerial photograph (Figure 5) just north of the central processing area; this area may have been used for product loading.

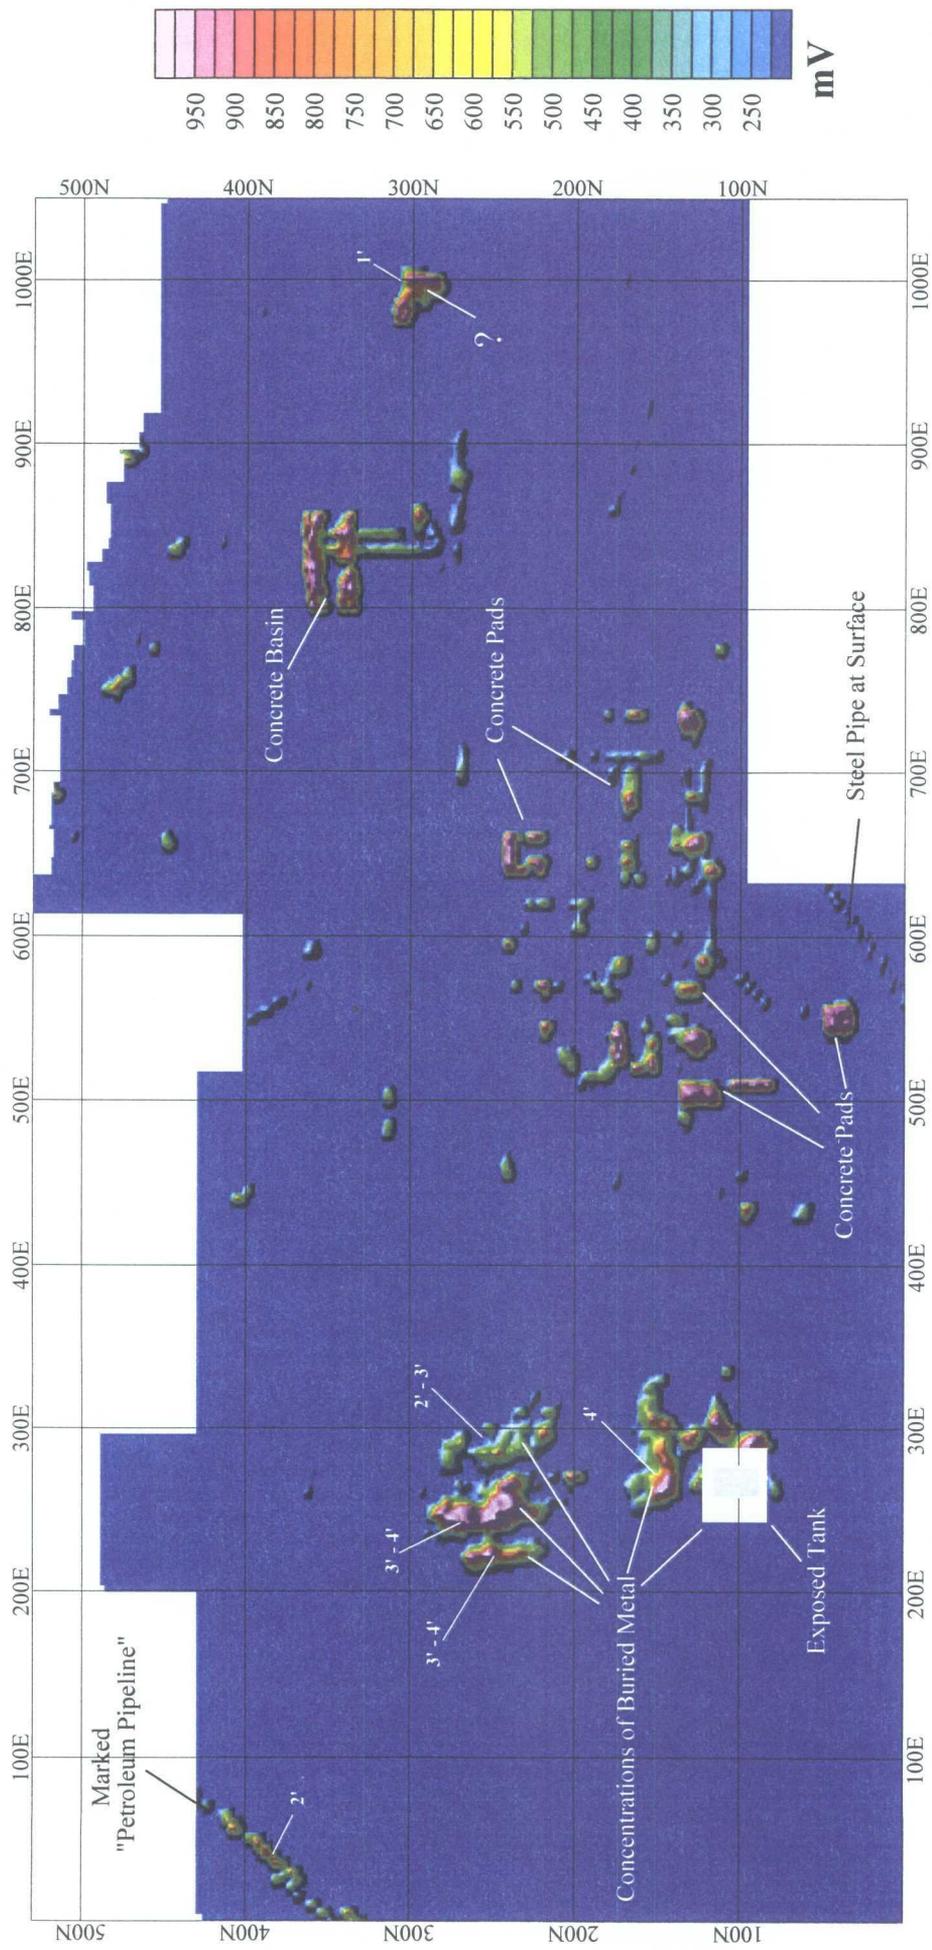
Figure 1. Enersource Site - Monument, New Mexico
 Strong EM-61 Response (Major Concentrations of Metal)

- A large buried pipe traverses the northwest corner of the Site. This pipe is marked by surface signs designating it as a "Petroleum Pipeline".
- Several concentrations of buried metal are found between 200E and 300E. A large metal tank is exposed just below the surface at 270E, 100N. There appear to be an additional four trenches containing buried waste. These have dimensions of approximately 90 ft by 60 ft. The depth of cover over the waste is annotated.

- The area between 500E, 0N to 750E, 250N contains several concrete pads and/or foundations that provide some but not all of the EM-61 response. Contributions from buried pipes are present as discussed below. A steel pipe is exposed at the surface crossing a corner of the survey.

- A shallow concrete basin is located at 825E, 350N. Several pipes cut flush with the surface are seen in the basin.
- An unidentified object is found at 1000E, 300N and is marked "?".

3' = depth of burial

- There are five significant major concentrations of buried demolition waste including the previously exposed buried tank.
- Buried pipes are found essentially across the entire site, and extend off-site to the north, south, and east. The depth of burial varies from just below the surface to approximately 4.5 ft.
- There is a concentration of buried pipes and fixtures from 500E, 100N to 700E, 250N, in the vicinity of several concrete pads.
- A second concentration of pipes and fixtures is located from 750E, 200N to 950E, 325N, immediately south of the concrete basin.

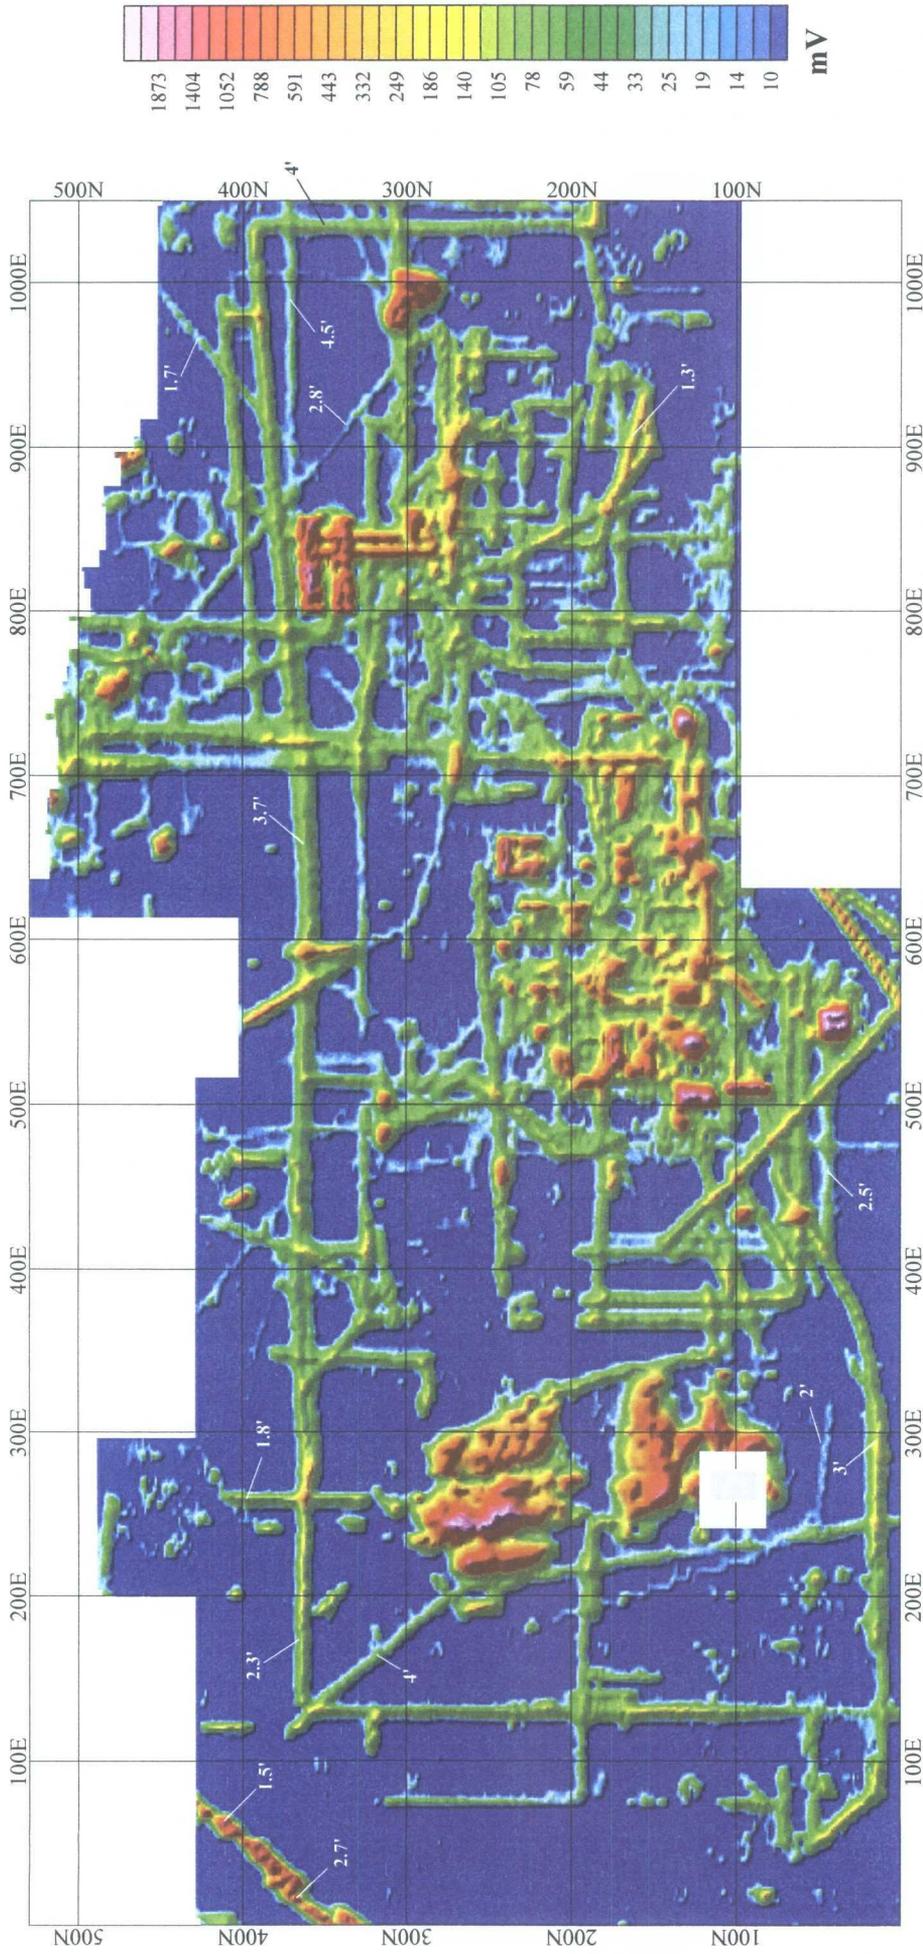
Figure 2. Enersource Site - Monument, New Mexico
Higher Resolution EM-61 Response

The EM-61 data are re-projected at higher resolution in Figure 2. The color contours are presented on a logarithmic scale to enhance low magnitude features (buried pipes) while retaining the larger features seen in Figure 1. Observations include:

- Buried pipes are found essentially across the entire site. The lateral runs of buried pipes combine to over one mile in total length. The approximate depths of several pipes are annotated, ranging from just below the surface to approximately 4.5 ft.
- Buried pipes associated with the Enersource Site penetrate the north, south, and east edges of the survey.
- There appears to be considerable interconnection by buried pipes between the concrete pads in the area 500E, 0N to 750E, 250N.
- Another concentration of buried pipes is found immediately south of the concrete basin.

2.8' = depth of burial

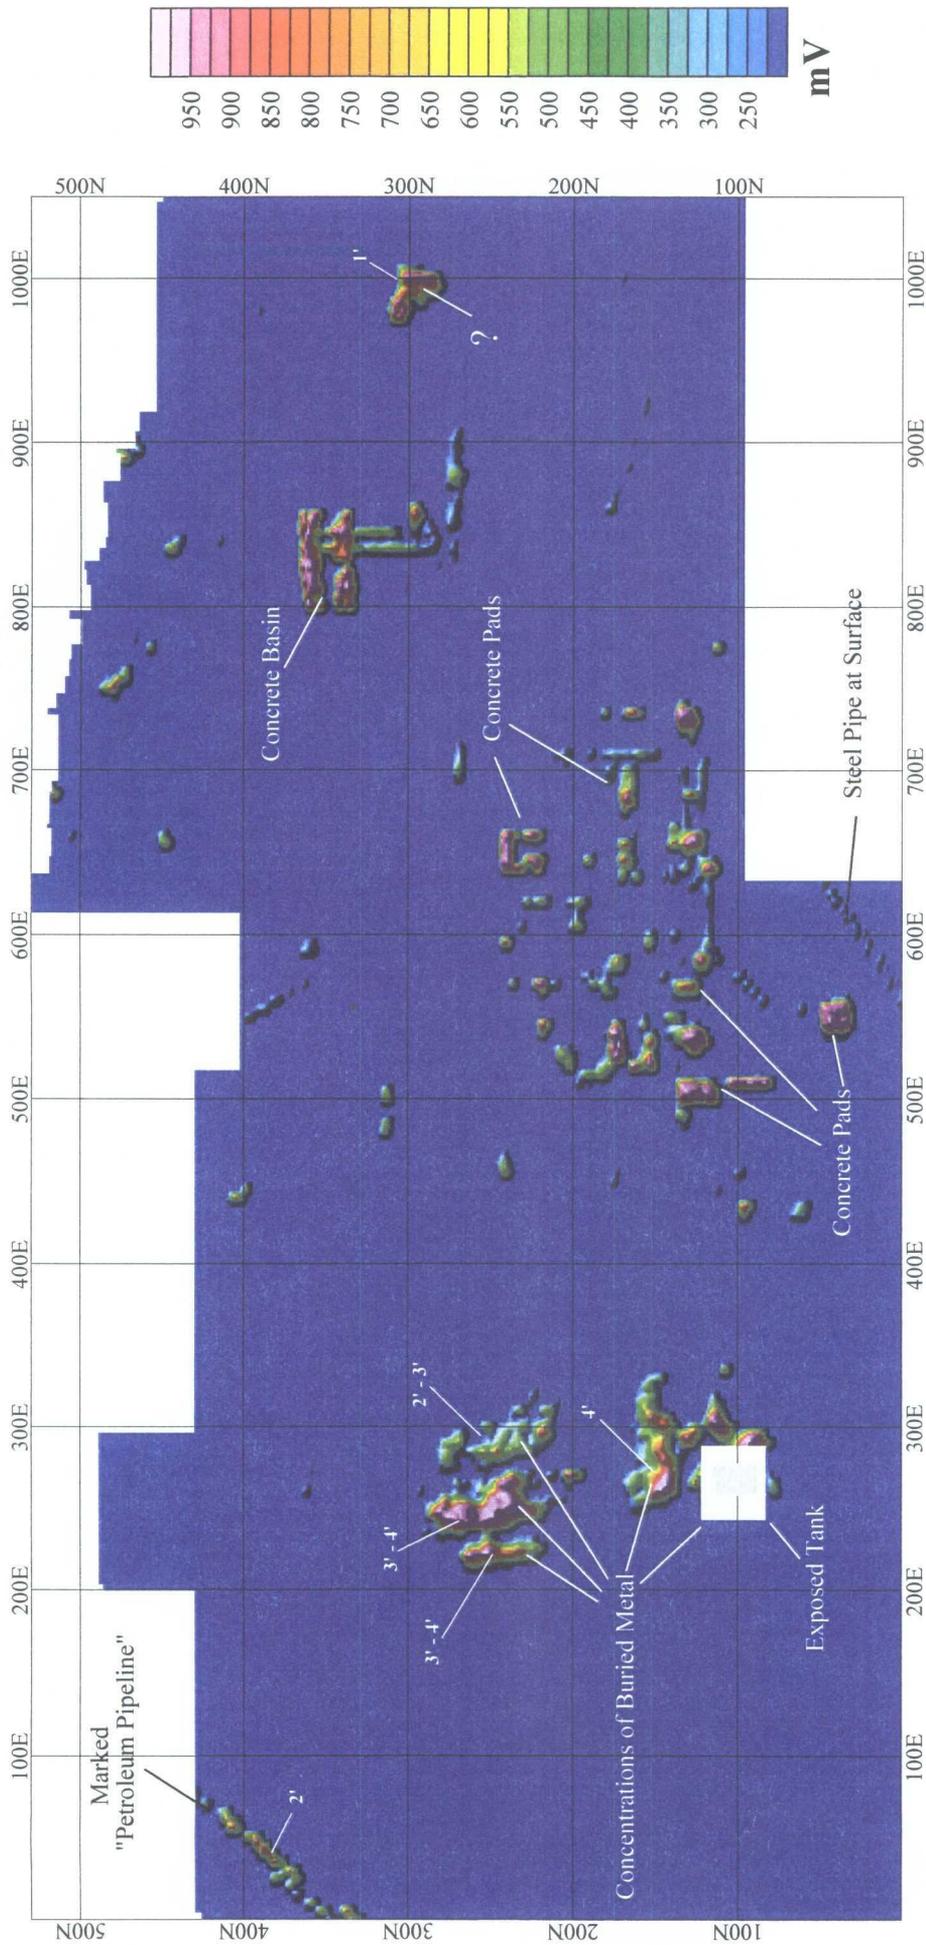
Figure 1. Enersource Site - Monument, New Mexico
 Strong EM-61 Response (Major Concentrations of Metal)

- A large buried pipe traverses the northwest corner of the Site. This pipe is marked by surface signs designating it as a "Petroleum Pipeline".
- Several concentrations of buried metal are found between 200E and 300E. A large metal tank is exposed just below the surface at 270E, 100N. There appear to be an additional four trenches containing buried waste. These have dimensions of approximately 90 ft by 60 ft. The depth of cover over the waste is annotated.

- The area between 500E, 0N to 750E, 250N contains several concrete pads and/or foundations that provide some but not all of the EM-61 response. Contributions from buried pipes are present as discussed below. A steel pipe is exposed at the surface crossing a corner of the survey.

- A shallow concrete basin is located at 825E, 350N. Several pipes cut flush with the surface are seen in the basin.
- An unidentified object is found at 1000E, 300N and is marked "?".

3' = depth of burial

- There are five significant major concentrations of buried demolition waste including the previously exposed buried tank.
- Buried pipes are found essentially across the entire site, and extend off-site to the north, south, and east. The depth of burial varies from just below the surface to approximately 4.5 ft.
- There is a concentration of buried pipes and fixtures from 500E, 100N to 700E, 250N, in the vicinity of several concrete pads.
- A second concentration of pipes and fixtures is located from 750E, 200N to 950E, 325N, immediately south of the concrete basin.
