**RE: Phase I and II Remediation, Former Enersource Facility, Monument, Lea County,
New Mexico**

WORK PLAN for PHASE II REMEDIATION

Former Enersource Facility, Monument, New Mexico

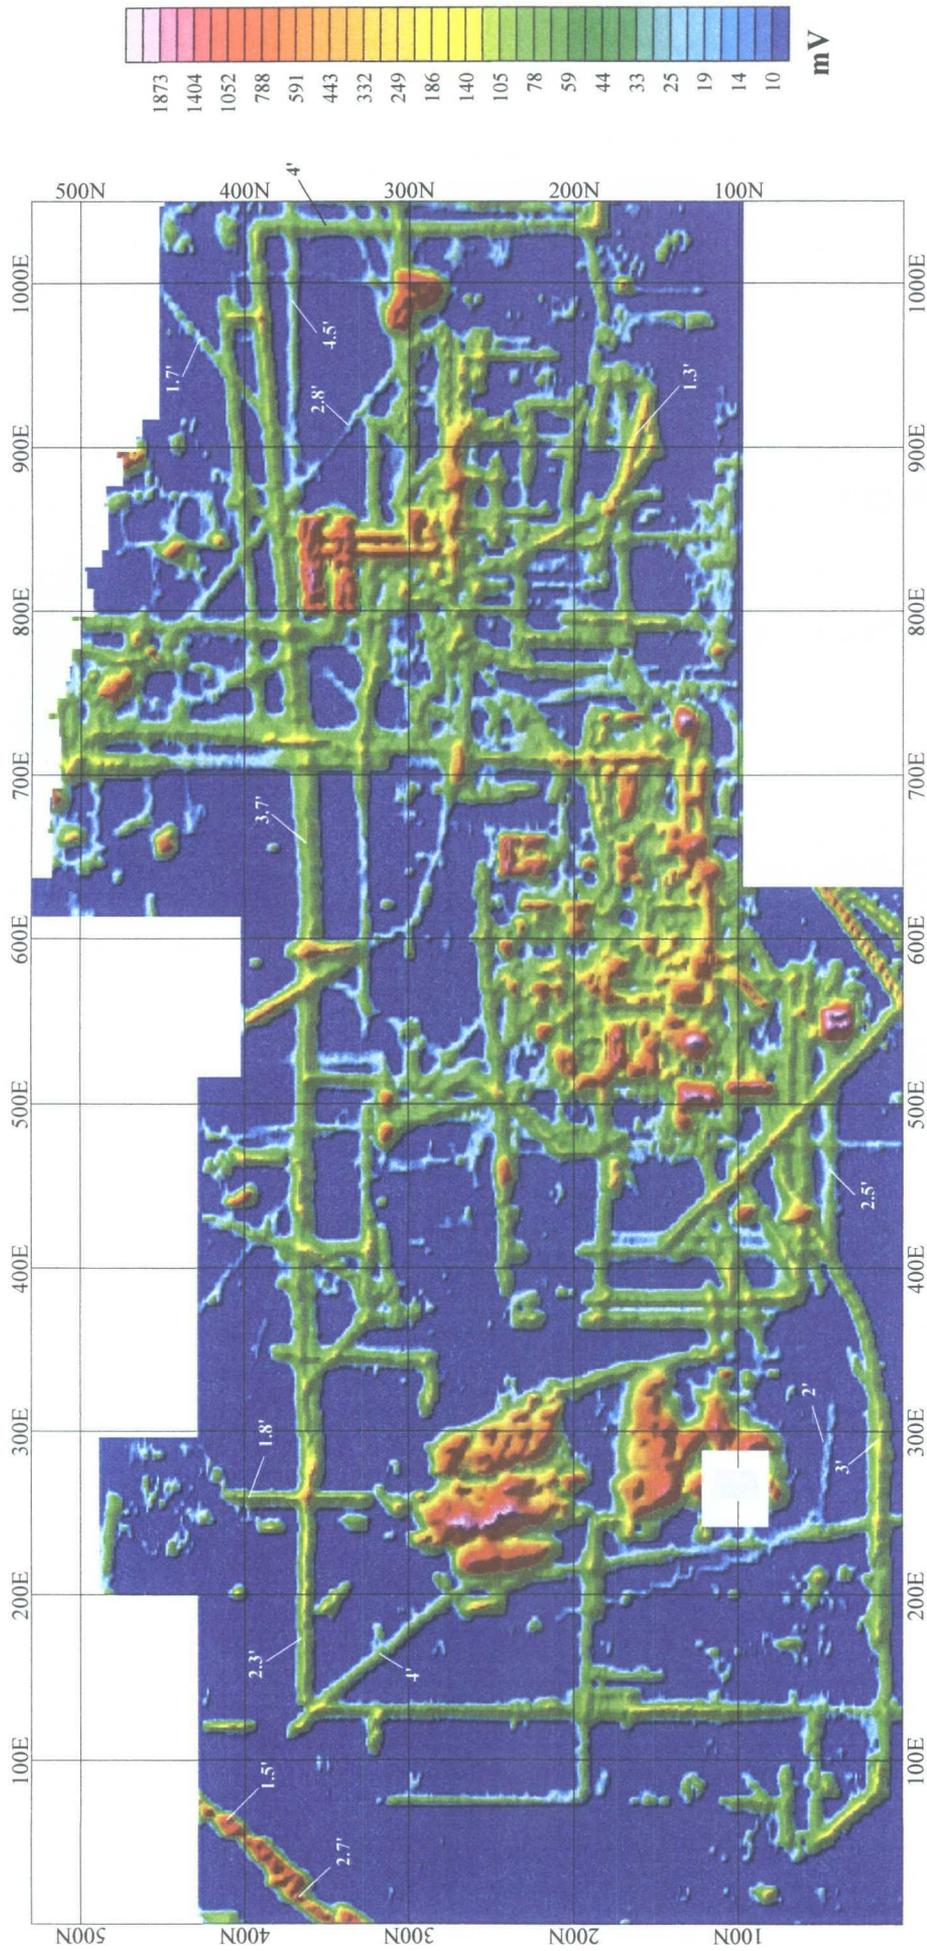
The EM-61 data are re-projected at higher resolution in Figure 2. The color contours are presented on a logarithmic scale to enhance low magnitude features (buried pipes) while retaining the larger features seen in Figure 1. Observations include:

- Buried pipes are found essentially across the entire site. The lateral runs of buried pipes combine to over one mile in total length. The approximate depths of several pipes are annotated, ranging from just below the surface to approximately 4.5 ft.
- Buried pipes associated with the Enersource Site penetrate the north, south, and east edges of the survey.
- There appears to be considerable interconnection by buried pipes between the concrete pads in the area 500E, 0N to 750E, 250N.
- Another concentration of buried pipes is found immediately south of the concrete basin.

2.8' = depth of burial

- There are five significant major concentrations of buried demolition waste including the previously exposed buried tank.
- Buried pipes are found essentially across the entire site, and extend off-site to the north, south, and east. The depth of burial varies from just below the surface to approximately 4.5 ft.
- There is a concentration of buried pipes and fixtures from 500E, 100N to 700E, 250N, in the vicinity of several concrete pads.
- A second concentration of pipes and fixtures is located from 750E, 200N to 950E, 325N, immediately south of the concrete basin.
