STAGE 1 & 2 ABATEMENT PLAN

BD JCT. P-26-1 SITE (1R-0426-106)

BD JCT. P-26-2 SITE (1R-0426-107)

T21, R37E, SECTION 26 UNIT LETTER P
LEA COUNTY, NEW MEXICO

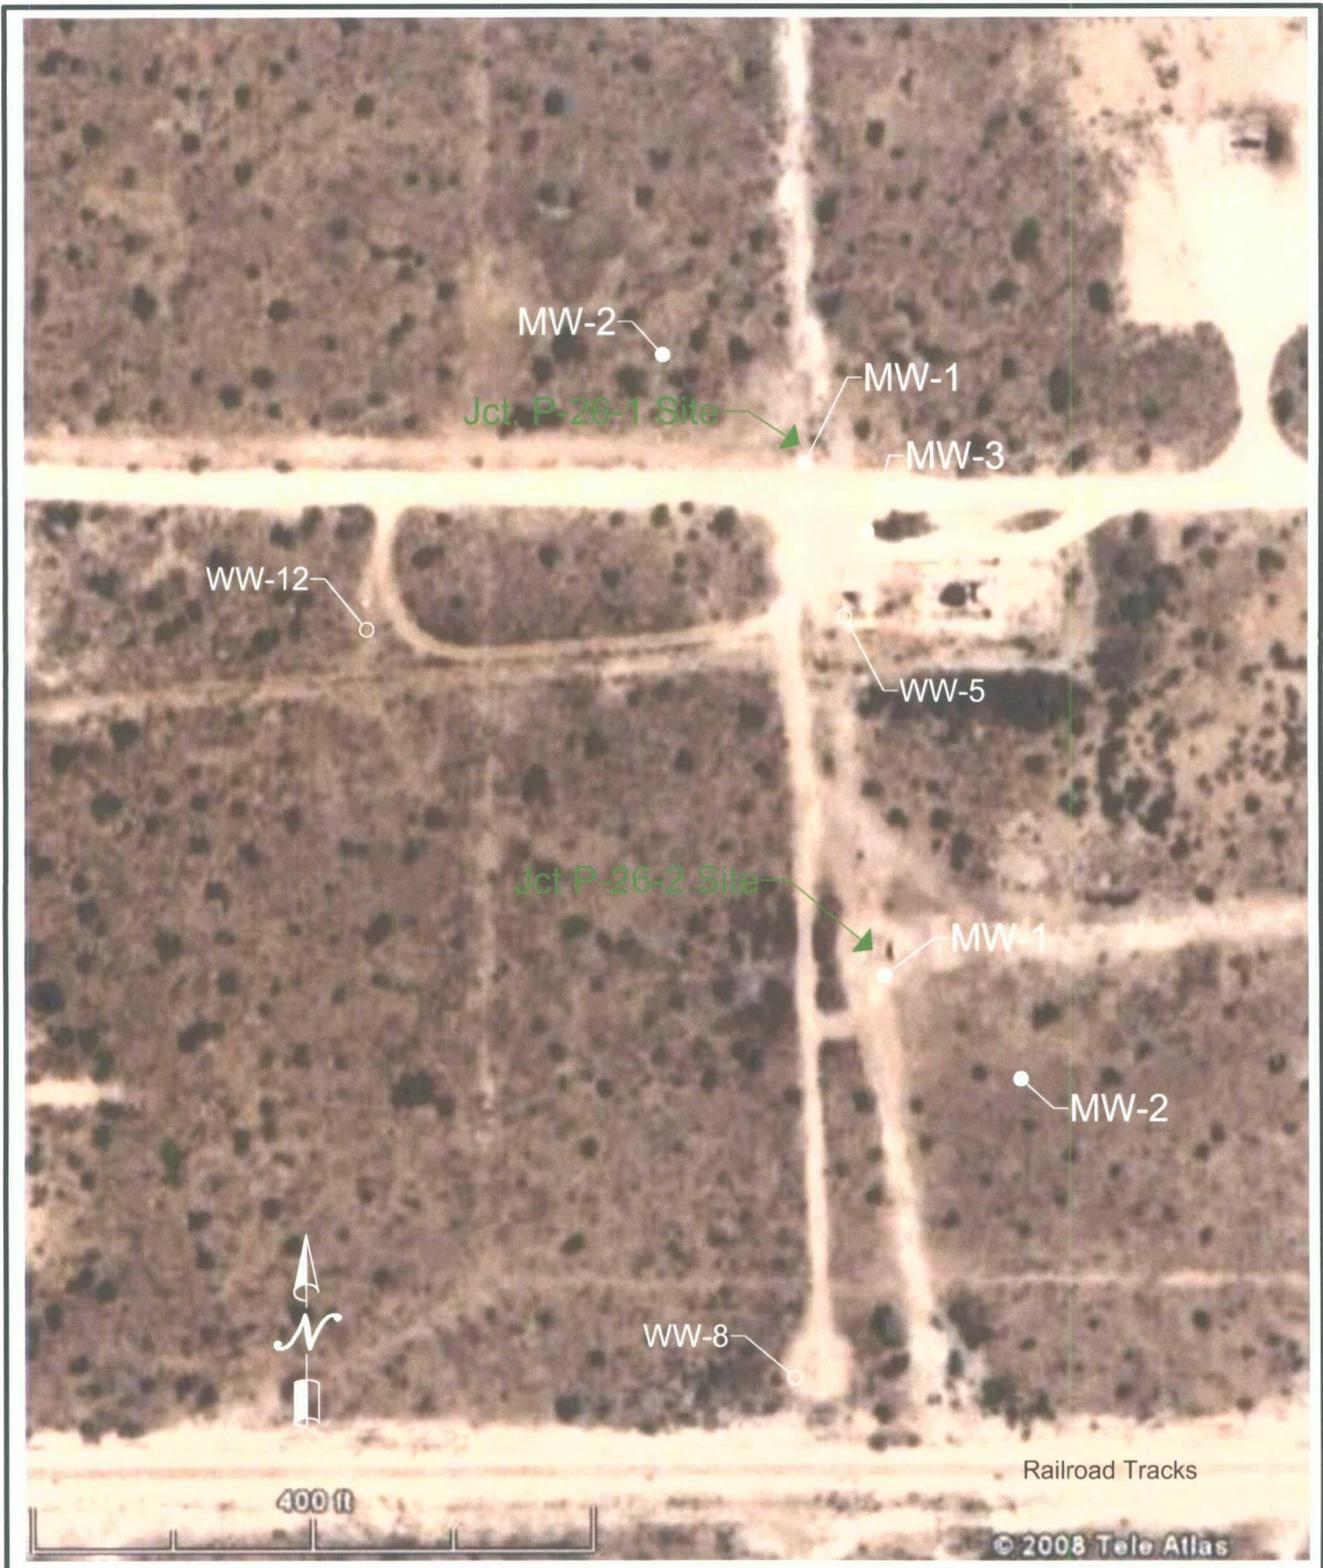
FIGURE 2
AERIAL PHOTO MAP
(2005)

The Jct. P-26-1 and P-26-2 sites are located on land owned by Delrose Scott in Township 21 South, Range 37 East, Section 26, unit letter P approximately 2 miles east of Eunice, NM as shown on the attached Site Location Map (Figure 1). Produced water gathered by the BD SWD System in the site area is sent to the C-2 SWD well, which is located approximately 1 mile south-southeast of the Jct. P-26-1 and P-26-2 sites. Land in the site area is primarily utilized for oil & gas production, and cattle ranching. Figure 2 is a recent aerial photograph (2005) showing both sites and other pertinent features.

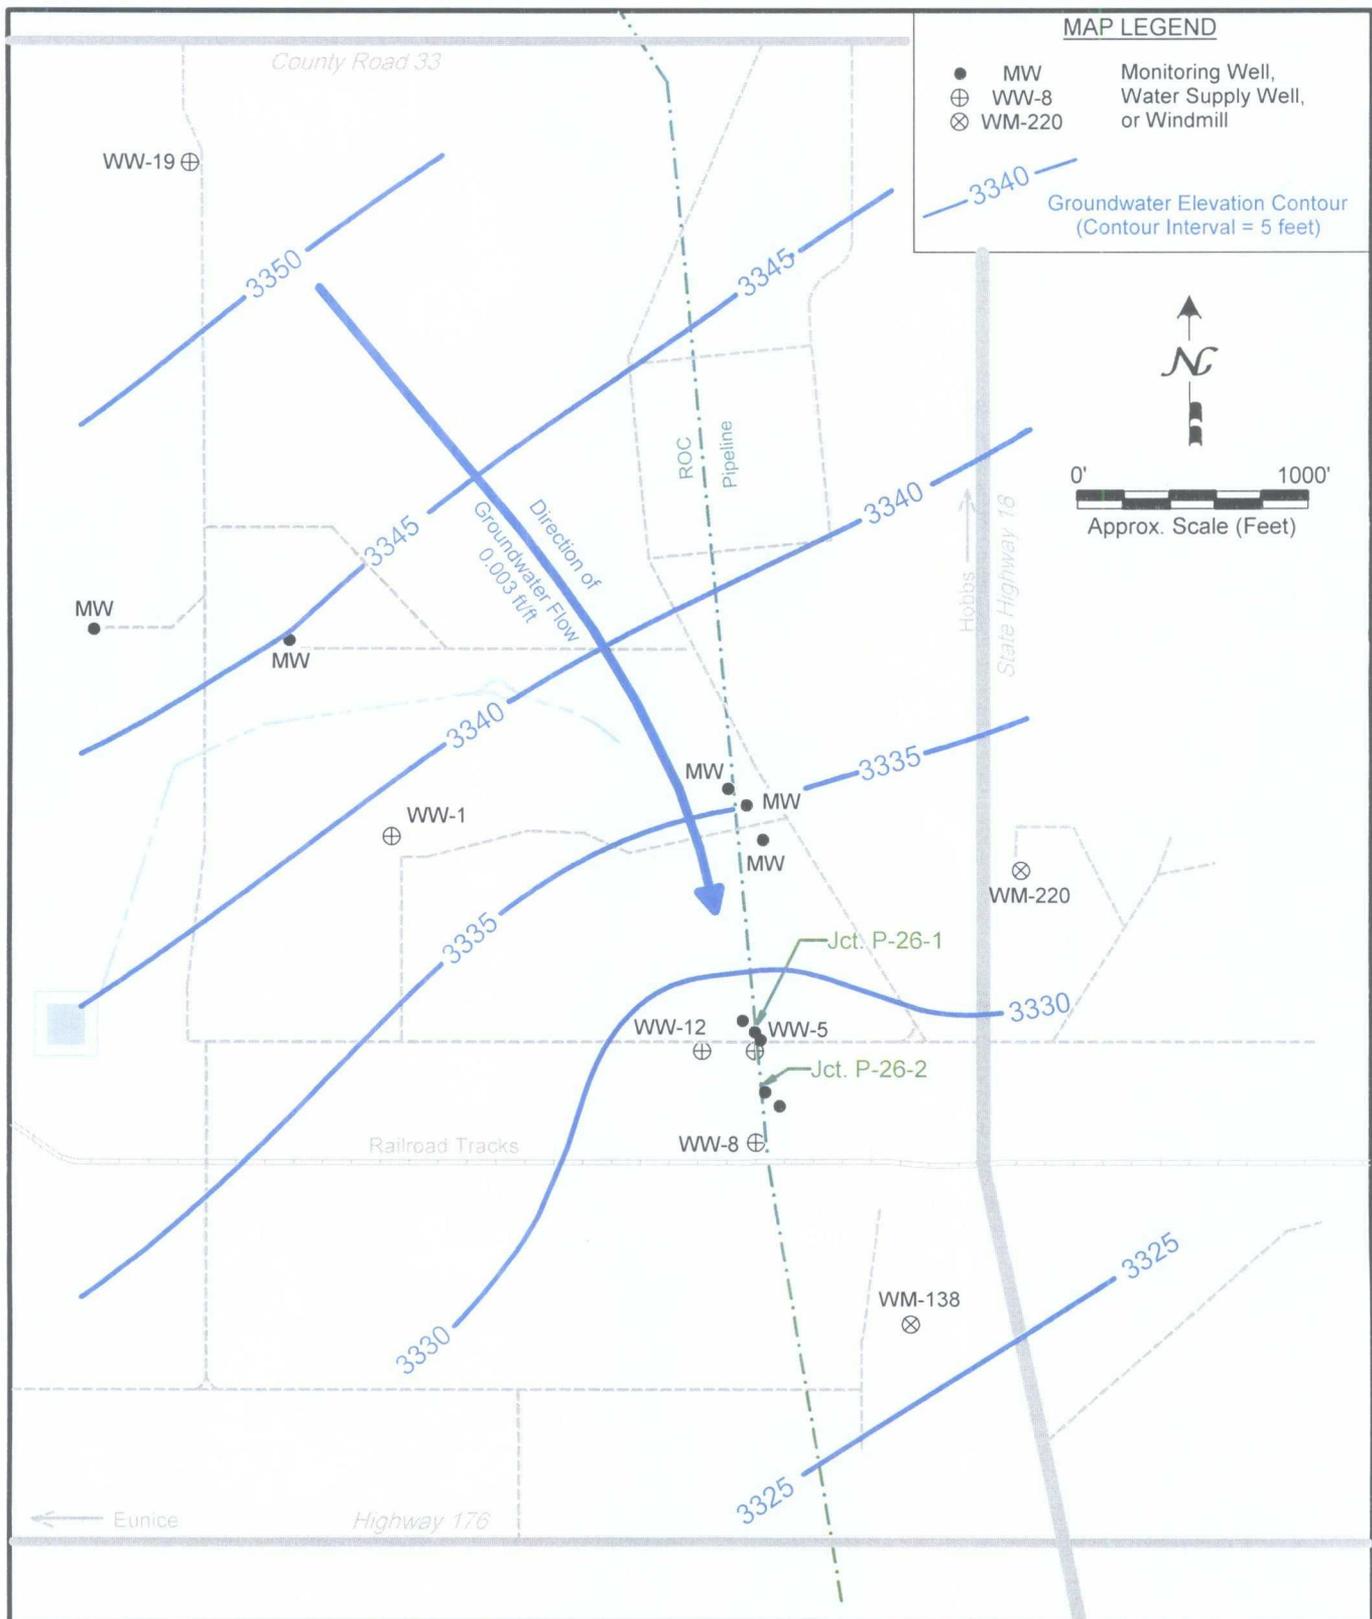
FIGURE 3
WATER TABLE ELEVATION MAP
 (October 9, 2008)

Based on the known depth to groundwater data from accessible wells located within a mile of the Jct. P-26 sites the magnitude of the regional groundwater gradient is 0.003 feet/foot and the prevailing direction of flow is to the southeast (Figure 3). However, the magnitude and direction of the groundwater gradient in the vicinity of the P-26-1 and P-26-2 sites is significantly influenced by the groundwater withdrawal from several nearby industrial water supply wells. Based on records from the New Mexico Office of the State Engineer (NMSEO) these wells are consistently pumping at a combined rate of approximately 80 to 90 gallons per minute (gpm). The groundwater withdrawal induces groundwater to flow from the site towards the water supply wells. During times when the water supply wells are not in service the gradient intermittently returns to the prevailing southeast direction.

A summary of active water wells located in the vicinity of the Jct. P-26-1 and P-26-2 sites are listed in Table 1 below. These wells are also depicted in Figure 3.

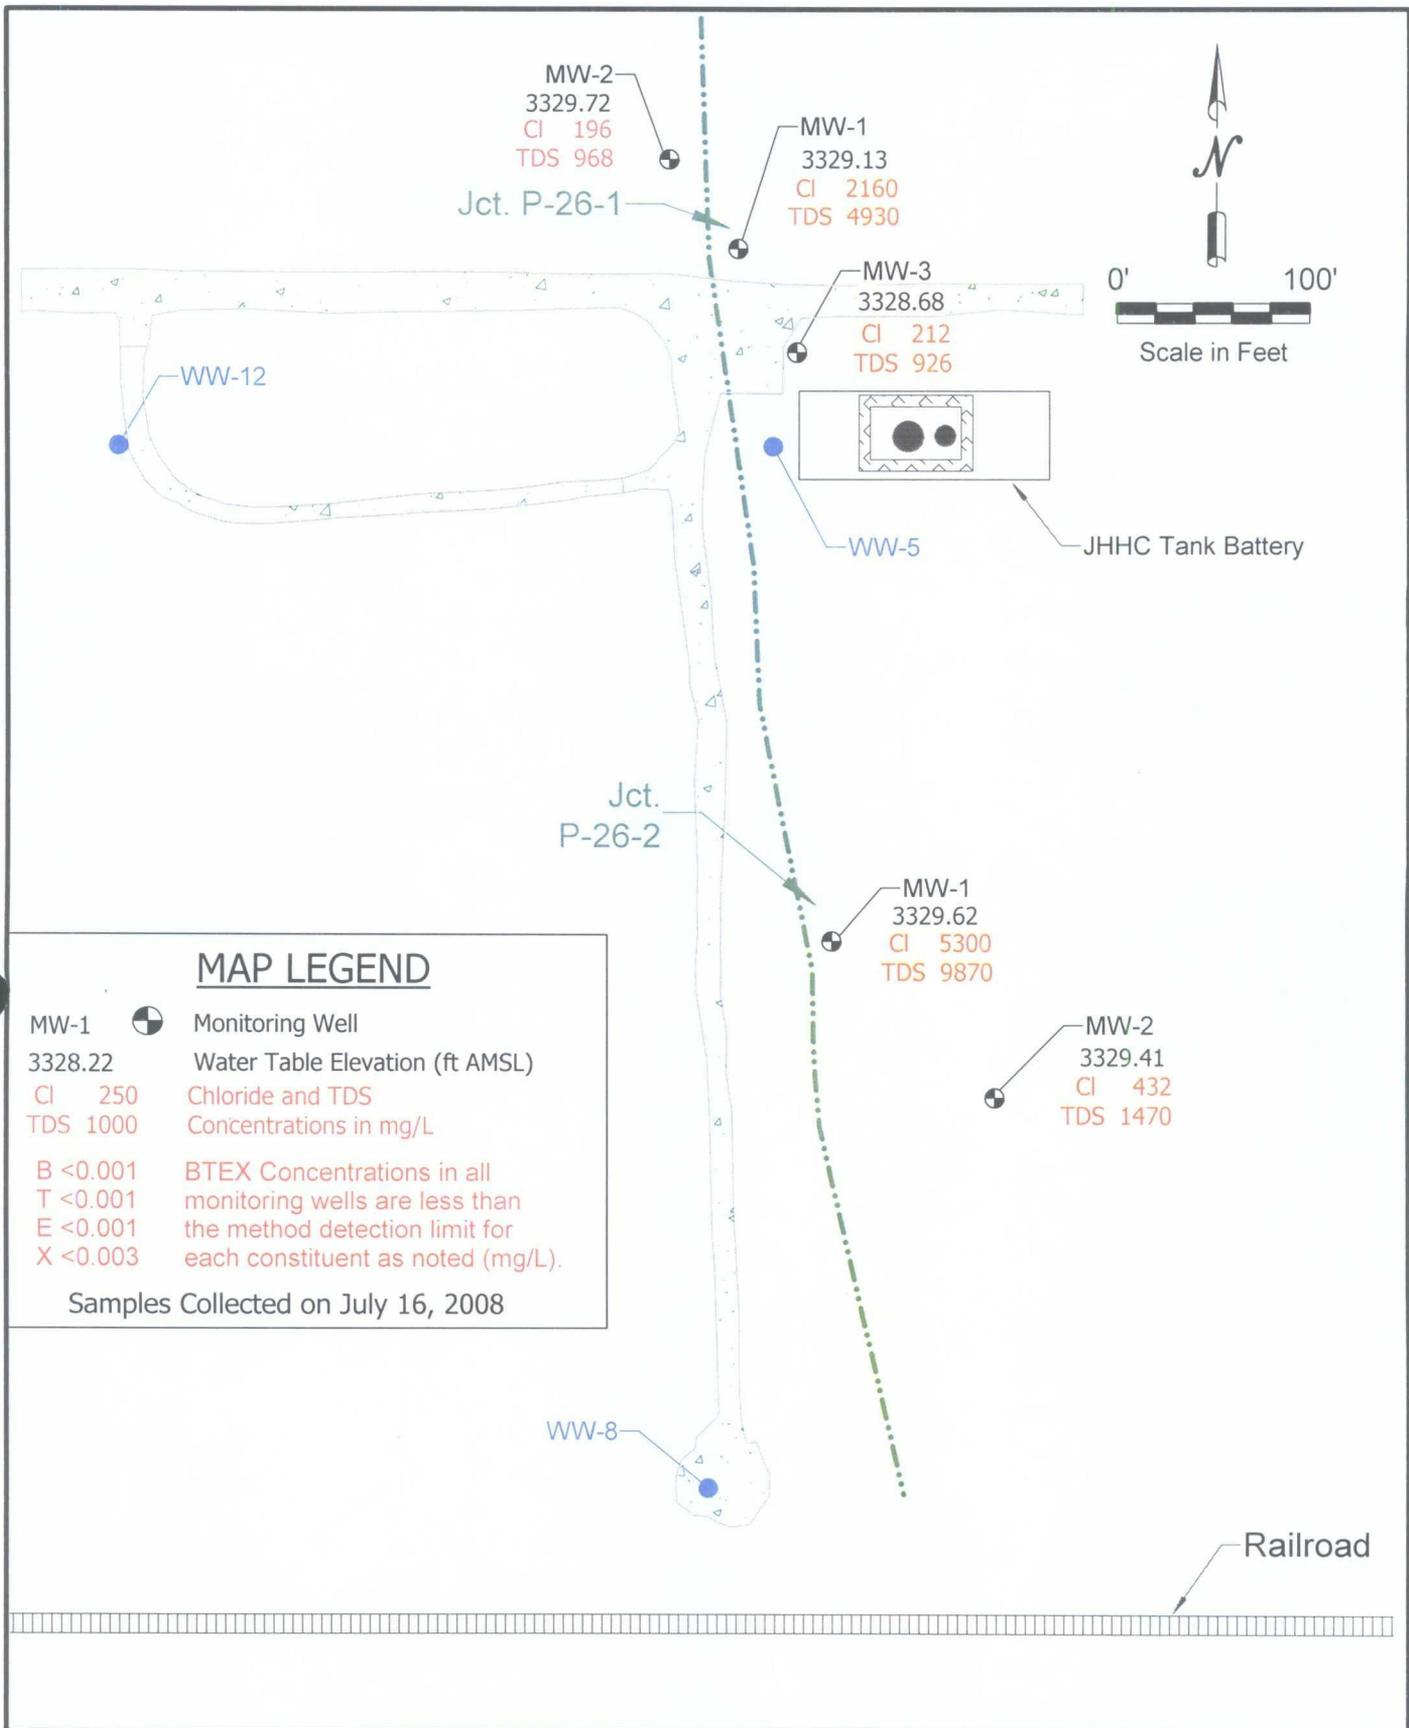
FIGURE 5
 WATER TABLE ELEVATIONS AND
 CHLORIDE, TDS, and BTEX
 CONCENTRATIONS IN
 GROUNDWATER

- The elevated chloride and TDS concentrations are limited to the near vicinity of the former junction box locations at each site.
- Maximum chloride (4,350 mg/L) and TDS (8,396 mg/L) concentrations in monitoring well MW-1 at the Jct. P-26-1 site were recorded on November 12, 2007. The levels of these constituents have since decreased by 50 percent, with chloride and TDS concentrations of 2,160 mg/L and 4,930 mg/L, respectively, during the last sampling event on July 16, 2008.
- Chloride (5,300 mg/L) and TDS (9,870 mg/L) concentrations in monitoring well MW-1 at the Jct. P-26-2 site have remained relatively stable during the period of record (November 2007 through July 2008).
- The upgradient and downgradient monitoring wells at each site allow complete characterization of the lateral extent of chloride and TDS impact to groundwater.

A summary of historical analytical results and ground water elevations is listed in Table 3. Analytical results for the most recent sampling event conducted on July 16, 2008, are also depicted in graphical format in Figure 5. A copy of the laboratory analytical report and chain of custody form for the most recent ground water sampling event is included in Appendix C.

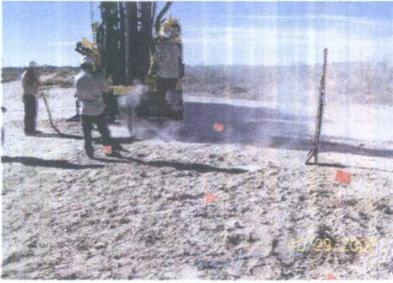
SOIL BORING LITHOLOGIC LOG

BOREHOLE NO.: <u>B-1</u>	TOTAL DEPTH: <u>45 Feet</u>
SITE ID: <u>BD Jct. P-26-1 Vent</u>	CLIENT: <u>RICE Operating Company</u>
CONTRACTOR: <u>Harrison & Cooper, Inc.</u>	COUNTY: <u>Lea</u>
DRILLING METHOD: <u>Air Rotary</u>	STATE: <u>New Mexico</u>
START DATE: <u>10/29/07</u>	LOCATION: <u>T21S-R37E-Sec 26-Unit P</u>
COMPLETION DATE: <u>10/29/07</u>	FIELD REP.: <u>G. Van Deventer</u>
COMMENTS: <u>Boring located 14 feet west-southwest of former junction box (plate marker)</u>	
<u>Photo at left shows drilling of B-1 (facing west). Orange pin flagging identifies active brine water lines.</u>

14.50	Split Spoon	1001		SM/CAL	Very fine-grained sand, olive gray (5Y 4/1), with calcium carbonate in matrix, loose, unconsolidated, dry, slight hydrocarbon odor.

15.42	Split Spoon	1704			Very fine-grained sand, very pale orange (10YR 8/2), hard (indurated caliche). Sand grains are medium sorted, subrounded, unconsolidated, slightly moist.
	45	1556 Cuttings	1570			Bottom of boring at 45 ft below ground surface.
	50

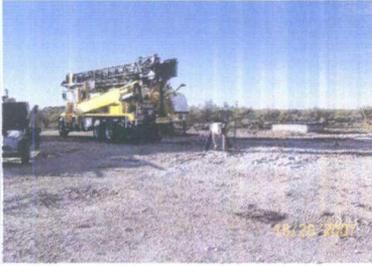
LITHOLOGIC LOG AND MONITORING WELL CONSTRUCTION DIAGRAM

MONITORING WELL NO.: <u>MW-1</u>	TOTAL DEPTH: <u>55 Feet</u>
SITE NAME: <u>BD Jct. P-26-1 Vent Site</u>	CLIENT: <u>RICE Operating Company</u>
CONTRACTOR: <u>Harrison & Cooper, Inc.</u>	COUNTY: <u>Lea</u>
DRILLING METHOD: <u>Air Rotary</u>	STATE: <u>New Mexico</u>
START DATE: <u>10/29/07</u>	LOCATION: <u>T21S-R37E-Sec 26 - Unit P</u>
COMPLETION DATE: <u>10/29/07</u>	FIELD REP.: <u>G. Van Deventer</u>
COMMENTS: <u>Located approximately 12 feet southeast of former junction box (plate marker).</u>	
<u>Photo at left shows completed MW-1 (facing northwest) and new junction box (right-center).</u>

Sample			Chloride (ppm)	PID (ppm)	USCS	LITHOLOGIC DESCRIPTION: <small>LITHOLOGY, COLOR, GRAIN SIZE, SORTING, ROUNDING, CONSOLIDATION, DISTINGUISHING FEATURES</small>
	Depth	Time	Type				
Surface							Fine-grained sand, grayish orange (5YR 7/4) with some very pale orange (10YR 8/2) calcium carbonate in matrix. Sand grains are medium-sorted, subrounded, unconsolidated, dry.
5							
	1620		Split Spoon	1242			Fine-grained sand, grayish orange (5YR 7/4) with some very pale orange (10YR 8/2) calcium carbonate in matrix. Sand grains are medium-sorted, subrounded, unconsolidated, dry.
10							
	1625		Split Spoon	623			Fine-grained sand, pale yellowish brown (10YR 6/2) with some very pale orange (10YR 8/2) calcium carbonate in matrix. Sand grains are medium-sorted, subrounded, unconsolidated, dry.
15							
	1628		Split Spoon	692			Very fine and fine-grained sand with calcium carbonate in matrix, very pale orange (10YR 8/2). Sand grains are medium-sorted, subrounded, unconsolidated, dry.

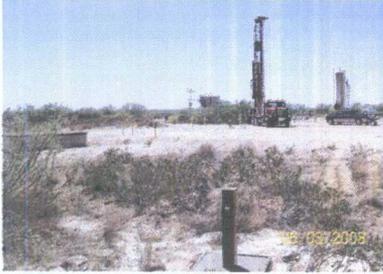
LITHOLOGIC LOG AND MONITORING WELL CONSTRUCTION DIAGRAM

MONITORING WELL NO.: MW-2
 SITE NAME: BD Jct. P-26-1 Vent Site
 CONTRACTOR: Harrison & Cooper, Inc.
 DRILLING METHOD: Air Rotary
 START DATE: 06/03/08
 COMPLETION DATE: 06/03/08
 COMMENTS: Located approximately 80 ft NW of the former junction box (plate marker) and 100 ft NW of MW-1.
 Photo at left shows completed MW-2 in foreground (facing SE). Drill rig in background is at MW-3.

45	0859	Cuttings	139		SM/CAL	Fine-grained sand, very pale orange (10YR 8/2) with some grayish orange (5YR 7/4), medium sorted, subrounded, dry, <10% calcium carbonate (semi-hard caliche) in matrix..
20/40 Brady Silica Sand Pack	50					SW	Groundwater encountered
2" Diameter Screen with 0.010" Slots	55					SW	Fine and medium-grained sand, light brown (5YR 5/6), moderately well sorted, subrounded, damp
20/40 Brady Silica Sand Pack	60					SW	Fine and medium-grained sand, light brown (5YR 5/6), moderately well sorted, subrounded, moist
	65						Fine and medium-grained sand, light brown (5YR 5/6), moderately well sorted, subrounded, wet
							Bottom of boring at 62 ft below ground surface.

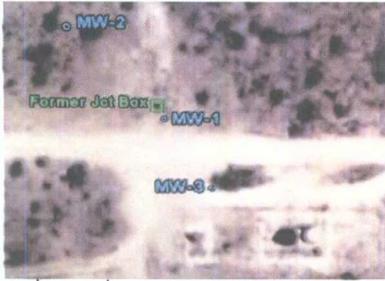
LITHOLOGIC LOG AND MONITORING WELL CONSTRUCTION DIAGRAM

MONITORING WELL NO.: MW-3

45		Cuttings	236			Fine-grained sand, very pale orange (10YR 8/2) with some grayish orange (5YR 7/4), medium sorted, subrounded, dry, <10% calcium carbonate (semi-hard caliche) in matrix..
						Groundwater encountered
50						Fine and medium-grained sand, light brown (5YR 5/6), moderately well sorted, subrounded, damp
55					SW	Fine and medium-grained sand, light brown (5YR 5/6), moderately well sorted, subrounded, moist
60						Fine and medium-grained sand, light brown (5YR 5/6), moderately well sorted, subrounded, wet
						Bottom of boring at 62 ft below ground surface.
65

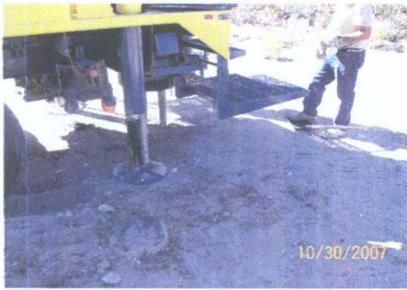
SOIL BORING LITHOLOGIC LOG

BOREHOLE NO.: <u>B-1</u>	TOTAL DEPTH: <u>40 Feet</u>
SITE ID: <u>BD Jct. P-26-2</u>	CLIENT: <u>RICE Operating Company</u>
CONTRACTOR: <u>Harrison & Cooper, Inc.</u>	COUNTY: <u>Lea</u>
DRILLING METHOD: <u>Air Rotary</u>	STATE: <u>New Mexico</u>
START DATE: <u>10/30/07</u>	LOCATION: <u>T21S-R37E-Sec 26-Unit P</u>
COMPLETION DATE: <u>10/30/07</u>	FIELD REP.: <u>G. Van Deventer</u>
COMMENTS: <u>Boring located 8 feet west of former junction box (plate marker).</u>	
<u>Photo at left shows drilling of B-1 (facing west) with marker plate in foreground.</u>

Depth	Sample		Chloride (ppm)	PID (ppm)	USCS	LITHOLOGIC DESCRIPTION: STRUCTURE, STRATIFICATION, DISCONTINUITIES, FEATURES	
	Time	Type					
		Surface			BF	Compacted backfill material consisting of fine-grained silty sand with calcium carbonate in matrix, pale yellowish brown (10YR 6/2), loose, unconsolidated, dry.	
5					CL	Compacted clay layer, dusky red (5R 3/4).	
10					BF	Compacted backfill material consisting of fine-grained silty sand with calcium carbonate in matrix, pale yellowish brown (10YR 6/2), loose, unconsolidated, dry.	
	1405	Split Spoon	209	0			
15					SW/CAL	Fine-grained sand with calcium carbonate in matrix, pale yellowish brown (10YR 6/2), unconsolidated, dry.	
	1408	Split Spoon	294	4			Fine-grained sand with calcium carbonate in matrix, pale yellowish brown (10YR 6/2), unconsolidated, dry.
20							Fine-grained sand, grayish orange (5YR 7/4) with some very pale orange (10YR 8/2) calcium carbonate in matrix, moderately hard. Sand grains are medium-sorted, subrounded, unconsolidated, dry.

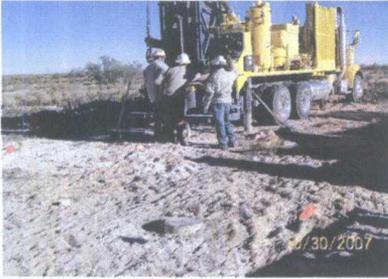
LITHOLOGIC LOG AND MONITORING WELL CONSTRUCTION DIAGRAM

MONITORING WELL NO.: MW-1	TOTAL DEPTH: 56 Feet
SITE NAME: BD Jct. P-26-2	CLIENT: RICE Operating Company
CONTRACTOR: Harrison & Cooper, Inc.	COUNTY: Lea
DRILLING METHOD: Air Rotary	STATE: New Mexico
START DATE: 10/30/07	LOCATION: T21S-R37E-Sec 26 - Unit P
COMPLETION DATE: 10/30/07	FIELD REP.: G. Van Deventer
COMMENTS: Located approximately 15 feet southeast of former junction box (plate marker).	
Photo at left shows MW-1 drilling activities (facing southeast). Orange pin flagging identifies active brine water lines and marker plate is shown in foreground.

Depth	Sample Time	Sample Type	Chloride (ppm)	PID (ppm)	USCS	LITHOLOGIC DESCRIPTION:
						LITHOLOGY, COLOR, GRAIN SIZE, SORTING, ROUNDING, CONSOLIDATION, DISTINGUISHING FEATURES
5		Surface			SW	Fine-grained dune sand, light brown (5YR 6/4), well sorted, well-rounded, unconsolidated, dry.
1540		Split Spoon	516	0	SM/CAL	Very fine-grained sand with calcium carbonate in matrix, very pale orange (10YR 8/2), unconsolidated, dry.
10	1542	Split Spoon	359	0		Fine-and medium-grained sand, pale yellowish brown (10YR 6/2) and grayish orange (10YR 7/4), moderately well-sorted, subrounded, unconsolidated, dry.
15	1543	Split Spoon	564	0	SW	Fine-and medium-grained sand, pale yellowish brown (10YR 6/2) and grayish orange (10YR 7/4), moderately well-sorted, subrounded, unconsolidated, dry. Sample submitted for laboratory analysis with results as follows: Chloride = 162 mg/kg.
20	1545	Split Spoon	457	0		Fine-and medium-grained sand, pale yellowish brown (10YR 6/2) and grayish orange (10YR 7/4), moderately well-sorted, subrounded, unconsolidated, dry.

55	1620	Cuttings	605			Fine-and medium-grained sand, pale yellowish brown (10YR 6/2), well-sorted, sub to well-rounded, moist.
60	1625	Cuttings	41			Fine-and med-grained sand, pale yellowish brown (10YR 6/2), well-sorted, sub to well-rounded, moist.
65						Bottom of boring at 60 ft below ground surface.

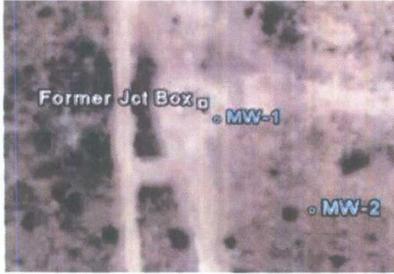
LITHOLOGIC LOG AND MONITORING WELL CONSTRUCTION DIAGRAM

MONITORING WELL NO.: MW-2 TOTAL DEPTH: 58 Feet
 SITE NAME: BD Jct. P-26-2 Site CLIENT: RICE Operating Company
 CONTRACTOR: Harrison & Cooper, Inc. COUNTY: Lea
 DRILLING METHOD: Air Rotary STATE: New Mexico
 START DATE: 06/03/08 LOCATION: T21S-R37E-Sec 26 - Unit P
 COMPLETION DATE: 06/03/08 FIELD REP.: G. Van Deventer
 COMMENTS: Located approximately 115 ft SE of the former junction box (plate marker) and 100 ft SE of MW-1.
 Image at left shows relative location of monitoring wells and former junction box.

Depth	Time	Sample Type	Chloride (ppm)	PID (ppm)	USCS	LITHOLOGIC DESCRIPTION:
						LITHOLOGY, COLOR, GRAIN SIZE, SORTING, ROUNDING, CONSOLIDATION, DISTINGUISHING FEATURES
1300		Surface			SW	Fine-grained dune sand, light brown (5YR 6/4), well sorted, well-rounded, unconsolidated, dry.
5		Cuttings	144		SM	Very fine- to fine-grained sand, very pale orange (10YR 8/2) and grayish orange pink (5YR 7/2), subangular, medium to poorly sorted, dry.
10		Cuttings	115		SM/CAL	Very fine-grained sand, grayish orange (10YR 7/4) with very pale orange (10YR 8/2) soft and hard caliche. Sand grains are subrounded/subangular, medium to poorly sorted, dry.
15		Cuttings	122		SW	Fine- to medium-grained sand, very pale orange (10YR 8/2) and grayish orange (10YR 7/4). Sand grains are subrounded/subangular, medium sorted, dry.
20		Cuttings	145		SM/CAL	Very fine- to fine-grained sand, grayish orange pink (5YR 7/2), with some slightly hard caliche chunks, very pale orange (10YR 8/2), dry.
