**FINAL CLOSURE
REPORT**

Re: OCD Case 131142 Order R-12152-A
Humble State #3 Tank Battery Site

Enclosed is the final closure report for the Maralo, LLC – Humble State #3 Tank Battery site and associated wells. In compliance with Order R-12152-A and the letter dated March 3, 2006 all required work, sampling, and documentation has been completed. As per the meeting on August 8, 2008 sampling has been completed around the Jal City Water Line.

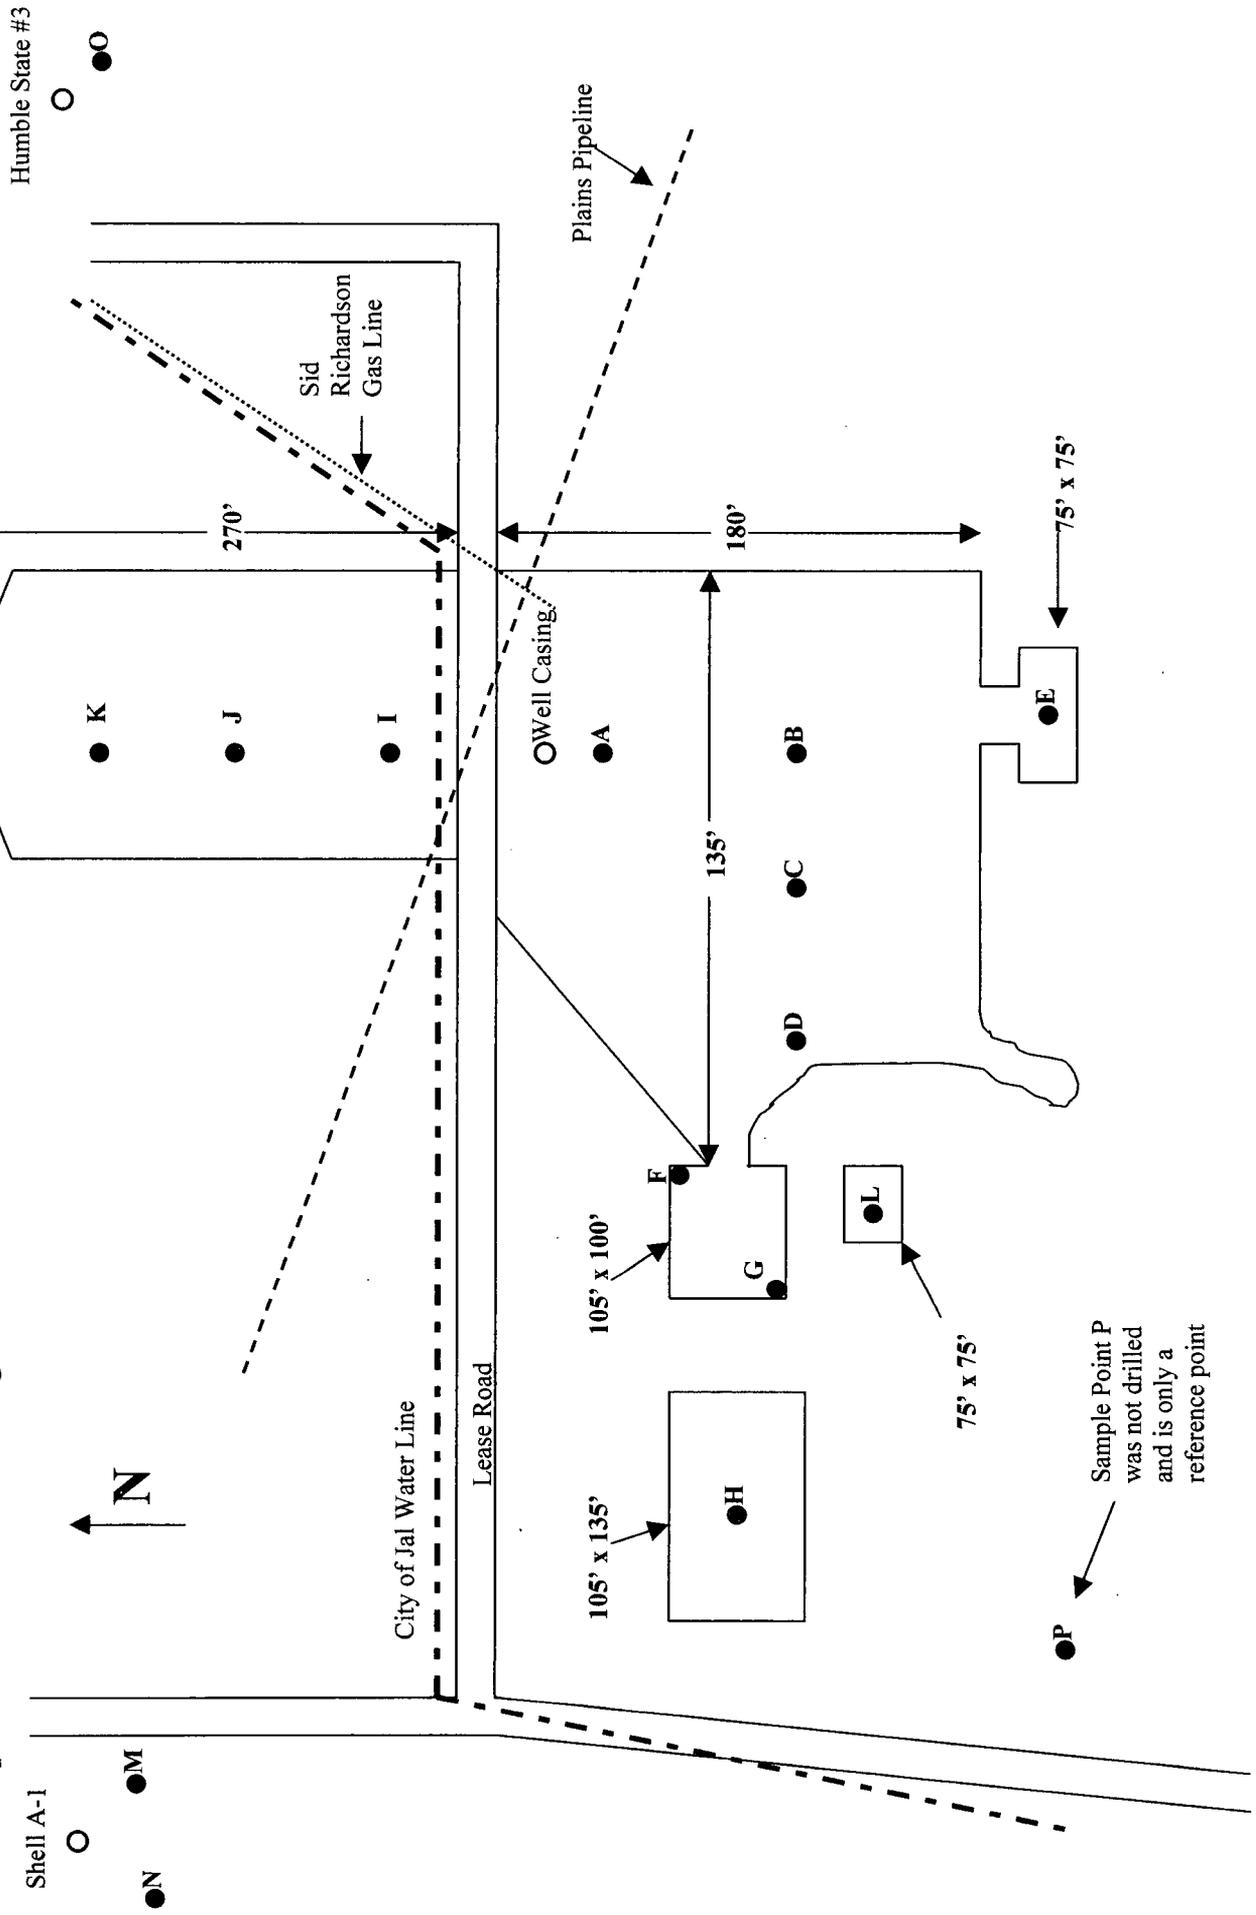
Maralo, LLC
Humble State #3 Tank Battery
Plat Map of Projected Dimensions before Excavation
and Sample Points from Core Drilling Delineation

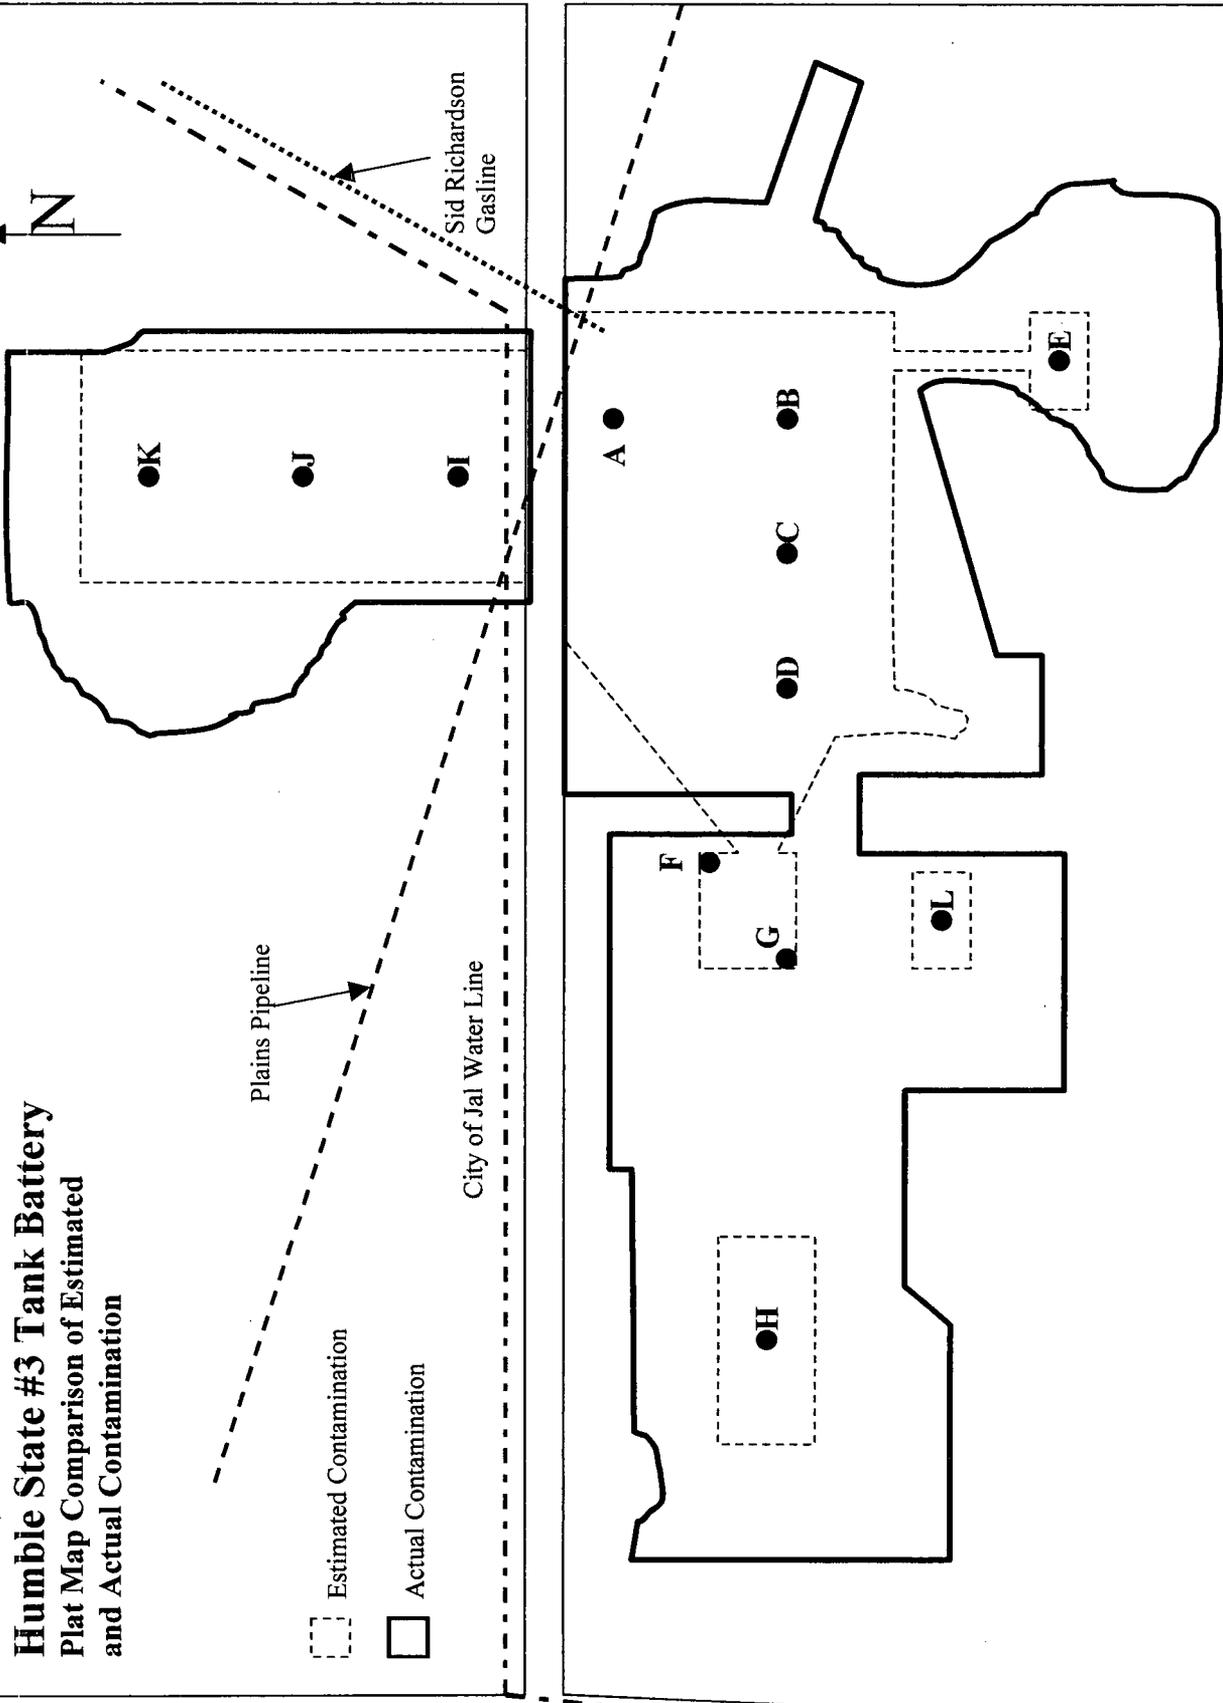
**Humble State #3 Tank Battery
Plat Map Comparison of Estimated
and Actual Contamination**

Estimated Contamination
-

Actual Contamination

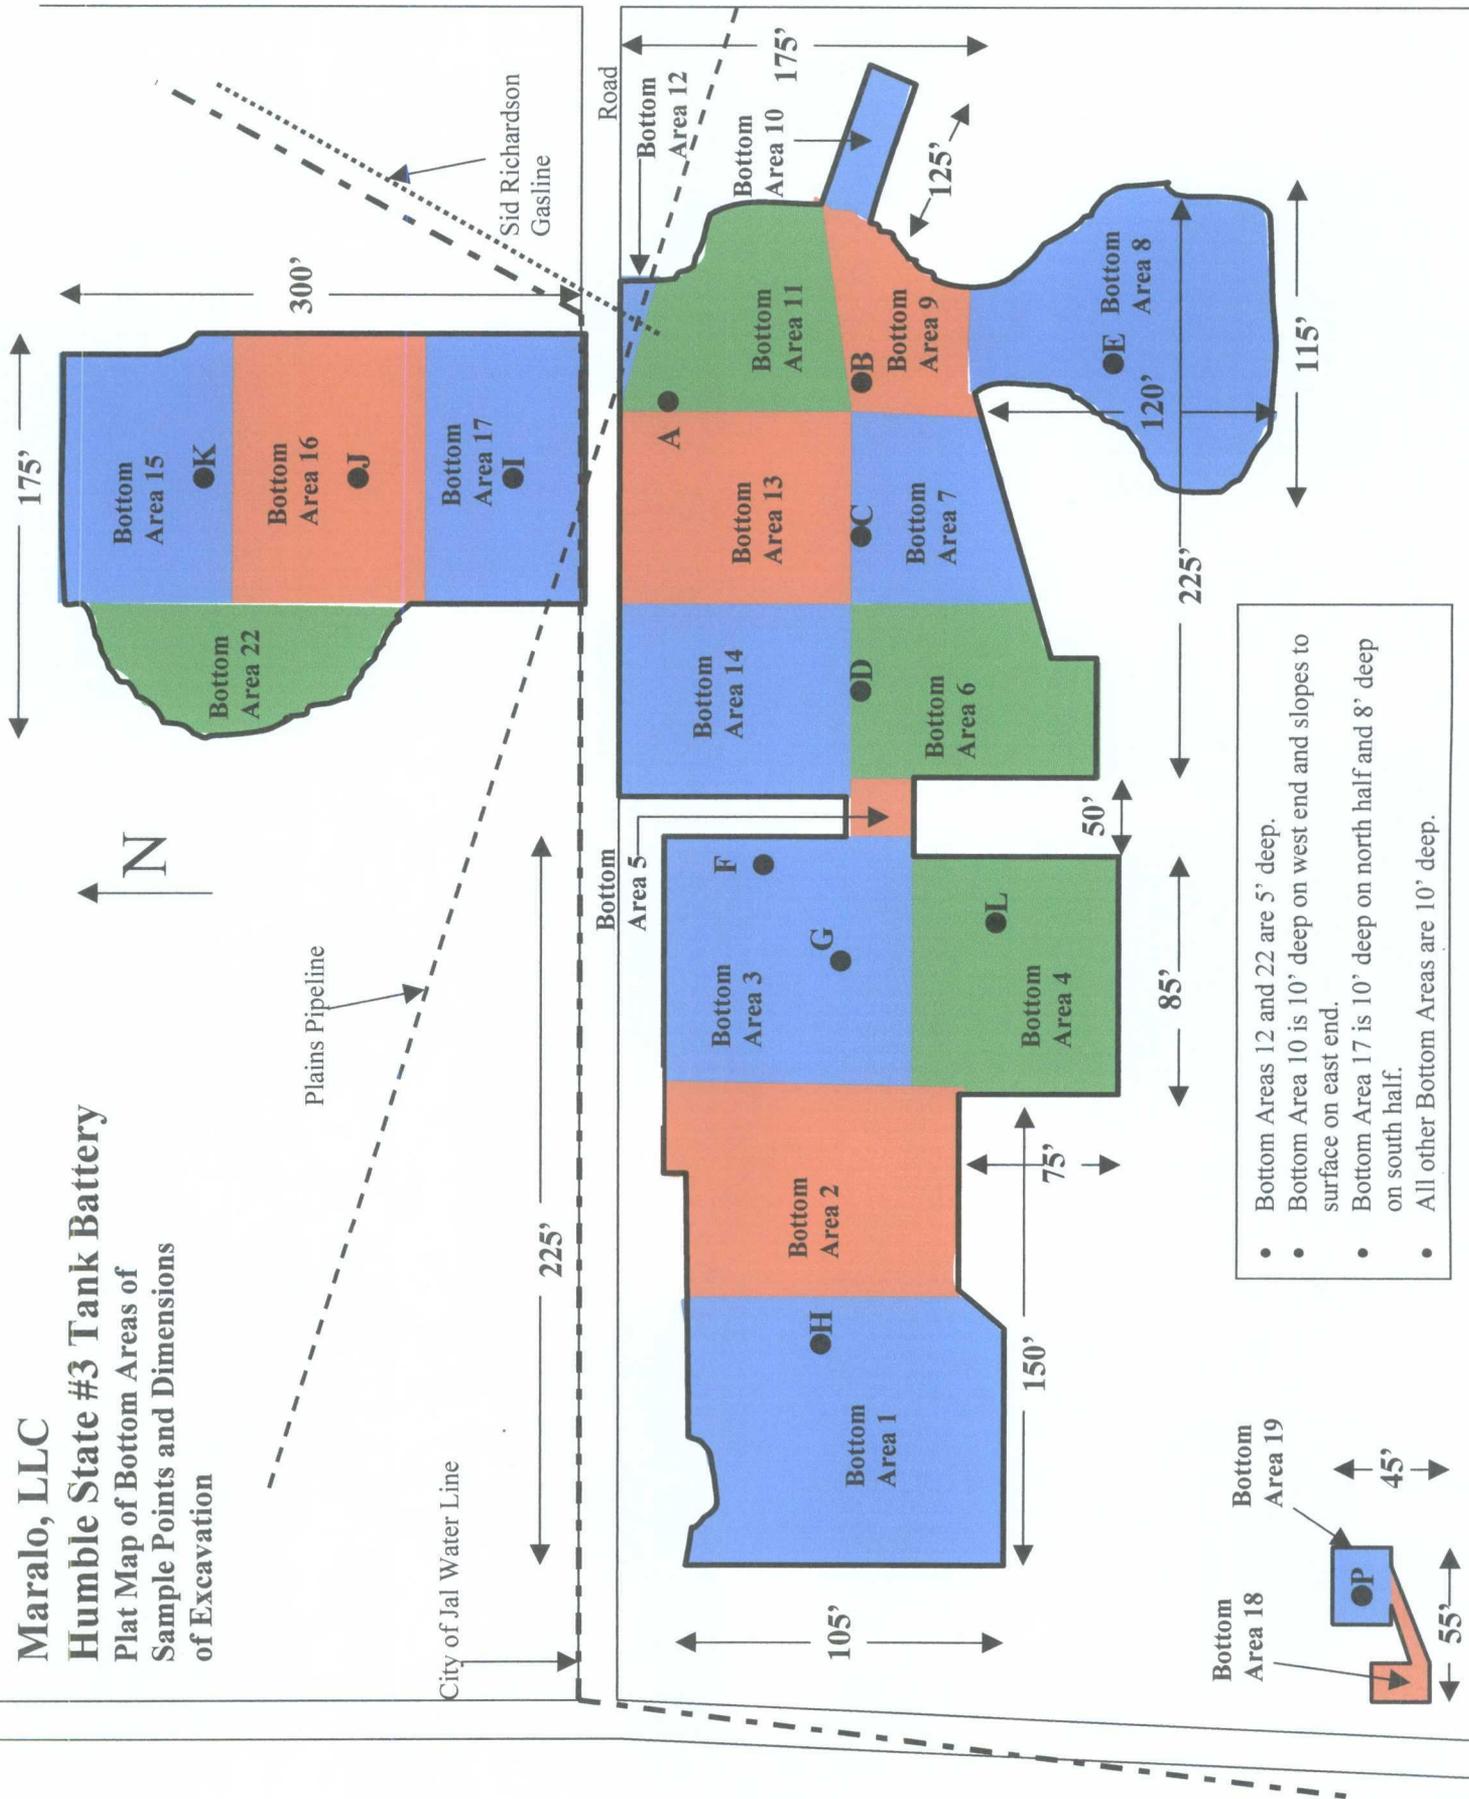
Plat Map of Bottom Areas of
Sample Points and Dimensions
of Excavation

- Bottom Areas 12 and 22 are 5' deep.
- Bottom Area 10 is 10' deep on west end and slopes to surface on east end.
- Bottom Area 17 is 10' deep on north half and 8' deep on south half.
- All other Bottom Areas are 10' deep.

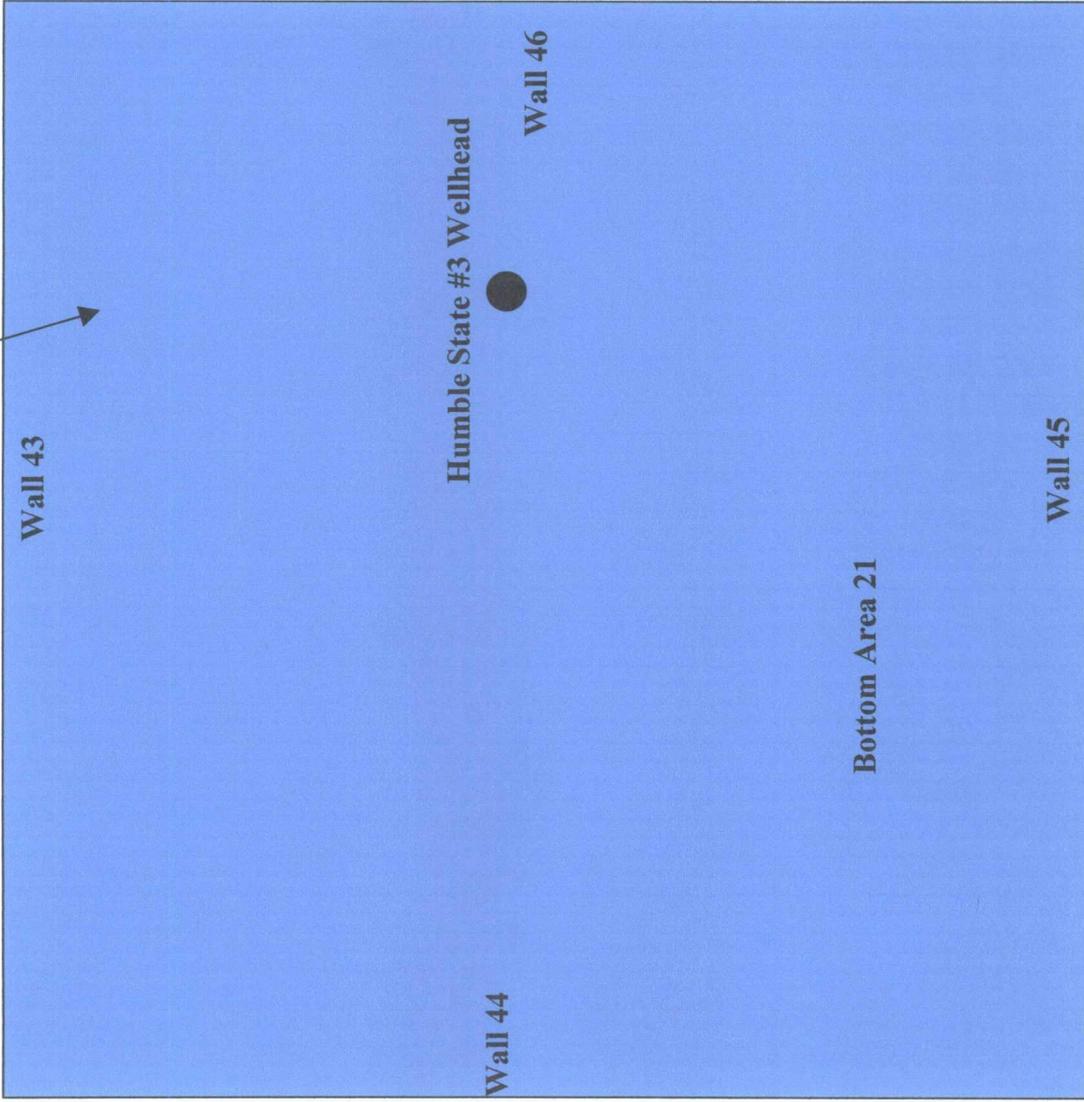
Maralo, LLC
Humble State #3 Tank Battery
Plat Map of Humble State #3 Well
and Dimensions of Excavation

4 ft. Deep

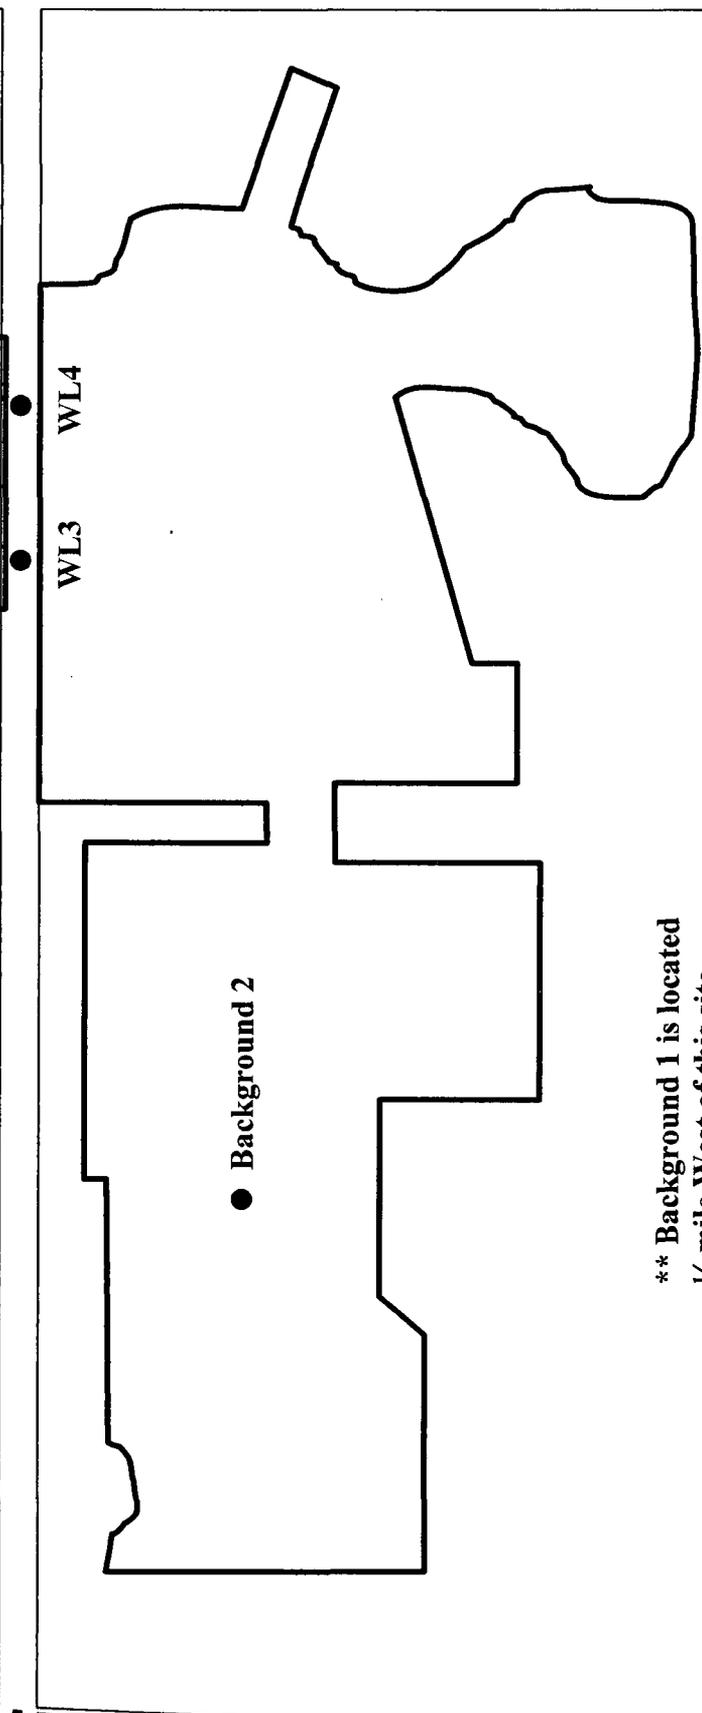
Maralo, LLC
Humble State #3 Tank Battery
Plat Map of Sampling around Jal City Water Line

** Background 1 is located
1/4 mile West of this site
adjacent to the Jal City
Water Line.

#2 – All samples taken around the Jal City Water Line meet either the NMOCD Standard for this site or background levels.
