C-141 Form
Avalon Delaware Unit
Eddy County, New Mexico

Release Notification and Corrective Action

RE: Final Closure Report
Exxon Mobil –Avalon (Delaware)TB Transfer Line
UL-C (NE ¼ of the NW ¼) of Section 31, T 20 S, R 28 E
Longitude: 32° 32' 5.22"; Latitude: 104° 13' 18.92"
Eddy County, New Mexico
NMOCD Ref. 2RP-201; EPI Ref. #190033

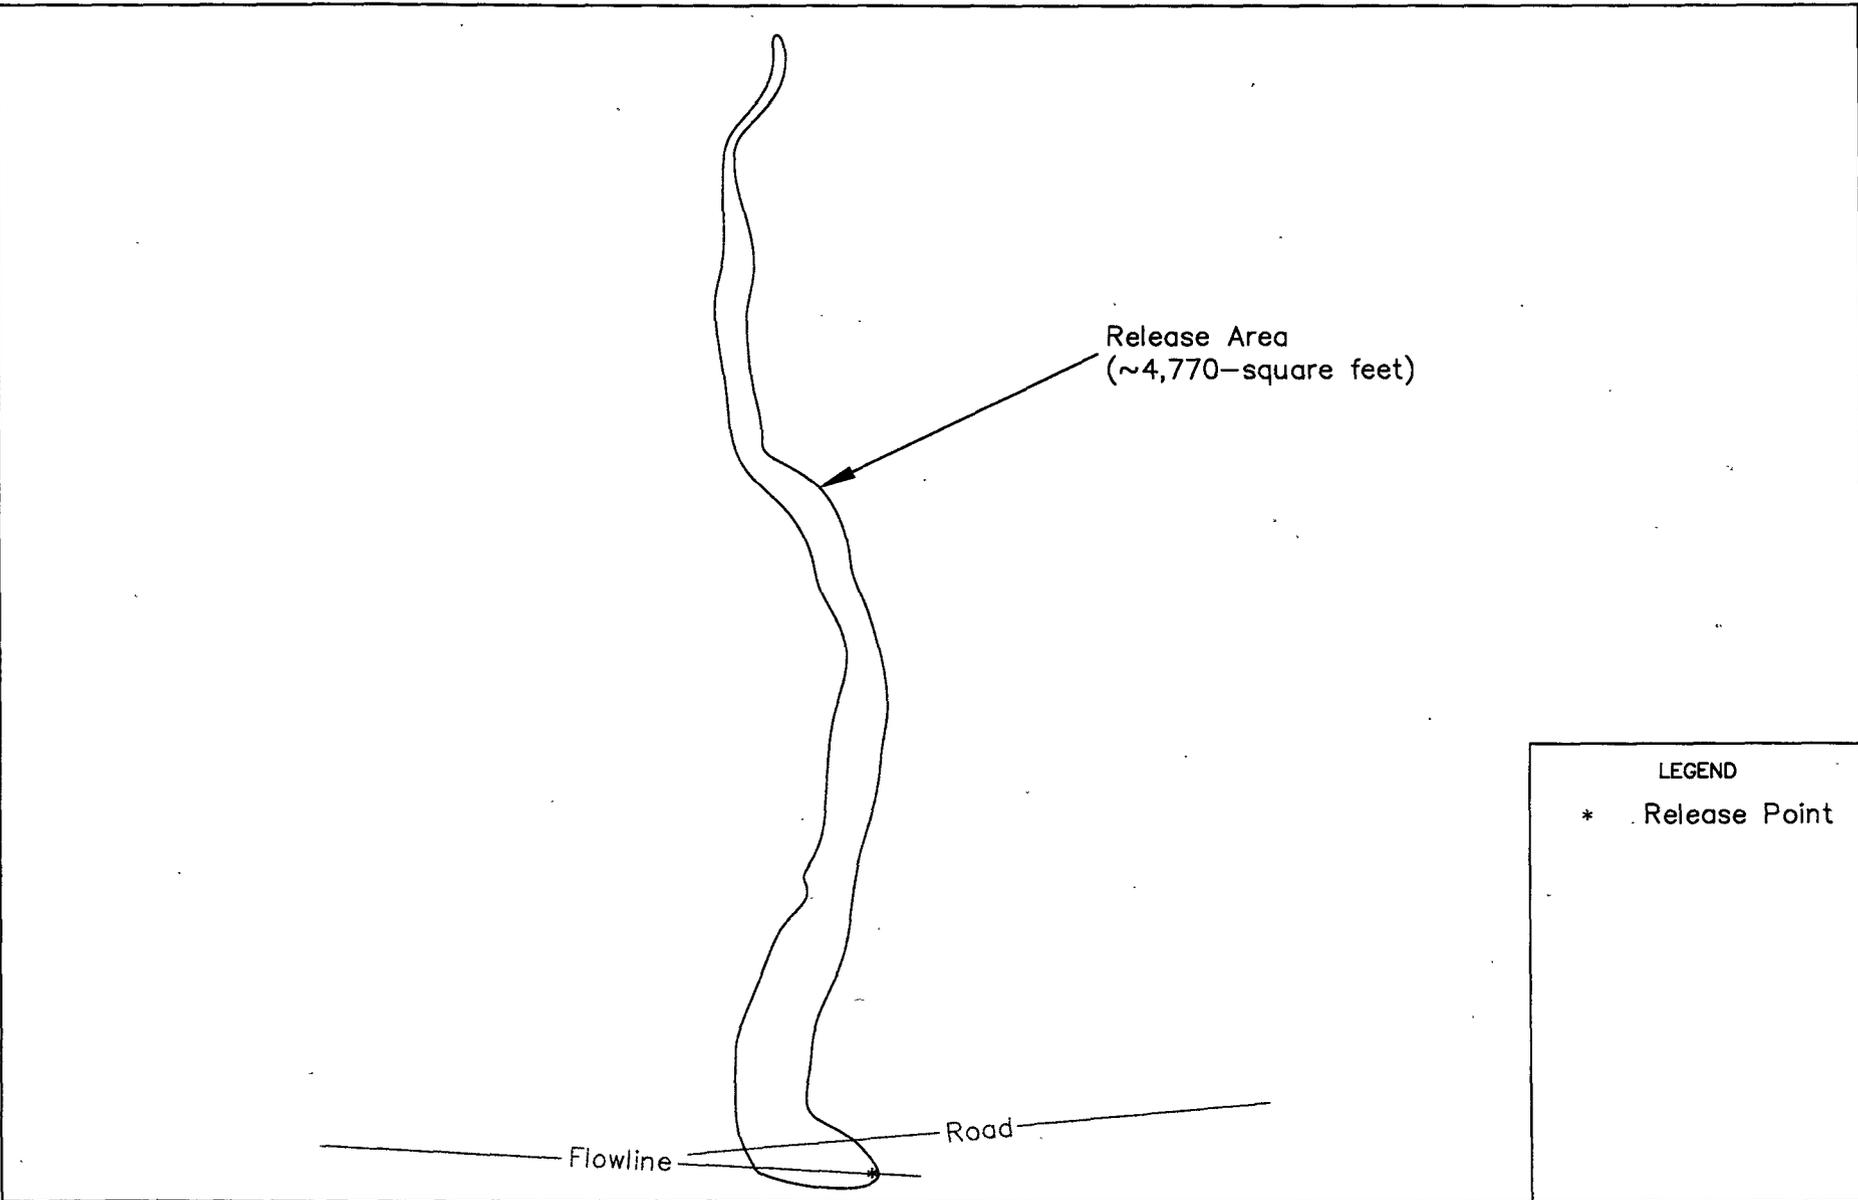
Figure 3
 Site Map
 ExxonMobil
 Avalon TB Transfer Line

* Release Point

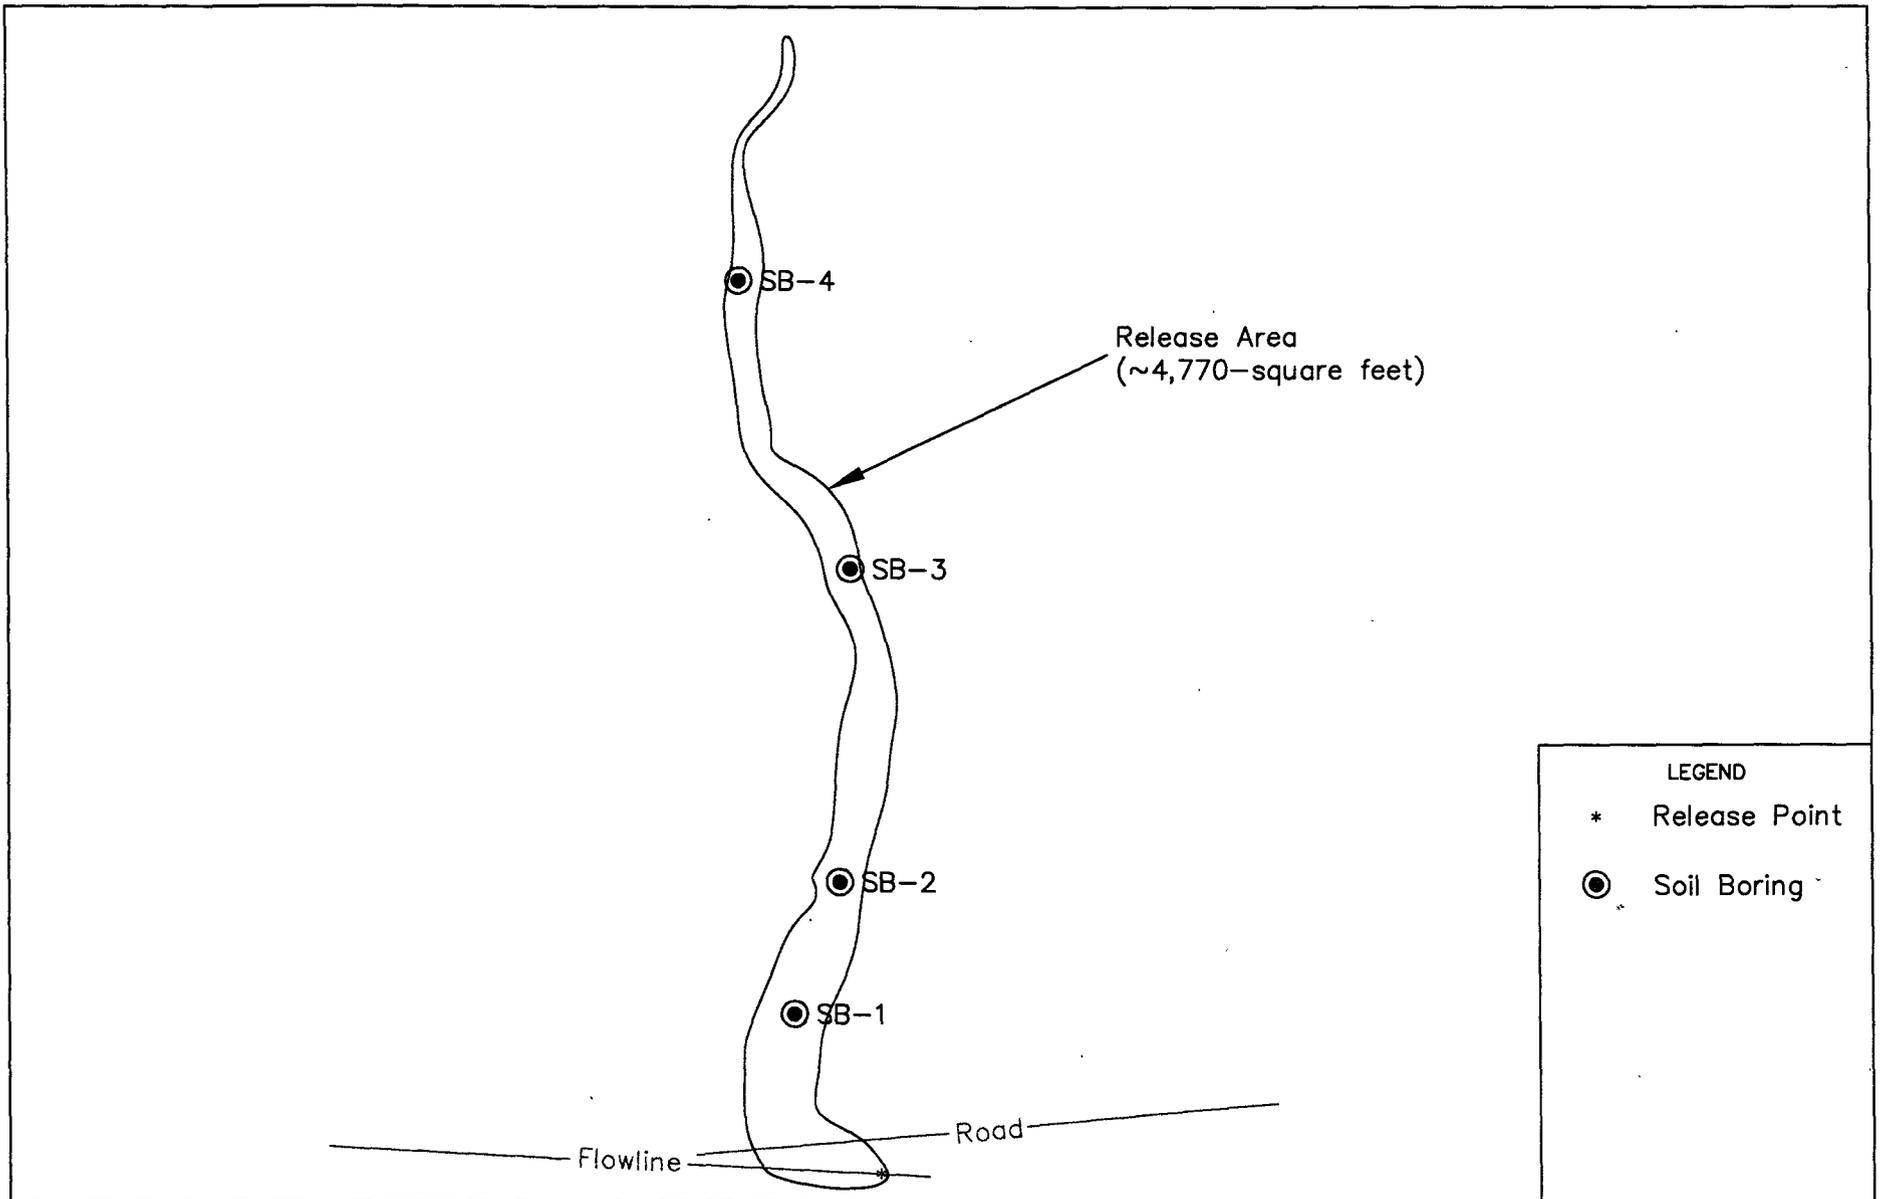
Figure 4
Soil Boring Location Map
ExxonMobil
Avalon TB Transfer Line

Field analysis of soil boring soil samples collected on July 23, 2008 indicated chloride concentrations decreased with depth. Laboratory analytical results indicated chloride concentrations ranged from 2,510 mg/kg (SB-1 @ 3-ft bgs) to 16.1 mg/Kg (SB-2 @ 5-ft bgs) confirming the values of field analyses results. Soil boring soil samples demonstrated the bulk of chloride concentrations reside in the zone from original ground surface to ±five (5) feet below ground surface (bgs).

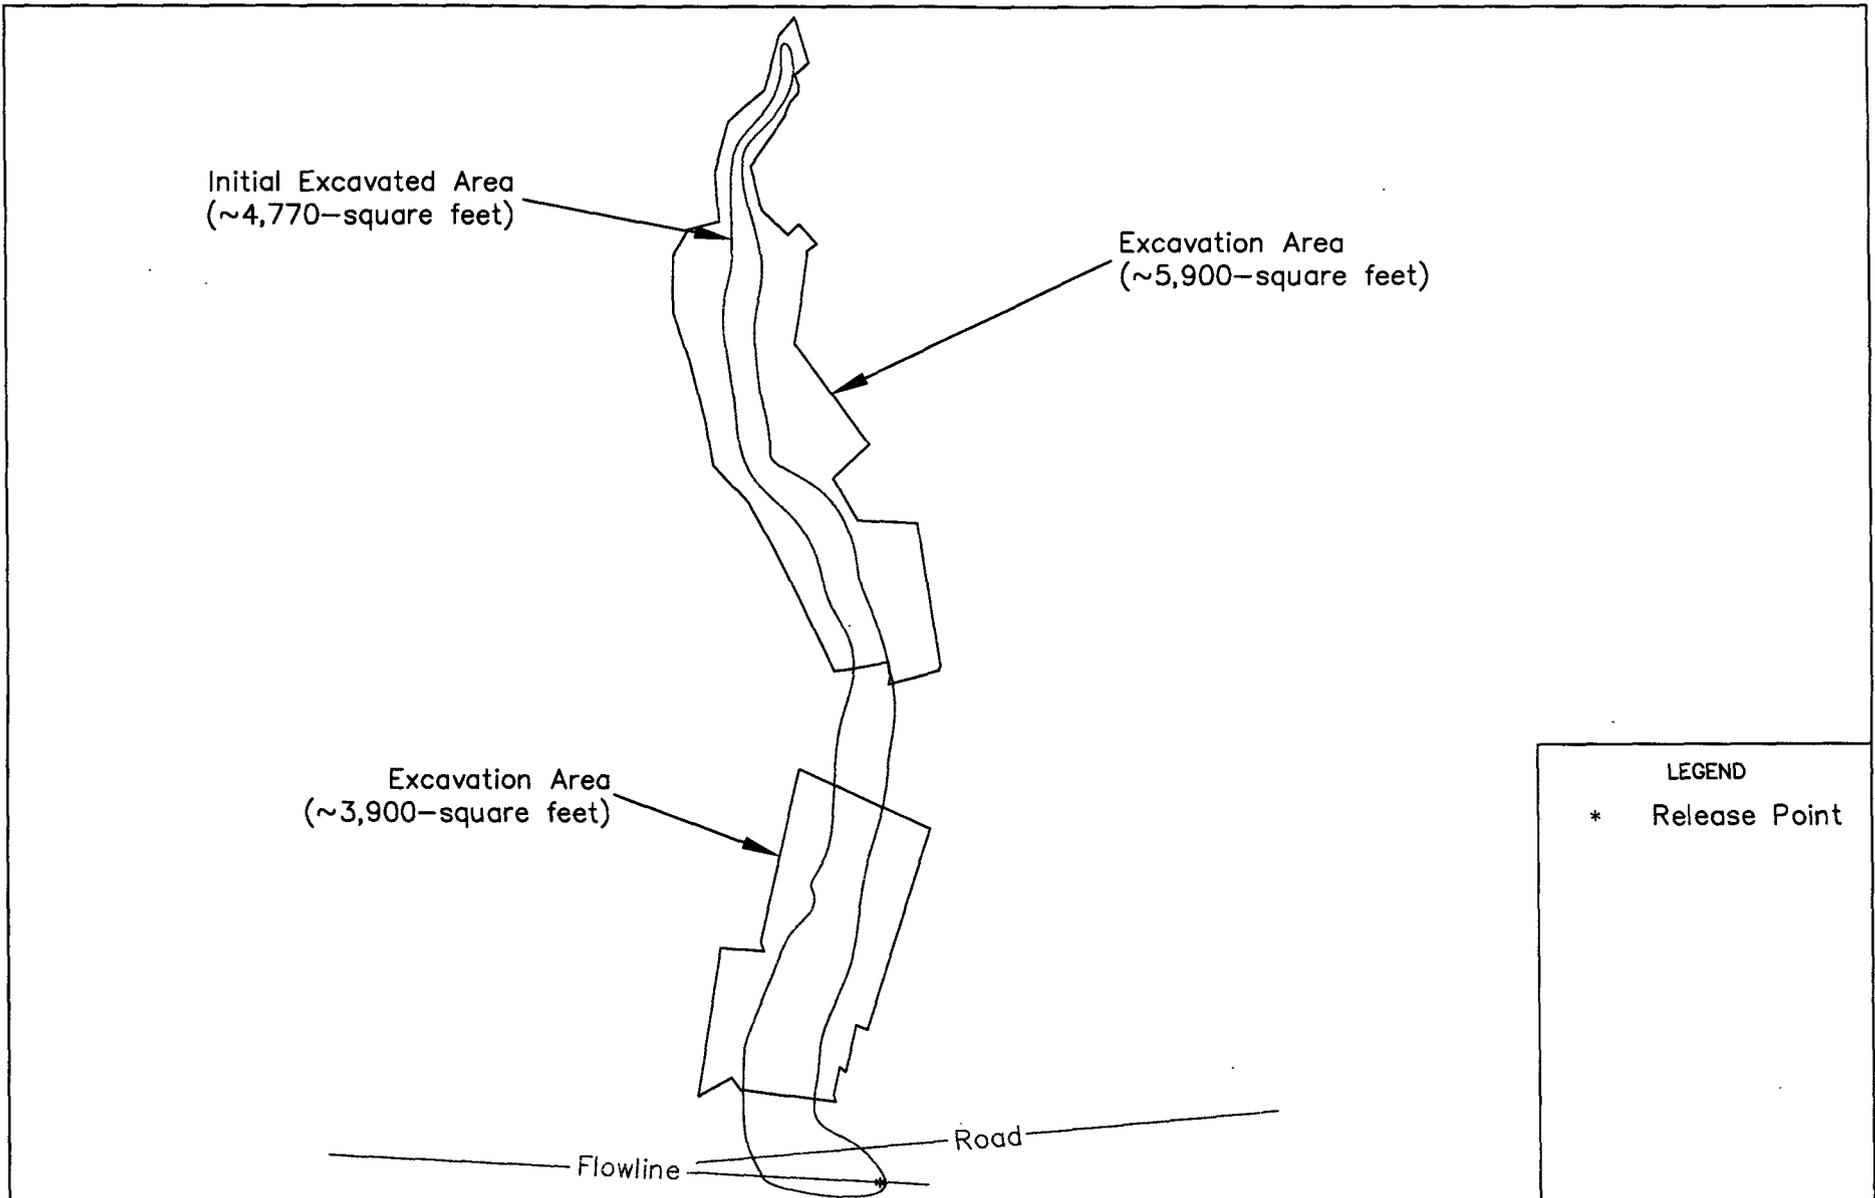
Figure 5
Excavation Map
ExxonMobil
Avalon TB Transfer Line

On October 27, 2008 EPI mobilized on site to commence remediation activities of the release area. From October 27 through November 11, 2008, EPI excavated approximately 1,968 cubic yards of impacted soil. Impacted material was transported to Sundance Services, Inc., for disposal. As noted in *Figure 5*, two (2) separate excavations were undertaken on the north and south sectors of the original release area. Depth of excavations ranged from three (3) to eight (8) feet below ground surface (bgs). During remedial activities, soil samples were collected from bottom and sidewalls of the excavation with transportation to XENON (ELT) Laboratory in Odessa, Texas for analyses of chloride concentrations. A review of *Table 3, Summary of Soil*

Sample Field Analyses and Laboratory Analytical Results, indicates soil impacted with chloride concentrations above NMOCD Remedial Threshold goals of 250 mg/Kg were completely removed from sidewalls and bottom of the excavation. With this knowledge, EPI began backfill activities commencing on November 12, 2008 and ending November 17, 2008. During this interim, approximately 714 cubic yards of caliche and 1,740 cubic yards of top soil were transported from an independent source for use as backfill material. Caliche was placed from bottom of excavation to within three (3) feet of original ground surface. Remainder of the excavation was backfilled with clean top soil. Disturbed areas were contoured to allow natural drainage and blend into surrounding topography.

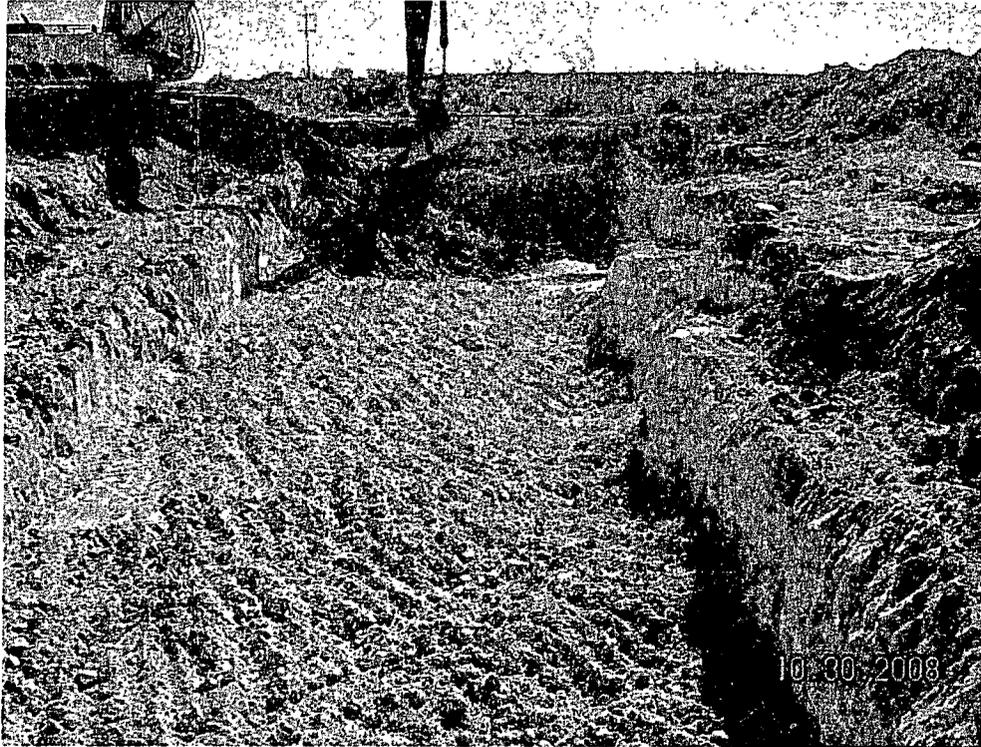
Photograph #3 – View across excavation

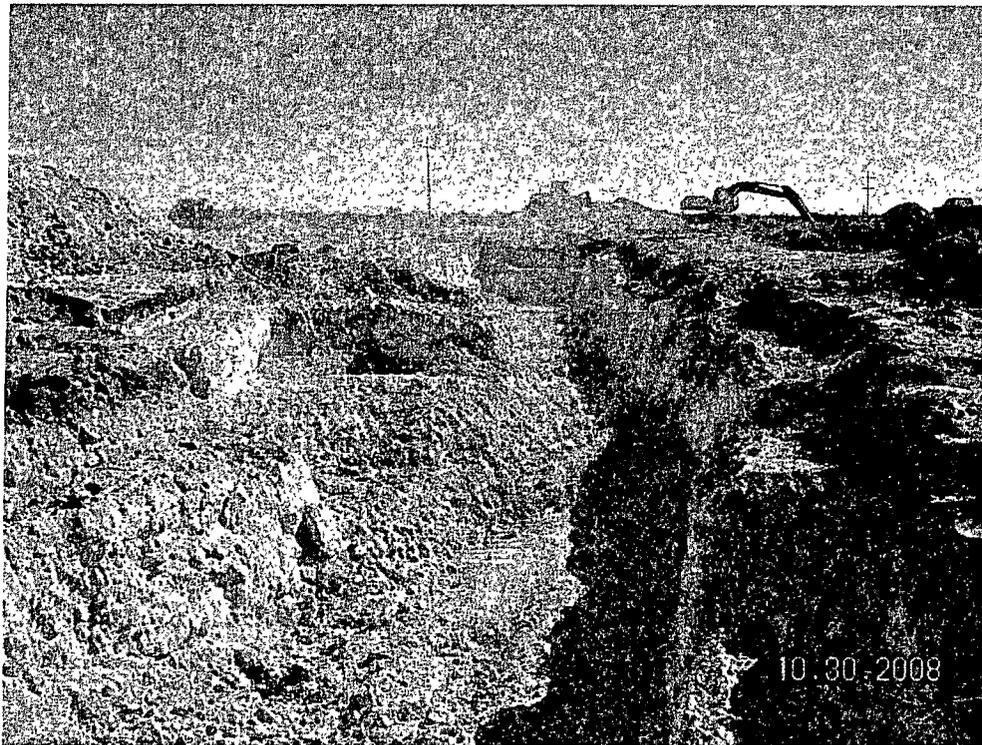
Photograph #4 – View across excavation

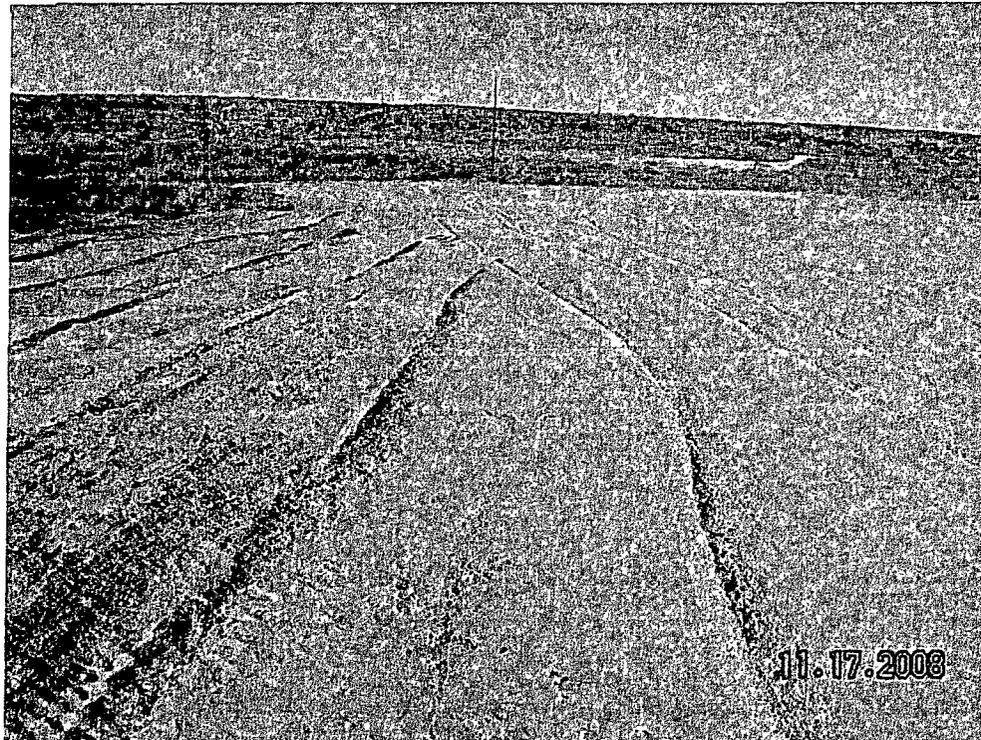
Photograph #6 – Remediated area

EPI recommends seeding the disturbed areas in late spring of 2009 when ground and weather conditions are more conducive to grass survival. Disturbed areas will be harrowed and disked then seeded with a blend approved by the BLM.
