Soil Closure Compliance Report

**Red Byrd #4 - Monument
NW ¼ of NW ¼ Section 12, Township 20 South, Range 36 East
Lea County, New Mexico**

**Plains All American Leak Number 2000-10479
Terracon Project Number A4087064
Railroad Commission Job #1643**

December 1, 2008

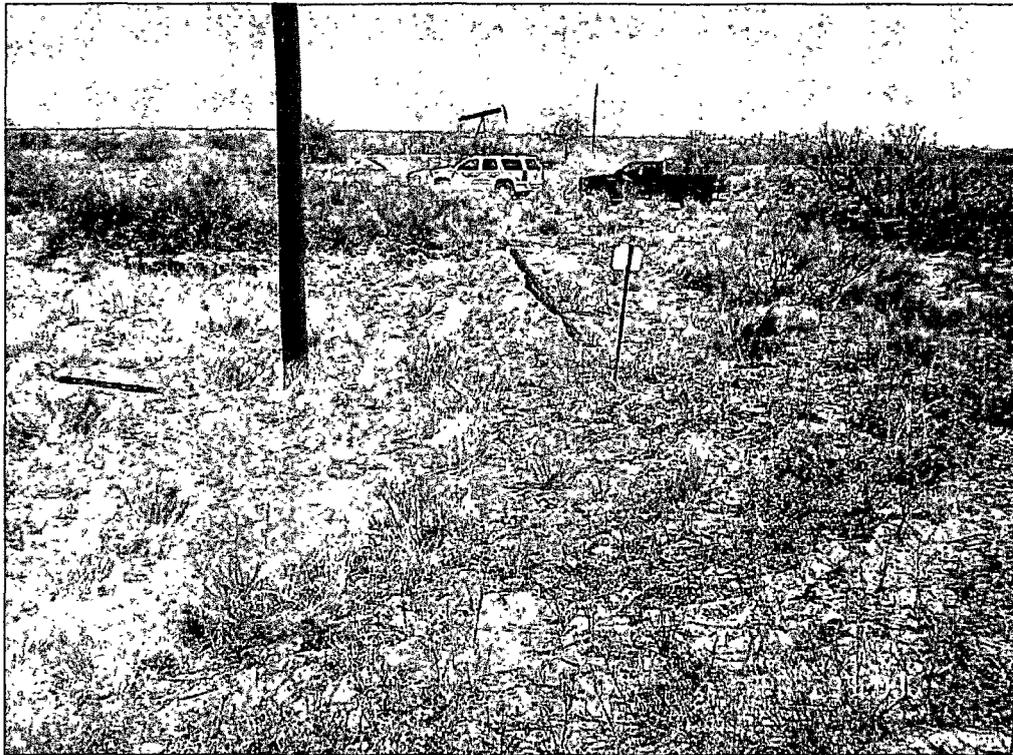
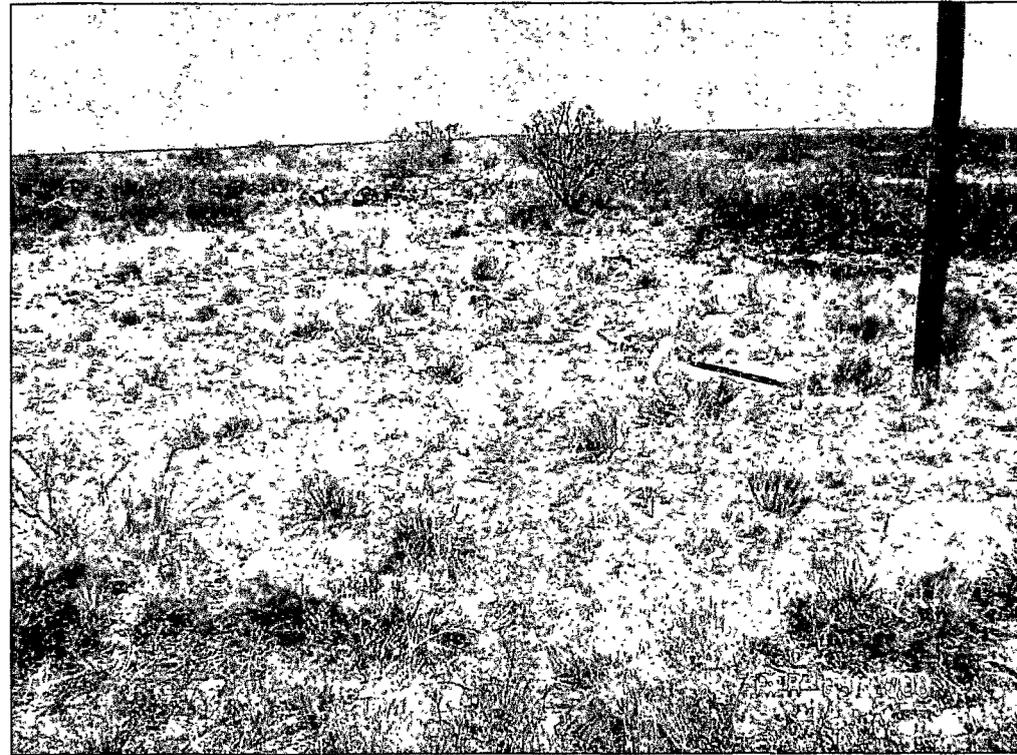
Initial assessment photographs. Southeast corner looking north and Southeast corner looking west.

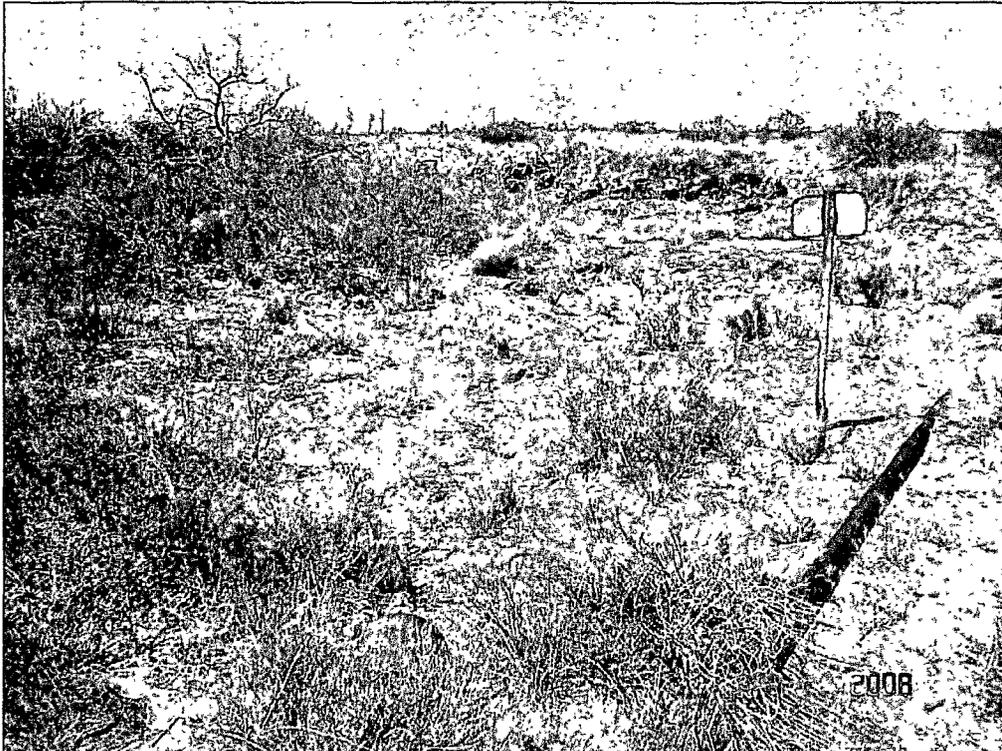
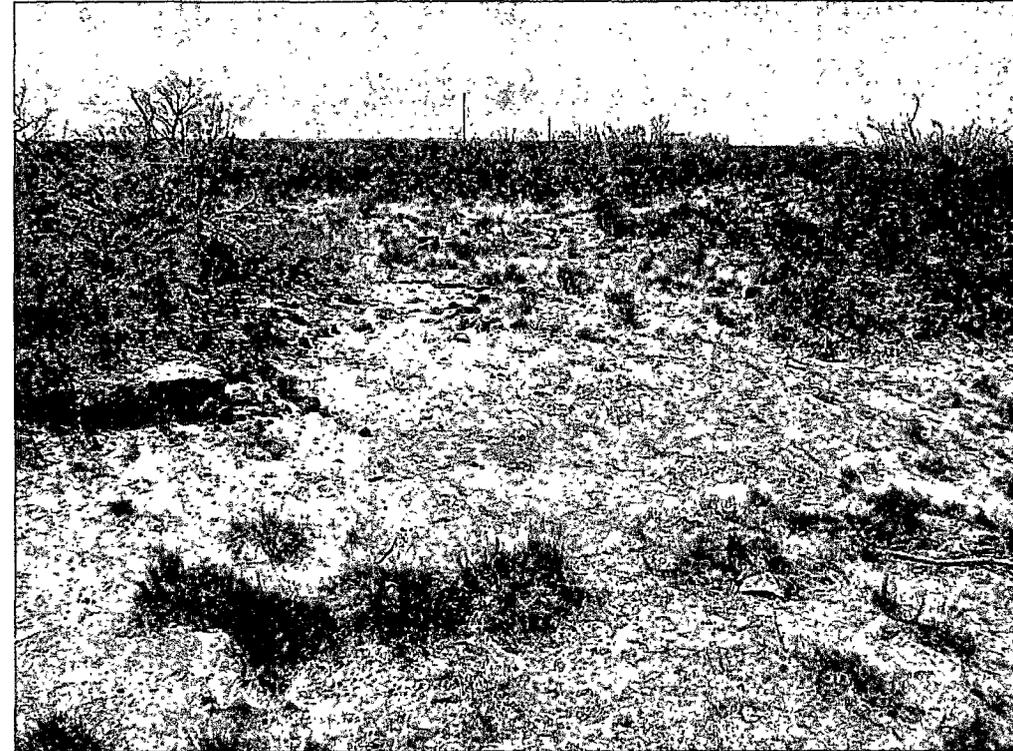
Initial assessment photographs. Southwest corner looking north and Southwest corner looking east.

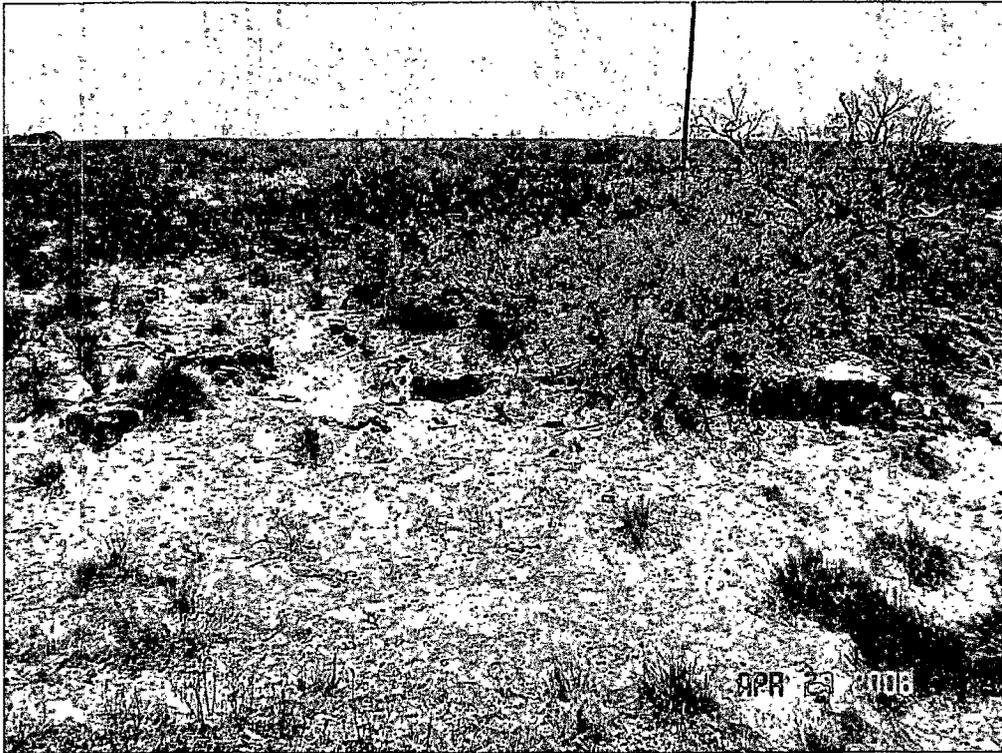
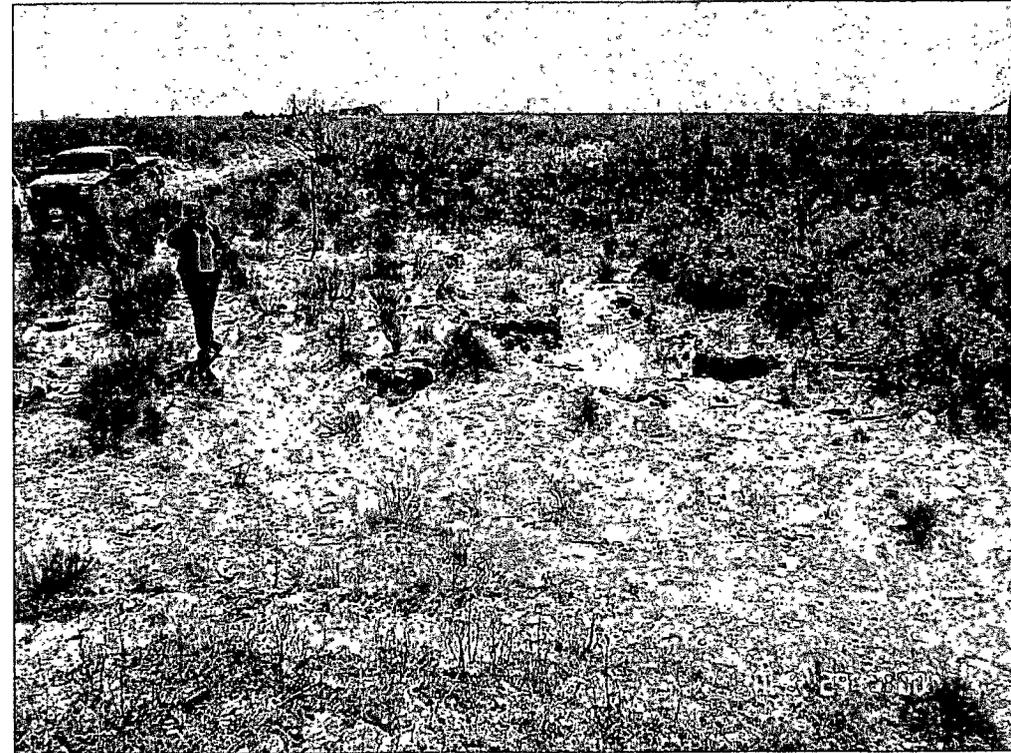
Initial assessment photographs. North side looking south and north side corner looking east.

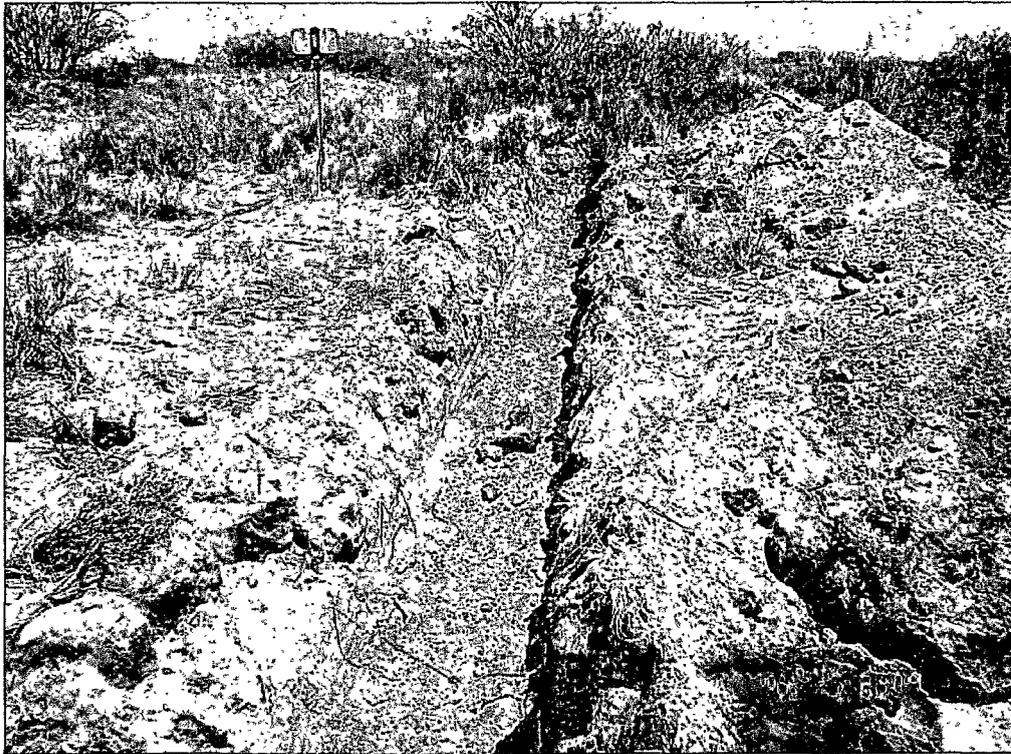
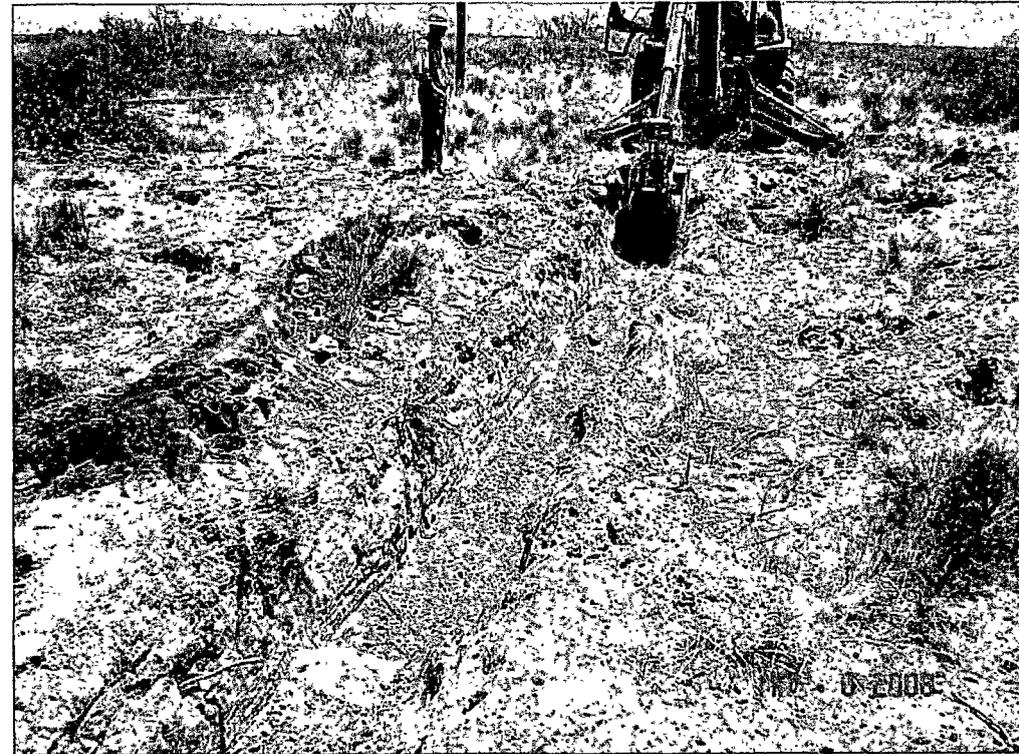
Photographs of site delineation trenches. Trenches were approximately 24 inches wide and 24 inches below ground surface.

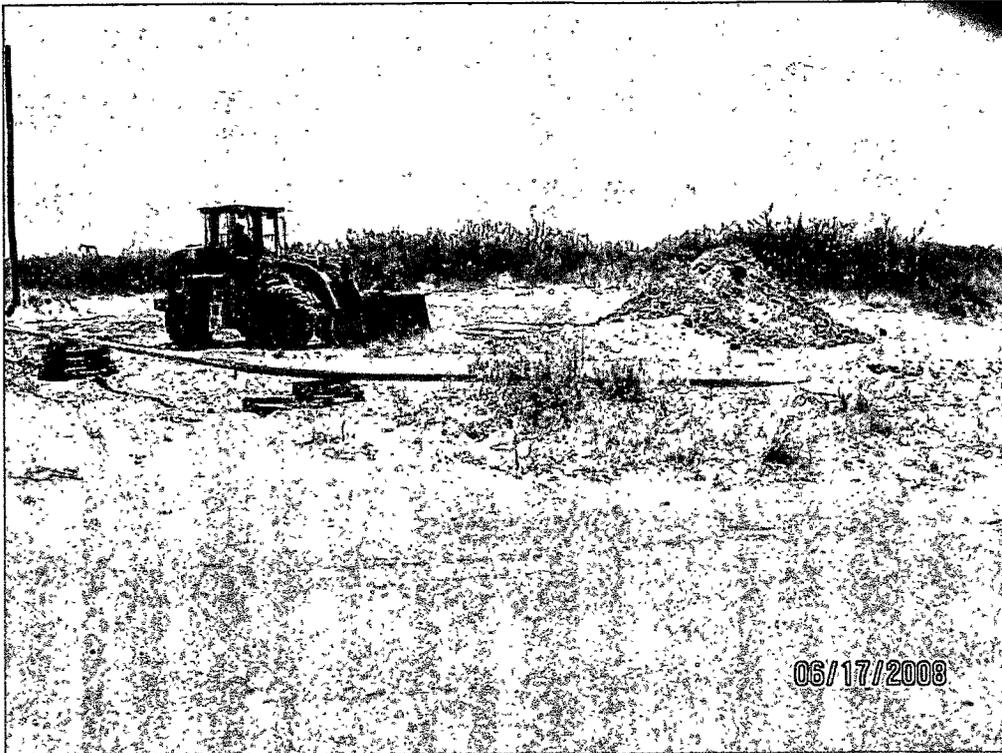
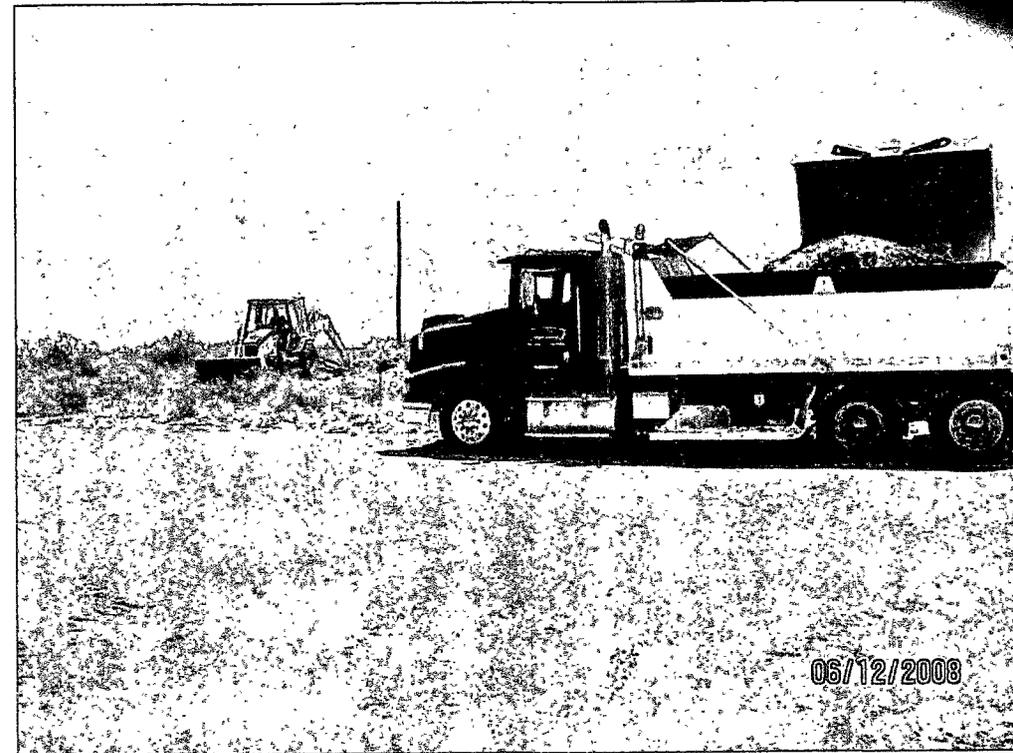
Photographs of site excavation activities and transport of excavated material to Plains Lea Station Land Farm.

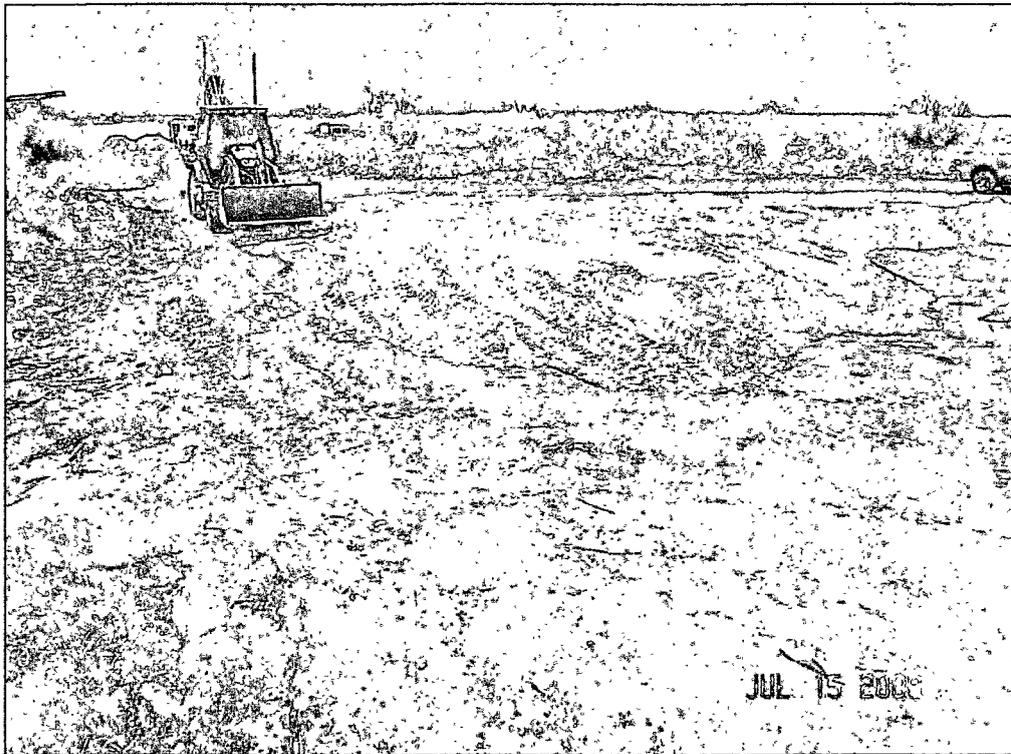
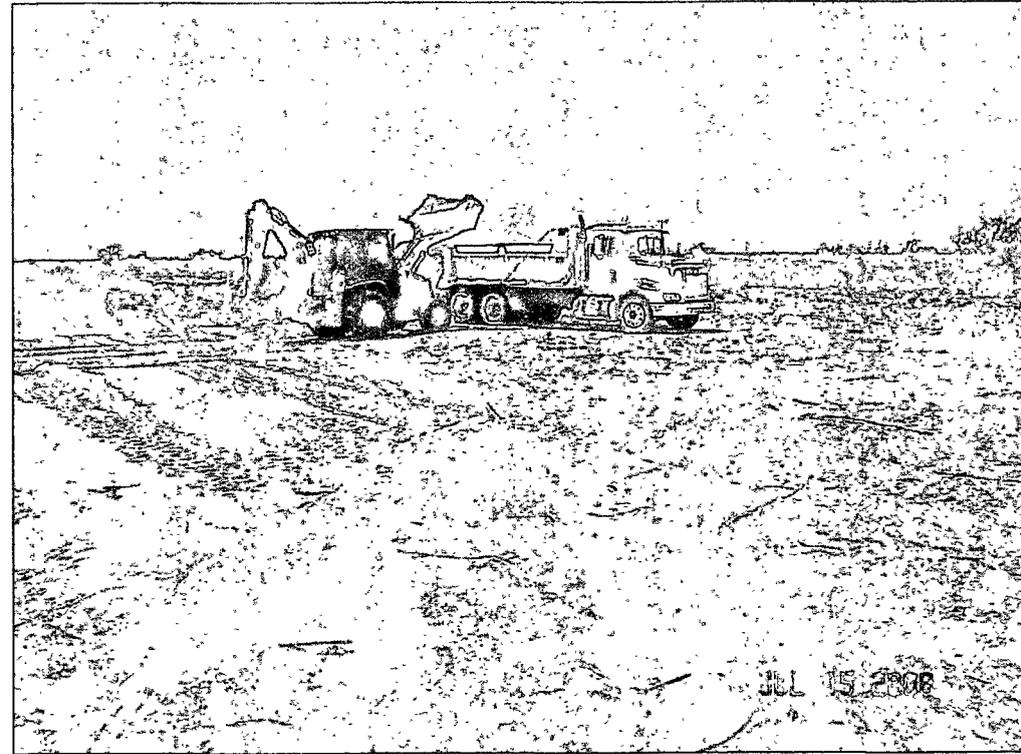
Photographs of site restoration activities and excavation / transport of ambient soil from landowner approved area.

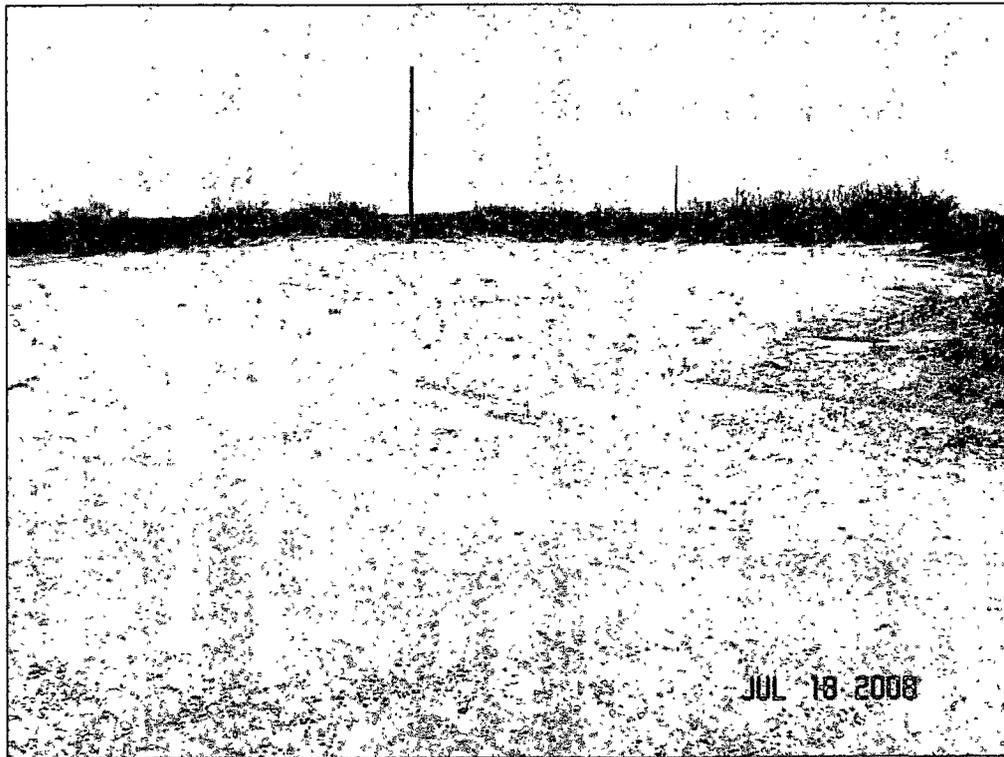
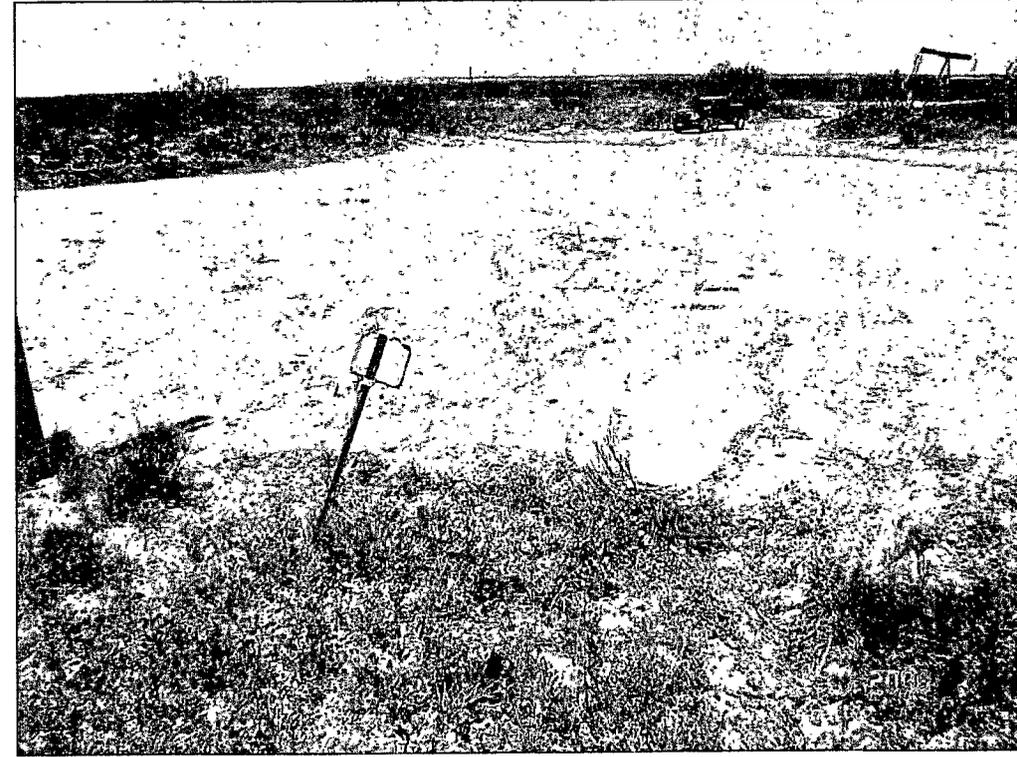
Photographs of site following restoration activities.
