**REMEDIATION SUMMARY  
AND  
SOIL CLOSURE REQUEST**

**PLAINS MARKETING, L.P. (231735)  
Monument Barber 10-Inch Sour  
Lea County, New Mexico  
Plains SRS # 2000-10655  
UNIT M (SW/SW), Section 32, Township 19 South, Range 37 East  
NMOCD Reference # 1RP-0738**

Prepared By:  
Basin Environmental Service Technologies, LLC

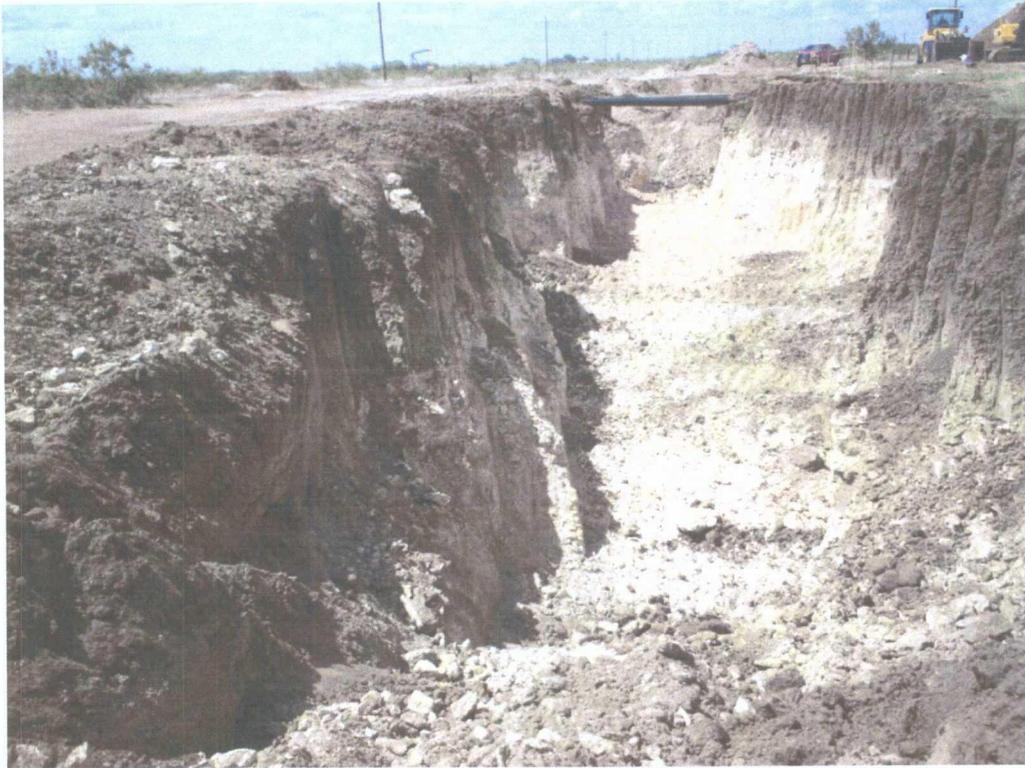
Looking North along North-South Excavation Toward Release Point

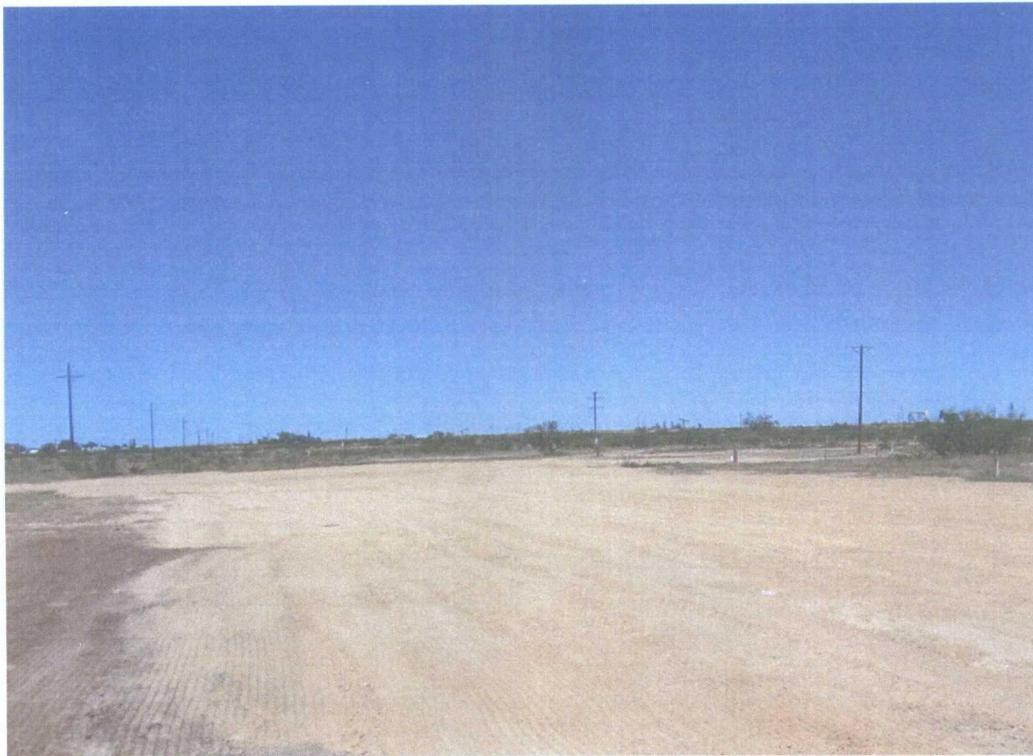
Looking North, Remediation Completed, Excavation Backfilled, Contoured and Seeded
