SITE CLOSURE REQUEST

PLAINS MARKETING, L.P. (231735)

CVU 6-Inch

NMOCD Reference # 1RP-1927

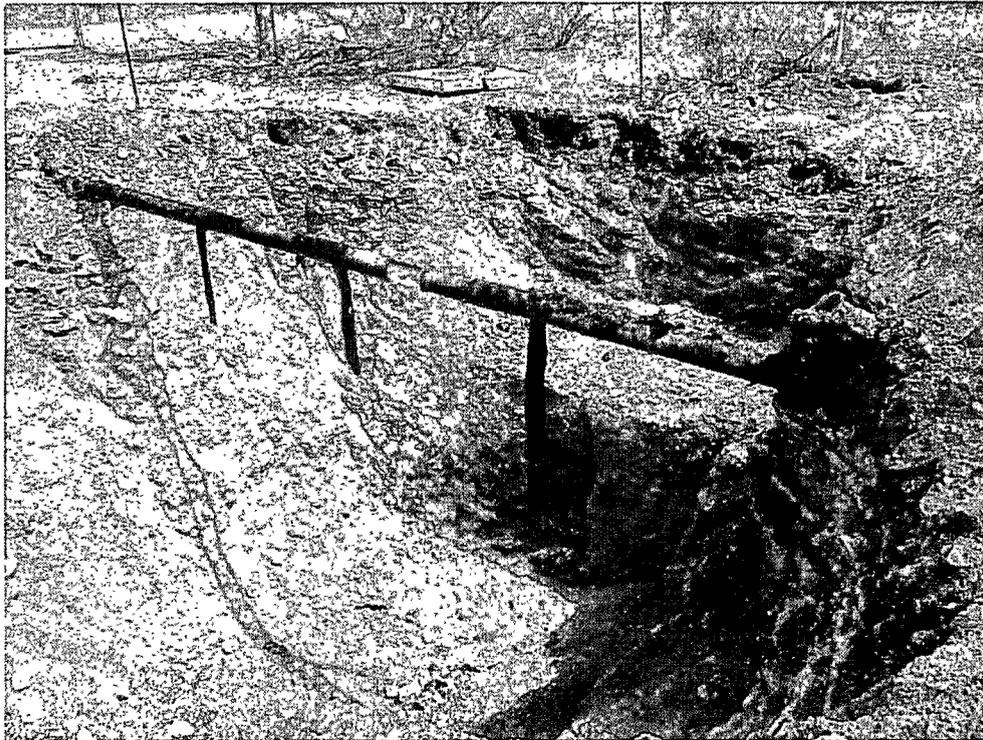
CVU 6-Inch release site facing east

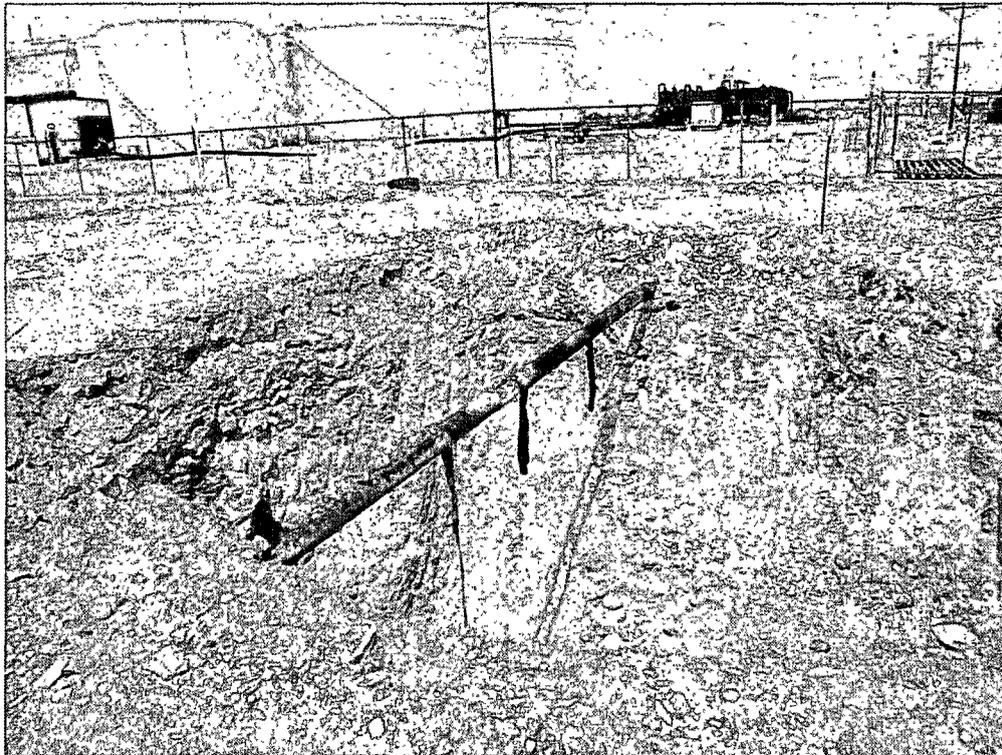
CVU 6-Inch release site facing north
