Release Notification and Corrective Action

Re: Pipeline Spill Investigation Report, Dynegy Midstream Services. L.P., Unit Letter N (SE/4, SW/4), Section 35, Township 22 South, Range 37 East, Lea County, New Mexico

**Table 1: Summary of Headspace and Laboratory Analyses of Soil Samples
Dynegy Midstream Services, L.P., Spill Site #56
SE/4, SW/4, Section 35, Township 22 South, Range 37 East
Lea County, New Mexico**

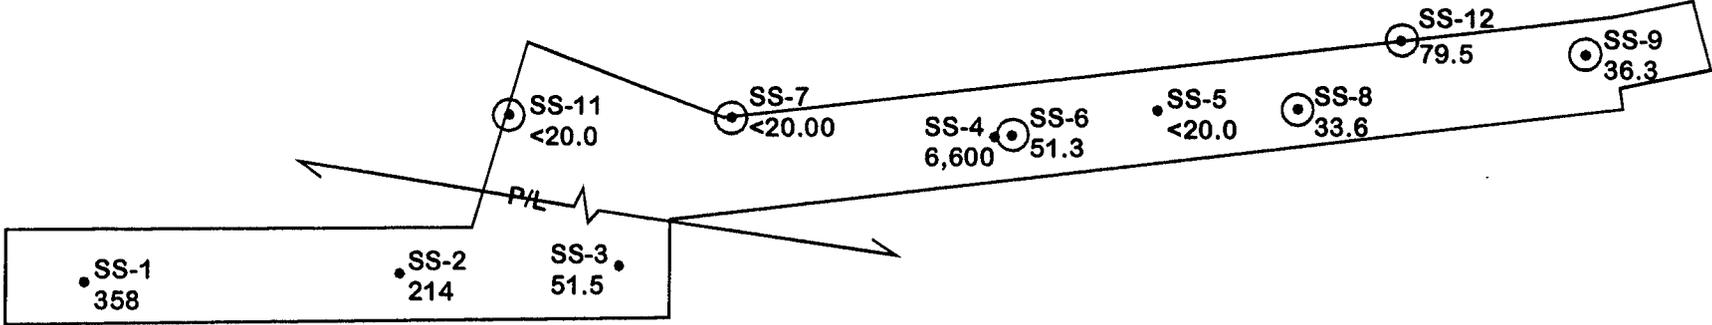
FIGURE #2

FILL-1
338.5

FILL-2
328.2

- SS-1 358 ● SOIL SAMPLE LOCATION with TPH CONCENTRATION (Mg/Kg), 8/21/03
- SS-6 51.3 ⊙ SOIL SAMPLE LOCATION with TPH CONCENTRATION (Mg/Kg), 8/26/03

SITE DETAIL

Referring to Table 1, TPH concentrations from all soil samples collected from the bottom of the excavation were below the RRAL, except sample SS-4 (6,600 mg/kg). The chloride concentrations from all soil samples collected from the bottom of the excavation were below the test method detection limit, except for sample SS-3 (177 mg/kg). The NMOCD does not have a published RRAL for chloride.

Referring to Table 1, TPH concentrations from the Site #56 excavation were below the RRAL, with the exception of the samples of stockpiled soil (Fill-1 [338.5 mg/kg] and Fill-2 [328.2 mg/kg]). Chloride concentrations in all soil samples were below the test method detection limit.

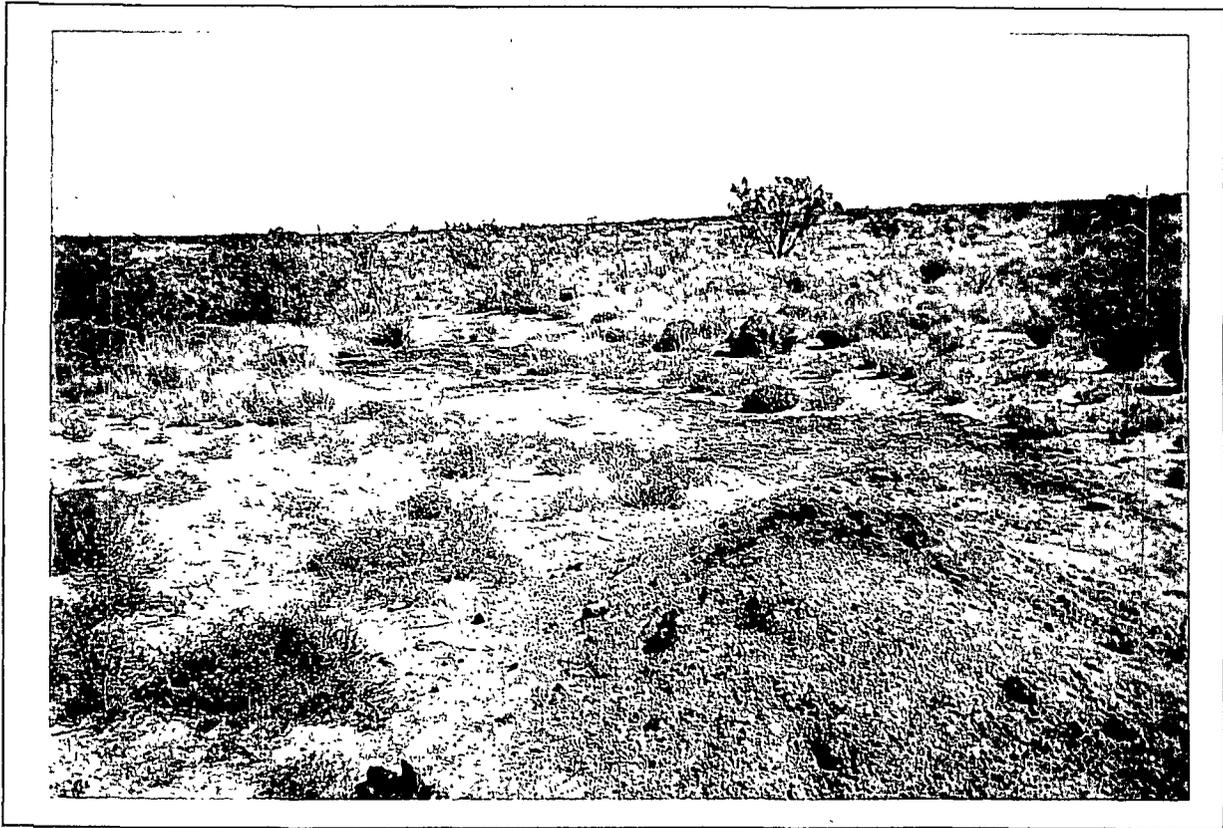
Photo# 1 View of site before excavation to N (8/19/03)

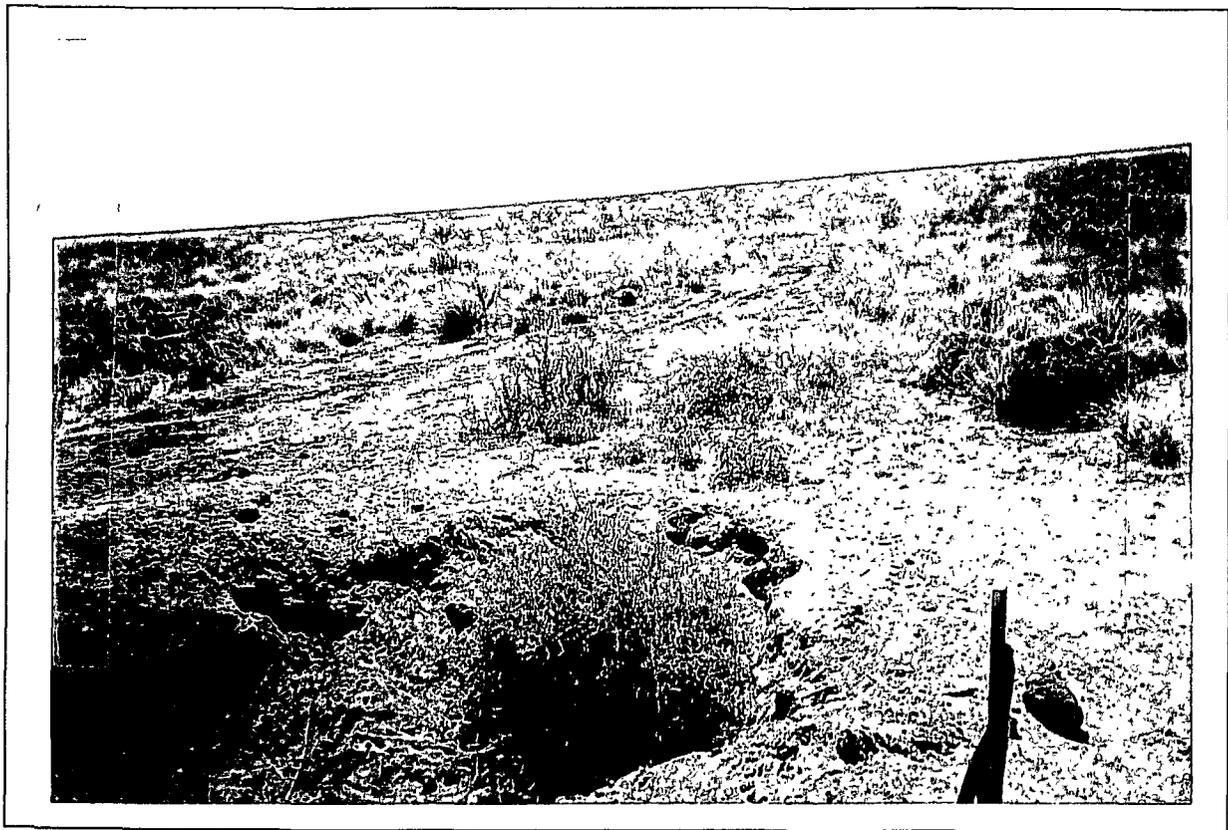
Photo# 2 View of site before excavation to S (8/19/03)

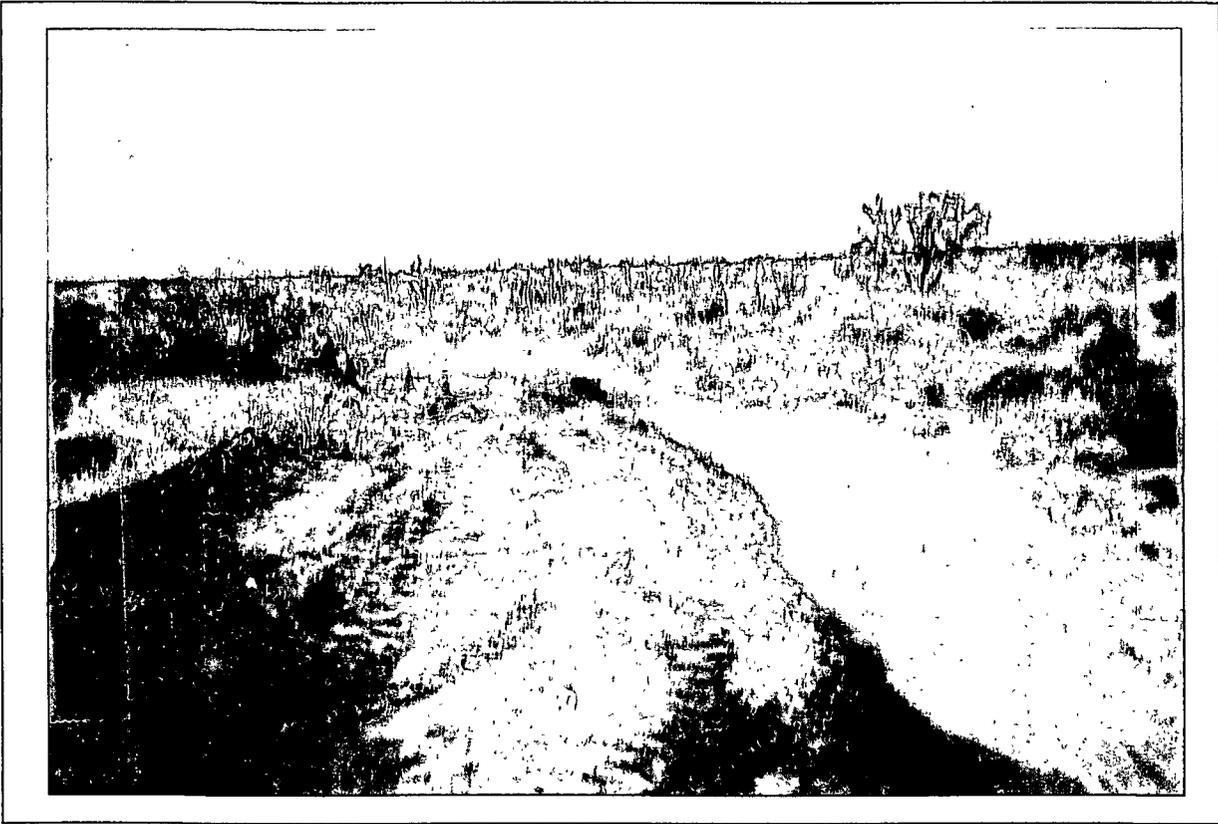
Photo# 3 View to SE of Excavation (8/21/03)

From August 19 to August 21, 2003, excavation was conducted at Site #56 to remove all impacted soil within the vicinity of the pipeline leak. On August 21, 2003, LA personnel collected soil samples along the bottom of the excavation, at depths ranging from seven and a half (7.5) to nine (9) feet below ground surface (bgs). The soil samples were placed in clean glass sample jars, labeled, chilled in an ice chest, and delivered under chain-of-custody control to Environmental Lab of Texas I, Ltd., (ELOT) located in Odessa, Texas. Soil samples were analyzed for total petroleum hydrocarbons (TPH) by EPA method SW-846-8015, and for chloride by EPA method SW-846-9253.
