Release Notification and Corrective Action

Name of Company	Plains Pipeline, LP	Contact	Daniel Bryant
Address	P.O. Box 3119 – Midland, Tx 79702	Telephone No.	(432) 557-5865
Facility Name	Dollarhide to Jal 8"	Facility Type	Pipeline

On June 6, 2008, Plains reported a release of 620 barrels of crude oil from the Dollarhide to Jal 8-Inch pipeline. Approximately 570 barrels of crude oil were recovered during initial response activities resulting in a net loss of approximately 50 barrels of crude oil. The resulting surface stain attributed to the release measured approximately 25 feet in width and 765 feet in length along a two-track road paralleling the pipeline. The release was attributed to internal corrosion of the 8-inch pipeline.

Figure 1
 Site Location Map
 Dollarhide to Jal 8-Inch
 Plains Marketing, L.P.
 Lea County, New Mexico
 SRS #2008-148
 NMOCD # 1RP-1876

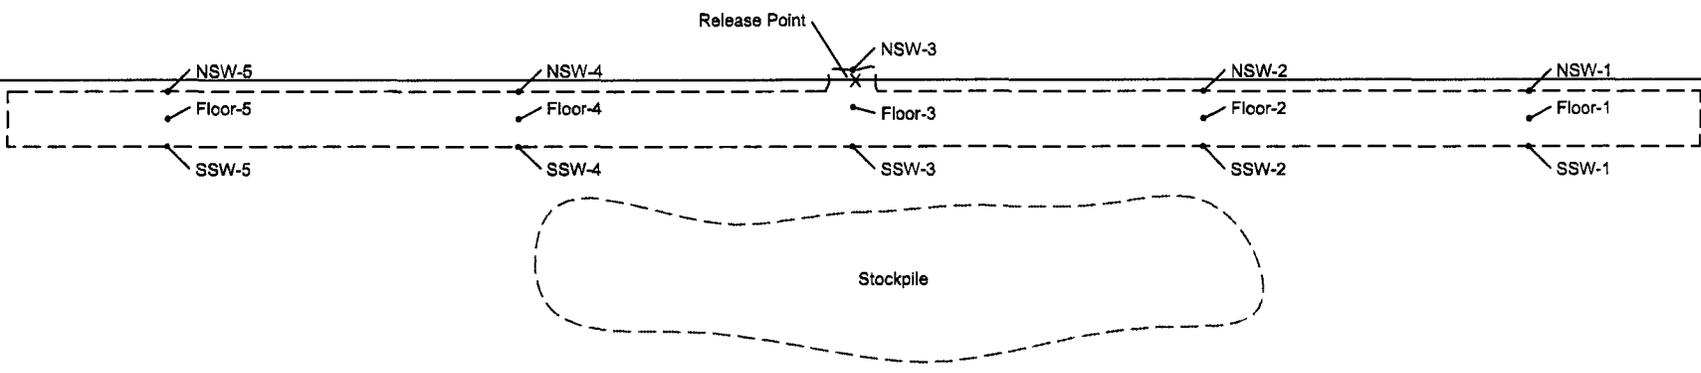
Figure 2
Site and Sample
Location Map
Plains Marketing, L.P.
Dollarhide to Jal 8-inch
Lea County, NM
SRS# 2008-148
1RP-1876

- Legend:
- — Excavation Extent
 - Grab Soil Sample Location
 - Pipeline

Based on the analytical results of confirmation soil samples collected from the floor and sidewalls of the excavation, along with the analytical results of soil blending / remediation and backfilling activities, Basin recommends Plains provide the NMOCD Hobbs District Office a copy of this Remediation Summary and Site Closure Request and request the NMOCD grant site closure to the Dollarhide to Jal 8-Inch release site.

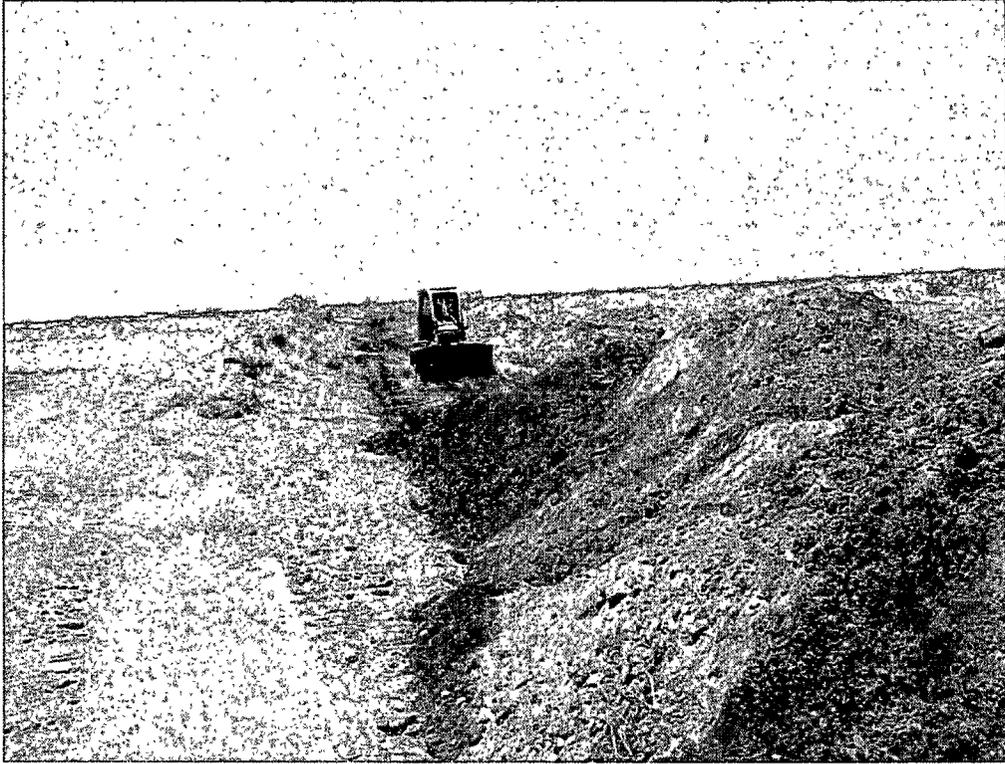
Dollarhide to Jal 8-Inch Release, Excavation in Progress, facing west

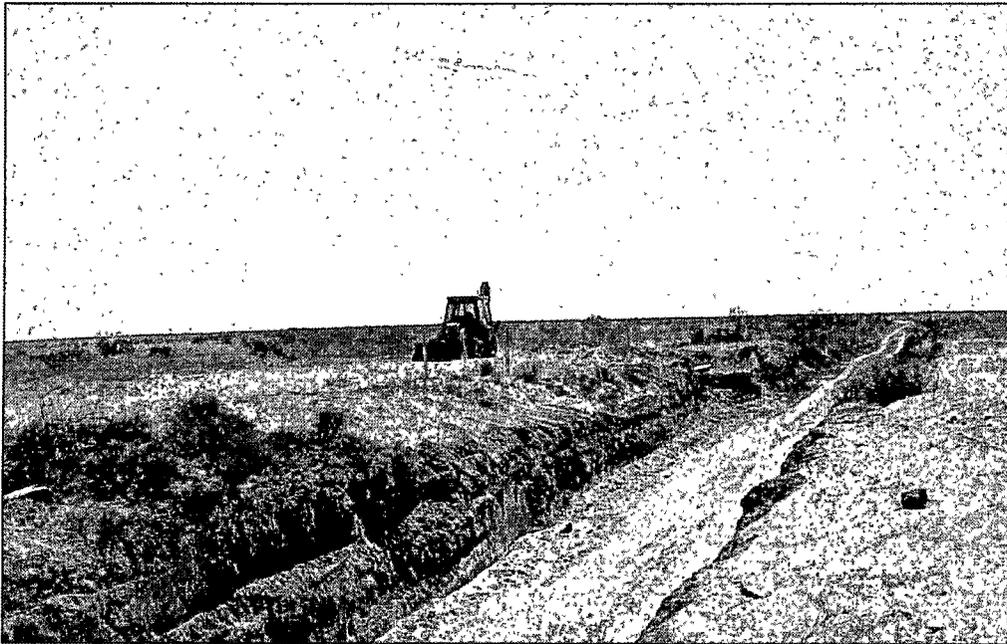
Dollarhide to Jal 8-Inch Release, Excavation Complete, facing east

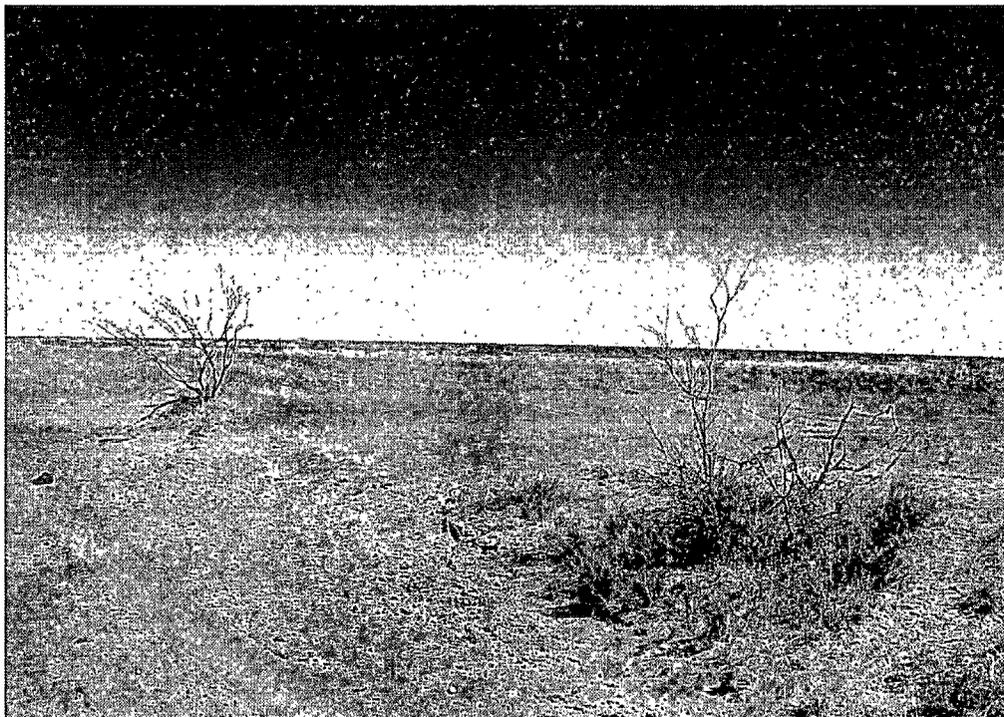
Dollarhide to Jal 8-Inch Release, Remediation Activities Complete
