Release Notification and Corrective Action

Name of Company: Targa Midstream Services L P	Contact: James Lingnau 505.394.2534, Chuck Tolsma 505.631.6026
Address: PO Box 1909 Eunice, NM 88231	Telephone No. (505) 394-2534
Facility Name: Eunice Gathering System	Facility Type Natural Gas Facility

Describe Area Affected and Cleanup Action Taken.*
Targa replaced 150 feet of pipeline. 264 yards of contaminated soil was excavated and haul to an approved landfarm. The area has been cleaned and tested per OCD Guidelines.

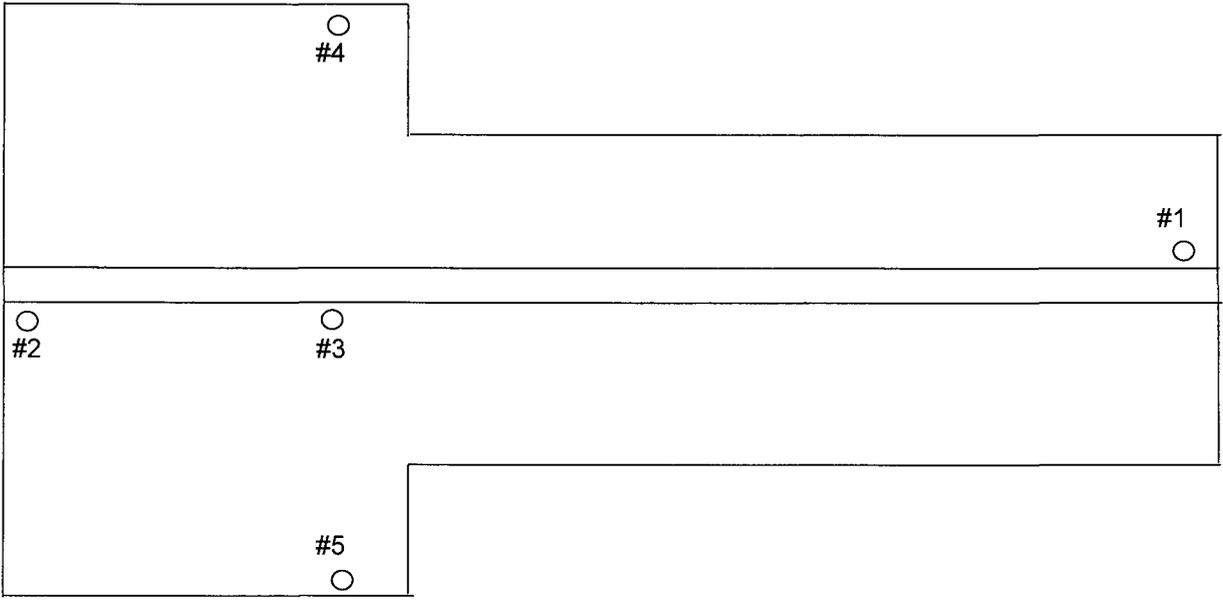
R.D. SIMS 8"

SAMPLE DATE	SAMPLE I.D.	SOIL STATUS	TPH GRO	TPH DRO	CHLORIDE
5/7/2009	#1 West Side	In Situ	<10	21.8	48
5/7/2009	#2 East Side	In Situ	<10	60.3	64
5/7/2009	#3 Bottom	In Situ	<10	90.1	288
5/7/2009	#4 North Side	In Situ	<10	11.7	64
5/7/2009	#5 South Side	In Situ	<10	172	<16

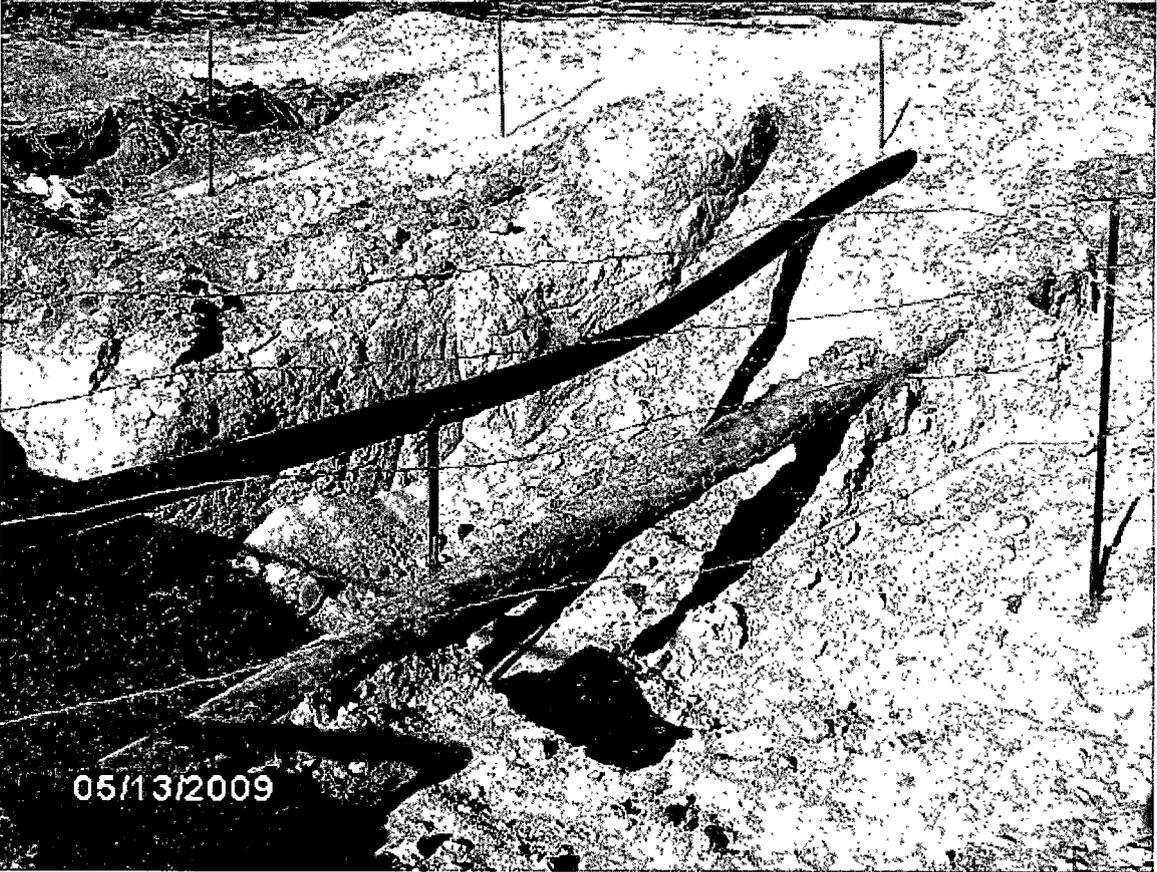
Describe Cause of Problem and Remedial Action Taken.*
An 8 inch gathering line had a leak and released gas and any produced liquids that were lying in the line. Line was repaired with clamp. Area will be cleaned to meet OCD guidelines. Line monitor aircraft discovered leak
