# **Closure Report**

**Roaring Springs 13 Fed #4 Flowline Leak  
Site #1 and Site #2  
Eddy County, NM**

2RP-259

***Elke Environmental, Inc.***

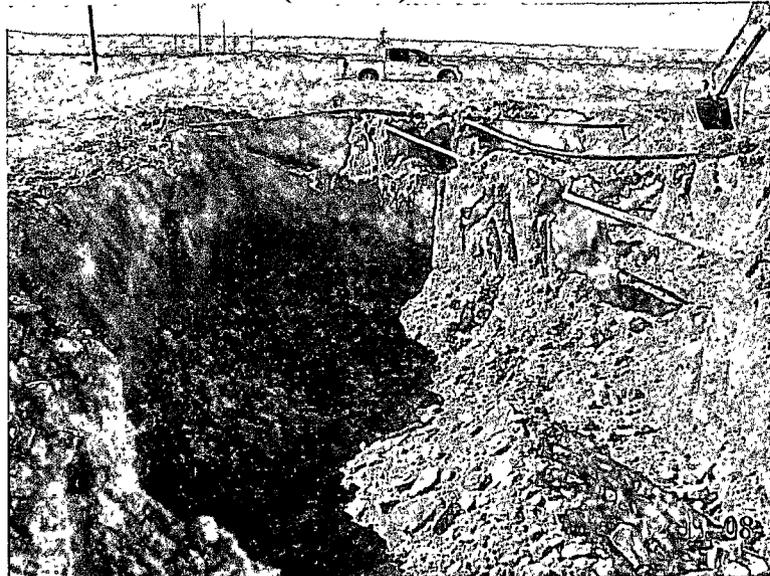
TP4 and TP5 after excavation of impacted soil.

Elke Environmental was contracted by Oxy USA to complete the remediation of the leaks at the Roaring Springs 13 Fed #4 Flowline. A delineation of both sites was completed using a backhoe. At Site #1 during the vertical delineation very hard rock was encountered at 7' depths in the site that was impenetrable by the backhoe. 8' samples were obtained using a pickax. As per the conversation between Sherry Bohnam (NMOCD) and Logan Anderson (Elke) the impacted soil was excavated to the rock and hauled to Lea Land Disposal. Clean Soil was backfilled into the excavation and seeded with BLM Seed Mixture #4.

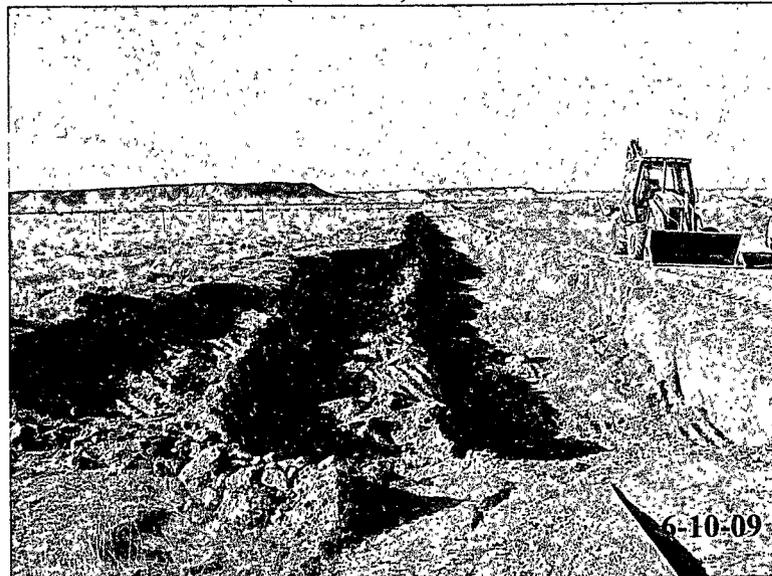
Site facing South after excavation of impacted soil to 4' bgs.

Site #2 - All impacted soil was excavated to 4' bgs and hauled to Lea Land Disposal. A 20 mil poly liner was installed at 4' bgs with 4 oz. Geotextile Liner above and below the poly liner. Clean native soil was backfilled into the excavation and the site was seeded with BLM Seed Mixture #3.

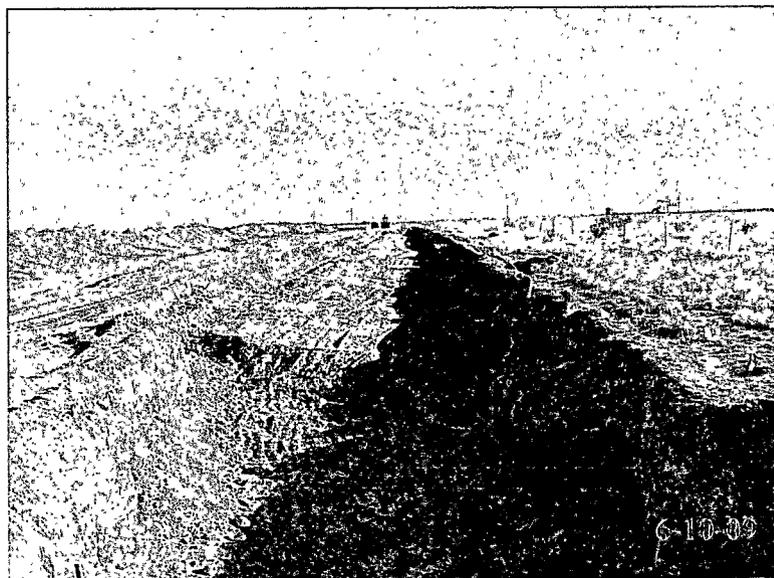
Site facing North after excavation of impacted soil to 4' bgs.

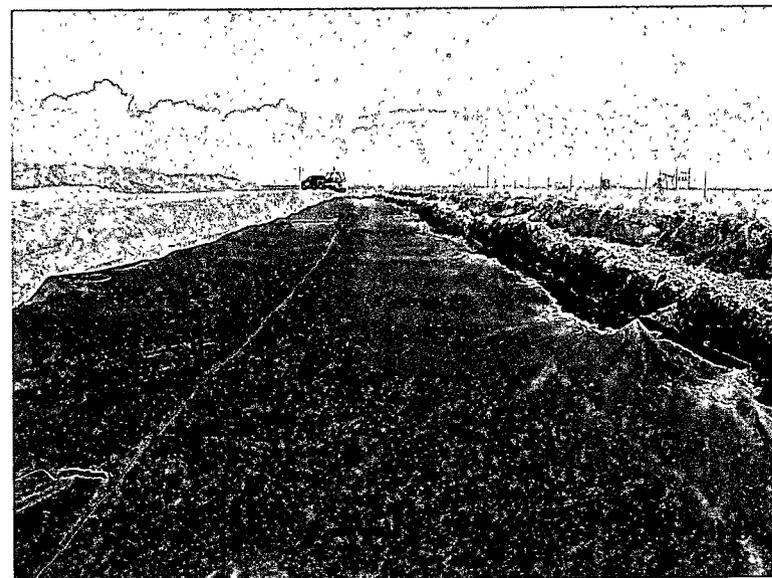
Site after installation of 1<sup>st</sup> Geotextile liner.

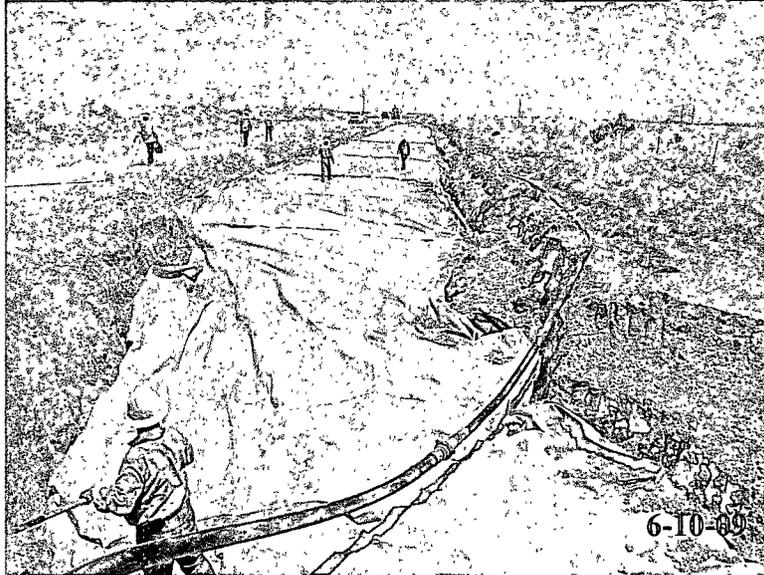
Site after installation of 20 mil poly liner at 4' bgs.

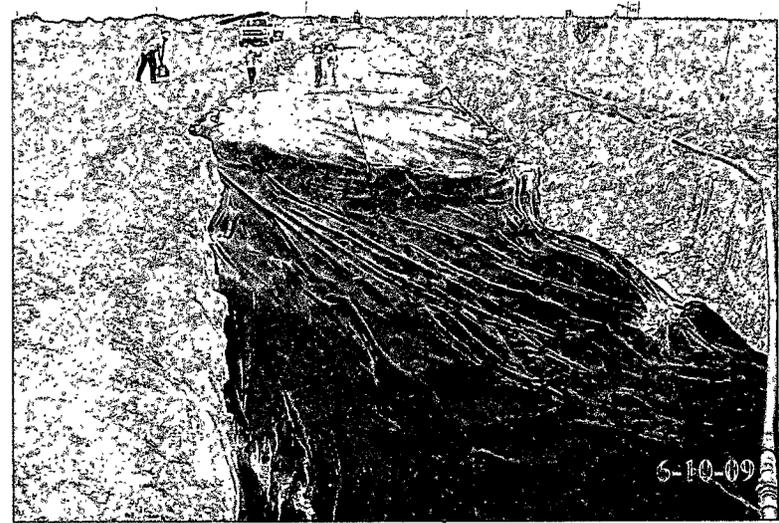
Site after installation of 2<sup>nd</sup> Geotextile liner.
