**Release Notification and Corrective Action**

Name of Company	Plains Pipeline, LP	Contact	Daniel Bryant
Address	3705 E. Hwy 158, Midland, TX 79706	Telephone No.	(432) 557-5865
Facility Name	DCP Plant to Lea Station 6"	Facility Type	Pipeline

Basin Environmental Consulting, LLC

Figure 1  
 Site Location Map  
 Plains Pipeline, L.P.  
 DCP Plant to Lea Station 6-Inch  
 Lea County, New Mexico  
 SRS 2008-275

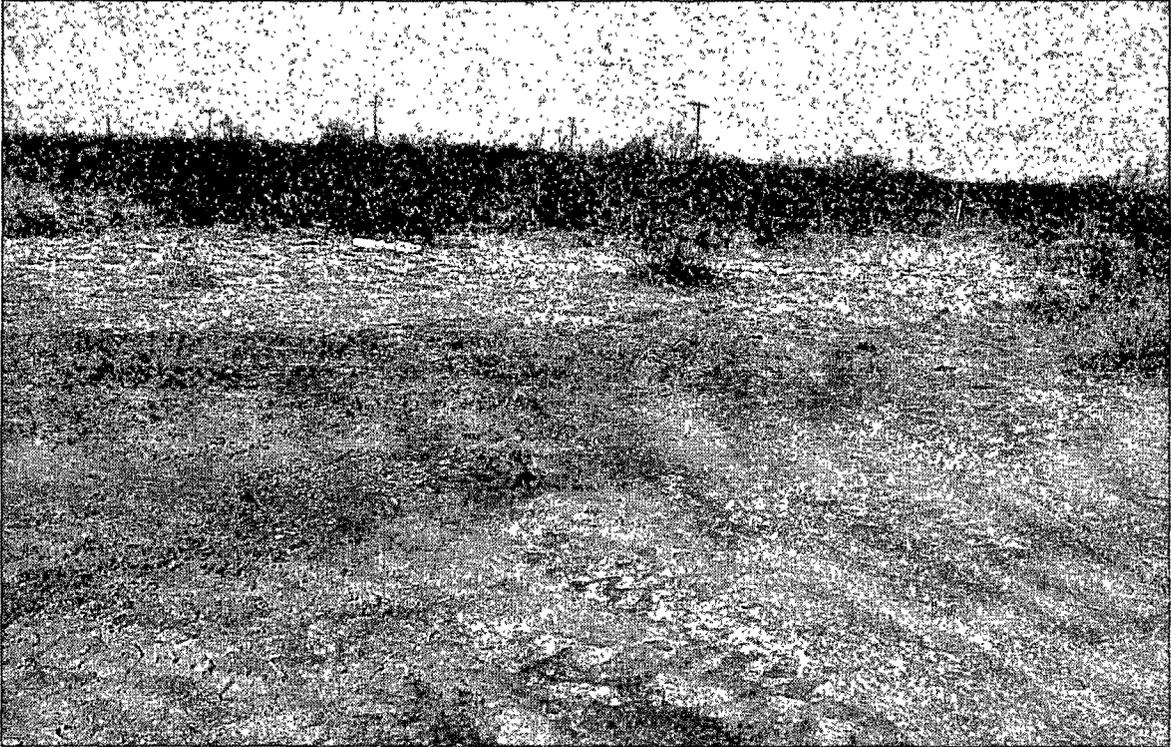
Initial Response at DCP Plant to Lea Station 6-Inch Release Site

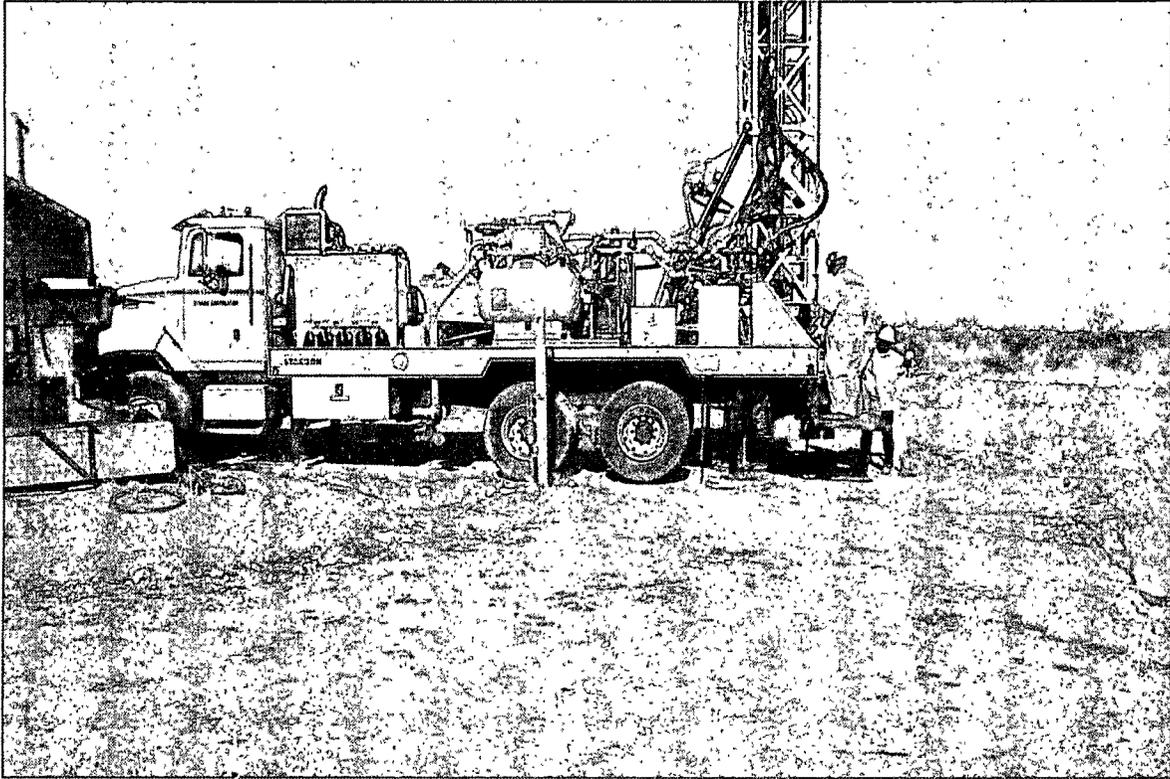
DCP Plant to Lea Station 6-Inch Release Site Soil Boring SB-1

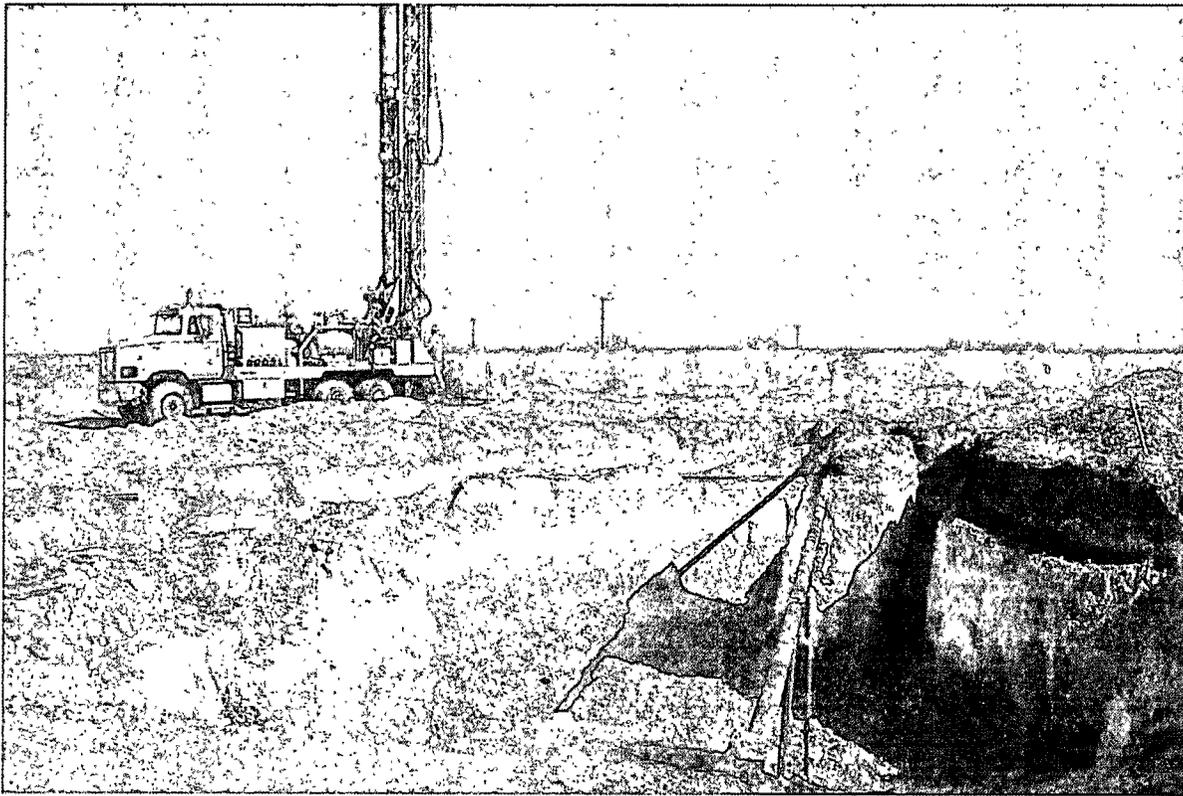
DCP Plant to Lea Station 6-Inch Release Site Soil Boring SB-2

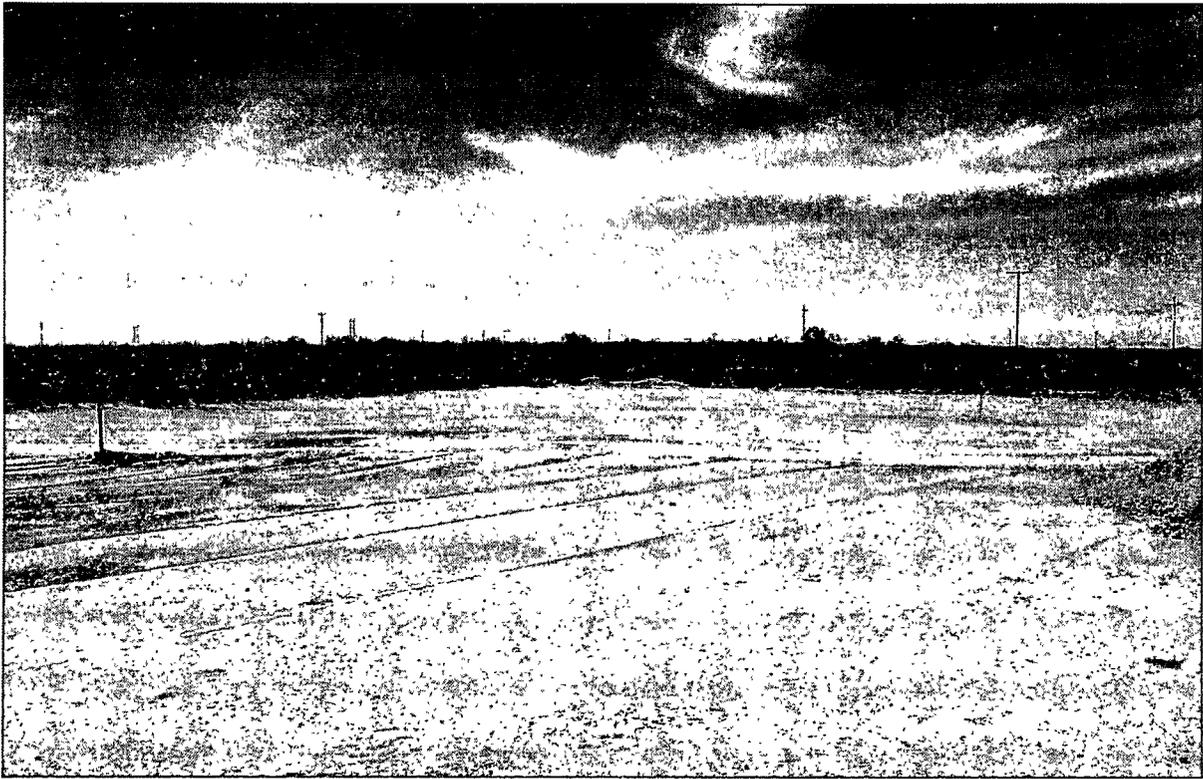
DCP Plant to Lea Station 6-Inch Release Site Remediation Completed and Backfilled

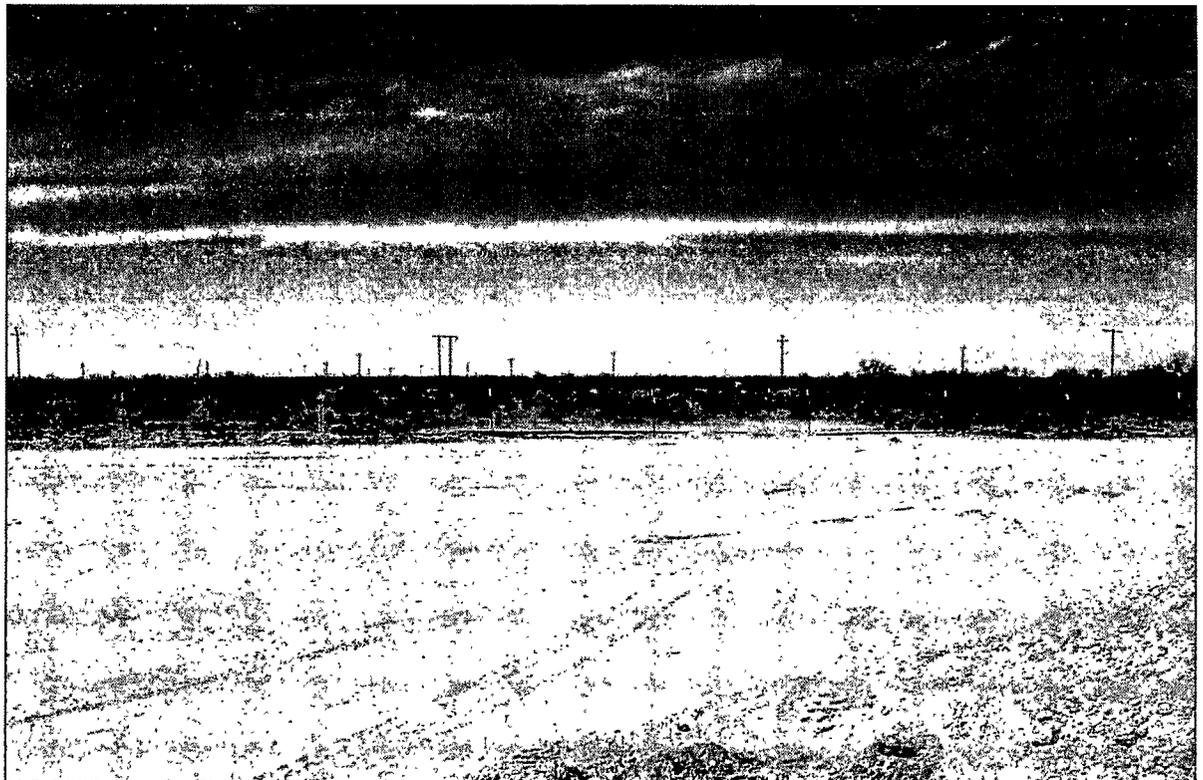
DCP Plant to Lea Station 6-Inch Release Site Remediation Completed and Backfilled
