Release Notification and Corrective Action

Name of Company	Apache Corporation	Contact	Natalie Gladden
Address	P.O. Box 1849 Eunice, NM 88231	Telephone No.	575-390-4186
Facility Name	NEDU #805	Facility Type	Produced Water Injection Well

1.0 Project Summary

REMEDIATION SUMMARY:

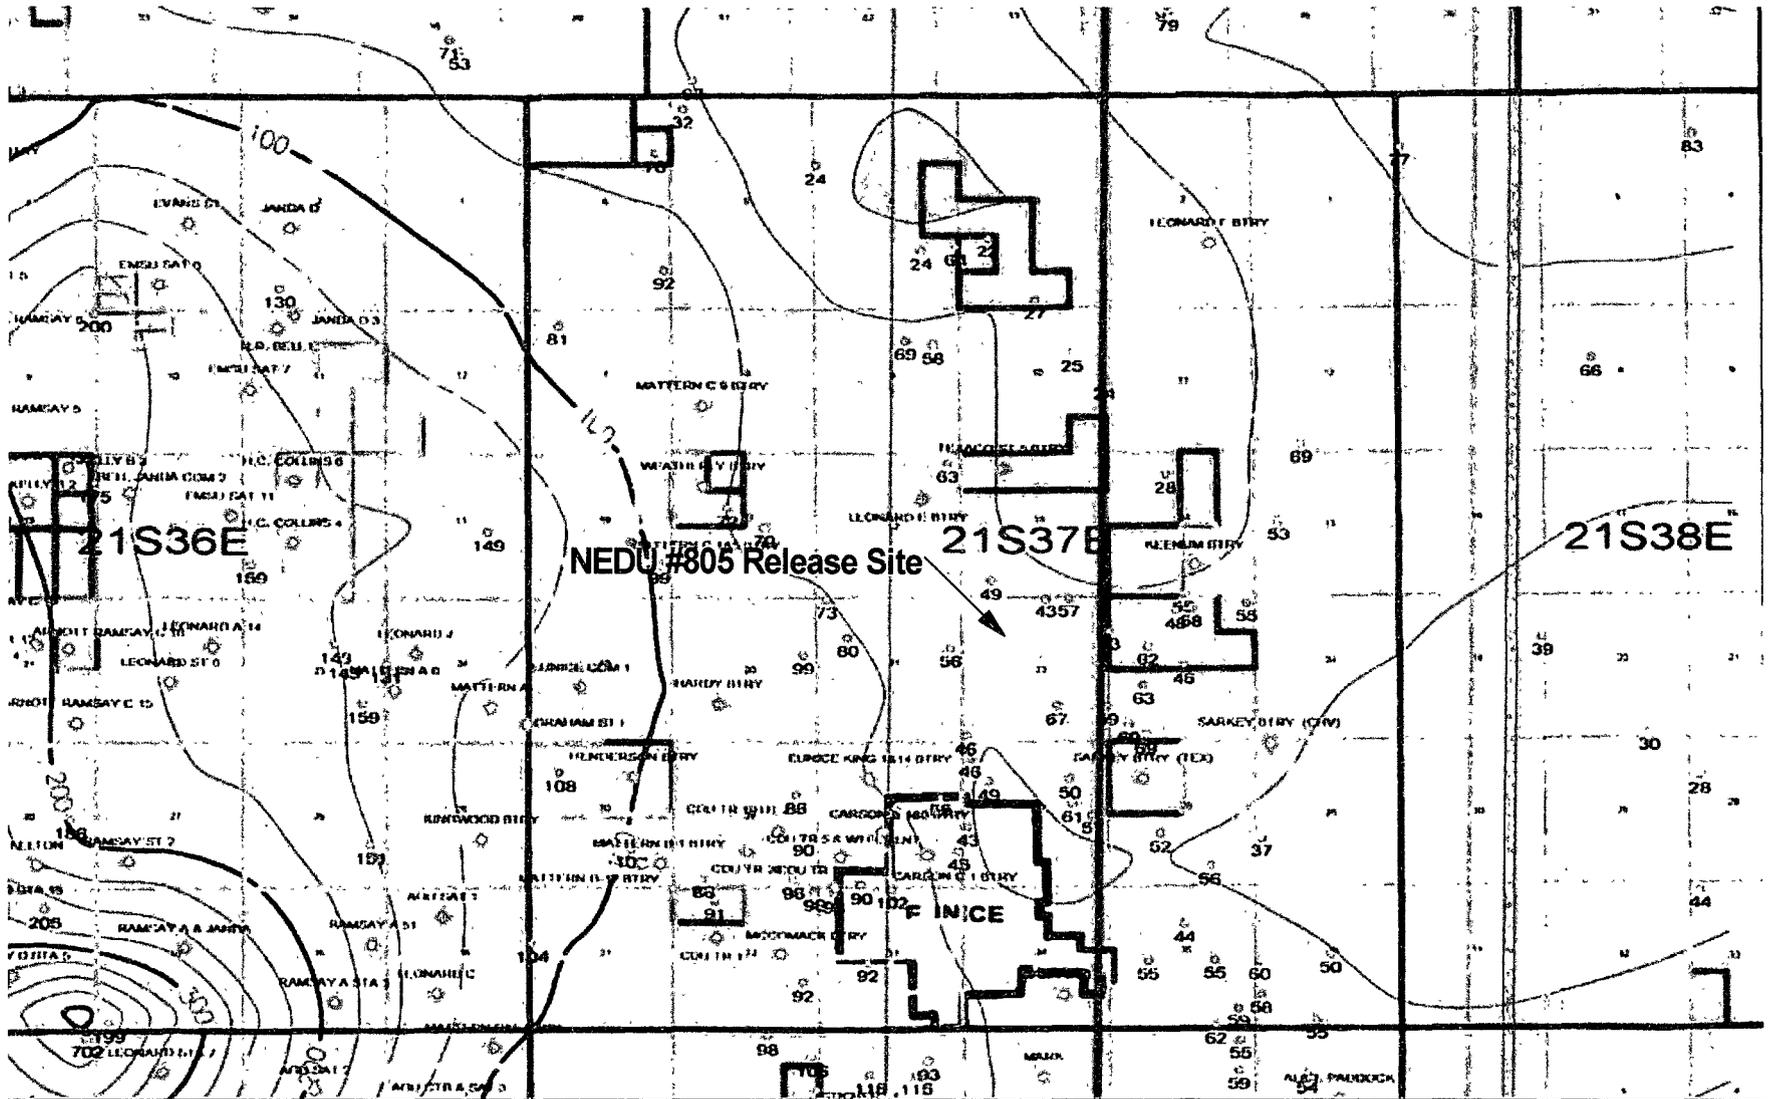
Plate 4
 Release Site Water Depth Contour
 Apache Corporation
 NEDU #805

The Chevron-Texaco water contour map (*Plate 4 of Attachments*) indicates that water in this area is 56' – 67' bgs. Two monitor wells drilled at the site resulted in 60-ft bgs water depths.

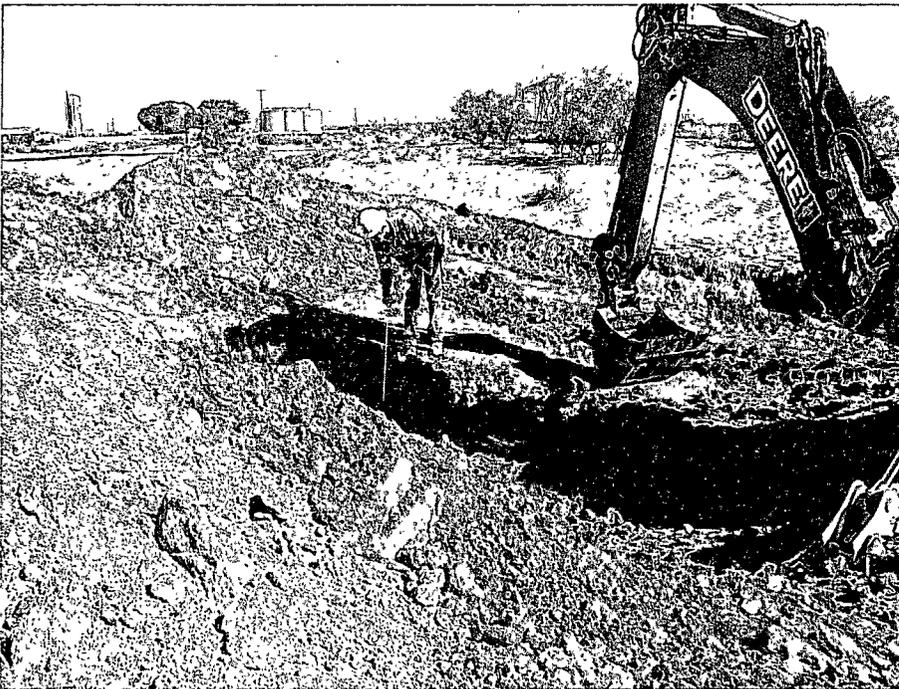
< 08/1/08 – Delineation trench at east release area

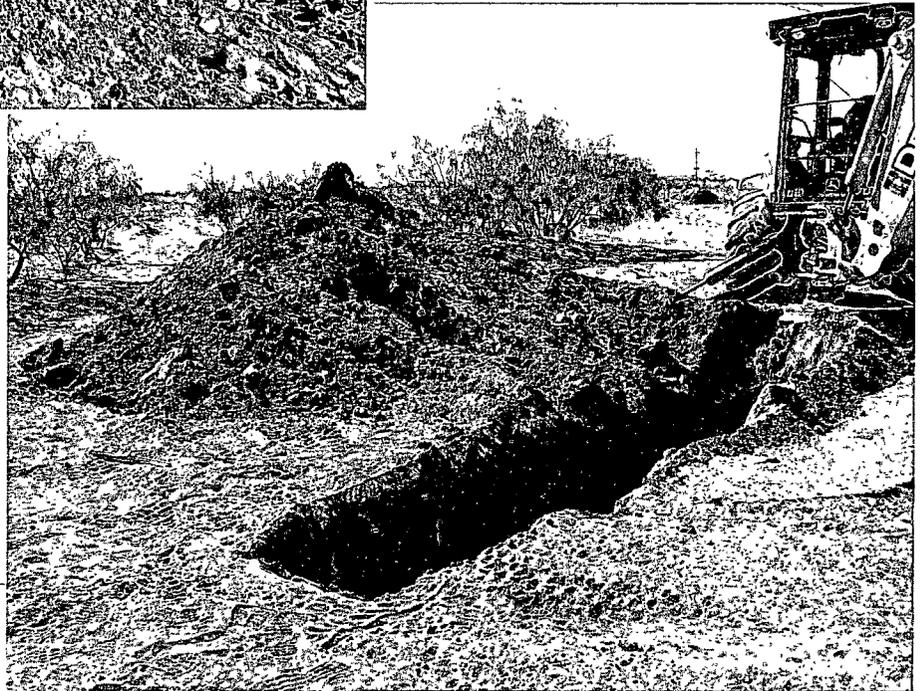
08/1/08 – Delineation trench in central release area >

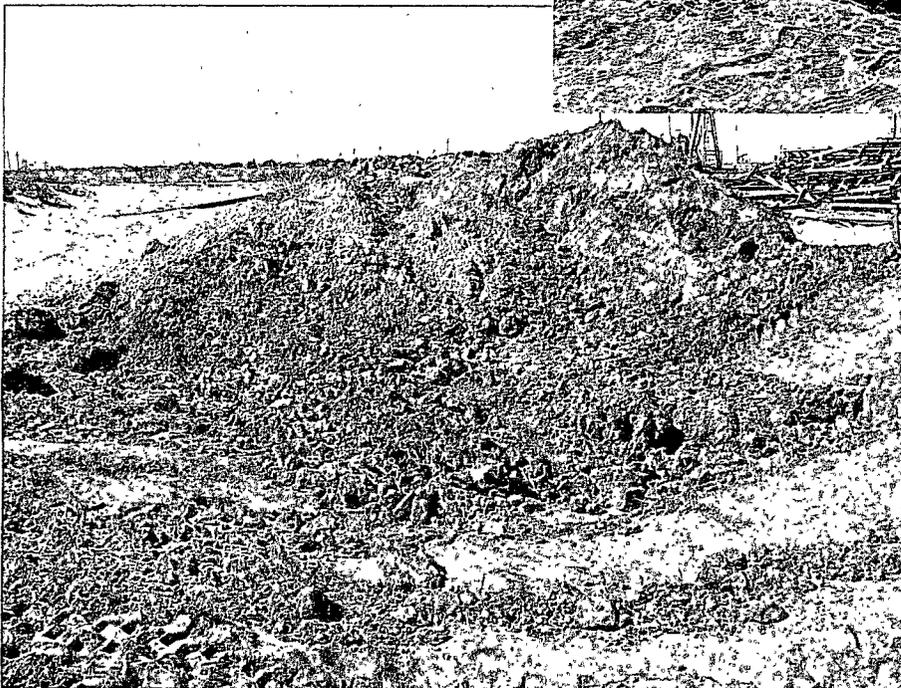
< 08/1/08 – Delineation trench in south portion of west release area. Note reduced iron sulfide.

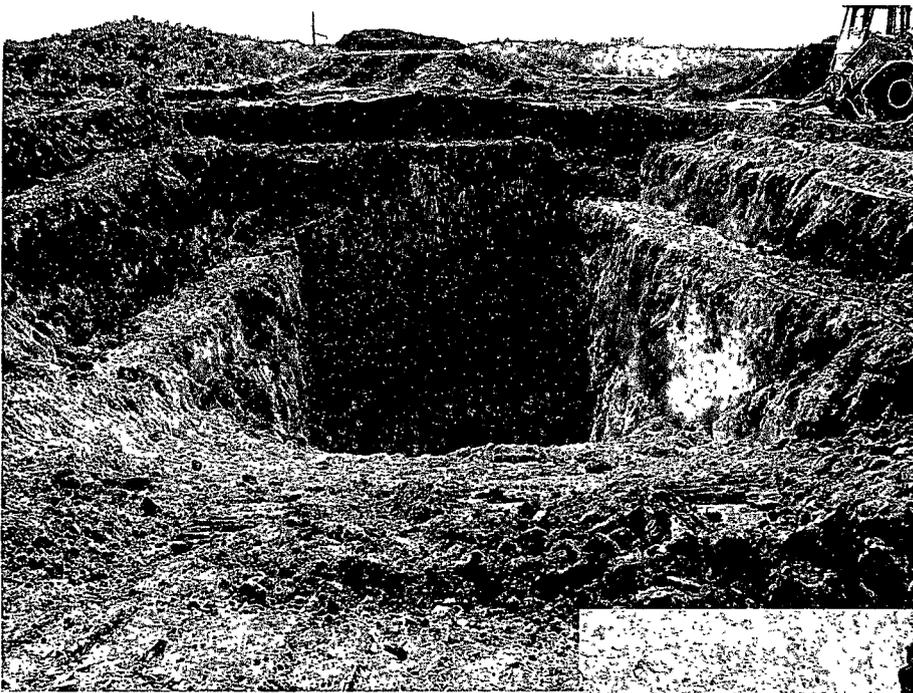
< 09/04/08 – Excavating east area.

Based on progressive field analyses for chlorides, the east area was excavated to 30-ft bgs resulting in 10,856-yd³ of contaminated soil disposal at Sundance Services. A delineation trench was extended from the 30-ft bgs level to ~59-ft bgs at the northwest area of the excavation. Field and laboratory analyses yielded the following chloride concentrations (ppm): @30'- (20,000); @37'-

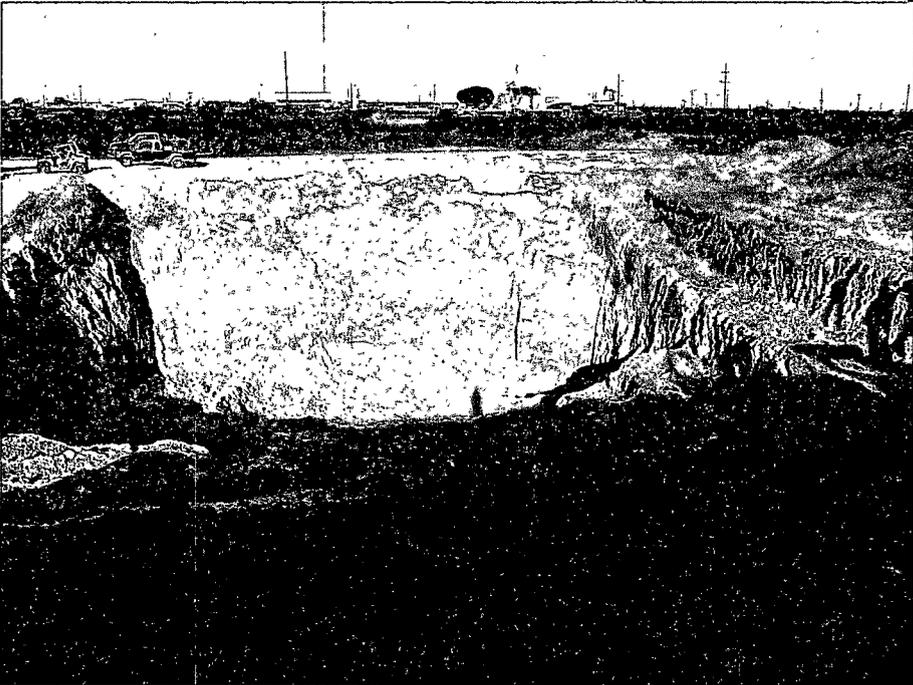
< 10/08/08 – Excavating from 30-ft to 37-ft bgs

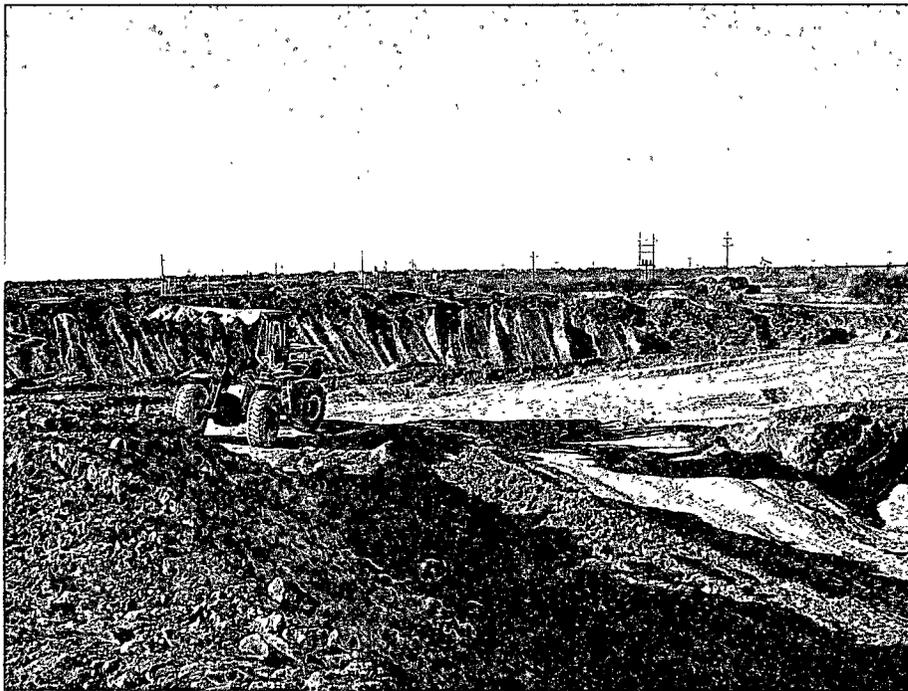
< 10/08/08 – stockpiling material for blending. Note clean topsoil stockpiled in background.

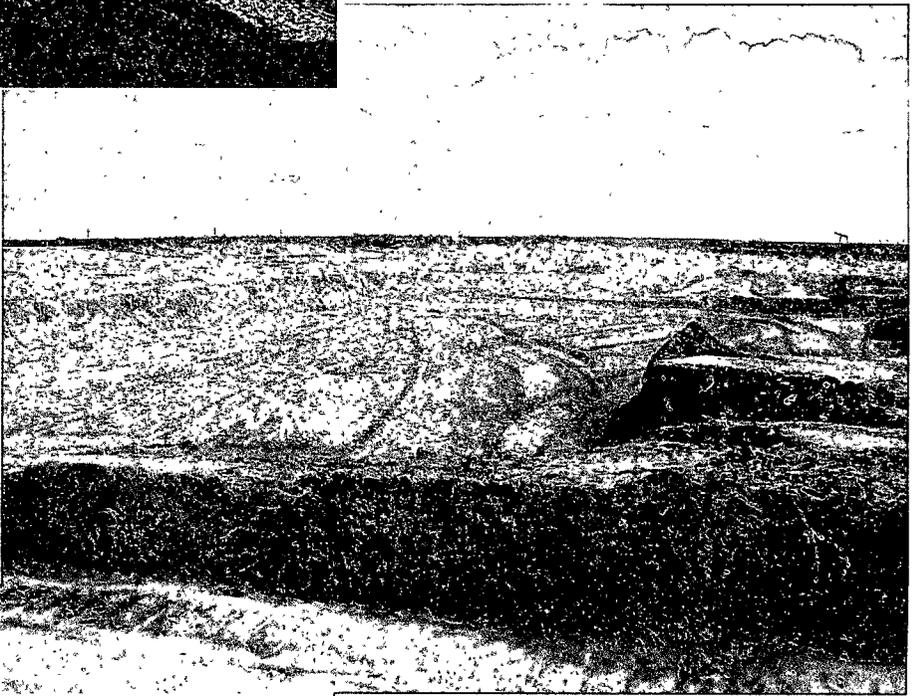
10/13/08 – East excavation backfilled up to liner level with blended and additional soil >

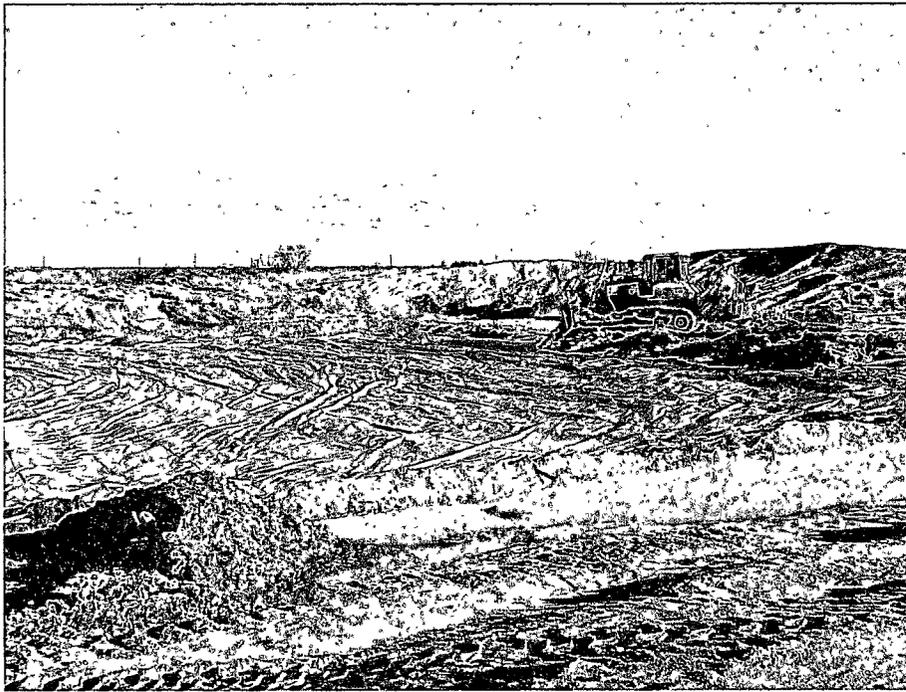
< 10/15/08 – placing red sand bedding layer over liner at east area

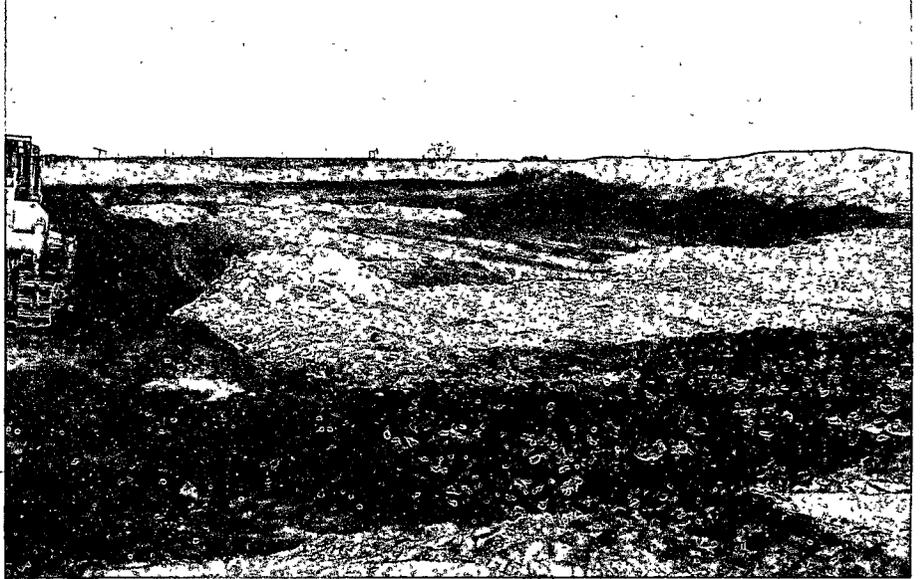
10/16/08 – placing additional clean caliche over liner at east area. >

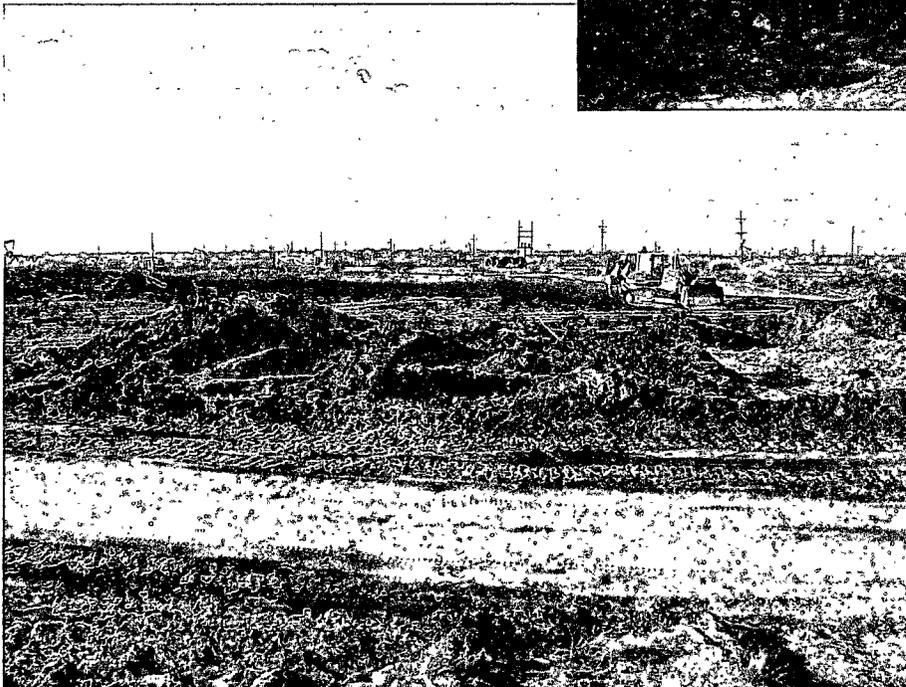
< 10/21/08 – placing final red sand topsoil layer over excavation at east area

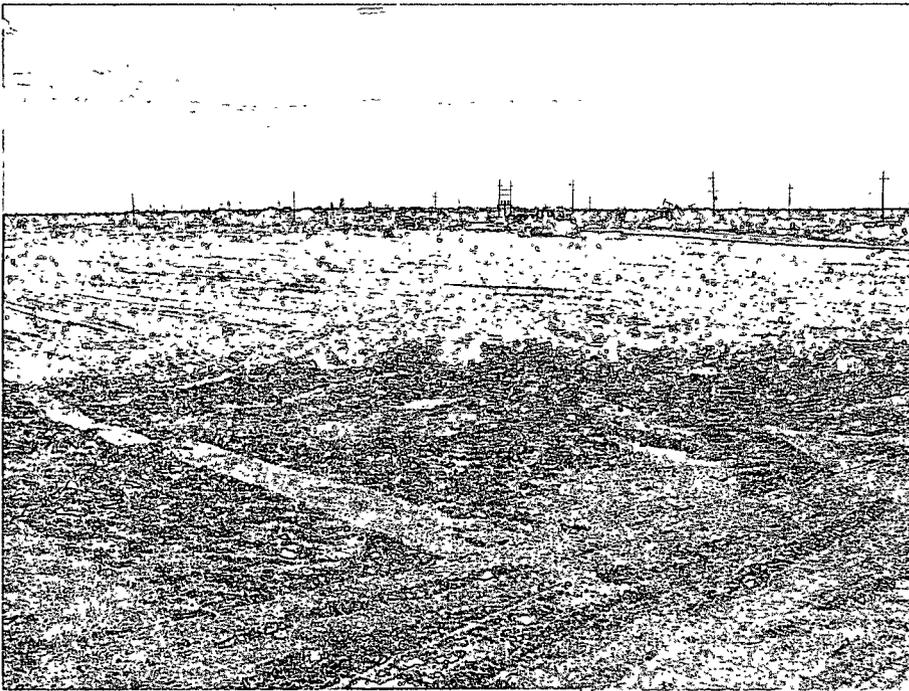
< 10/21/08 – final contouring of east area excavation.

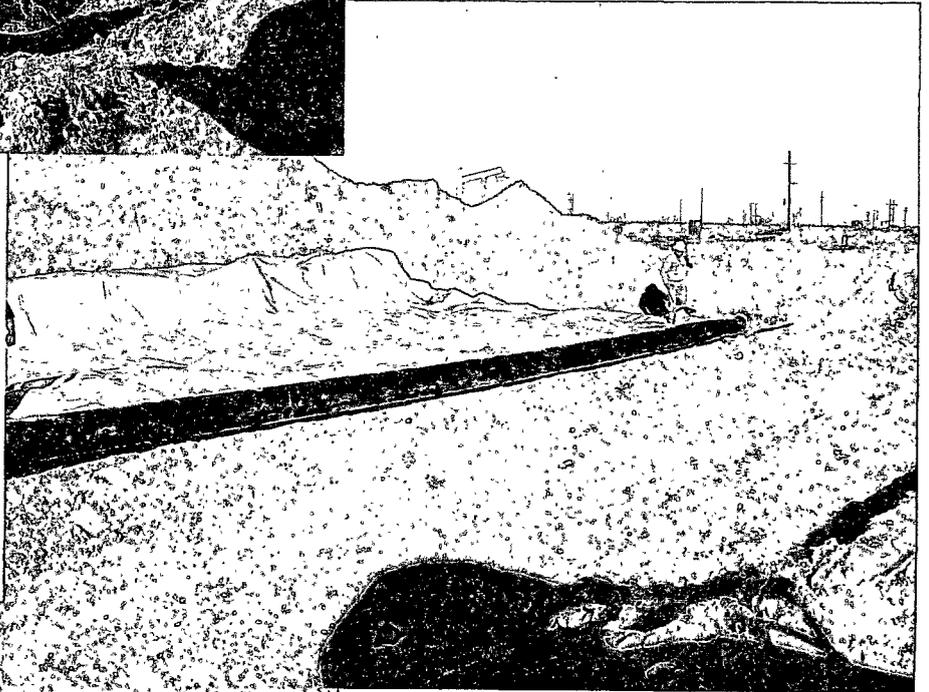
< 12/2/08 – north end liner was placed under both Targa gas lines present.

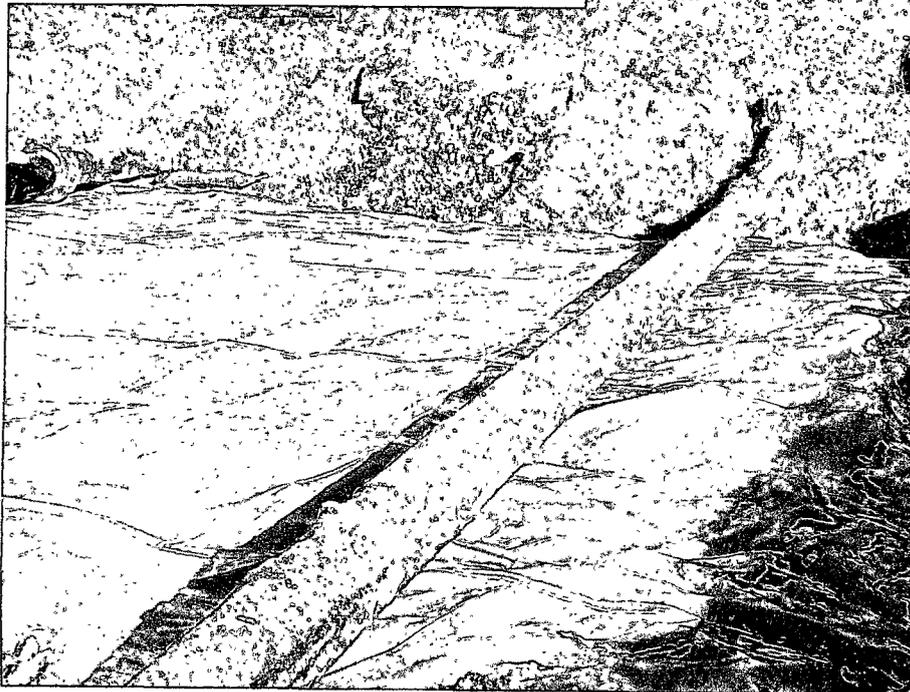
< 12/2/08 – north end liner installed and being covered with clean topsoil.

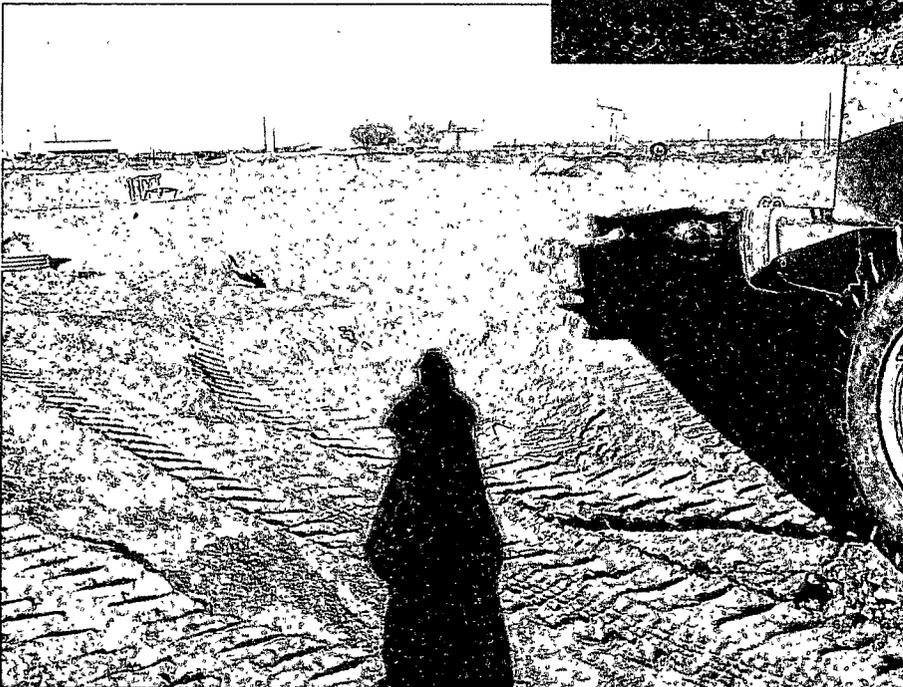
< 12/11/08 – Delineation Trench #4 on SE side of E/W injection line.

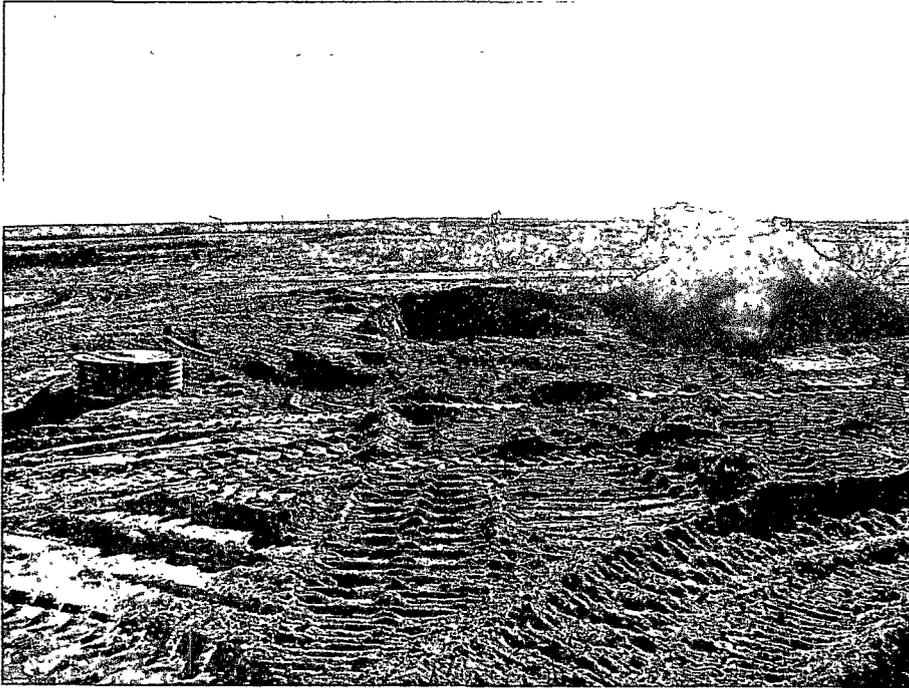
12/11/08 – Delineation Trench #3 on north side center of E/W injection line. >

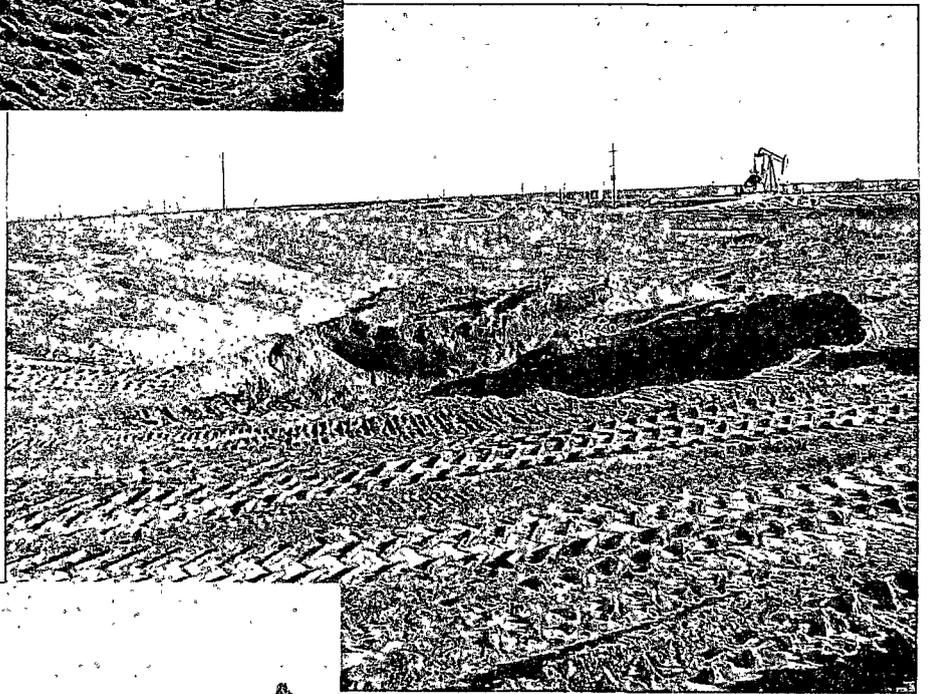
< 12/12/08 – installing two parallel 24' X 170' 20-mil liners on north and south sides of E/W injection line

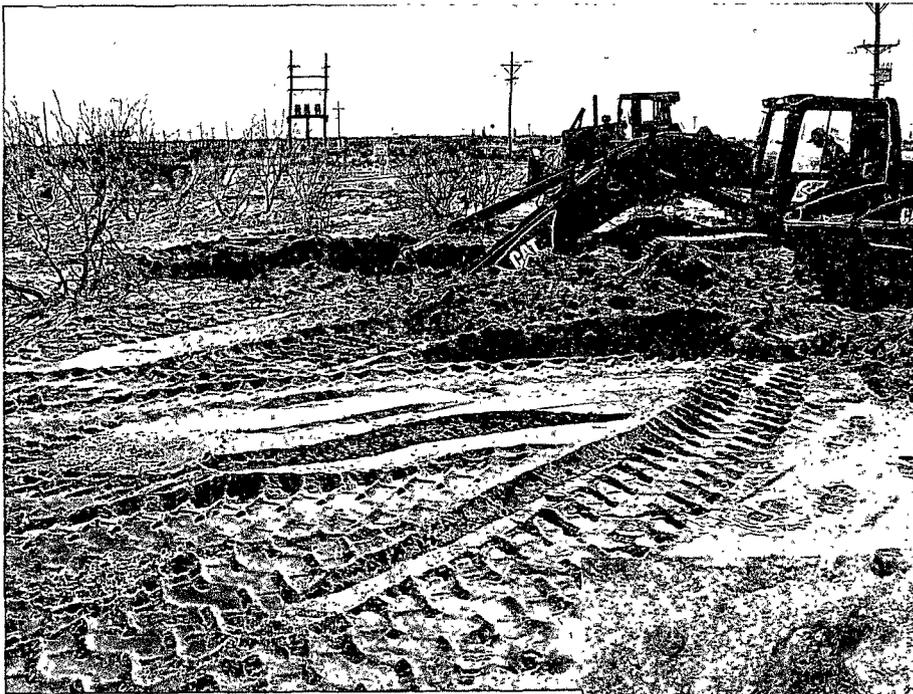
12/17/08 – Excavating to 38'-
bgs to determine depth of
contamination. >

The southern portion of the central affected area was delineated down to 38-ft bgs, yielding a Cl concentration of 128-ppm at that level. The highest concentration was ~2500-ppm at the 28-ft bgs level. This area was excavated to a dimension of 80' X 65' at which clean sidewalls were obtained. The excavation was backfilled with blended material, the sides were extended 5-ft and a 90' X 75' 12-mil polyvinyl liner was installed over the excavation. Final cover was clean topsoil.

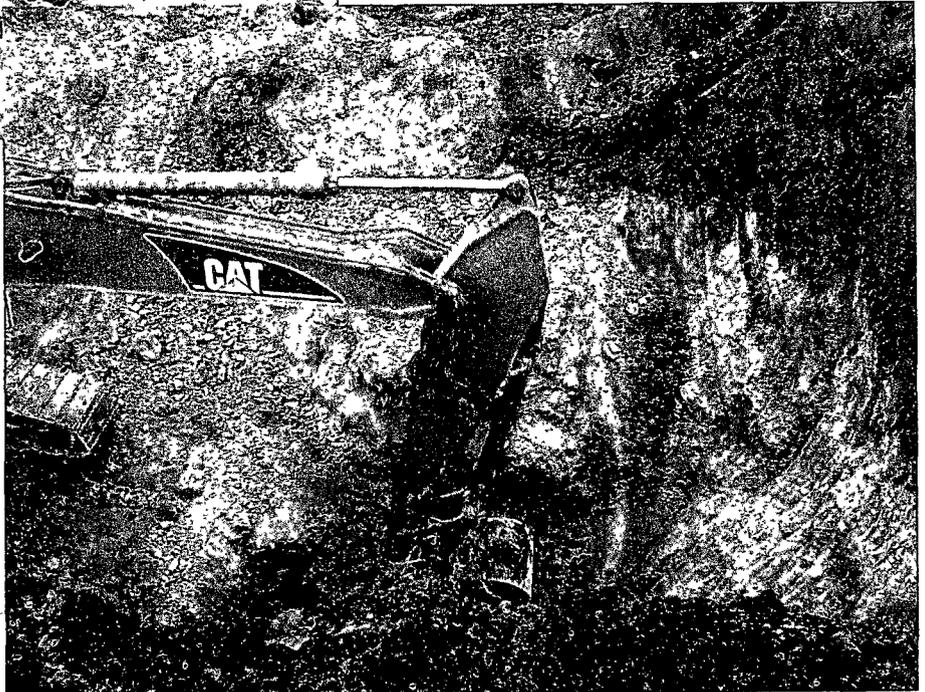
< 12/18/08 – preparing south
part of central area for liner
installation.

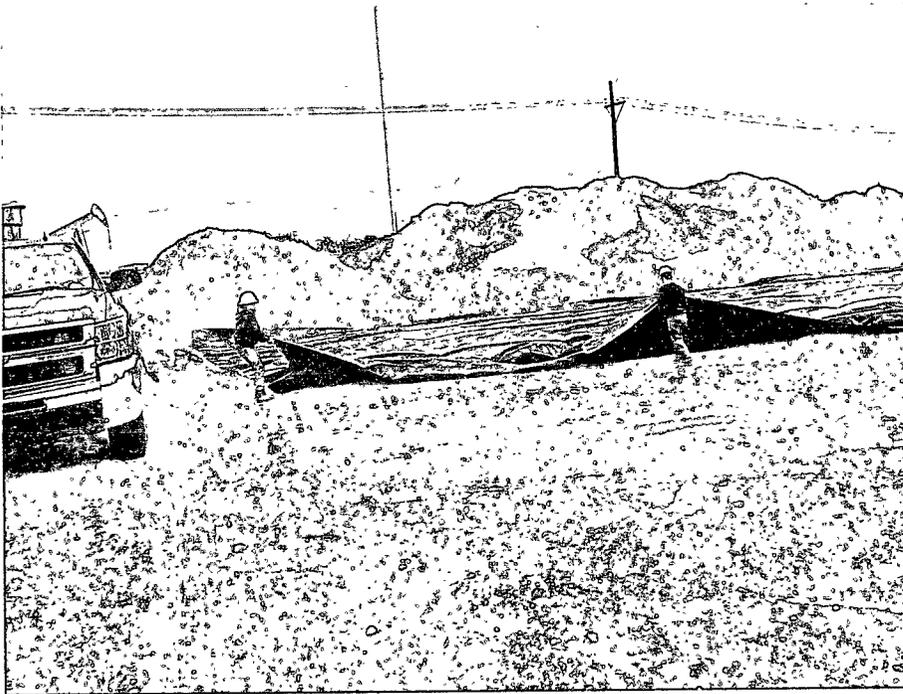
12/18/08 – Installing 60' X 25' 12-mil liner over pooling area opposite the east area.

A small pooling area on the west side of the road adjacent to the east area was excavated, blended and covered with a 60' X 25' 12-mil polyvinyl liner. The liner was covered with clean red sand.

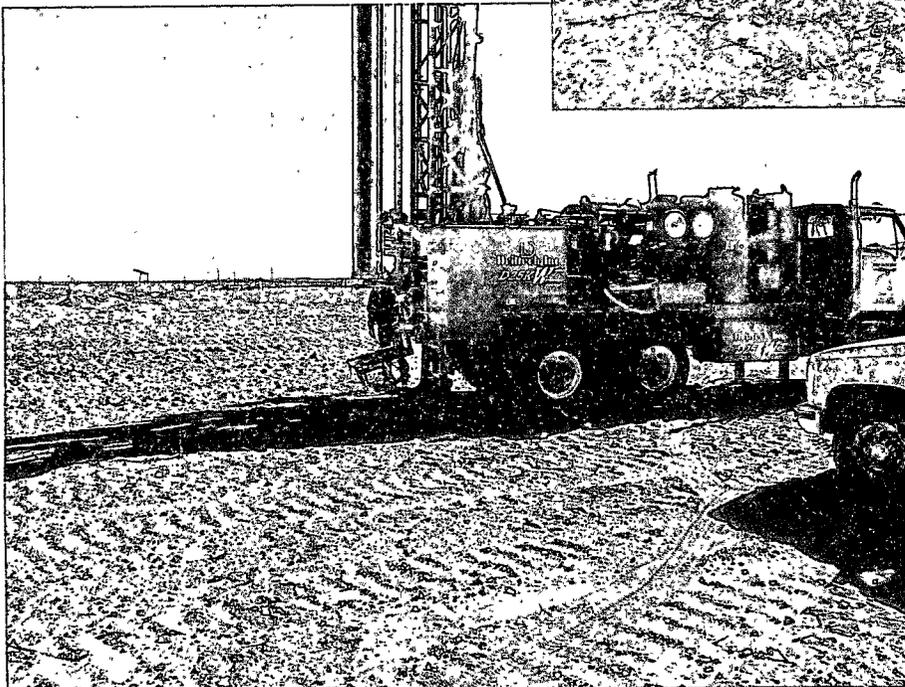
< 01/12/09 – commencing drilling of monitor well on SE side of east area remediation.

Two down-gradient monitor wells were installed (SE of the east area; SE of the west area). The remediation portion(s) of the project were completed on December 18, 2008.
