Release Notification and Corrective Action

Release Site Name: Arnold A #1 Battery Reclamation
Operating Company: Apache Corporation
Company Representative: Natalie Gladden, Environmental Tech Phone: 575-390-4186
Address: PO Box 1849, Eunice, NM 88231 Email: Natalie.Gladden@usa.apachecorp.com
Remediation Company: Ocotillo Environmental - Hobbs Phone: 575-738-0138

REMEDICATION SUMMARY:

Plate 1
Release Site Location
Apache Corporation
Arnold A #1 Reclamation

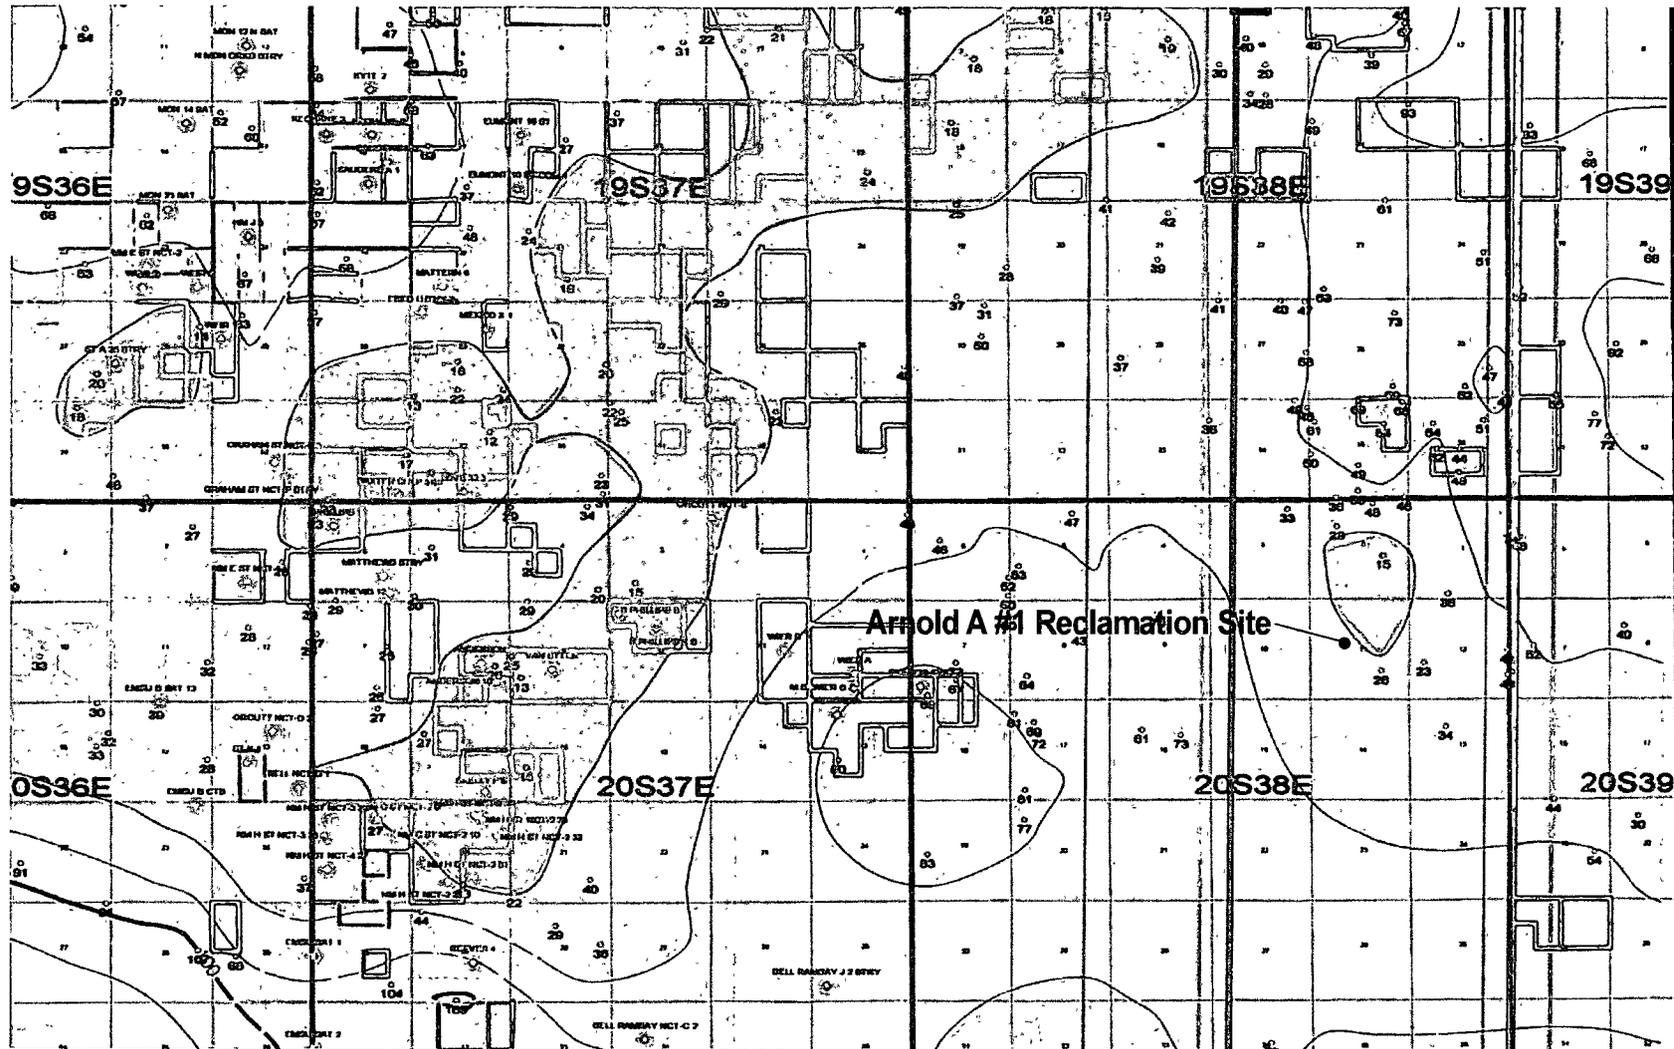
Plate 4
 Release Site Water Depth Contour
 Apache Corporation
 Arnold A #1 Reclamation

Lea County, New Mexico
 UL-F SECTION 11 T20S R38E
 N 32° 35.348', W 103° 7.249'
 Elevation: ~3591-ft amsl

The Chevron-Texaco water contour map (*Plate 4 of Attachments*) indicates that water in this area is 25' – 50' bgs. A monitor well drilled at the NW corner of the location measures 54-ft to water level.

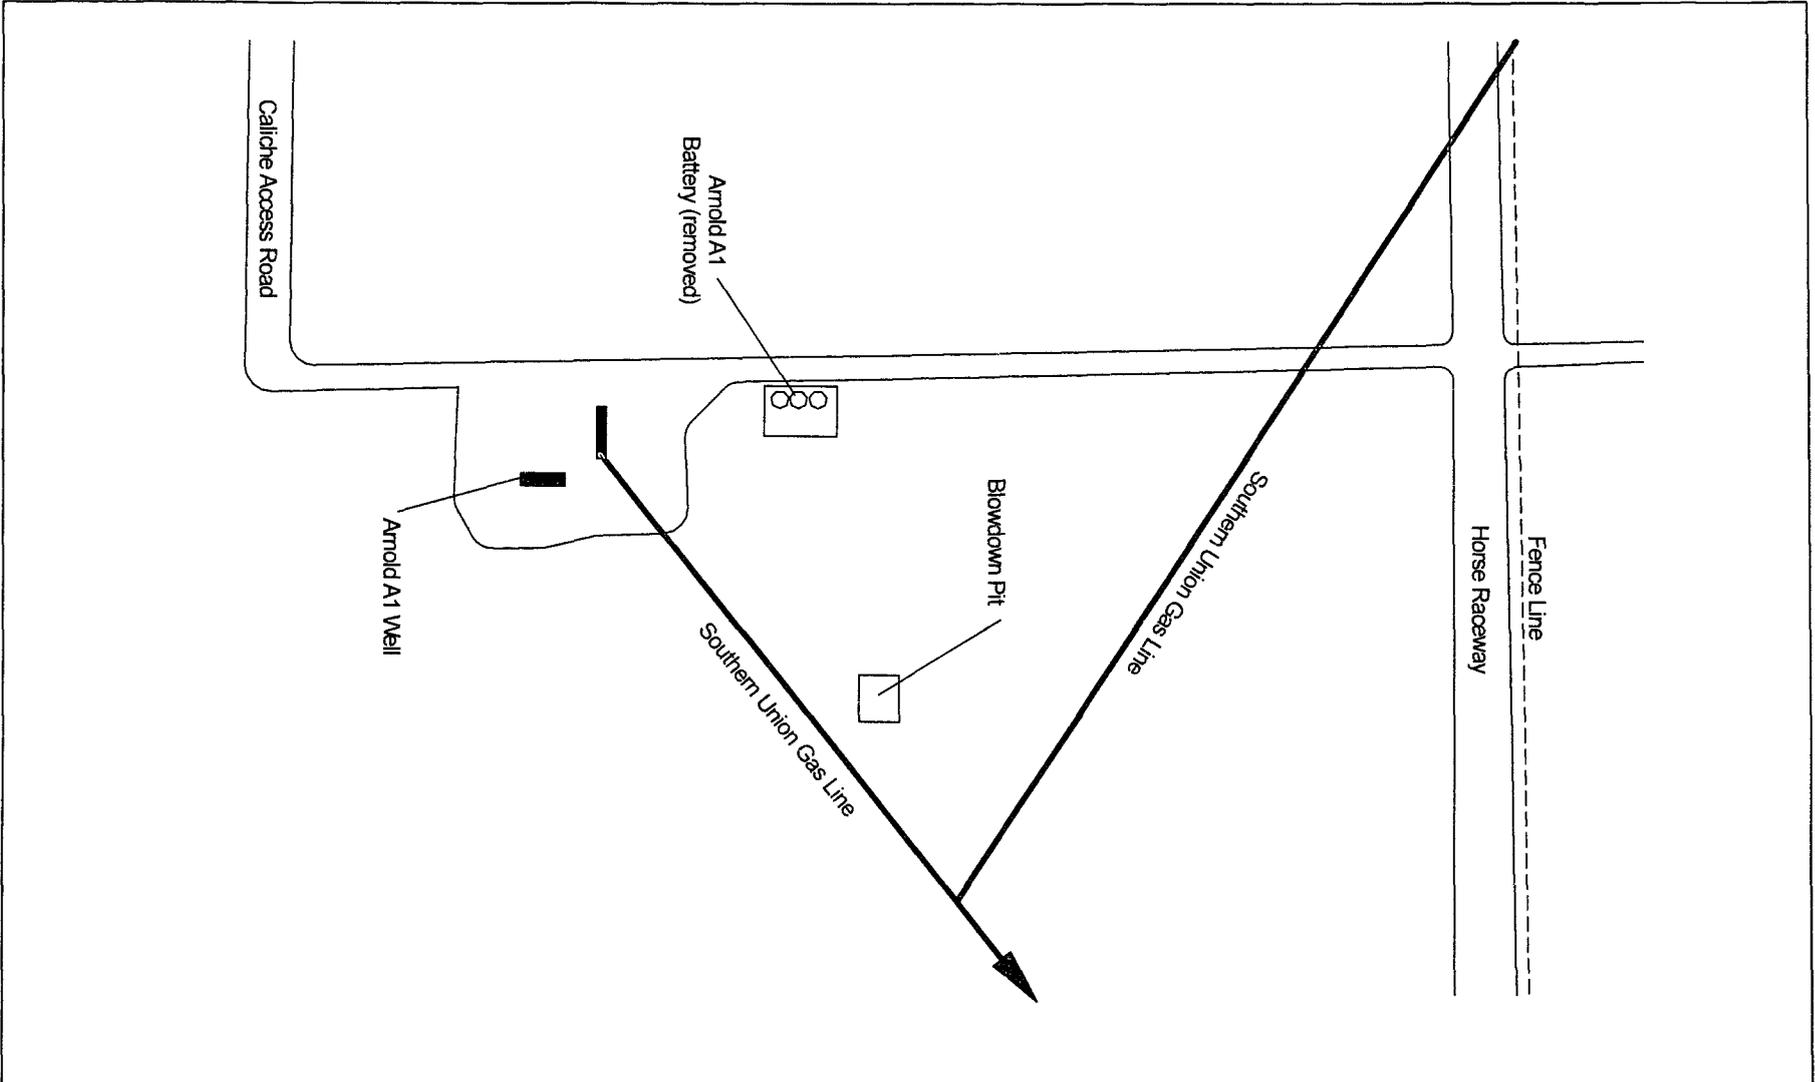
Plate 5
Site Drawing
Apache Corporation
Arnold A #1 Reclamation

Lea County, New Mexico
UL-F SECTION 11 T20S R38E
N 32° 35.348', W 103° 7.249'
Elevation: ~3591-ft amsl

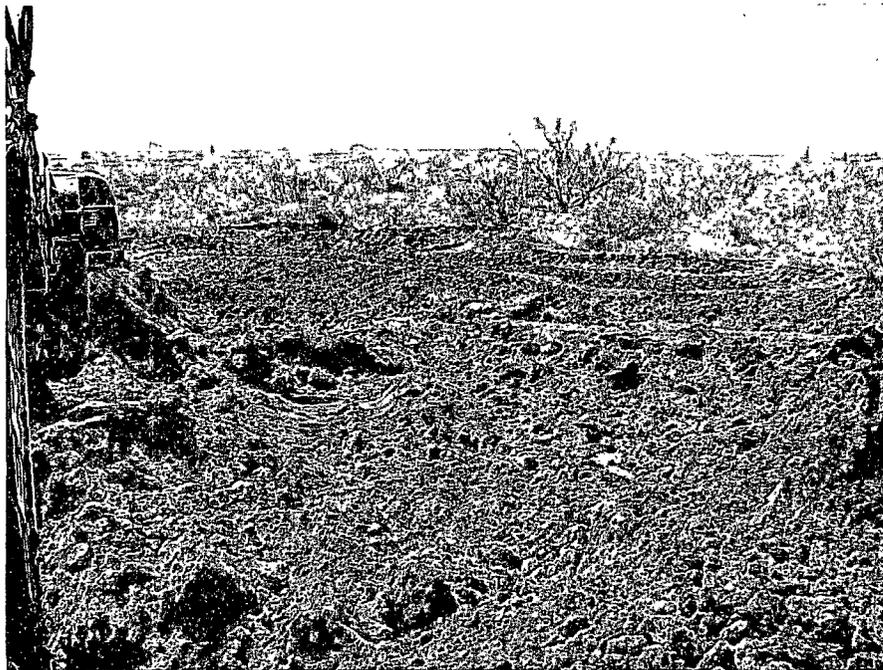
< 5/7/08 – Commencing excavation of old blow down pit

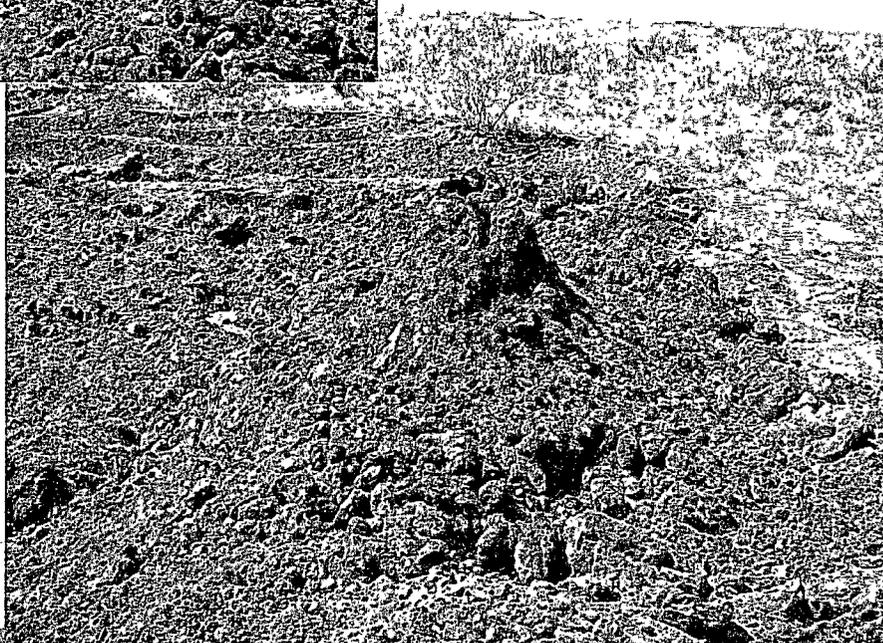
5/7/08 – Commencing excavation of old blow down pit >

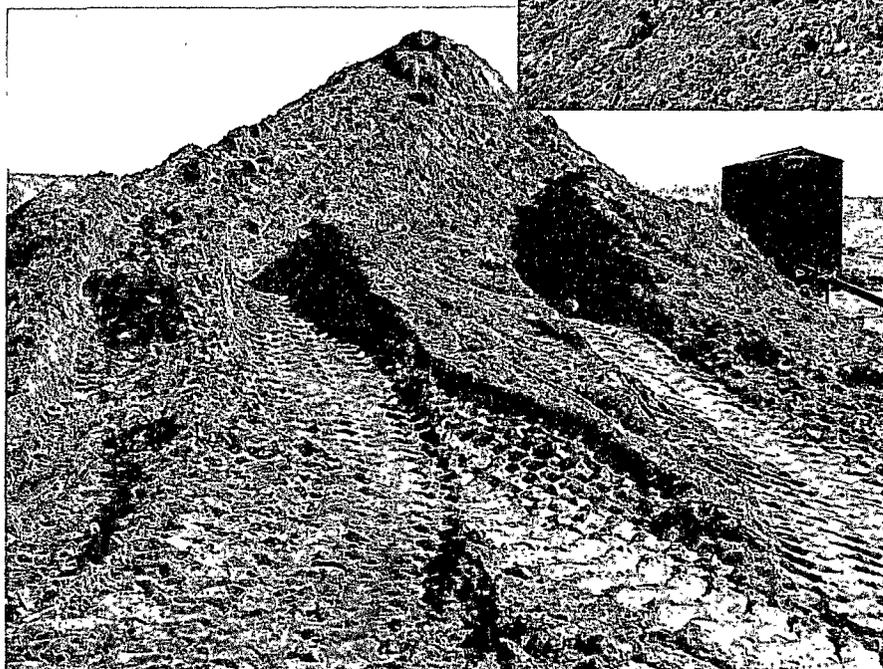
< 5/8/08 – Grossly contaminated soil stockpiled for disposal.

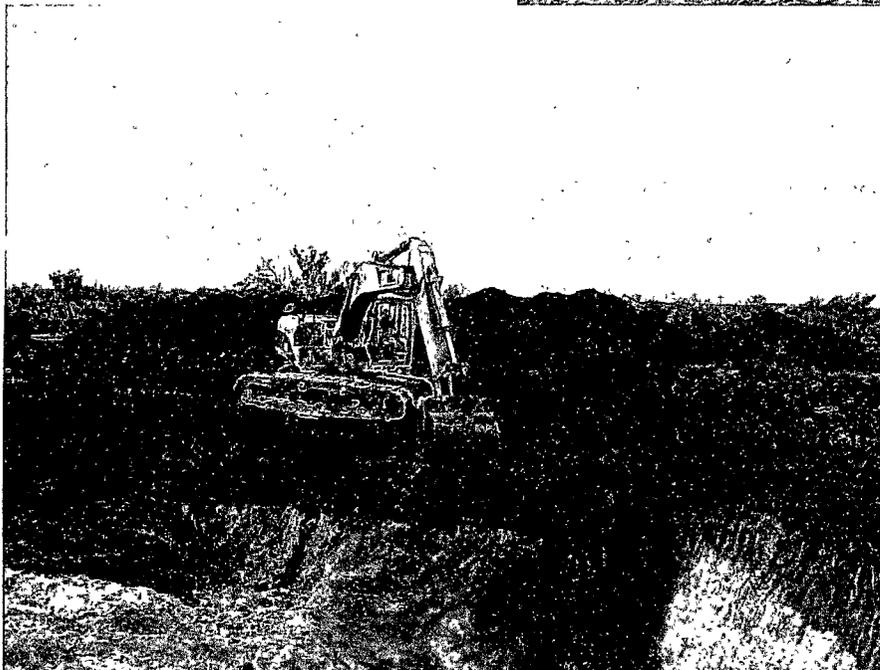
< 5/14/08 – Isolating clean topsoil for use as final cover.

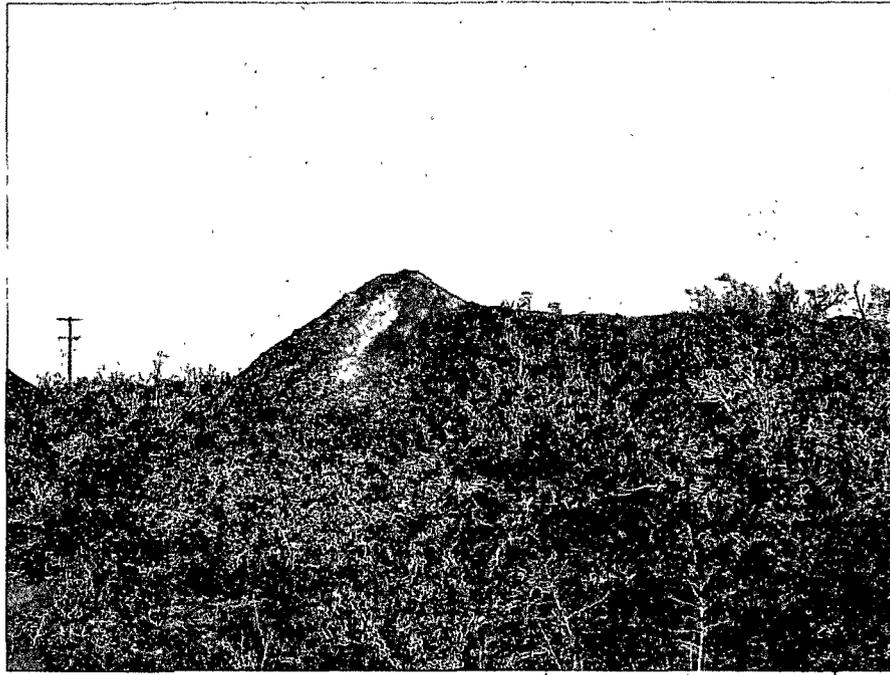
< 5/14/08 – Accumulated blend stockpile

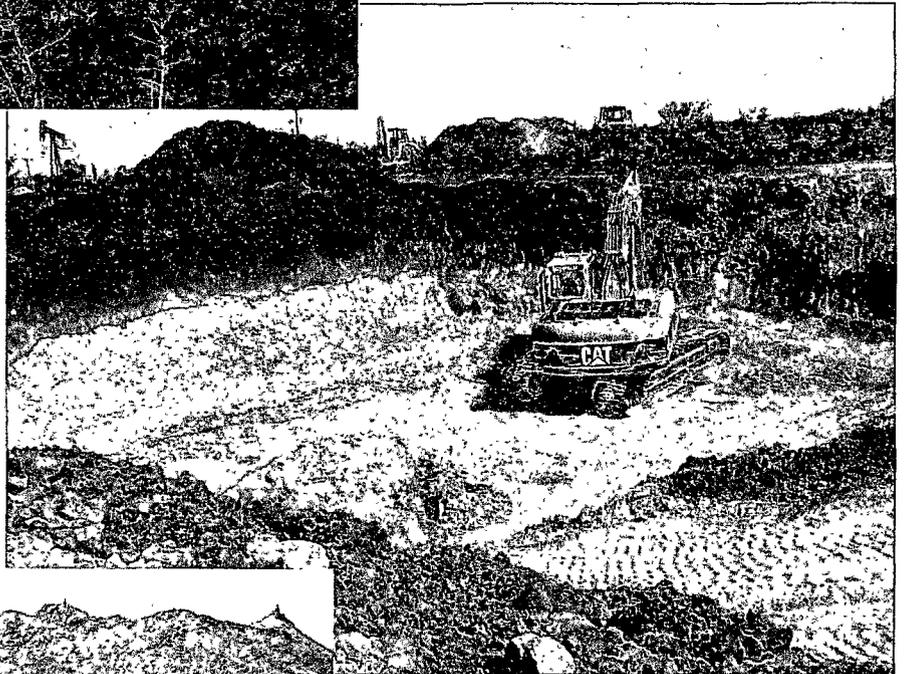
5/21/08 – Continuing bottom excavation. >

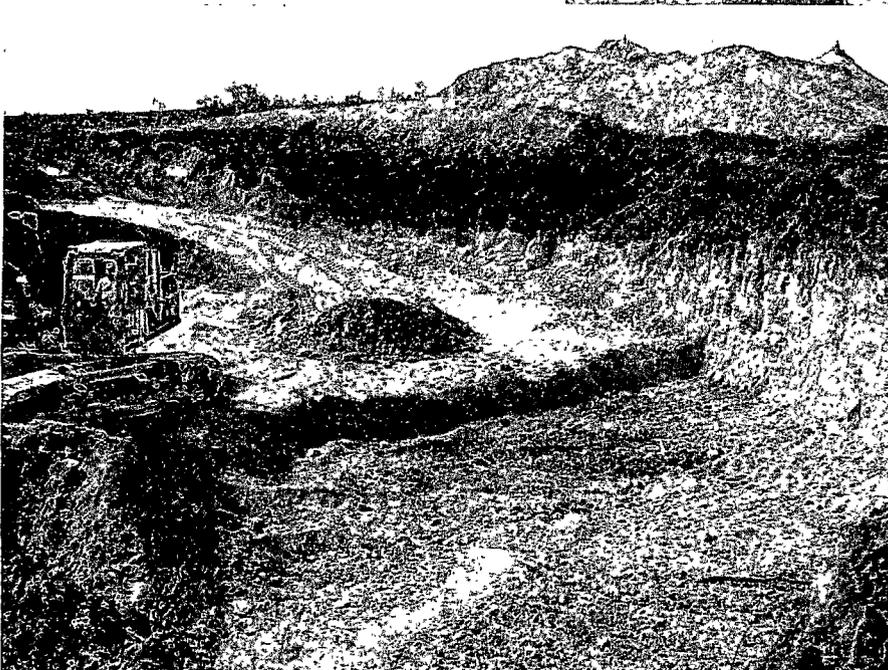
< 5/21/08 – Continuing bottom excavation.

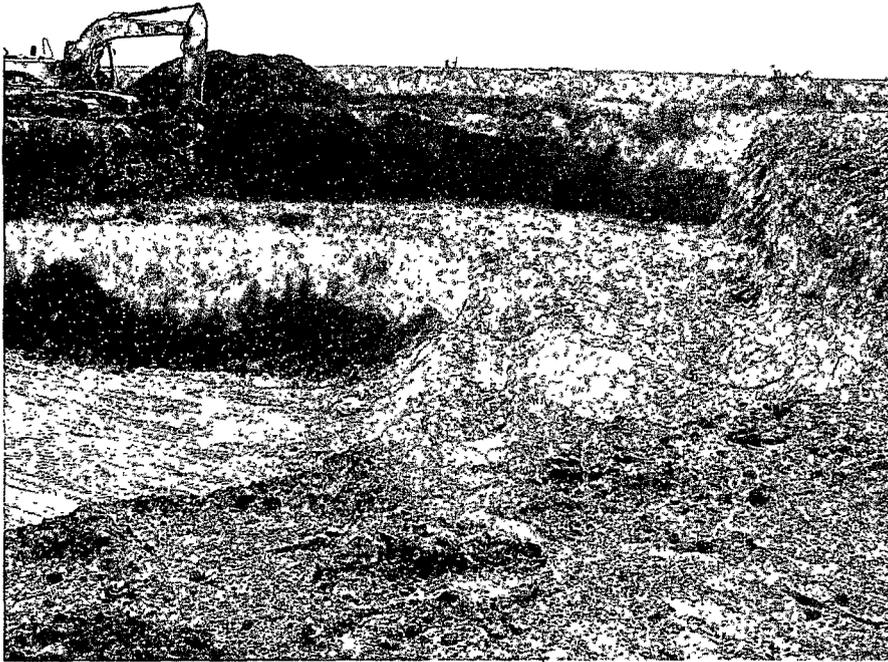
< 5/29/08 – Excavating clean topsoil from surface to enable lateral extension of excavation bottom.

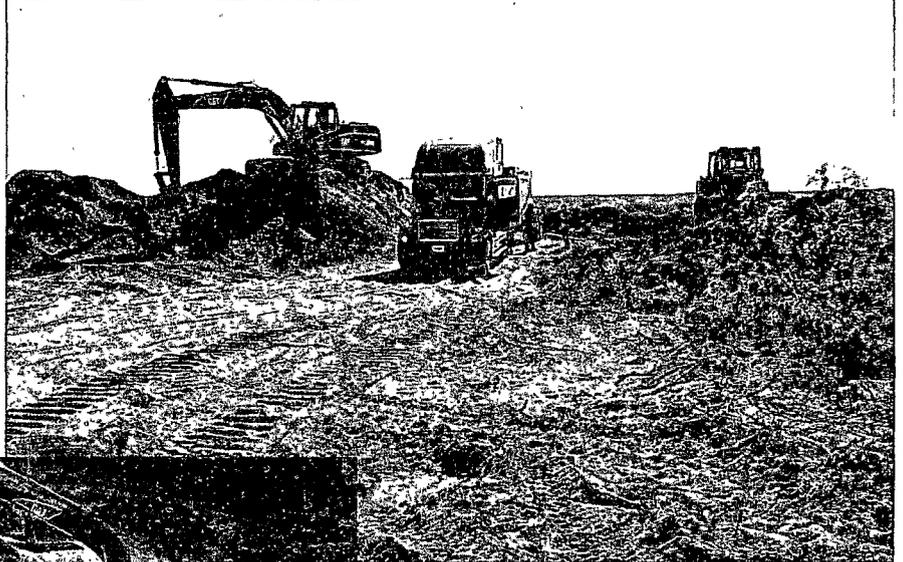
6/5/08 – Disposing of contaminated stockpile. >

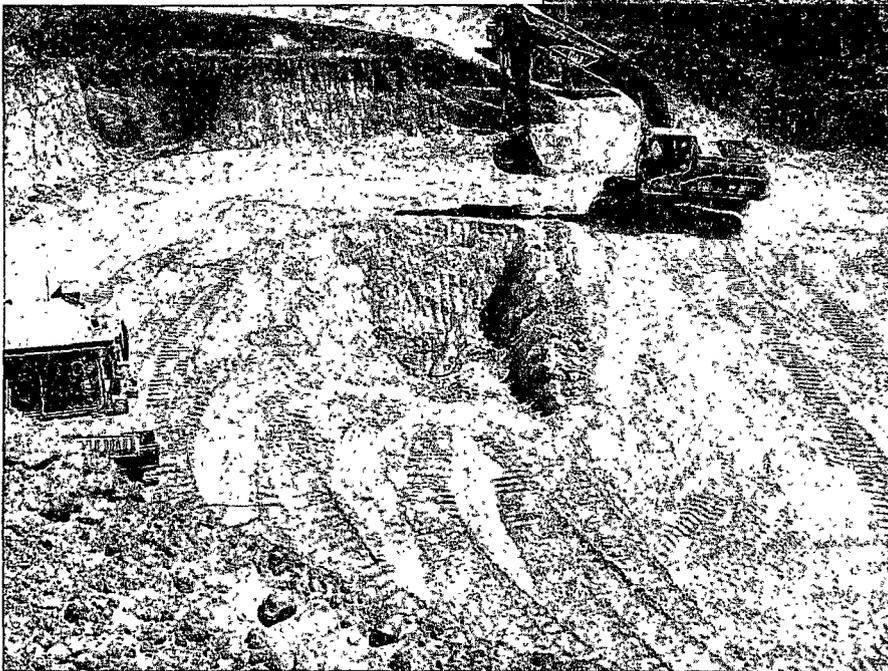
< 6/12/08 – Excavating from 25-ft bgs to 41-ft bgs to determine vertical extent of chloride contamination.

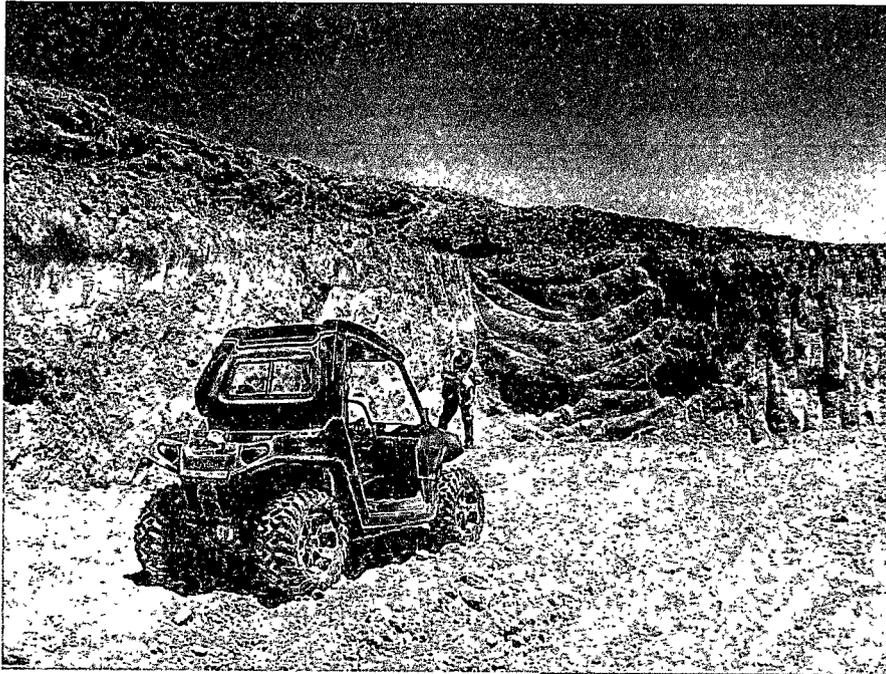
< 6/12/08 – Some fat boy taking final sidewall and bottom samples.

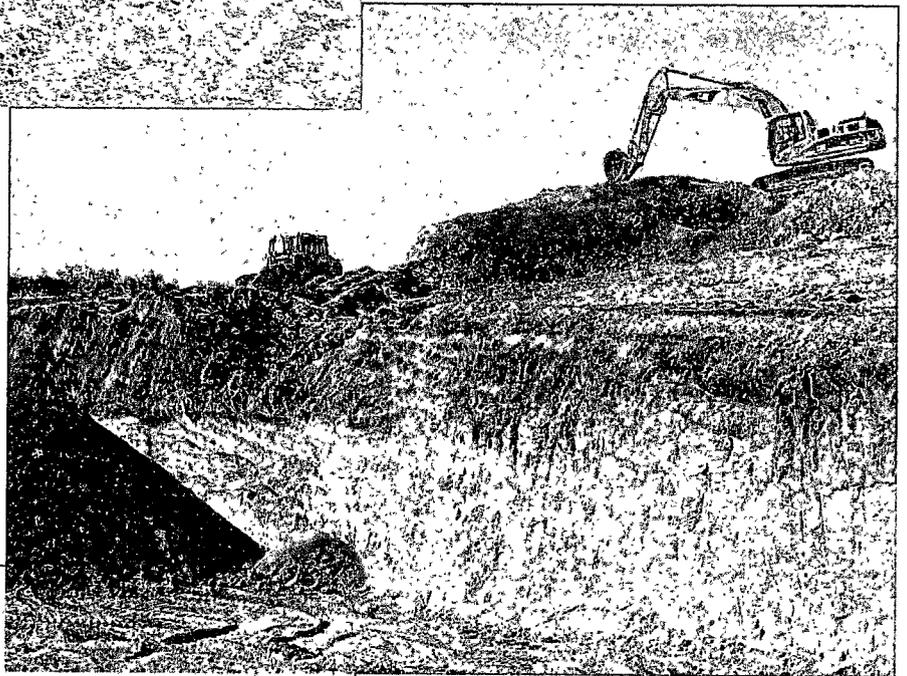
6/13/08 – Backfilling excavation with blended soil. >

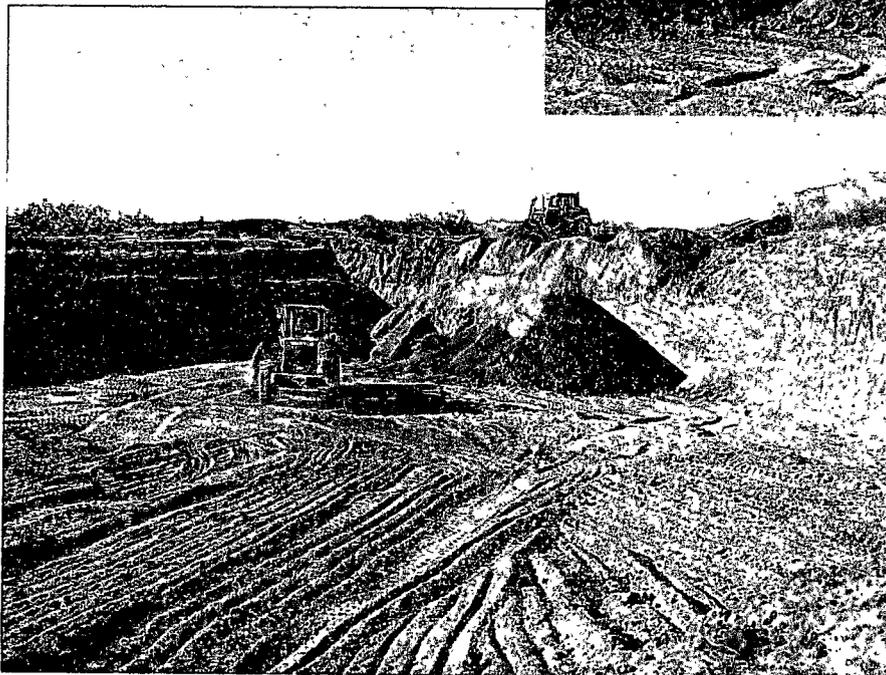
< 6/13/08 – Backfilling excavation with blended soil.

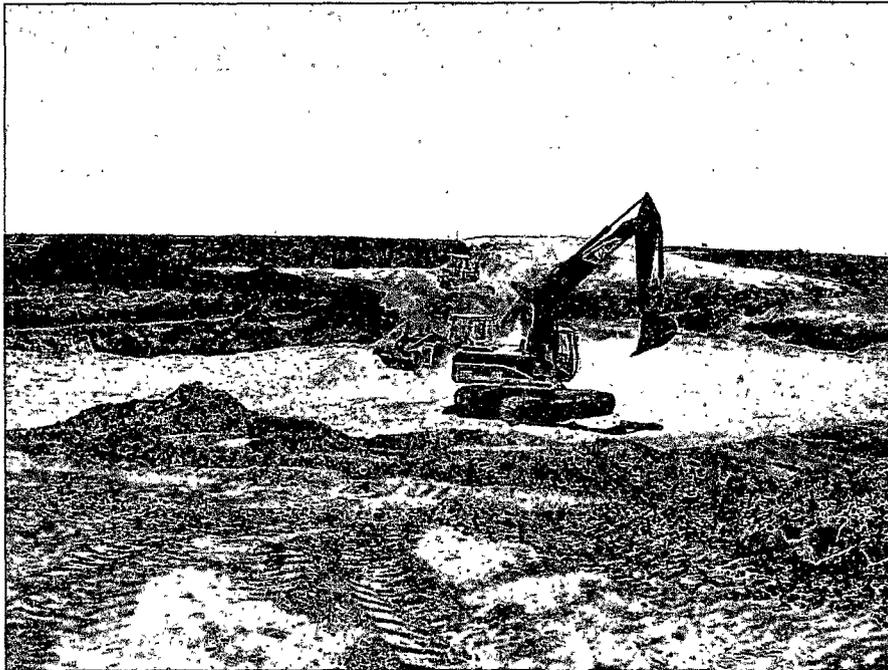
< 6/18/08 – Backfilling excavation with blended soil.

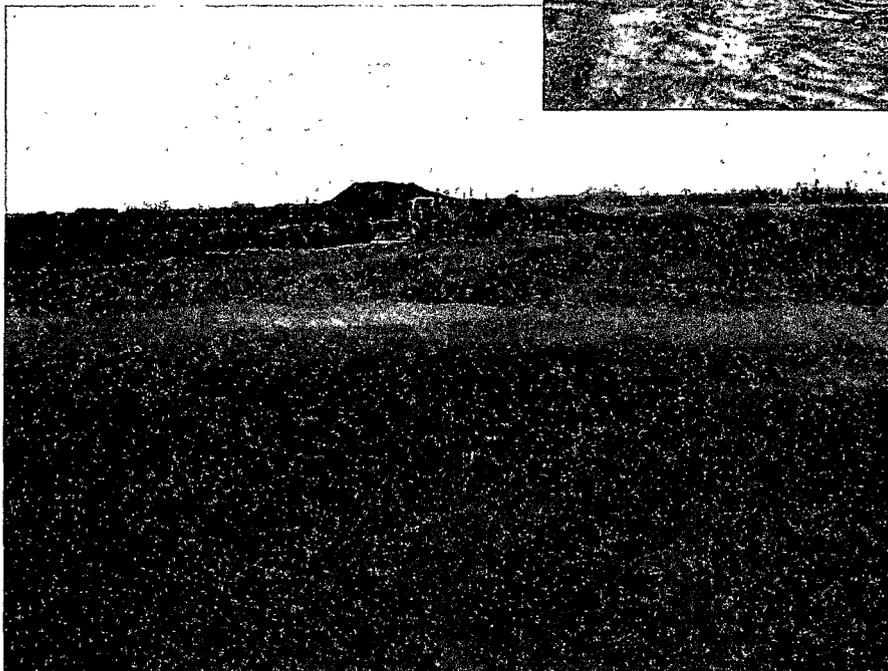
< 6/20/08 – Preparing caliche surface for liner installation. >

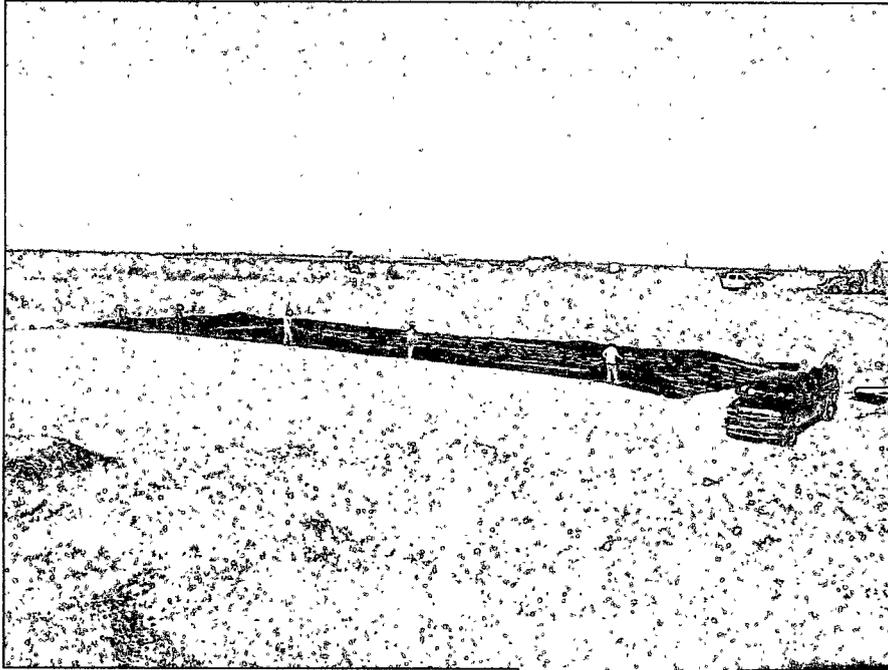
< 6/23/08 – Installing 20-mil polyvinyl liner (155' X 150').

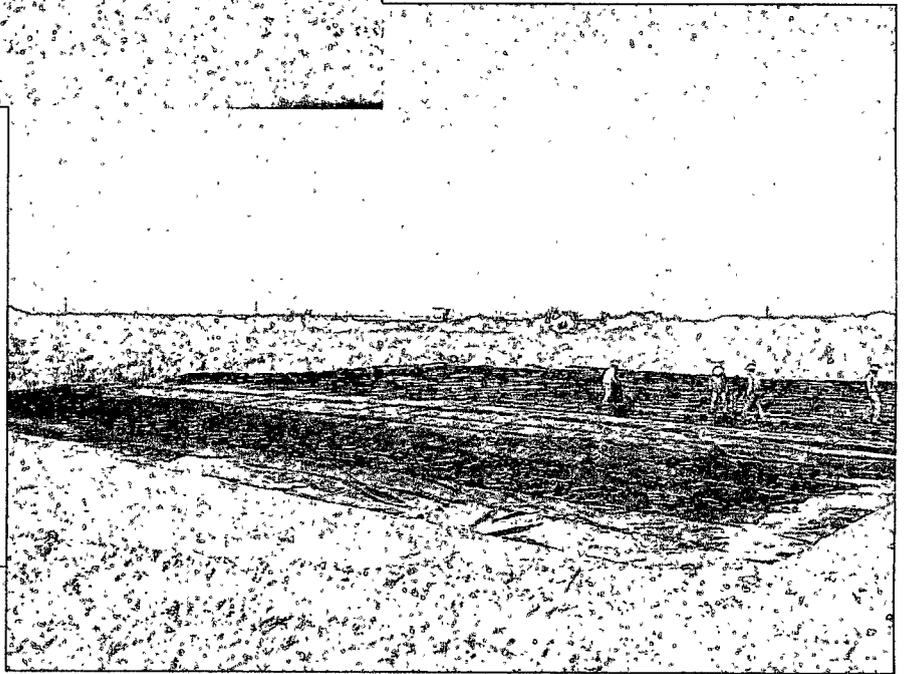
6/23/08 – 6/23/08 – Installing 20-mil polyvinyl liner (155' X 150'). >

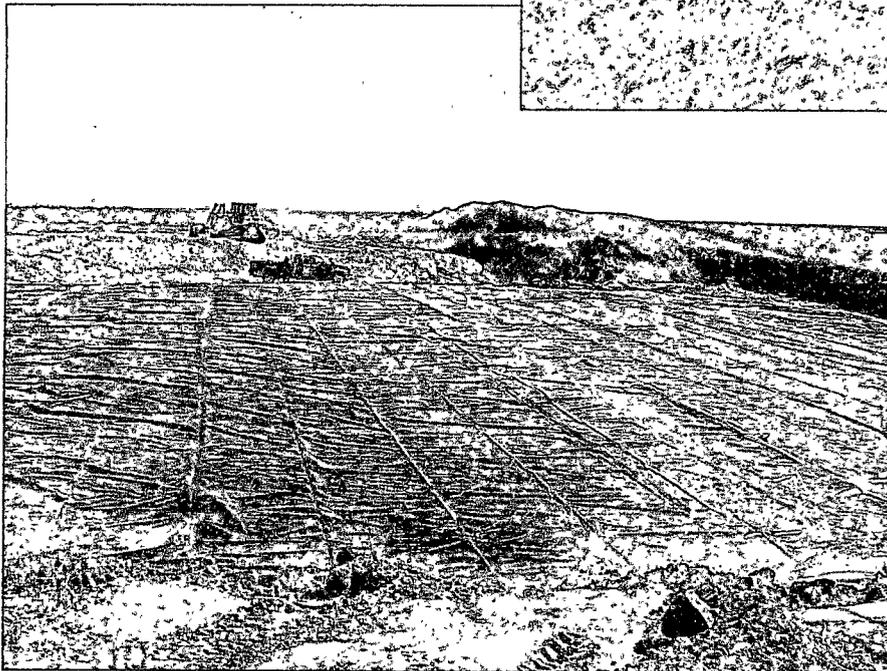
< 6/23/08 – Installing 20-mil polyvinyl liner (155' X 150').

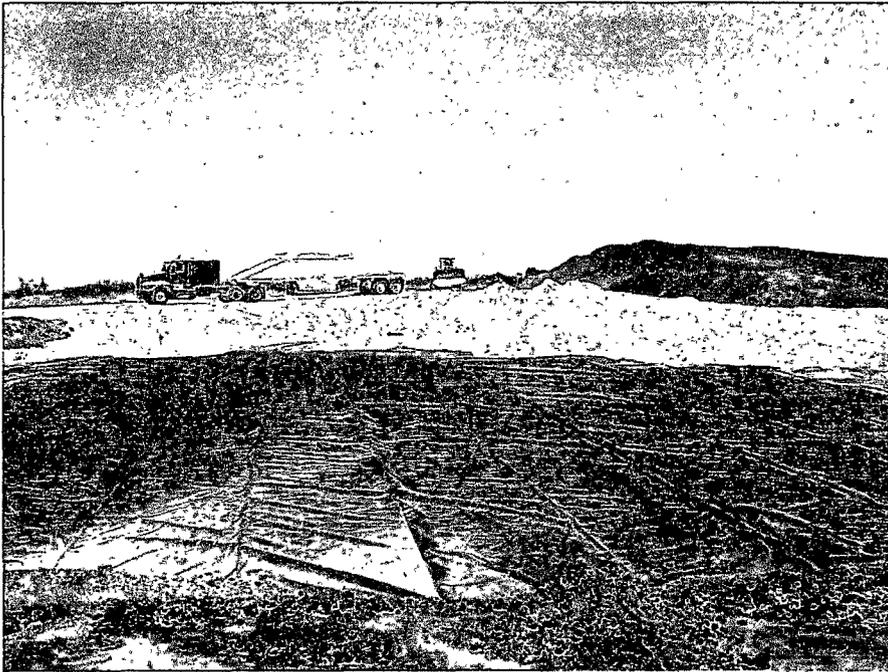
< 6/23/08 – Adding caliche layer over top of liner.

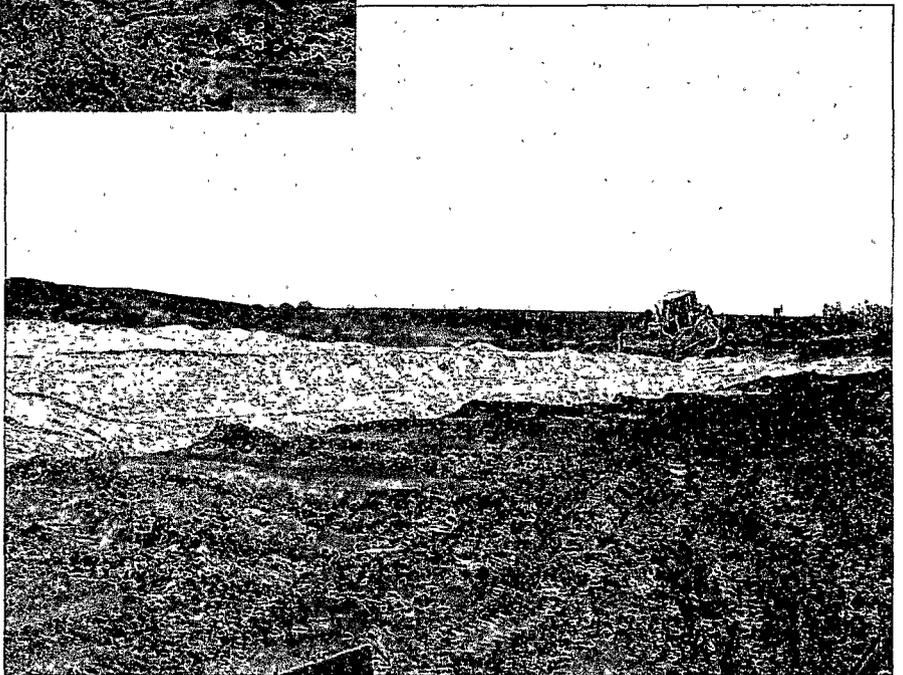
6/24/08 – Adding caliche layer over top of liner. >

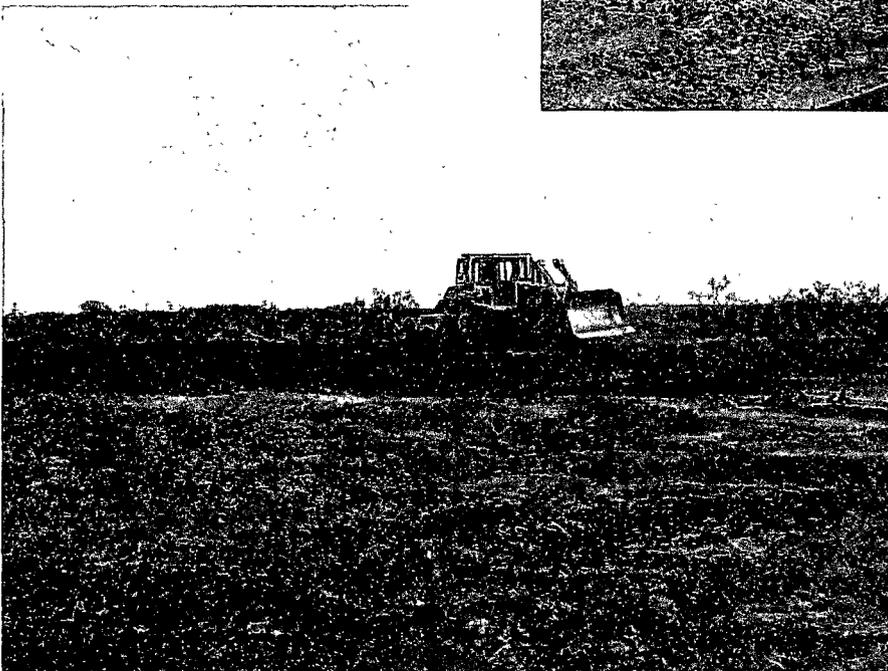
< 6/25/08 – Placing final 3-ft layer of topsoil
