# STAGE 2 REPORTS

RE: **Remediation Termination Request**  
**Rice Operating Company –EME SWD System**  
**C-16(1) and C-16(2) Leaks – OCD Case No. 1R0476 and 1R0477**  
**UL-C, Sec 16 T20S, R37E**

**AP-83**

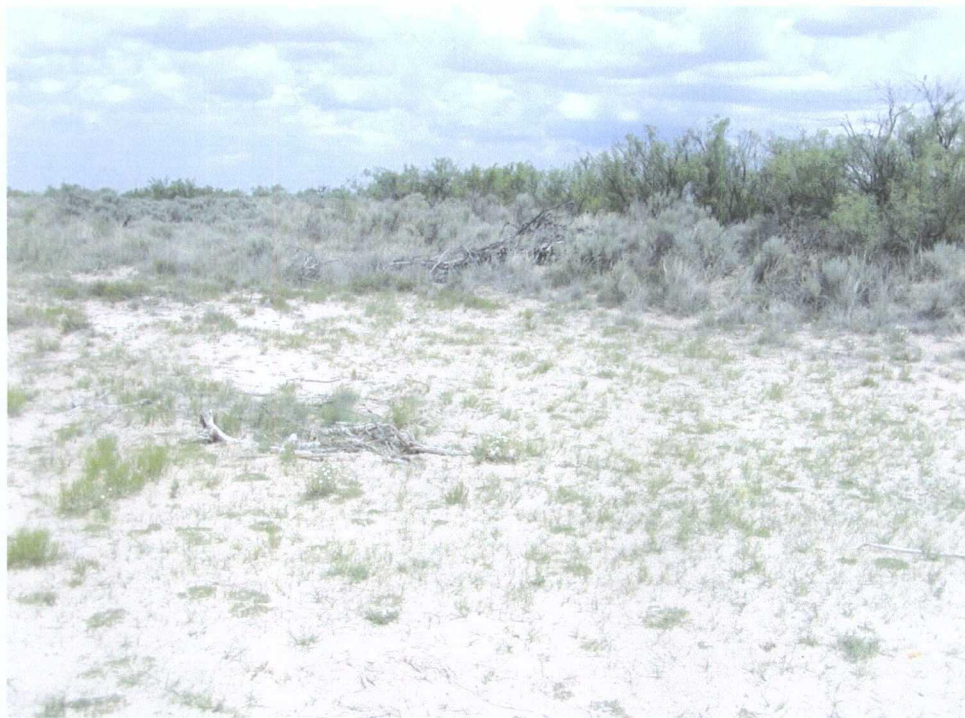
Figure 7 – EME C-16 (1) release location taken 06.30.09.

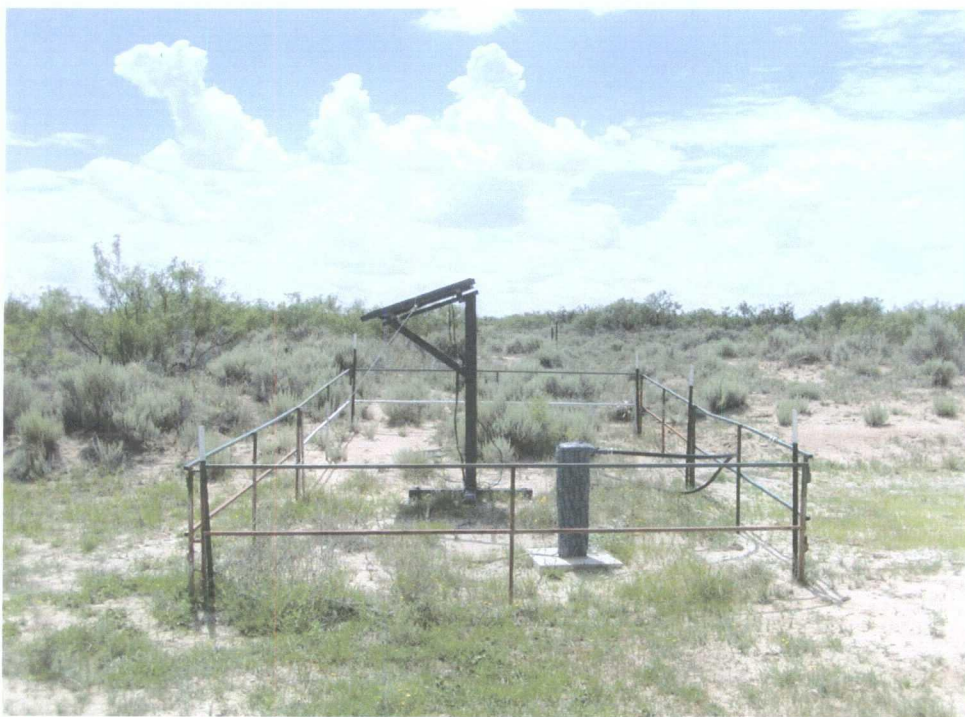
Figure 8 – EME C-16 (2) release location taken 06.30.09.
