1R - 426-117

Re: Rice Operating Company-wide Case Study of Residual Soil Petroleum Hydrocarbons
In regard to NMOCD Case No. IR426-117 (BD Oxy Owen A)

BD Oxy Owen A

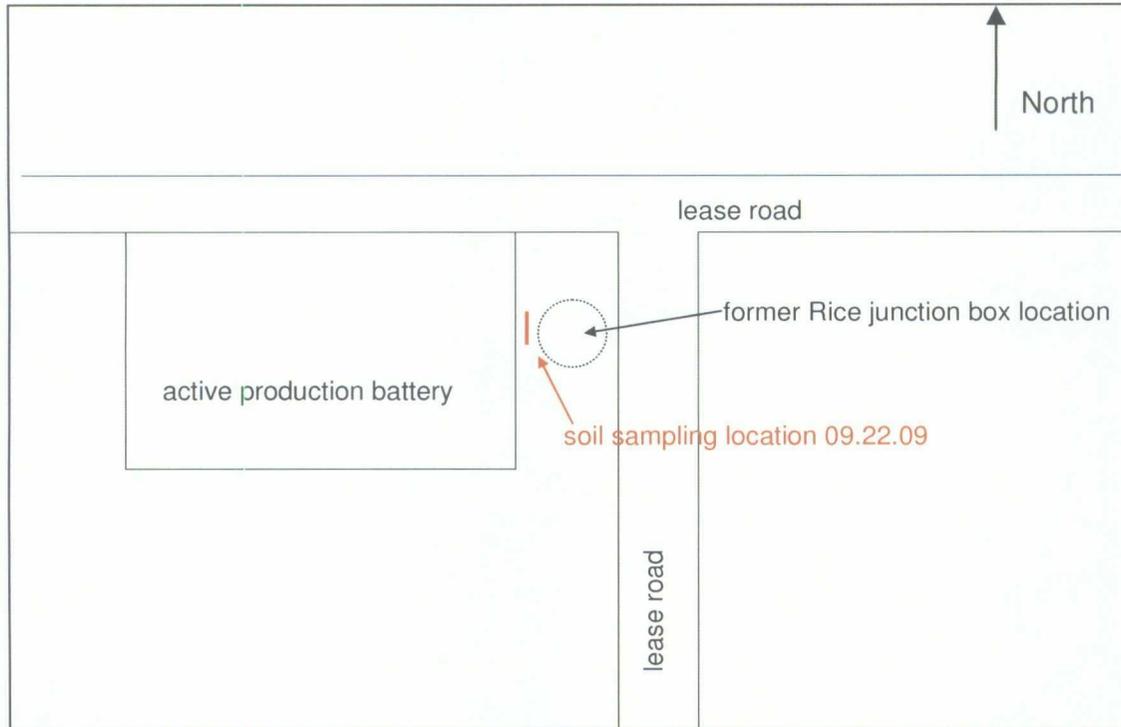
In follow-up to our meeting earlier this month and per your request, we sampled soils from a backhoe excavation to the west of the former junction box locations between these and an adjacent oil production battery (Figures 1 & 2). A trench was excavated to a depth of approximately 10 ft. (Safety concerns precluded going deeper due to the risks of shaking the earth in the immediate proximity of active production pipelines.)

Figure 1 – Location of soil sampling trench on 09.22.09.

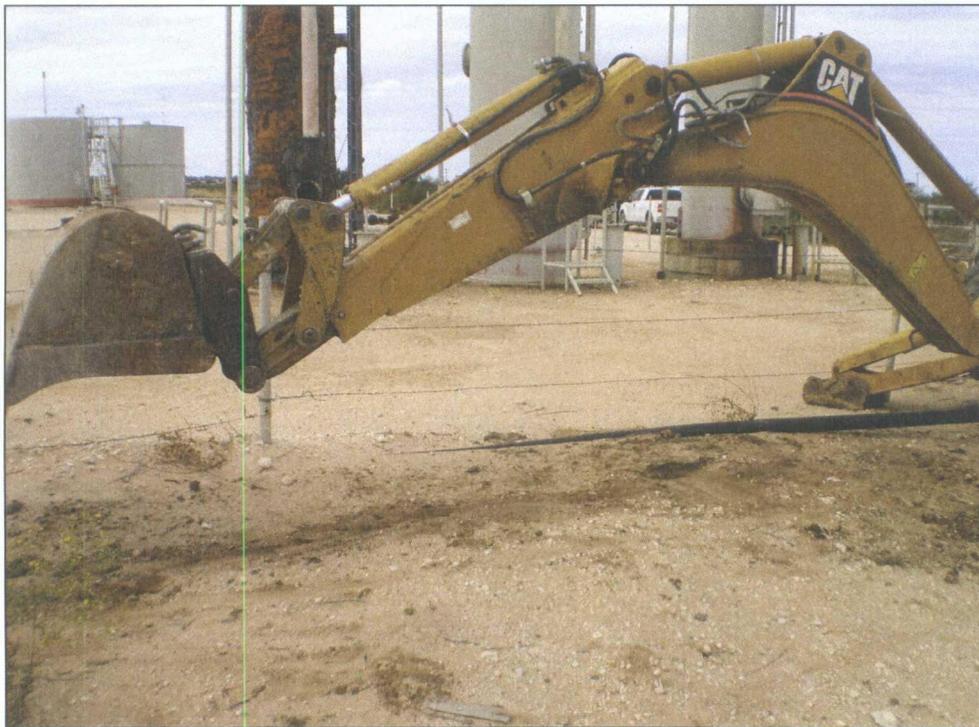
Figure 2 – Photograph of the same looking west.

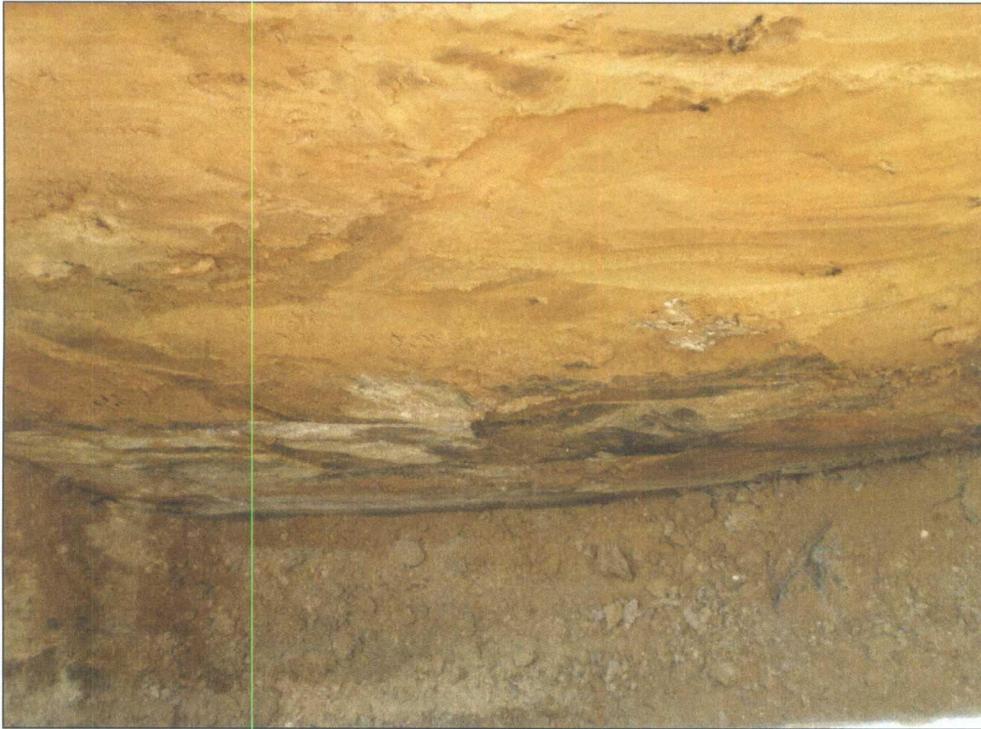
The excavated soils exhibited strong and increasing petroleum odor and visual evidence of petroleum contamination from approximately three feet below ground surface (bgs) to the limit of excavation at ten feet (Figures 3 & 4). Laboratory analysis indicated increasing hydrocarbon contamination eight to ten feet bgs (Figure 5). The combined DRO+GRO concentration at ten feet bgs totaled approximately 2,600 ppm at ten feet bgs. Soil chloride levels measured 576 ppm at this depth.

Figure 3 – View of open backhoe trench showing oil contaminated soil with depth.

We believe that these observations and data support the assertion made in our previous submittals¹ that the petroleum hydrocarbons found beneath the former junction boxes have migrated there from an off-site location. We therefore respectfully request that OCD grant remediation termination or similar closure status to this project.

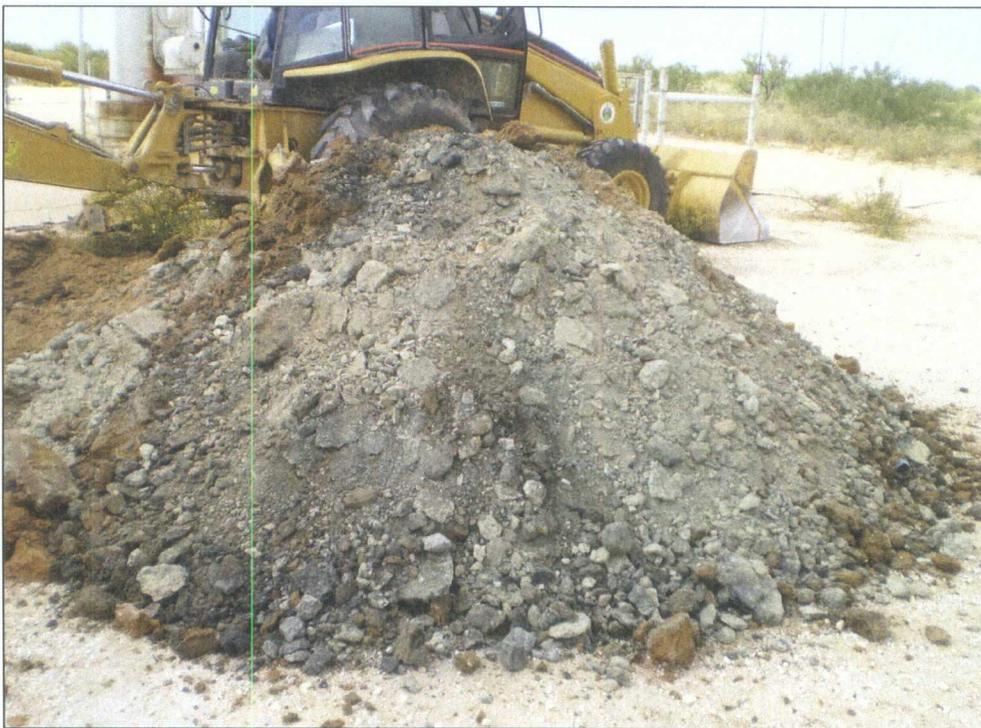
Figure 4 – View soil from bottom of sampling trench showing oil contaminated soil.
