Release Notification and Corrective Action

REMEDIATION SUMMARY AND SITE CLOSURE PROPOSAL

PLAINS PIPELINE, L.P. (231735)
Chevron Grayburg 6-Inch
Lea County, New Mexico
Plains SRS# 2009-163
UNIT B (NW/NE), Section 2, Township 18 South, Range 34 East
Latitude 32.78043° North, Longitude 103.52933° West
NMOCD Reference # 1RP-2243

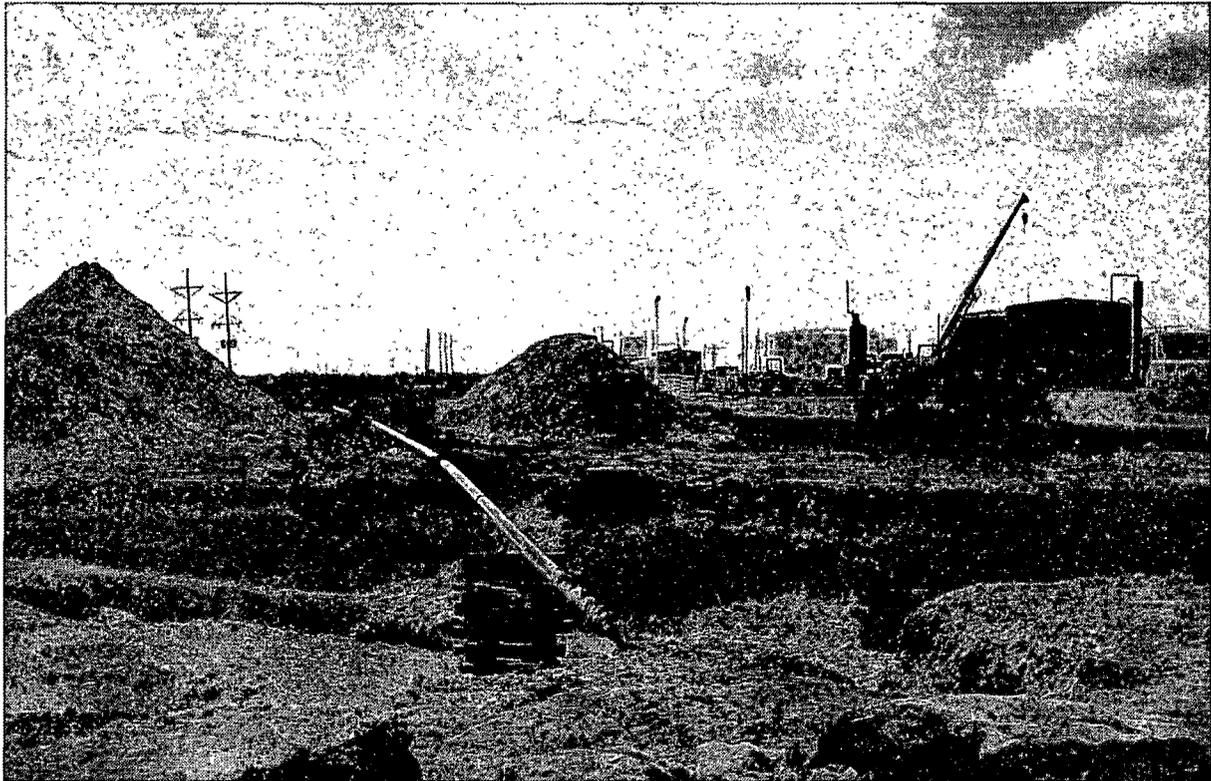
Chevron Grayburg 6-Inch Excavation (Looking West)

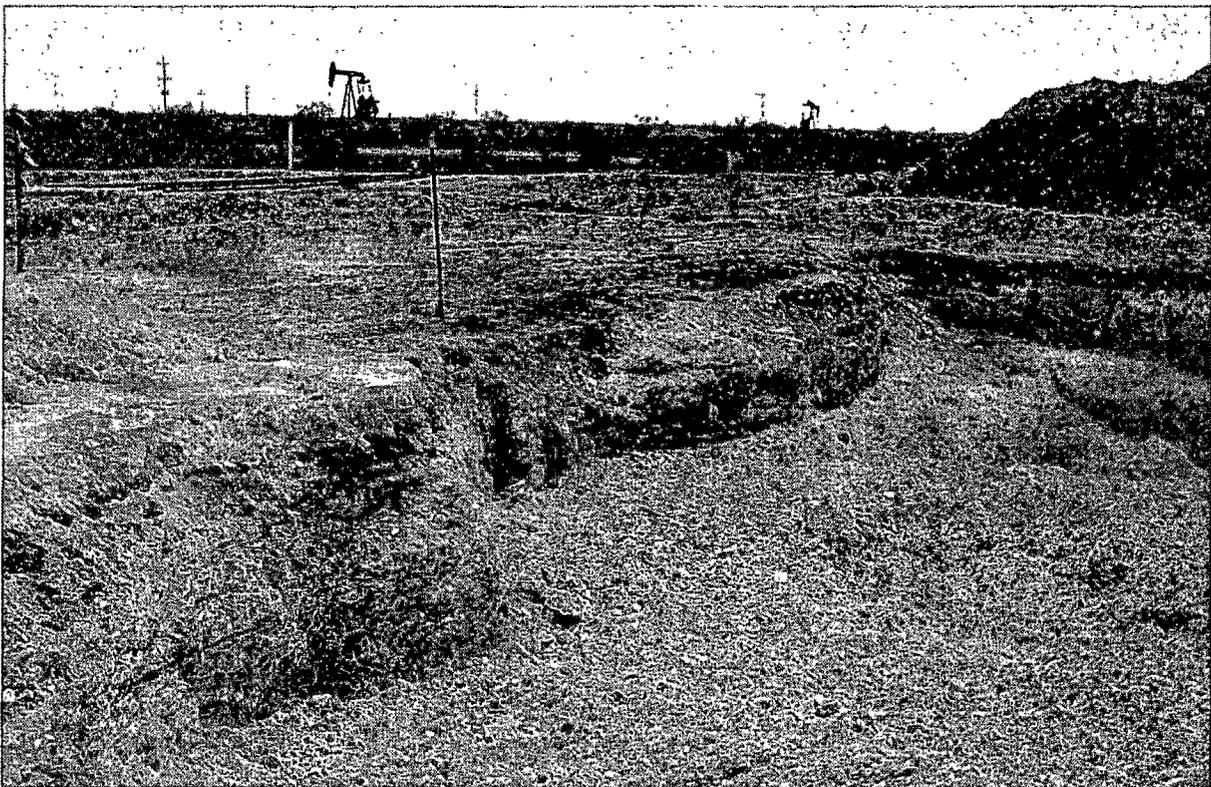
Chevron Grayburg 6-Inch Excavation (Looking Southwest)
