**Release Notification and Corrective Action**

Name of Company: XTO Energy Permian Division-SE New Mexico	Contact: Rick Wilson/Production Foreman
Address: P.O. Box 700, Eunice, New Mexico 88231	Telephone No.: (575) 394-2089
Facility Name: EMSU-Central Battery Tank I	Facility Type: Tank Battery-Nearest Well is EMSU Well #626 (API #30-025-31465)

Re: 1RP-09-09-2285  
Below Grade Tank Removal Documentation and Soil Sample Results  
XTO Energy, Inc., Eunice Monument South Unit – Central Battery Tank 1  
Unit E (SW/4, NW/4), Section 4, Township 21 South, Range 36 East  
Lea County, New Mexico

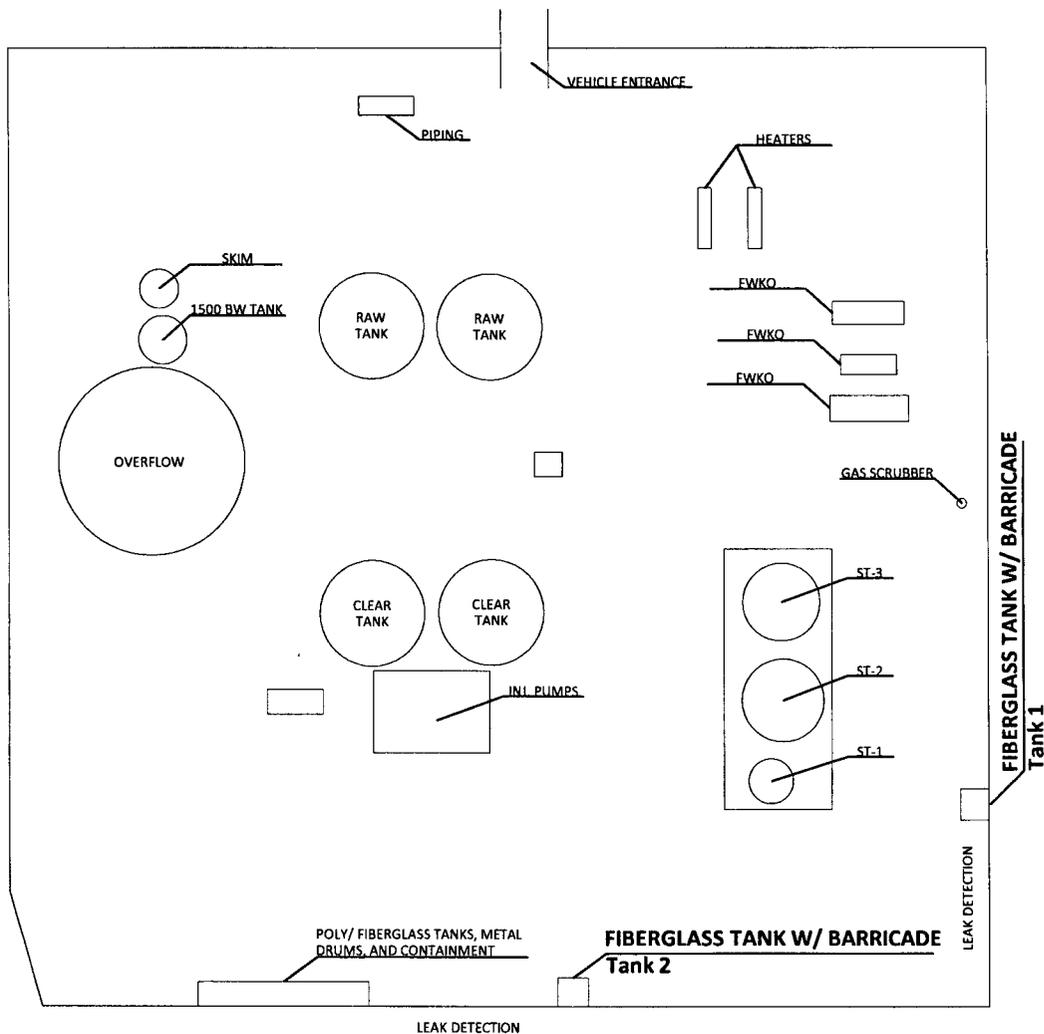
Figure 3 - Site Drawing

XTO Energy, Inc.  
 EMSU - Central Battery  
 Unit E, Sec. 4, T-21-S, R-36-E  
 Lea County, New Mexico

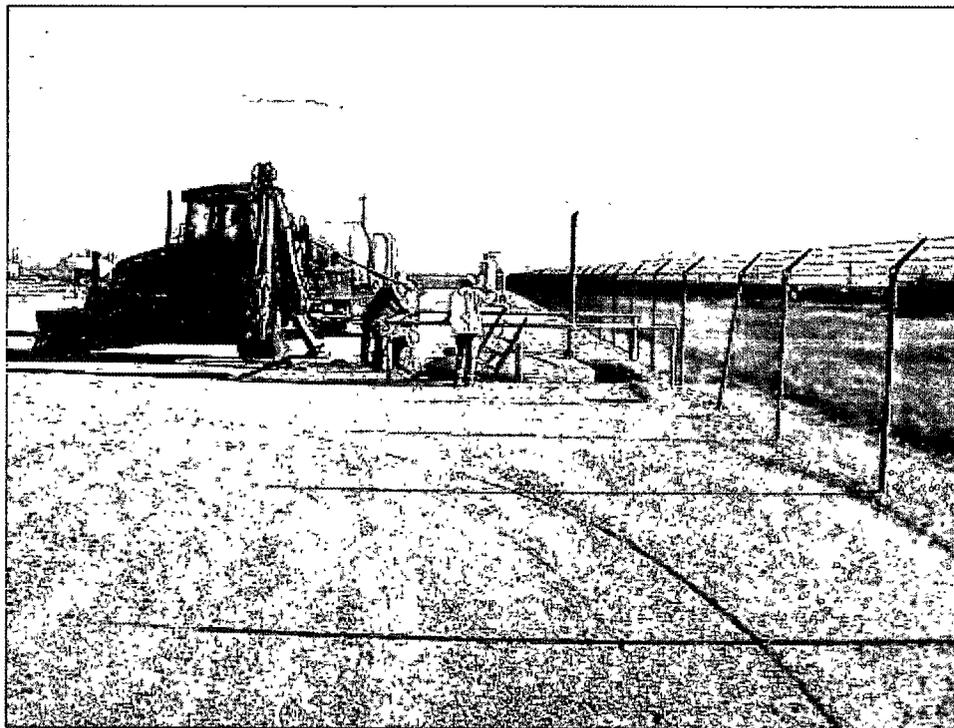
View Facing North: Below Grade Tank 1 Location along Eastern Fence Line

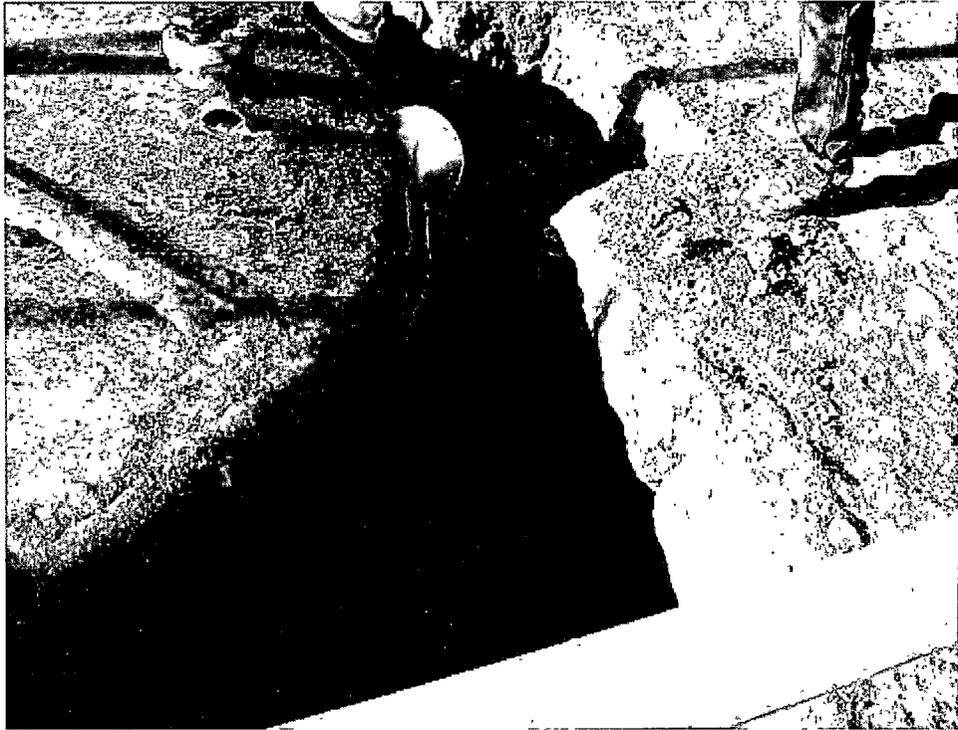
View Facing Down: Soil Removed From Western Side of Tank 1

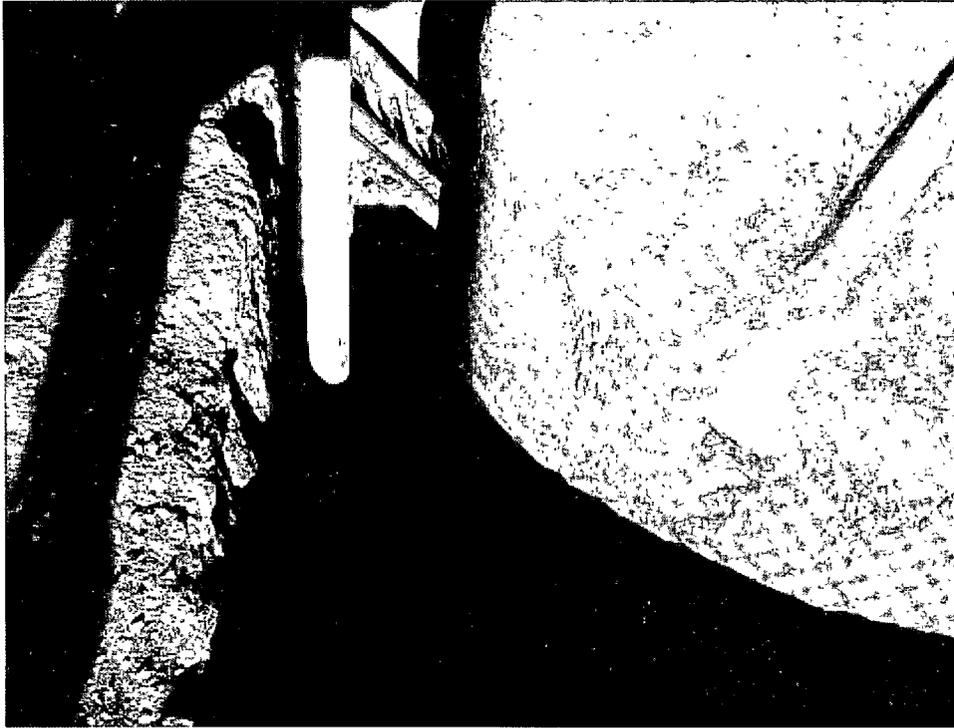
View Facing Down: Soil Removed from Southern Side of Tank 1

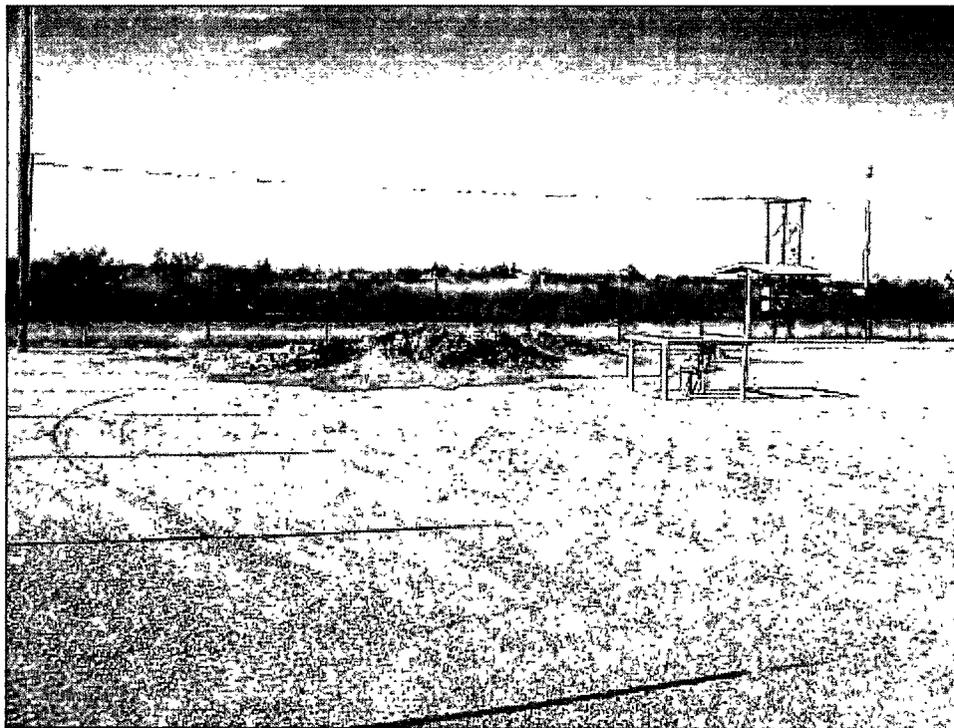
View Facing SSW: Tank 1 Soil Pile

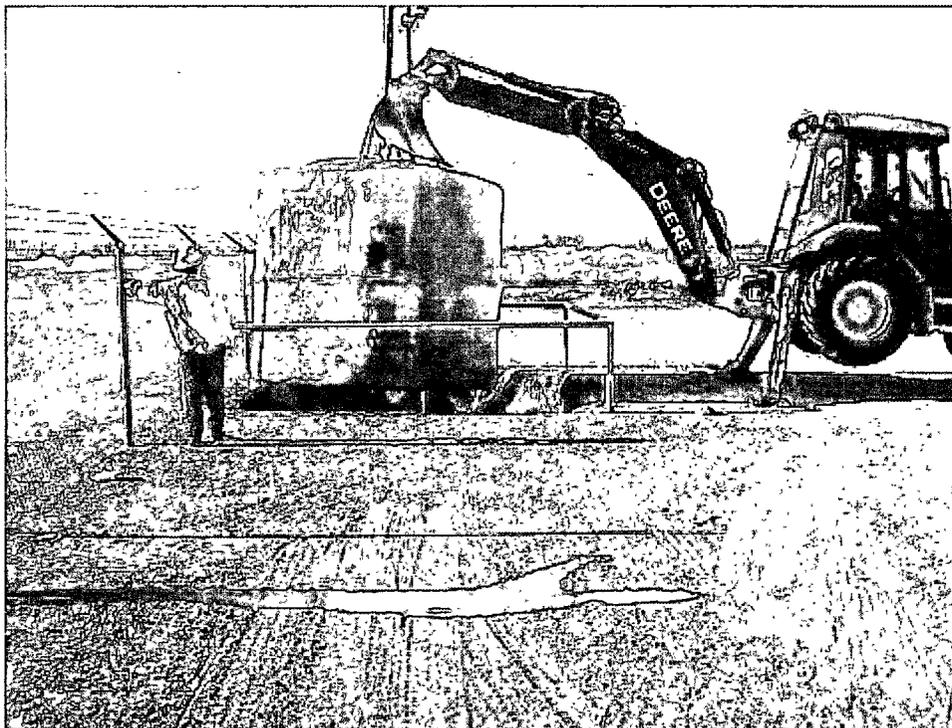
View Facing South: Backhoe Removing Tank 1 from Excavation

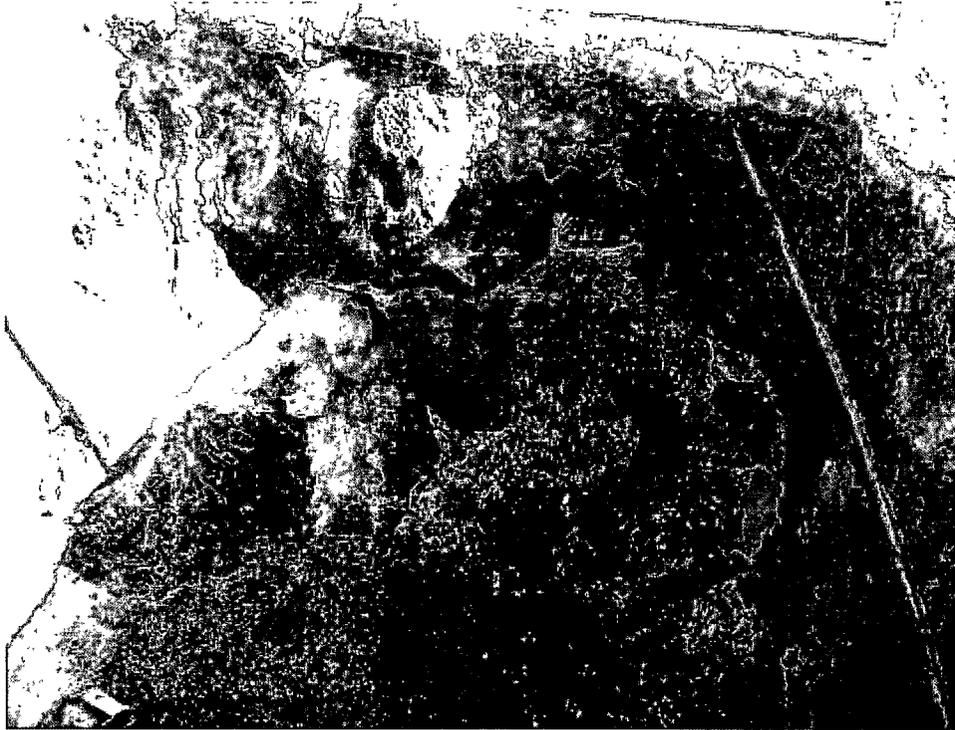
View Facing Down: Excavation North Wall

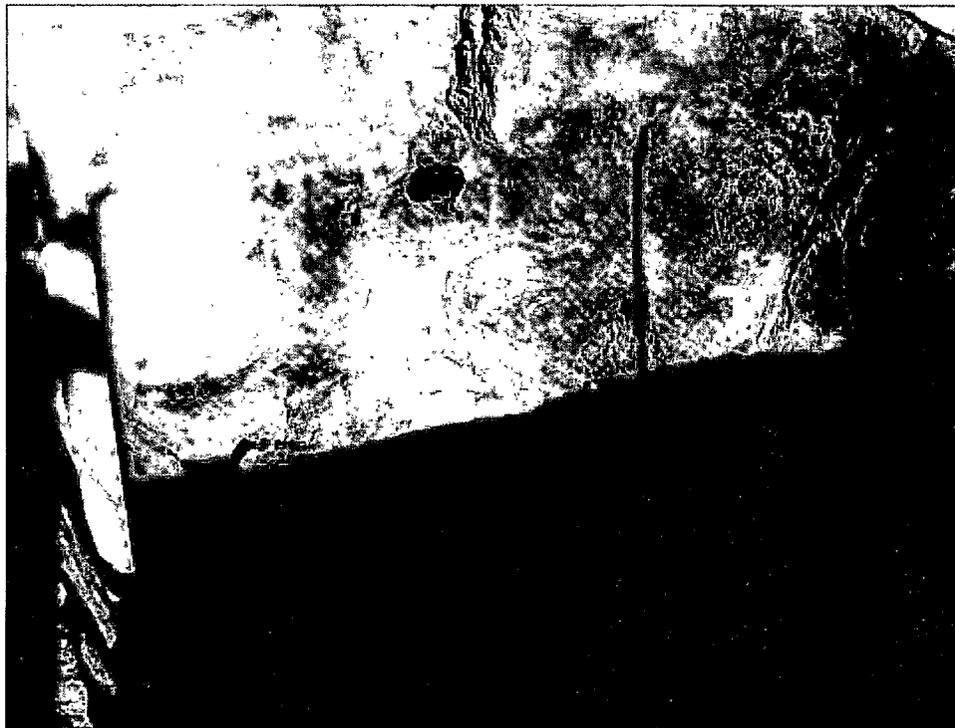
View Facing Down: Excavation West Wall w/Discharge Piping

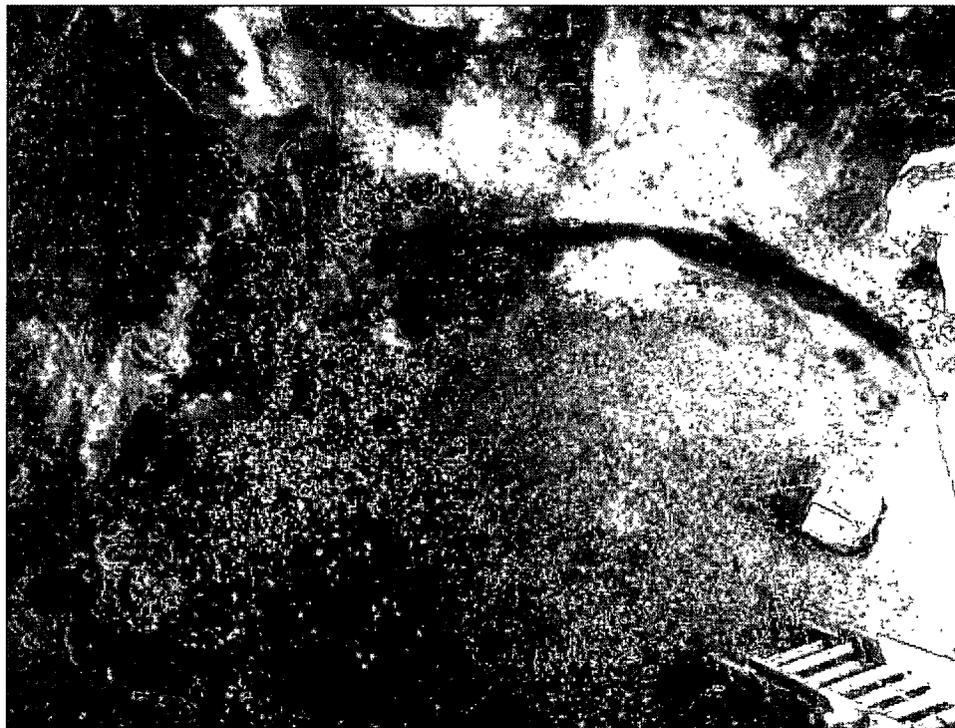
View Facing Down: Floor of Excavation w/Leak Detection Still In Place

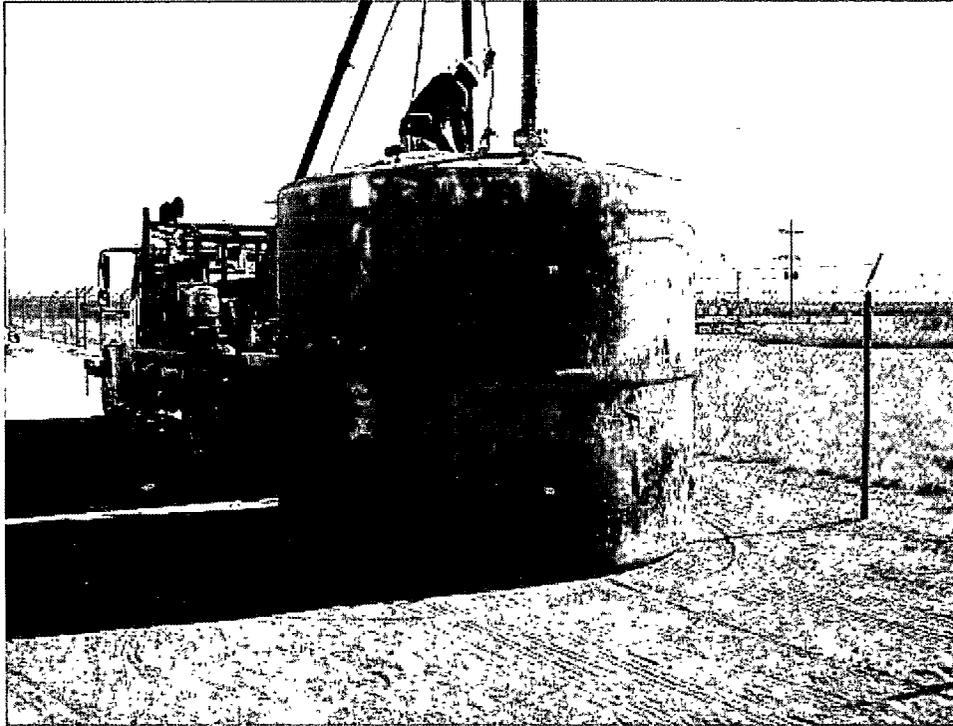
View Facing NNE: Outer Wall of Tank 1

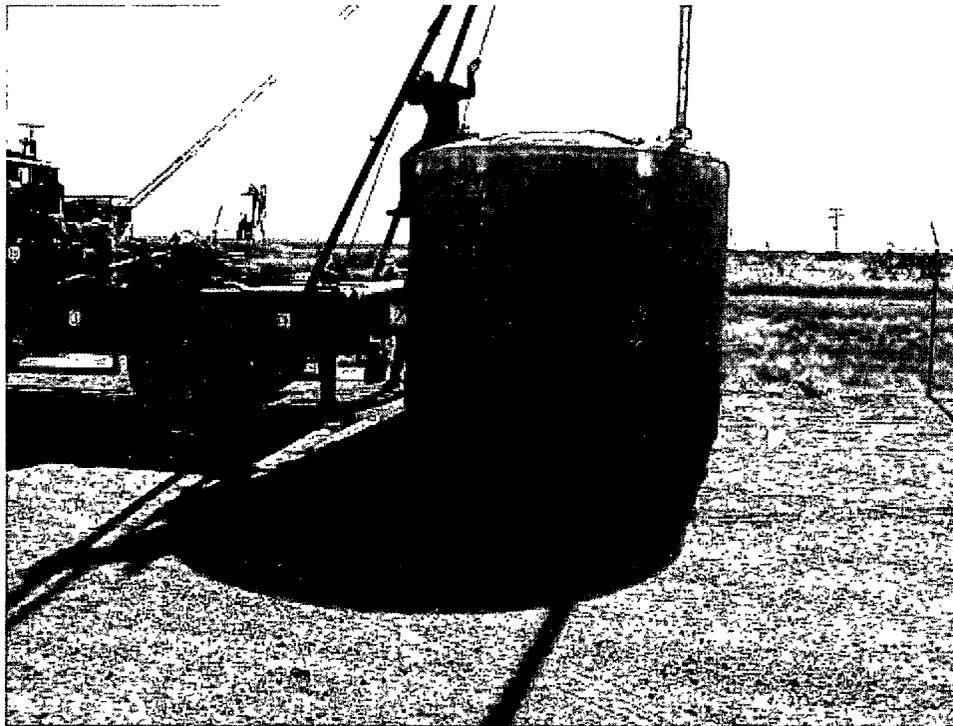
View Facing East: Outer Wall of Tank 1

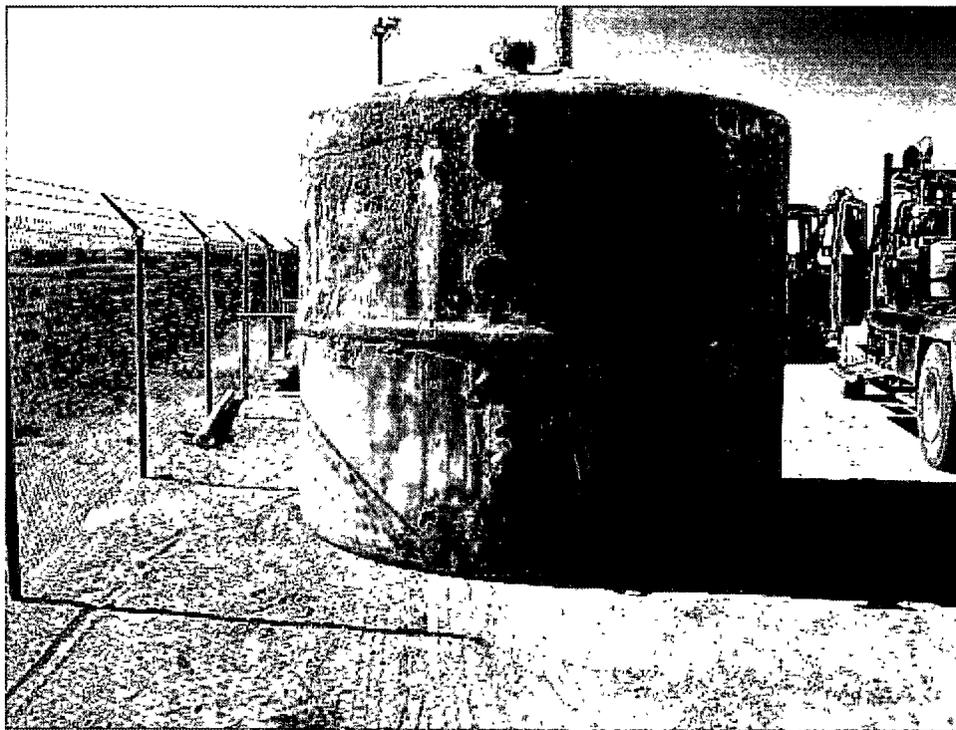
View Facing South: Tank 1 Outer Wall

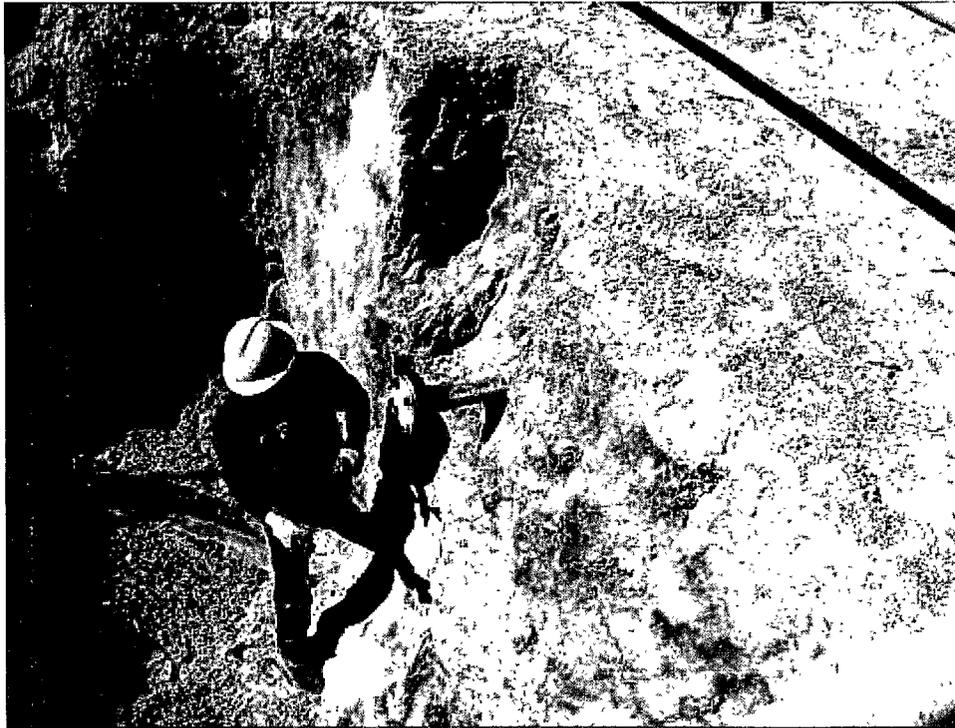
View Facing Down: Installing Slip Plate Cover to Discharge Line
