Justis Jct L-23

**RICE OPERATING COMPANY  
JUNCTION BOX DISCLOSURE\* REPORT**

SWD SYSTEM	JUNCTION	UNIT	SECTION	TOWNSHIP	RANGE	COUNTY	BOX DIMENSIONS - FEET		
							Length	Width	Depth
Justis	Jct. L-23	L	23	24S	37E	Lea	moved 50 ft north

Unit L, Section 23, T24S, R37E

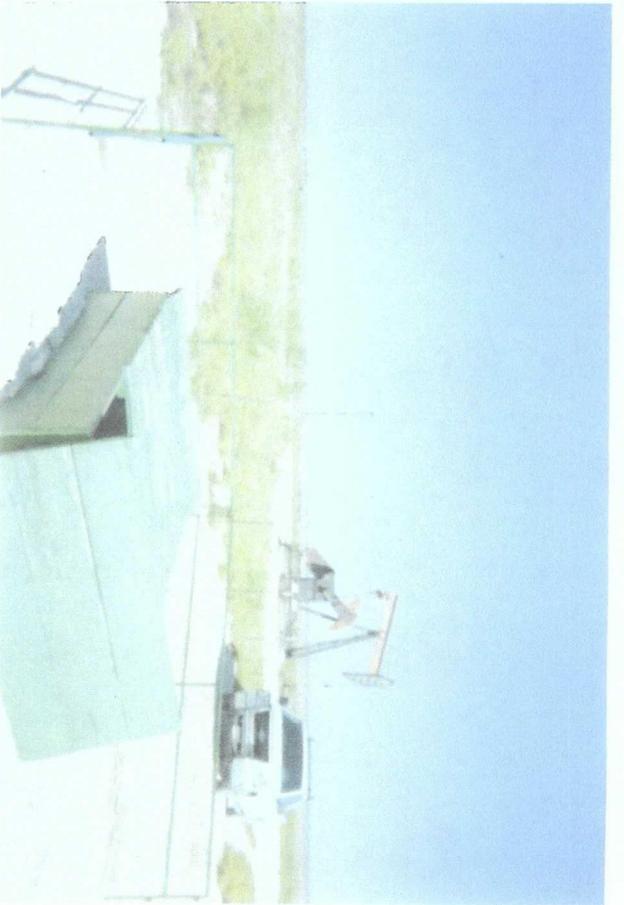
undisturbed junction box; facing north

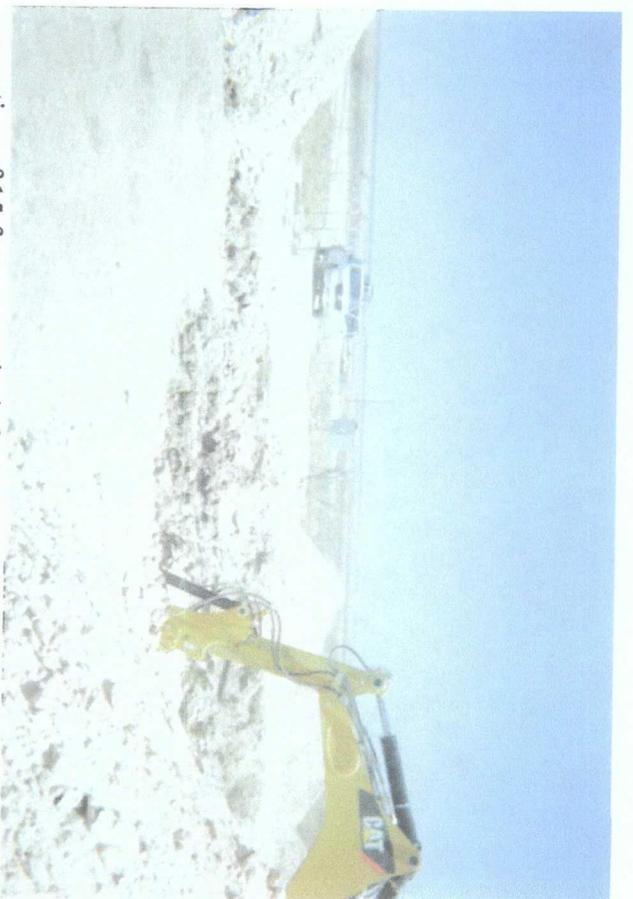
excavation of 15 ft west vertical; facing northeast

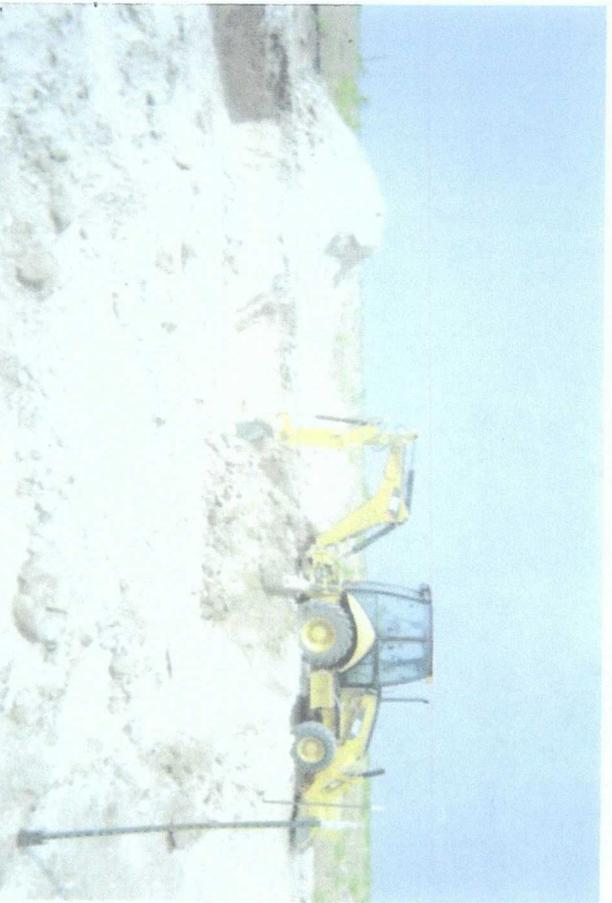
excavating bench on west side of location

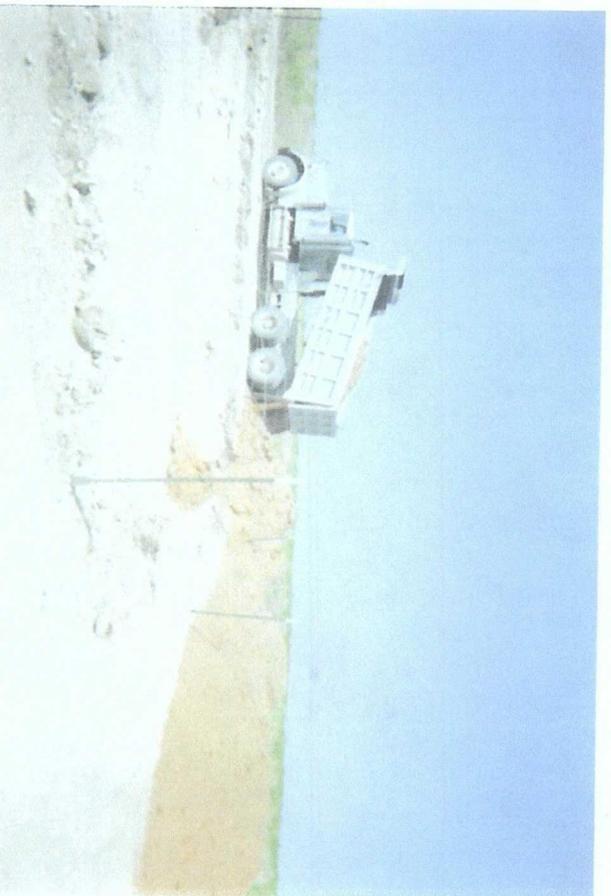
clean, imported dirt being unloaded; facing west

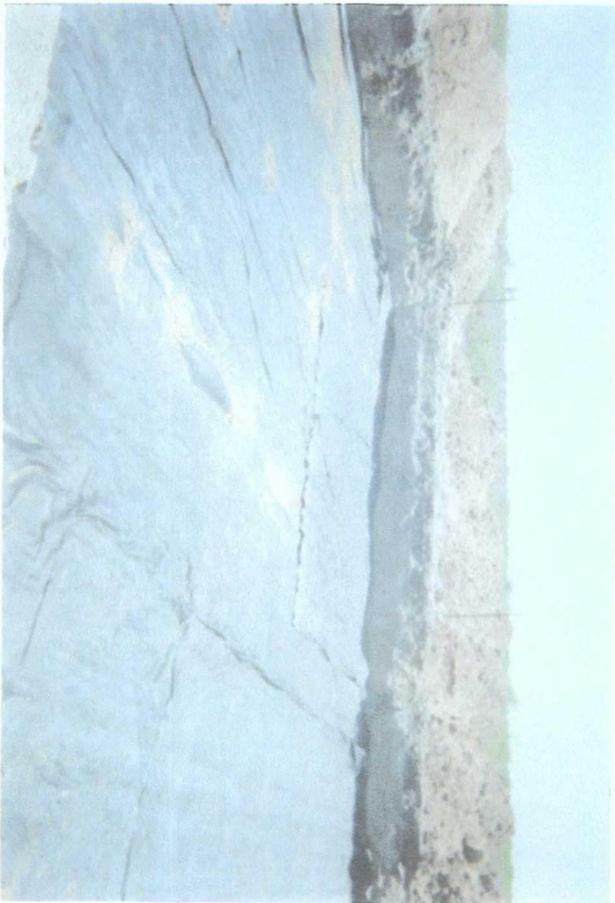
GCL in place, facing southwest

General Description of Remedial Action: This junction box was addressed under the pipeline replacement/upgrade program. A new, watertight junction box was installed 50 ft north of the former. After the former box was removed, an investigation was conducted using a backhoe to collect soil samples at regular intervals producing a 30x30x12-ft-deep hole. Each sample was field tested for chloride concentrations, which yielded elevated levels that did not relent with depth. Organic vapors were also measured using a PID. A 12 ft grab samples from the source and 15 ft north, south, east, and west were sent to a commercial laboratory for analysis. The site was then backfilled up to 6 ft below ground surface. A 6-ft-deep shelf was excavated 5 ft out from the north, south, east, and west walls to prepare the surface for the geosynthetic clay liner. At 6-5 ft BGS, a GCL was installed. The excavation was then backfill and contoured to the surrounding area with clean, imported soil. An identification plate was then placed on the surface at the former junction site to mark the presence of the GCL below. NMOCD was notified of potential ground-water impact on 7/30/2008.

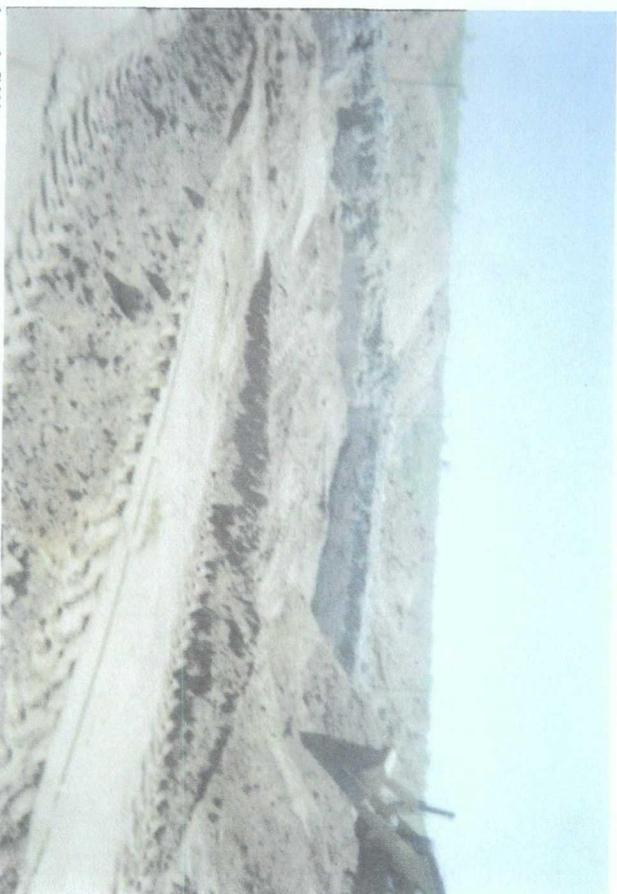
backfilling excavation site, facing west

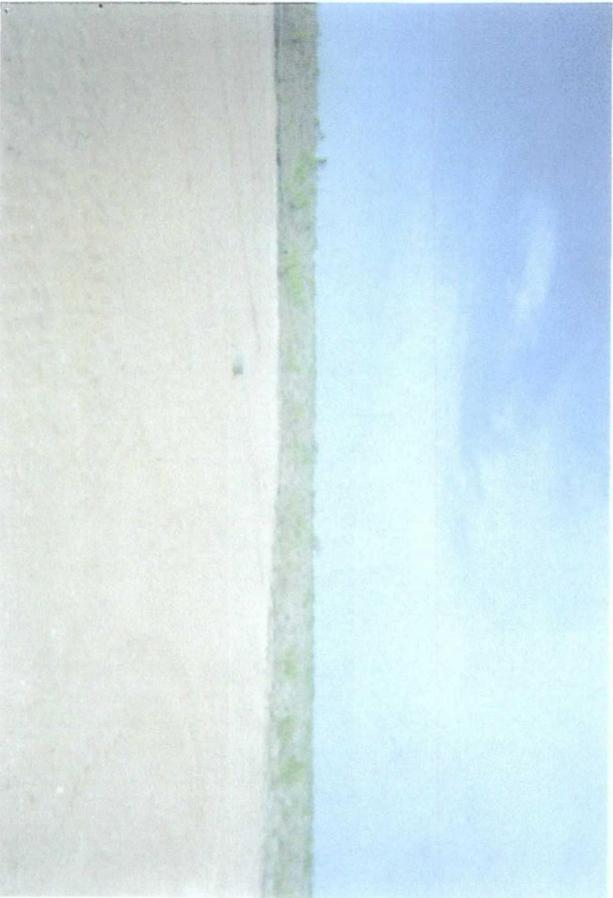
site complete with clay marker, facing southwest

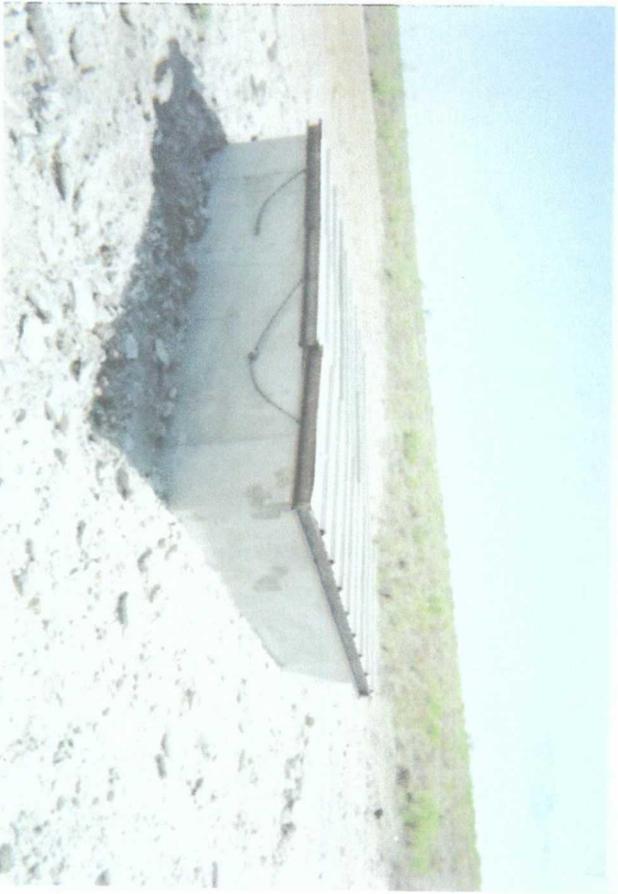
new, watertight junction box

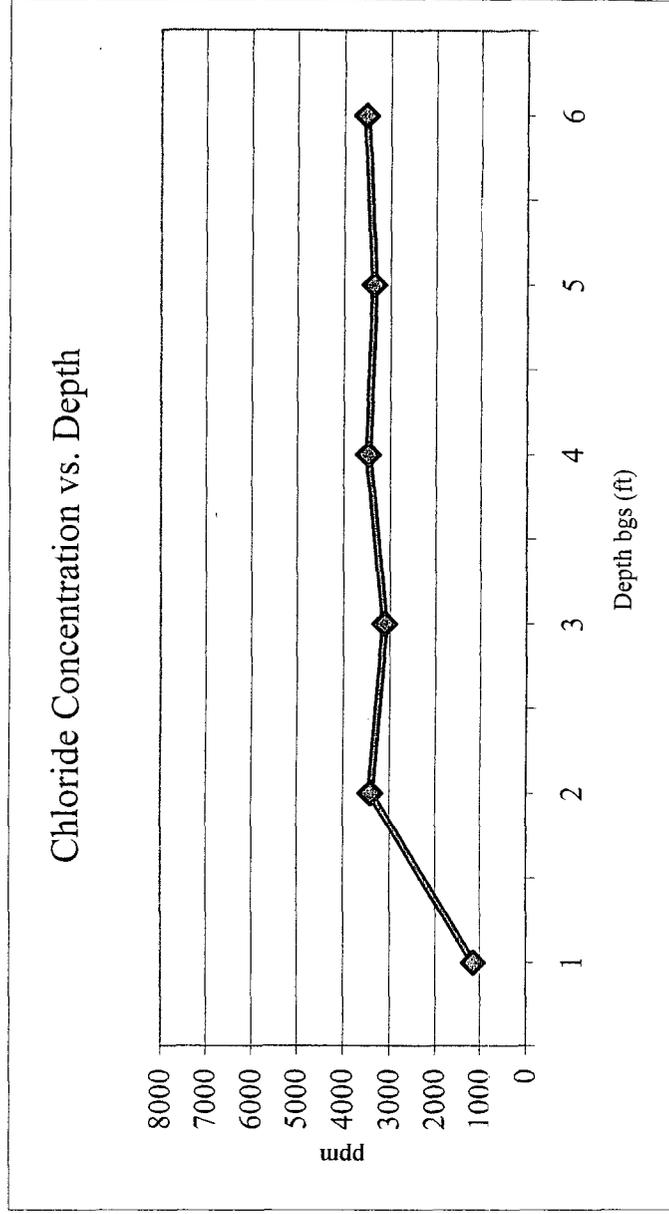
# CHLORIDE CONCENTRATION CURVE

Backhoe samples at 15 ft west of the junction (source)

Depth bgs (ft)	[Cl <sup>-</sup> ] ppm
2	1152
4	3418
6	3120
8	3481
10	3357
12	3527

Groundwater = 94 ft
