Vacuum M-33 Vent

**RICE OPERATING COMPANY  
JUNCTION BOX FINAL REPORT**

# Vacuum vent M-33

Unit M, Section 33, T17S, R35E

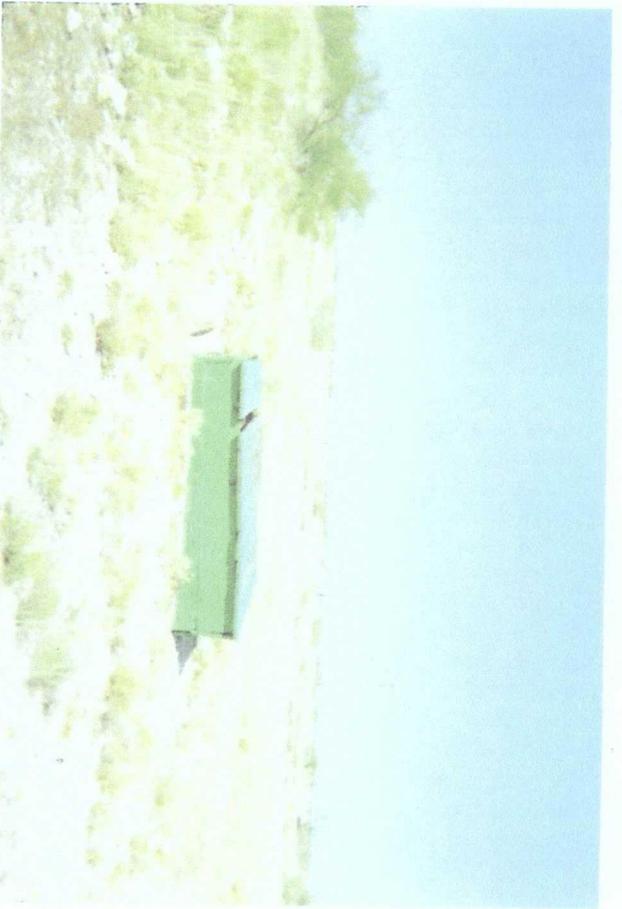
10/25/2005

undisturbed junction box, facing north

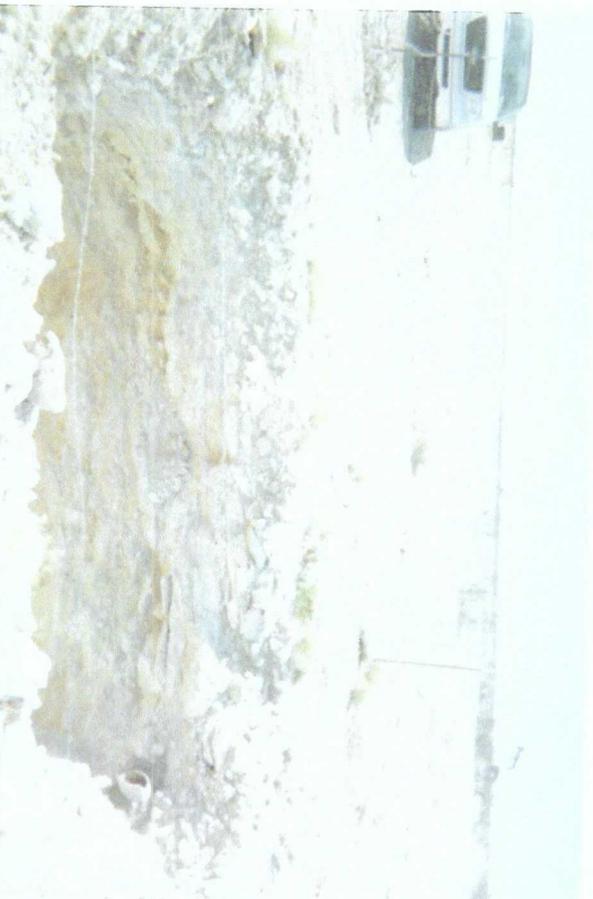
3/4/2008

delineation trench at former junction site, facing south

General Description of Remedial Action: This junction was addressed under the Vacuum SWD System abandonment. After this junction was removed, an investigation was conducted using a backhoe to collect soil samples at regular intervals producing a 5x3x14-ft-deep hole. Chloride field tests were performed on each sample, which yielded low concentrations. Organic vapors were measured using a PID, which also yielded low concentrations. The deepest sample, 14 ft BGS, was sent to a commercial laboratory for analysis of chloride and TPH, which confirmed low concentrations. The excavated soil was returned to the excavation and clean, imported soil was used to fill the excavation to ground surface and to contour to the surrounding area. On 3/20/2008, the site was seeded with a blend of native vegetation and is expected to return to a productive capacity at a normal rate.

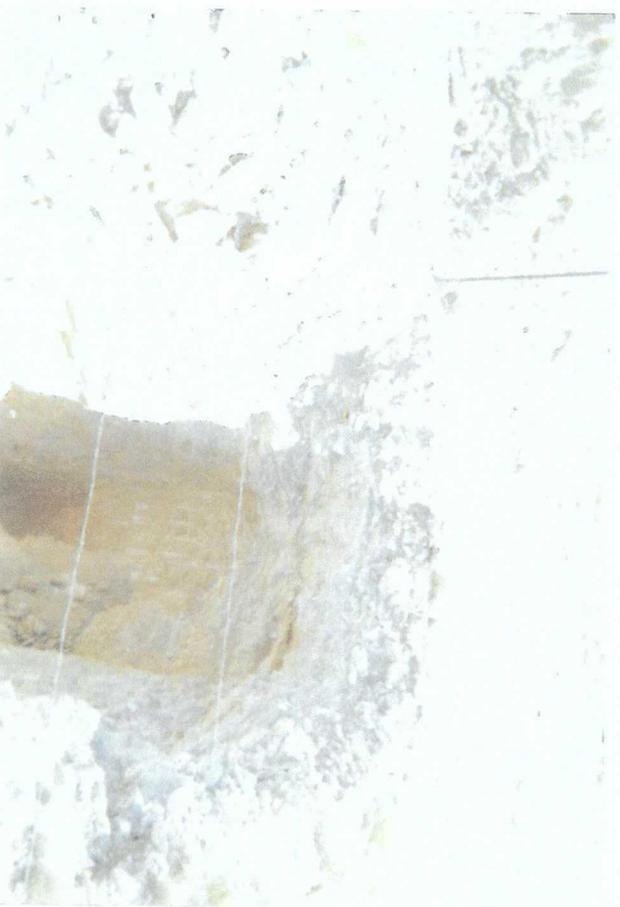
3/4/2008

delineation trench at former junction site, facing east

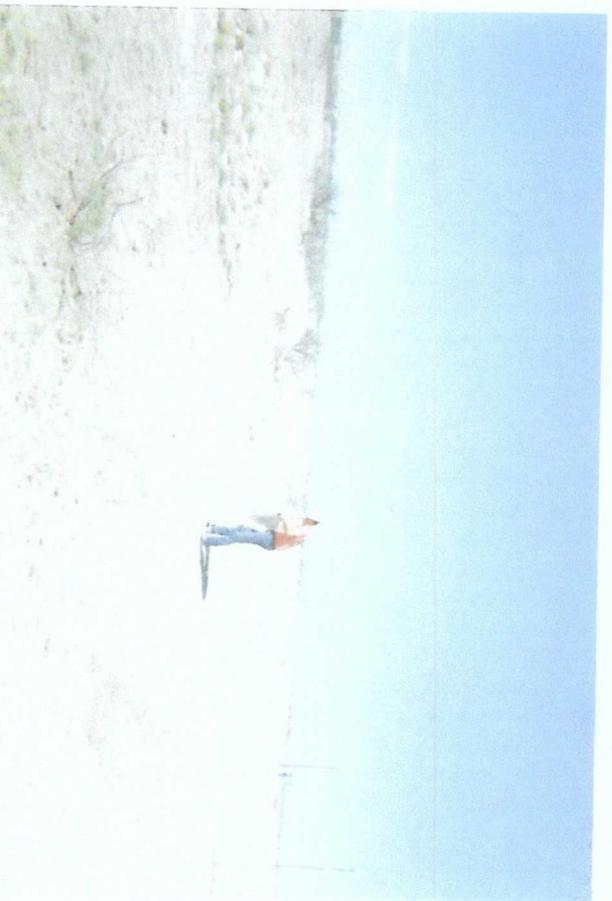
3/20/2008

seeding backfilled site, facing north

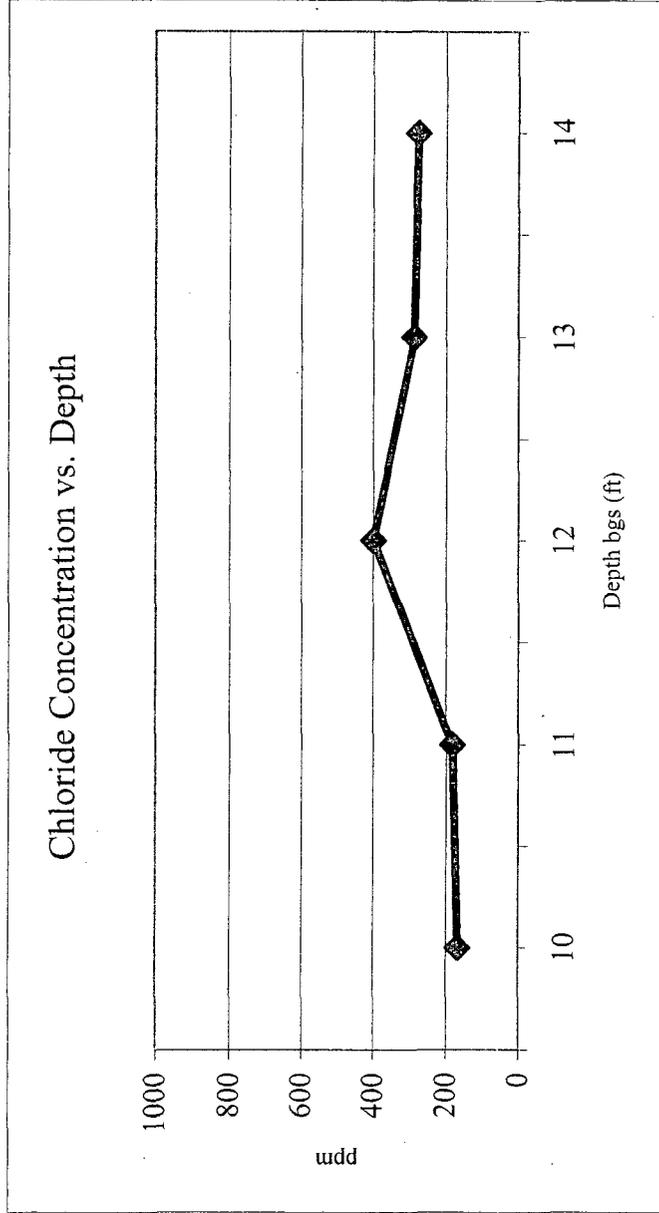
# CHLORIDE CONCENTRATION CURVE

*Backhoe samples at junction (source)*

Depth bgs (ft)	[Cl] ppm
10	168
11	183
12	400
13	288
14	277

Groundwater = 55 ft

LOCATION	DEPTH	mg/kg
background	6"	77
vertical delineation trench at junction (source)	10'	168
	11'	183
	12'	400
	13'	288
	14'	277
