Vacuum Jct C-31-1

CLOSURE

**RICE OPERATING COMPANY
JUNCTION BOX FINAL REPORT**

Unit C, Section 31, T17S, R35E

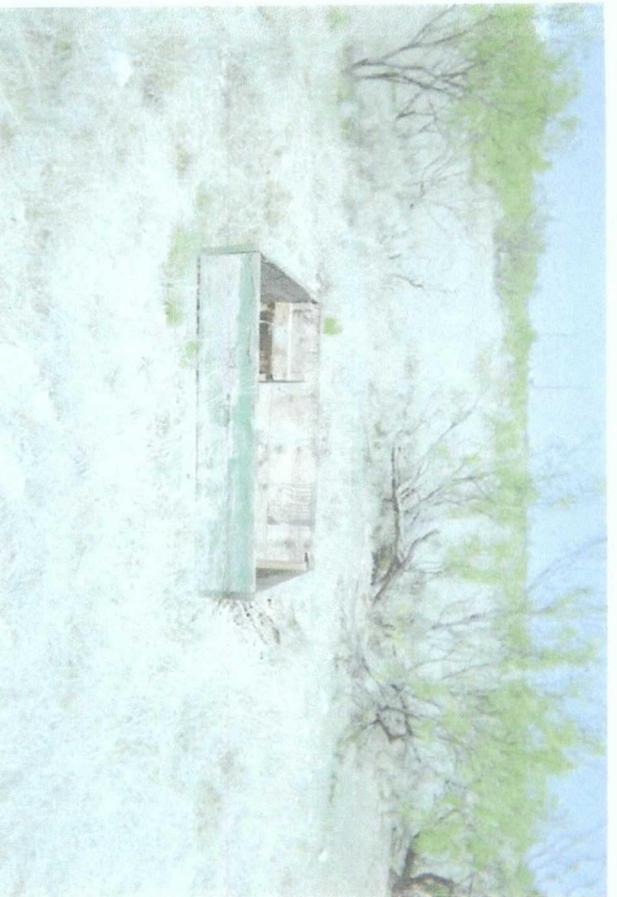
5/27/2008

junction box prior to removal, facing west

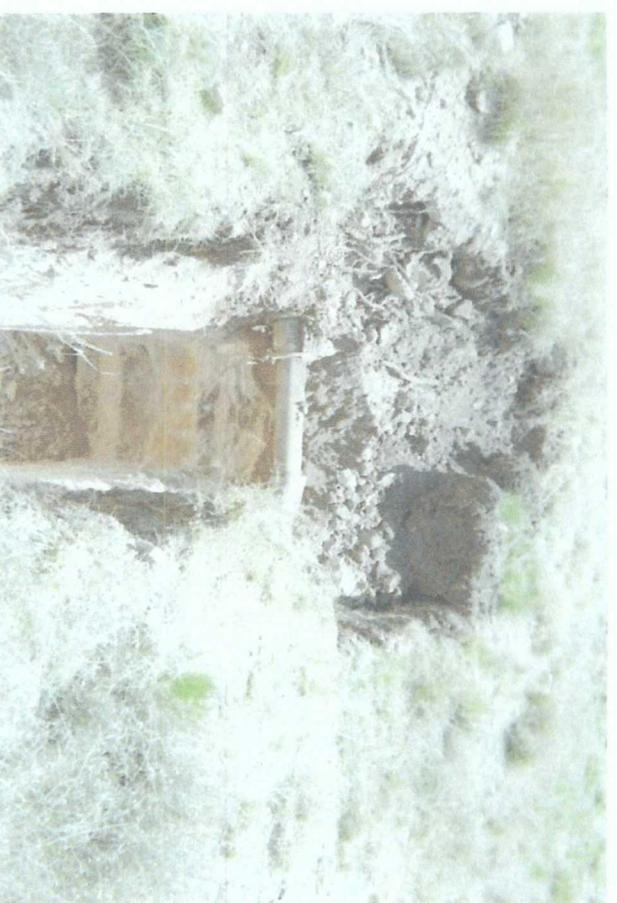
5/27/2008

delineation trench at former junction site, facing east

LOCATION	DEPTH	mg/kg
background	6"	211
vertical delineation trench at junction (source)	4'	108
	5'	128
	6'	109
	7'	107
	8'	135

General Description of Remedial Action: This junction was addressed under the Vacuum SWD System abandonment. After the junction was removed, an investigation was conducted using a backhoe to collect soil samples at regular intervals producing a 5x3x8-ft-deep hole. Chloride field tests were performed on each sample, which yielded low concentrations. Organic vapors were measured using a PID, which also yielded low concentrations. The deepest sample, 8 ft BGS, was sent to a commercial laboratory for analysis of chloride and TPH, confirming low concentrations. The excavated soil was returned to the excavation and clean soil was imported and used as a top cap and to contour to the surrounding area. On 6/5/2008, the site was seeded with a blend of native vegetation and is expected to return to a productive capacity at a normal rate.

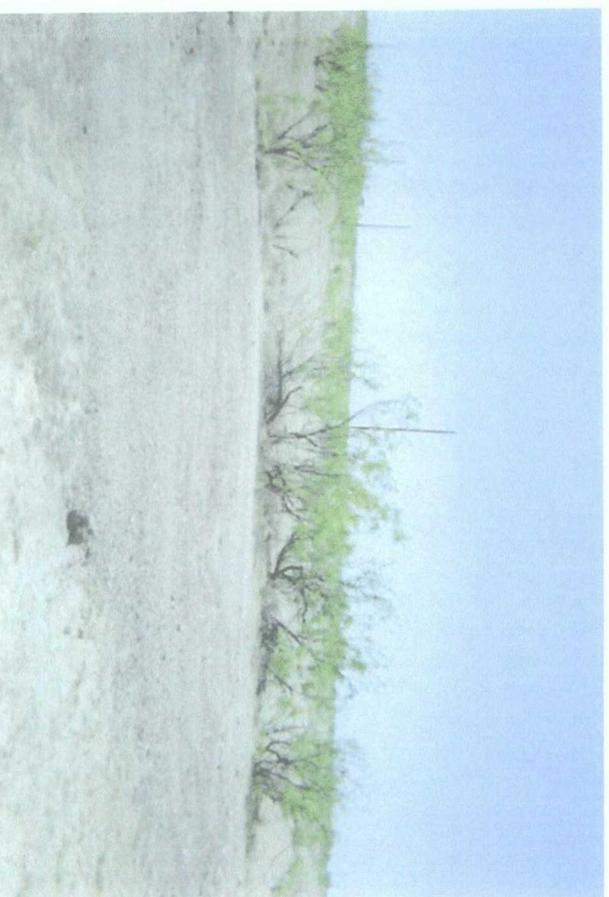
6/5/2008

backfilled site, facing west

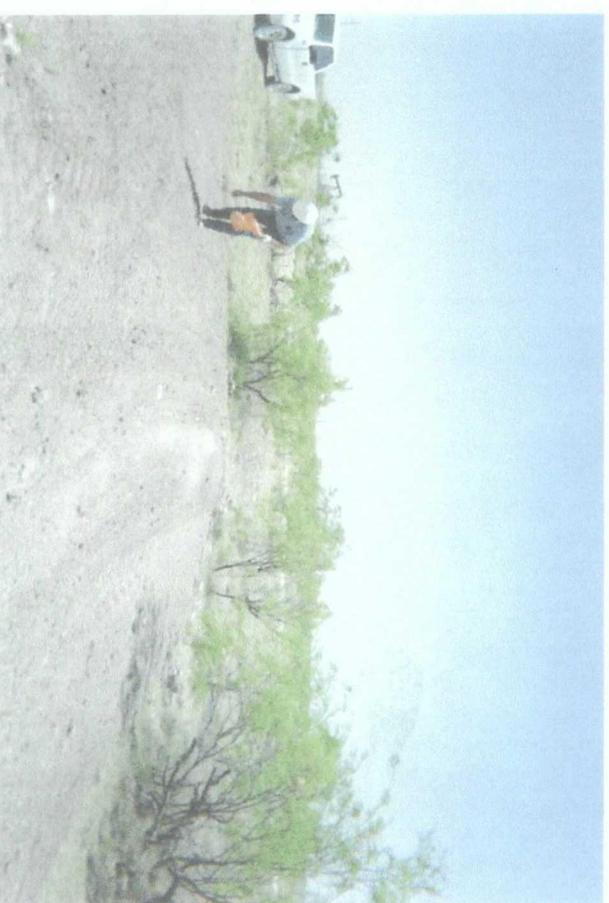
6/5/2008

seeding backfilled site, facing south

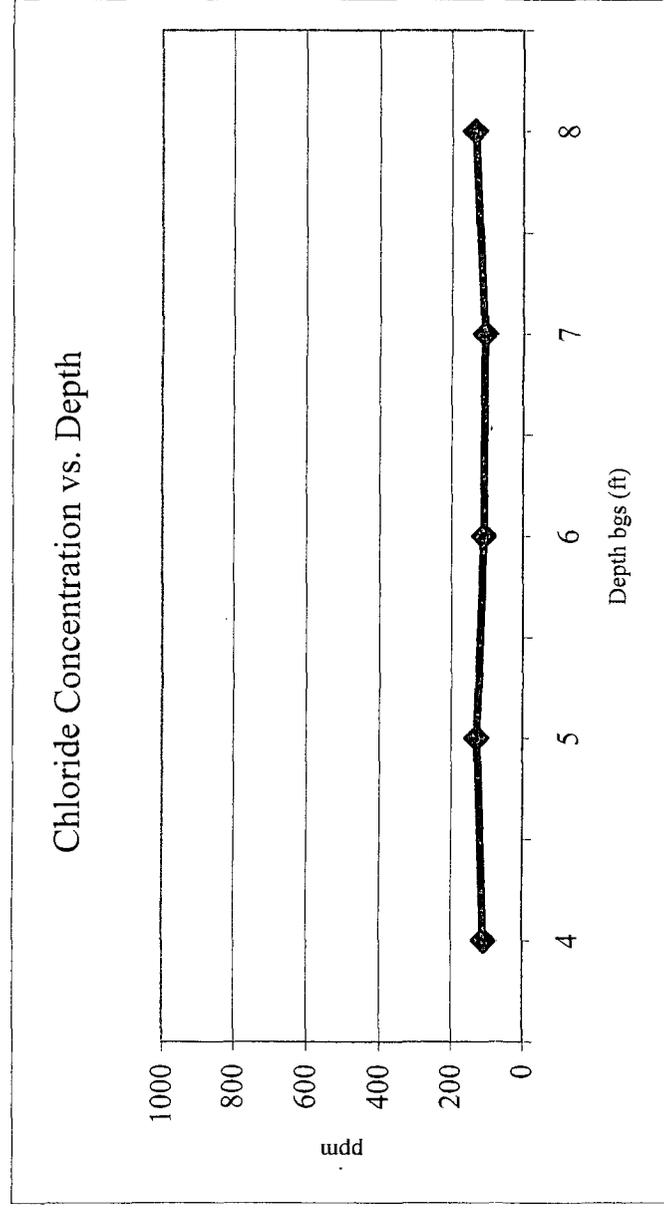
CHLORIDE CONCENTRATION CURVE

Backhoe samples at junction (source)

Depth bgs (ft)	[Cl ⁻] ppm
4	108
5	128
6	109
7	107
8	135

Groundwater = 90 ft
