Vacuum F-32 Vent Boot

**RICE OPERATING COMPANY
JUNCTION BOX FINAL REPORT**

Vacuum vent F-32 boot

Unit F, Section 32, T17S, R35E

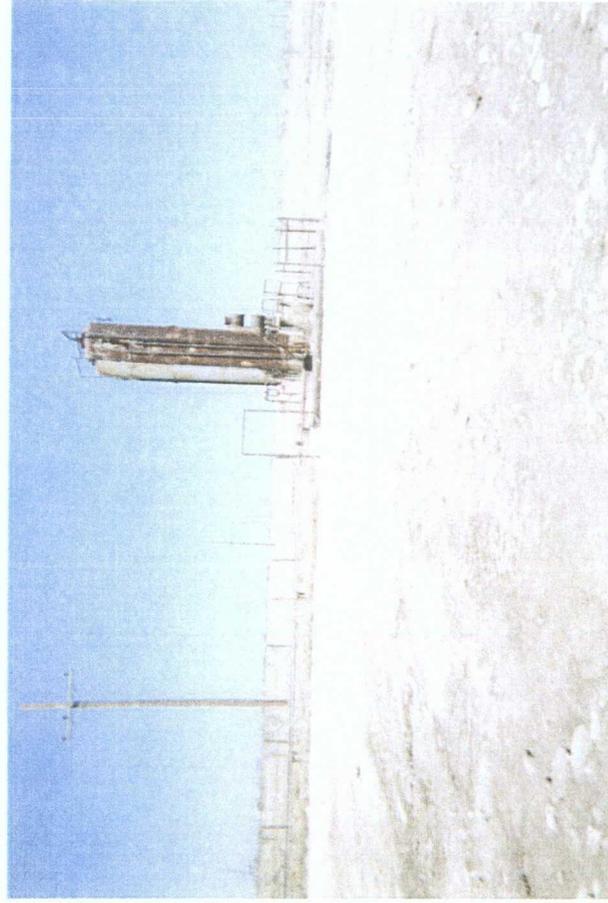
3/19/2008

backfilled site, facing north

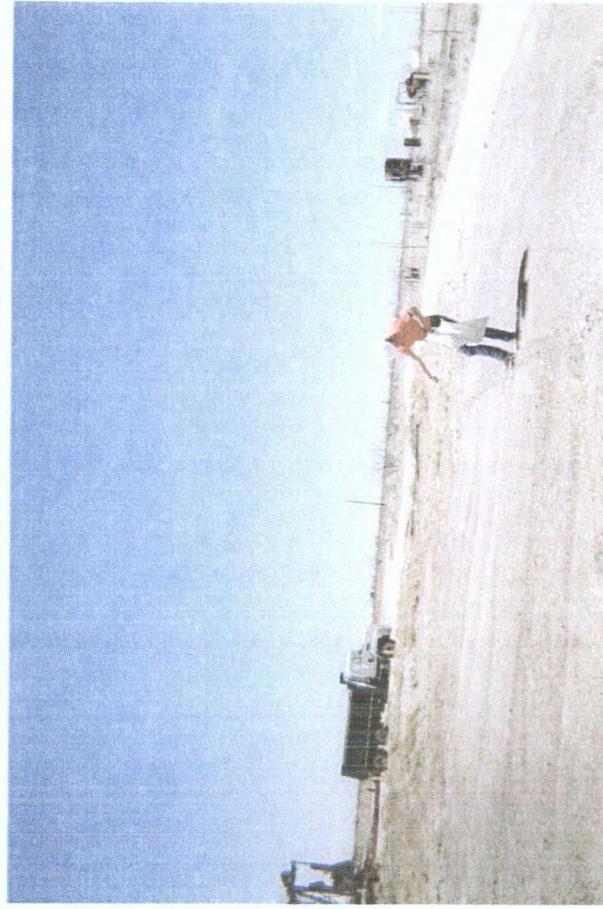
3/20/2008

seeding backfilled site, facing west

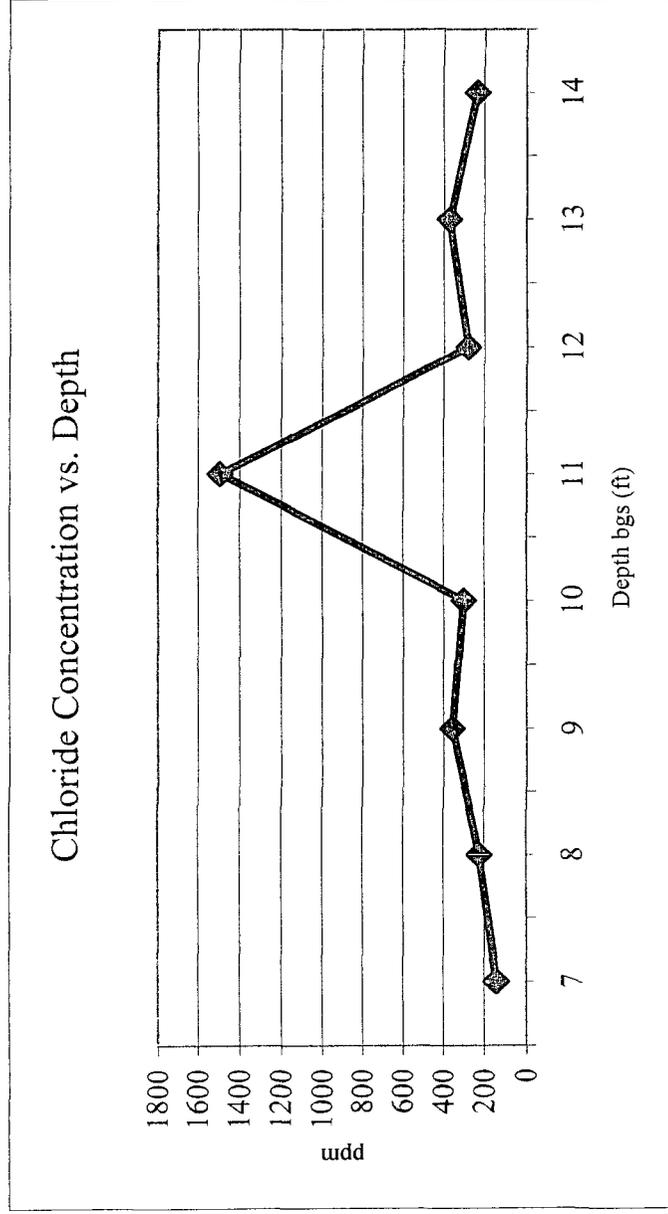
CHLORIDE CONCENTRATION CURVE

Backhoe samples at junction (source)

Depth bgs (ft)	[Cl] ppm
7	142
8	223
9	357
10	302
11	1496
12	280
13	370
14	233

Groundwater = 80 ft

LOCATION	DEPTH	mg/kg
background	6"	131
delineation trench at the former junction (source)	7'	142
	8'	223
	9'	357
	10'	302
	11'	1496
	12'	280
	13'	370
	14'	233
