# Vacuum G-28 Vent

# Vacuum G-28 vent

Unit G, Section 28, T17S, R35E

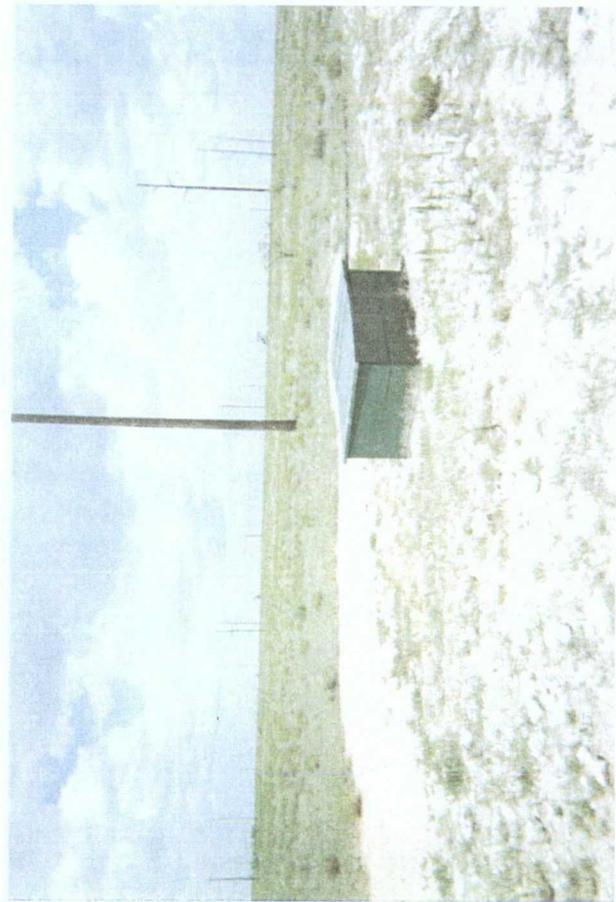
9/15/2005

undisturbed junction box, facing north

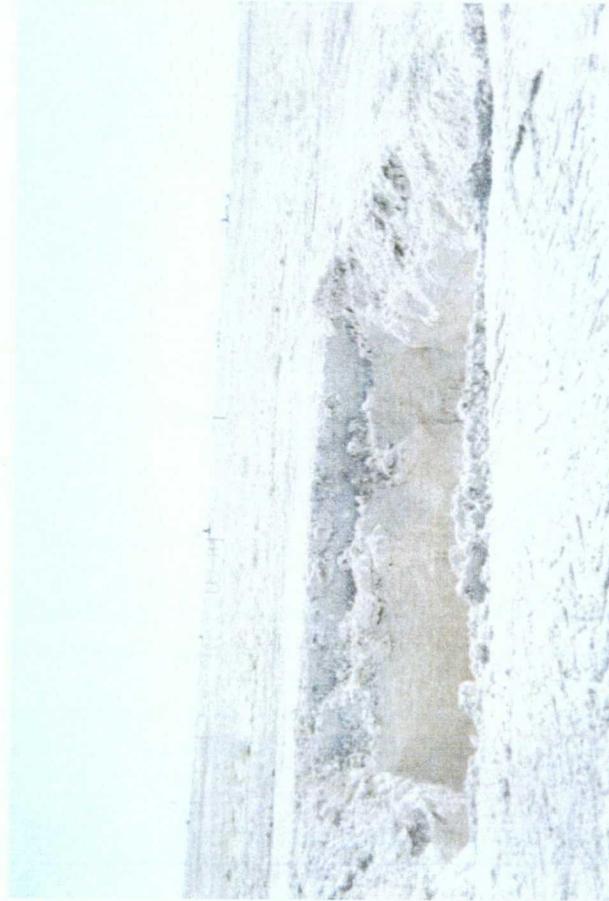
3/7/2008

20x20x12-ft deep excavation, facing south

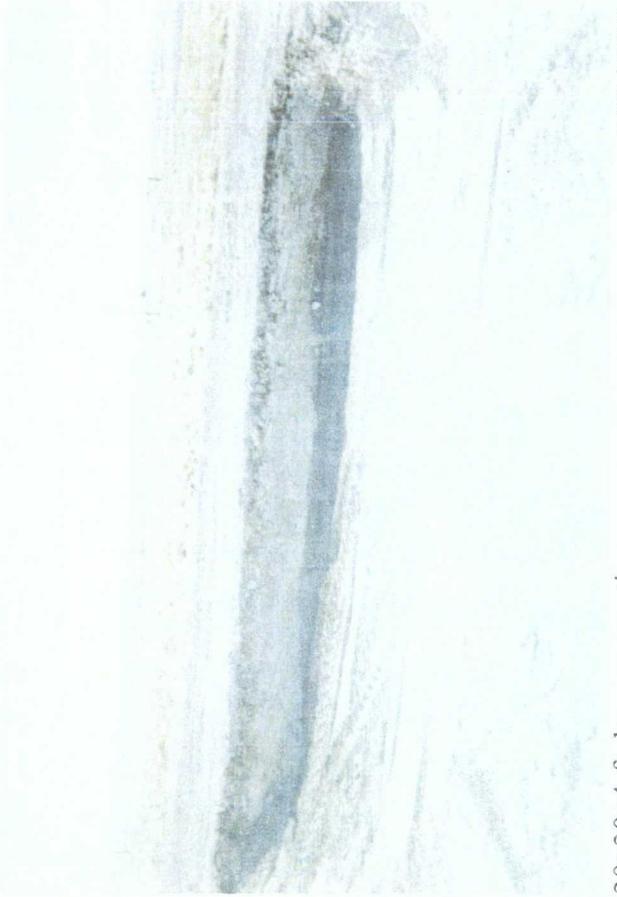
30x30x4-ft deep excavation prepared for geosynthetic liner, facing south 3/31/2008

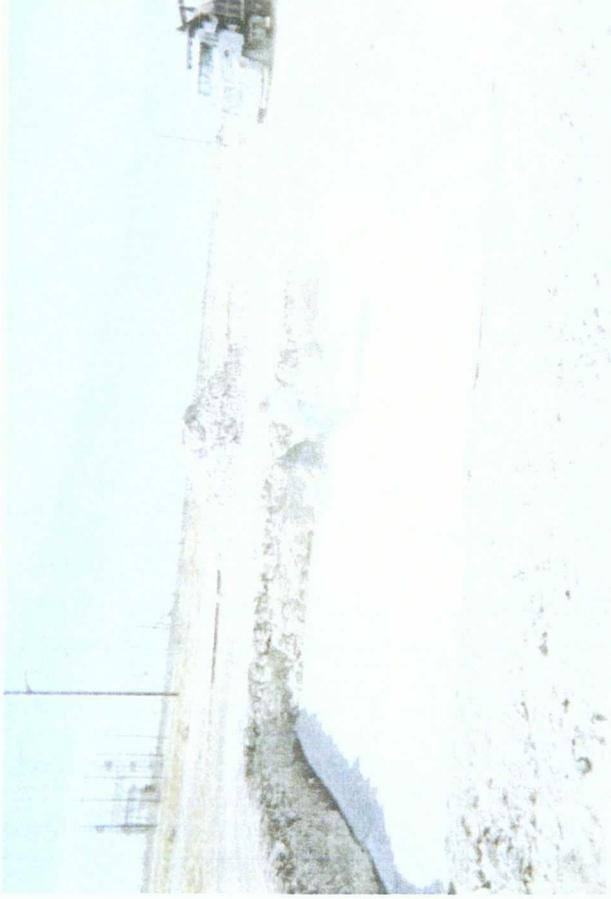
geosynthetic liner installed, facing west 3/31/2008

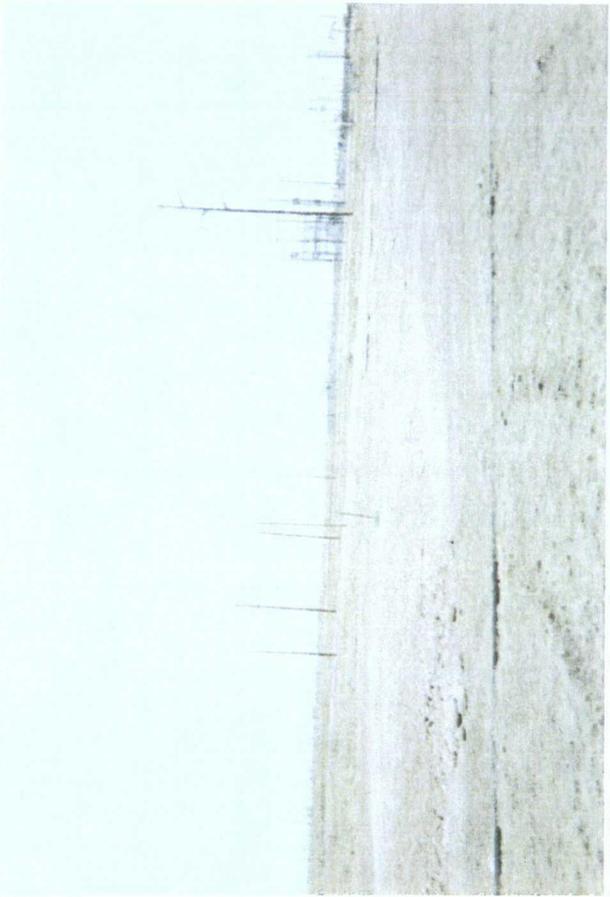
backfilled excavation, facing west 4/2/2008

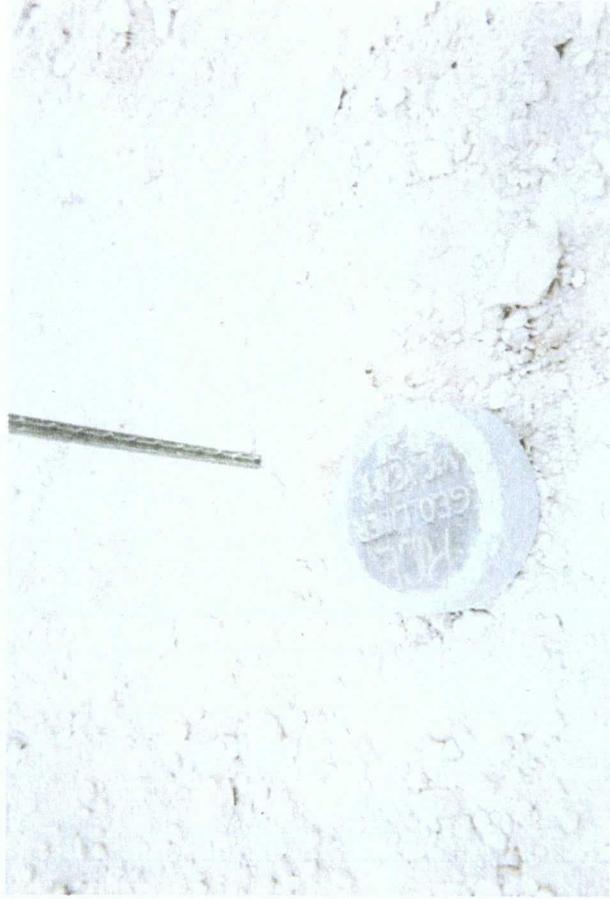
geosynthetic liner marker 4/2/2008

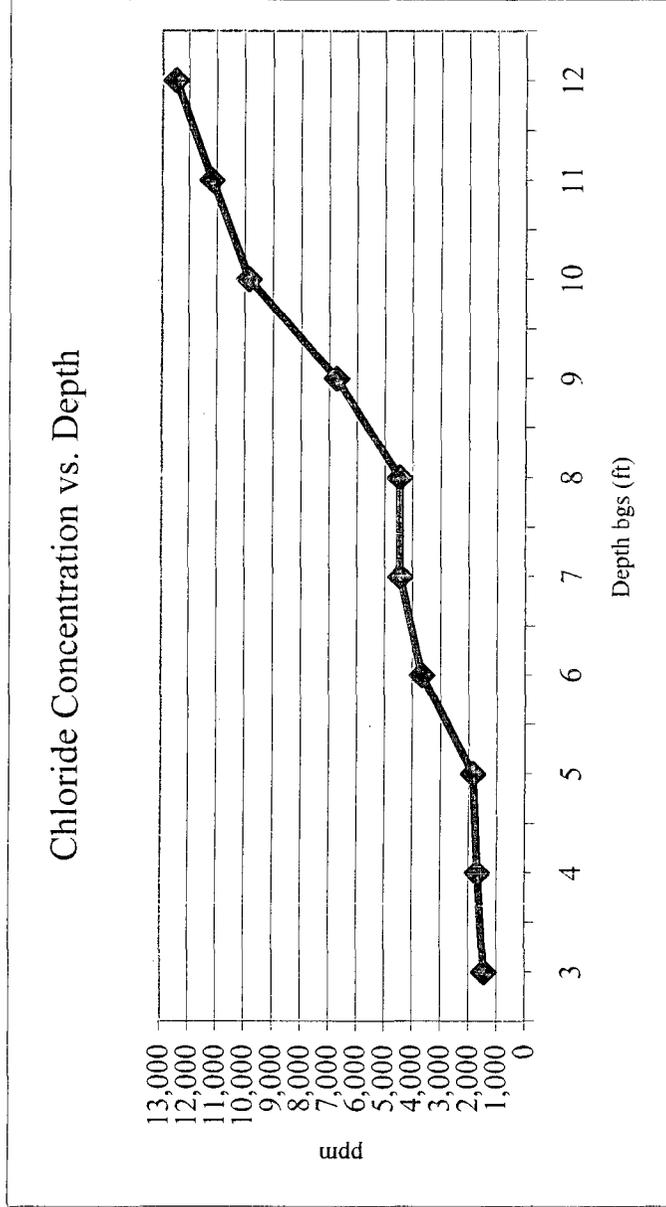
# CHLORIDE CONCENTRATION CURVE

Backhoe samples at 5 ft east of the junction (source)

Depth bgs (ft)	[Cl <sup>-</sup> ] ppm
3	1,448
4	1,678
5	1,836
6	3,652
7	4,449
8	4,467
9	6,734
10	9,852
11	11,176
12	12,472

Groundwater = 70 ft
