BD 'H' Corrigan EOL  
2008

RICE Operating Company

JUNCTION BOX FINAL REPORT

# BD 'H' Corrigan EOL

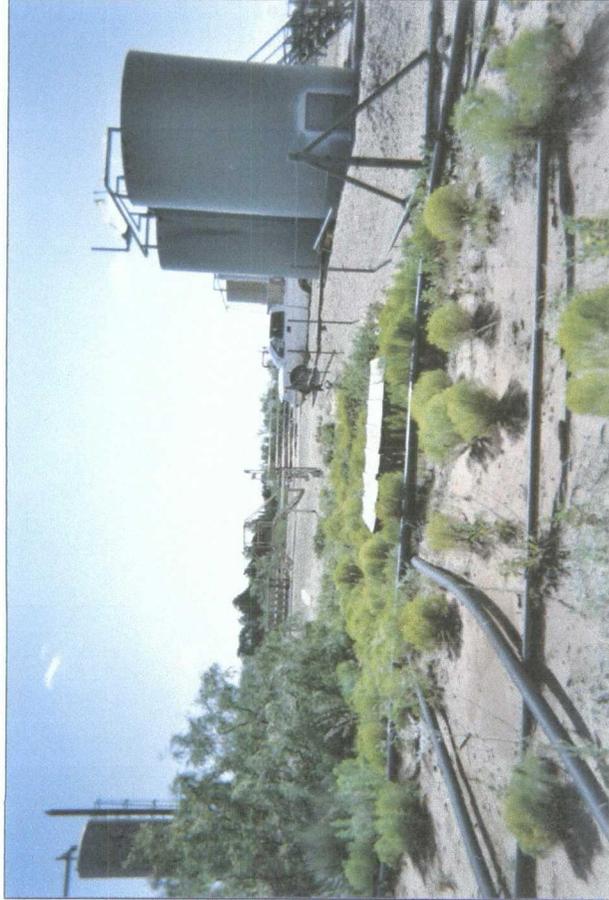
7/18/2007

undisturbed junction box

This junction was eliminated with the pipeline replacement/upgrade program. After the box was removed, a delineation trench was made using a backhoe to collect soil samples to 9 ft BGS. Chloride field tests were conducted on each sample and exhibited low concentrations that declined with depth, indicative of non-saturated historical vadose conditions. Organic vapors were also measured using a PID and yielded low concentrations as well. The deepest sample (9 ft) was collected for laboratory analysis which confirmed field results. NMOCD TPH guideline concentrations were met as they were not present within the lab's detection limit. The excavated soil from the trench was returned to the hole. Additional clean soil was imported and used to fill the remainder of the excavation. The disturbed surface was seeded with a blend of native vegetation on 7/31/2007 and is expected to return to productive capacity at a normal rate.

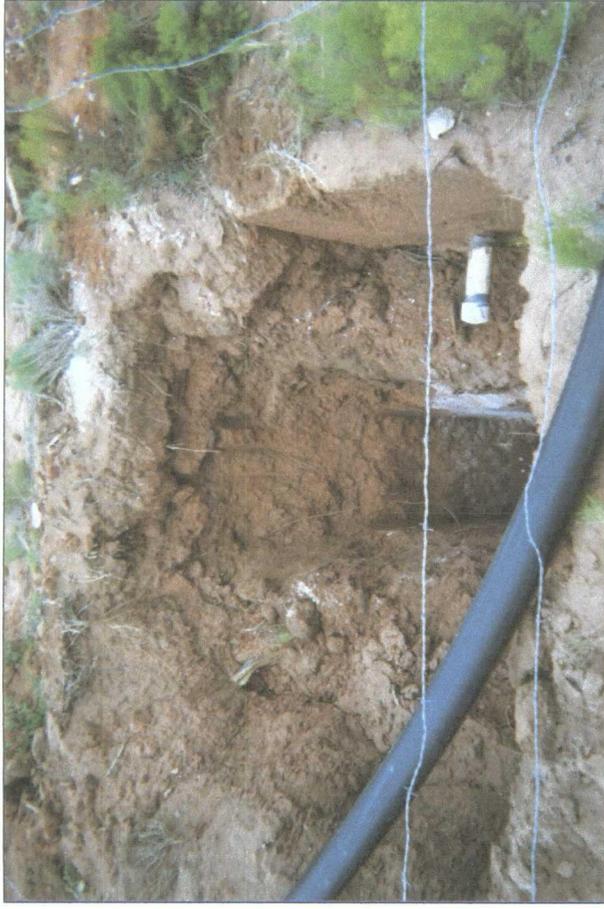
7/30/2007

delineation trench at formed junction site

LOCATION	DEPTH (ft)	ppm
delineation trench at former junction site	5	450
	6	335
	7	315
	8	290
	9	149

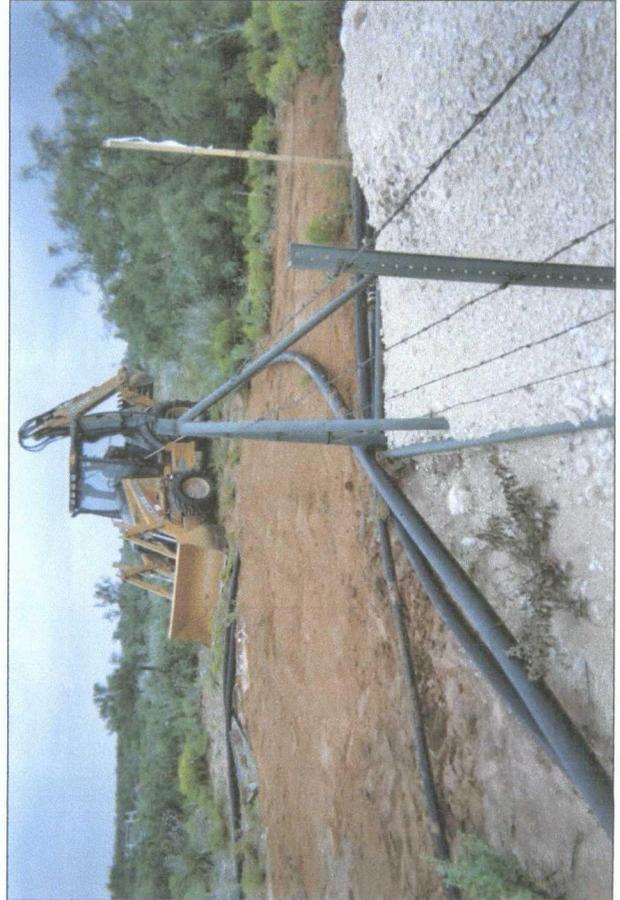
7/31/2007

spreading clean, imported topsoil on site

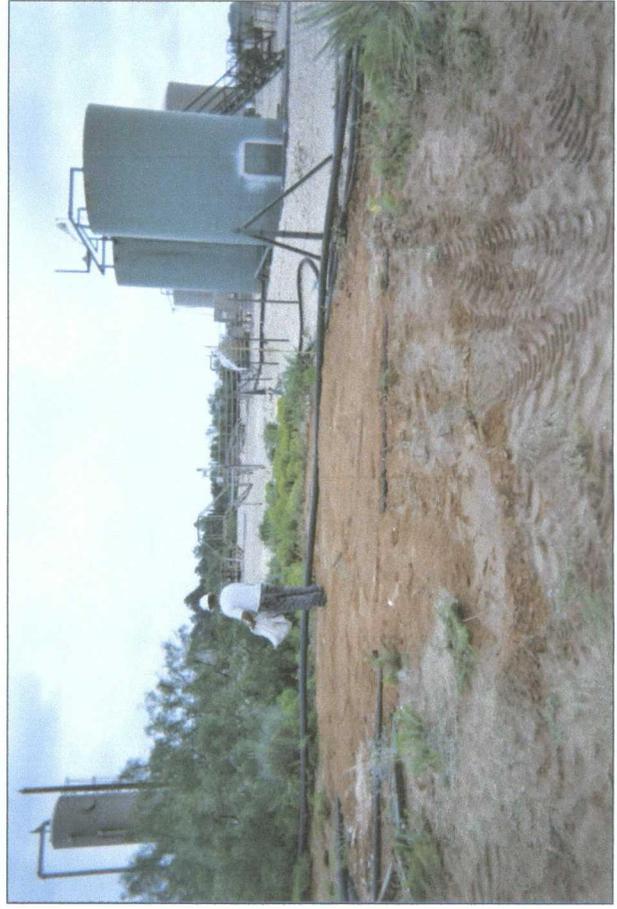
7/31/2007

seeding backfilled site

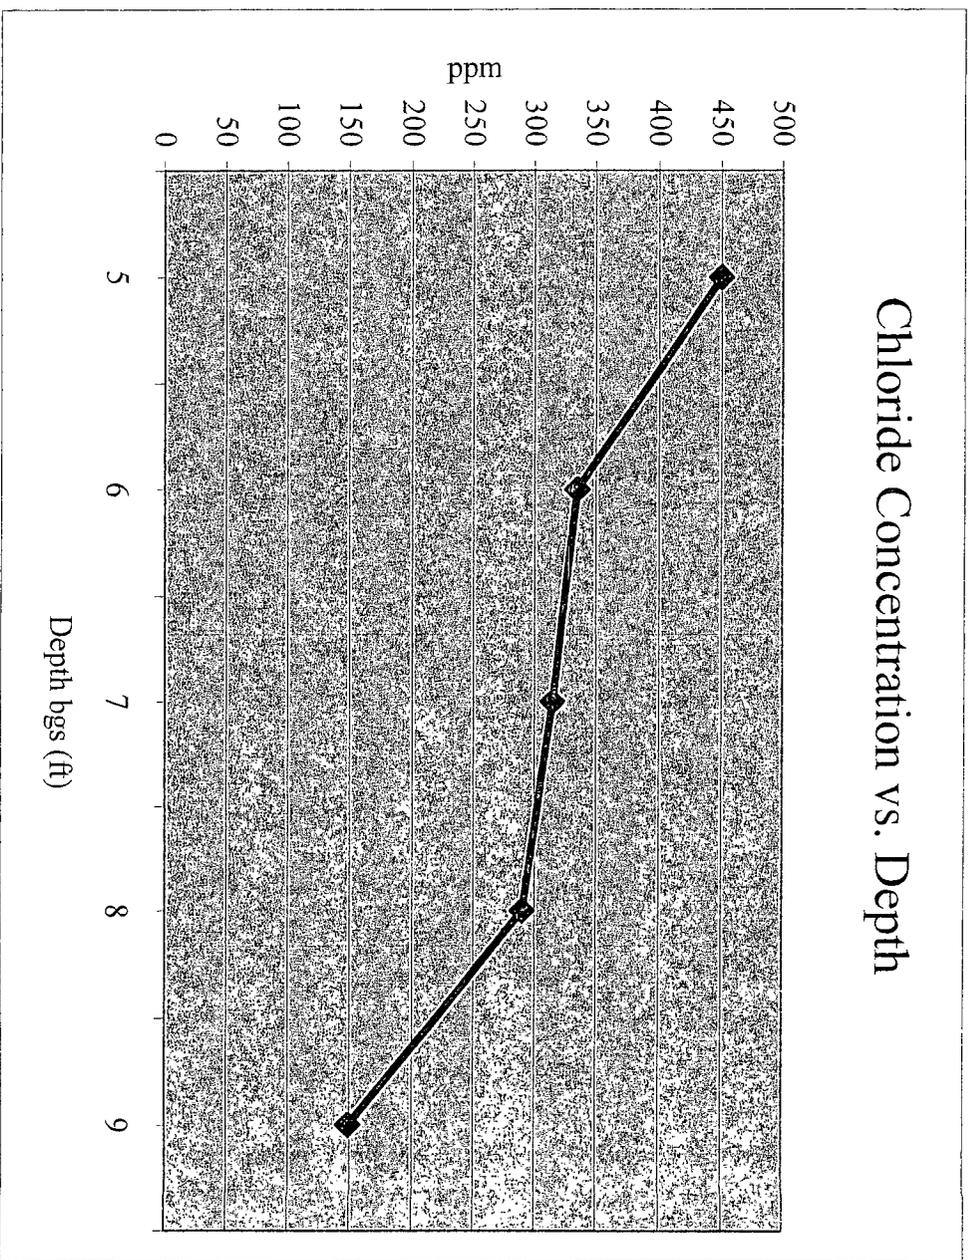
Backhoe samples at junction (source)

Depth bgs (ft)	Cl <sup>-</sup> ppm
5	450
6	335
7	315
8	290
9	149

Groundwater = 95 ft
