BD Mayne & Mertz EOL

CLOSURE

**RICE OPERATING COMPANY
JUNCTION BOX FINAL REPORT**

Unit G, Section 23, T21S, R37E

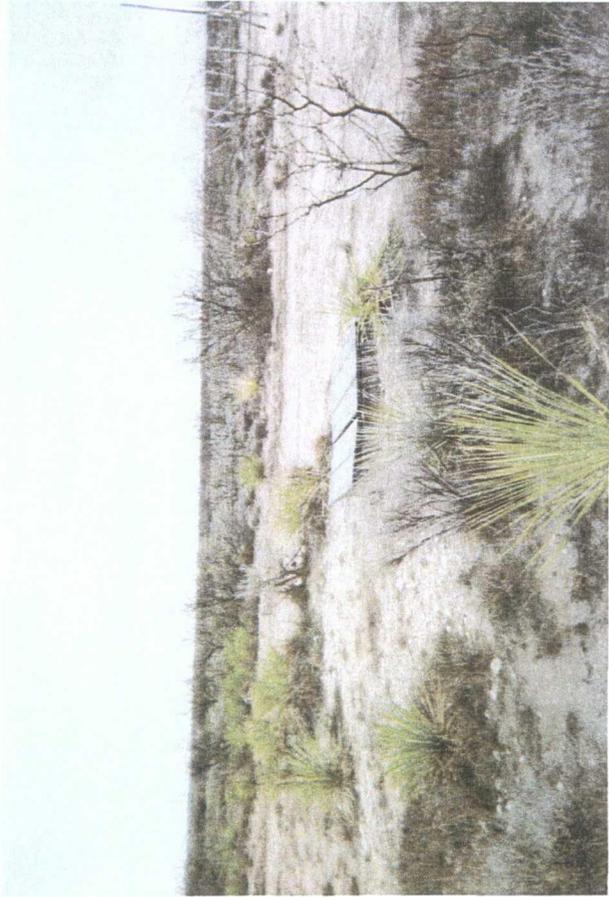
2/24/2004

undisturbed junction box

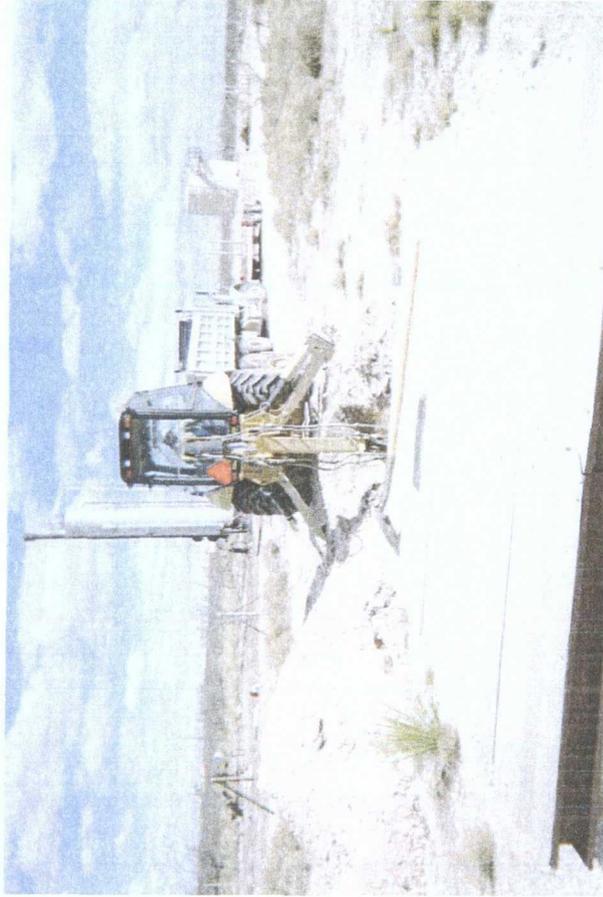
2/05/2008

source being excavated

General Description of Remedial Action: This junction box site was addressed under the pipeline replacement/upgrade program. A new, water-tight junction box was built 15 feet west. A backhoe was used to collect soil samples at regular intervals producing a 5x3x10-ft-deep hole. Chloride field tests revealed low concentrations throughout. Organic vapors were measured using a PID, which also revealed low concentrations. Commercial laboratory analyses confirmed that the samples were low in chloride and organics. The site was then backfilled using blended soil. On 2/5/2008 the site was seeded with a blend of native vegetation and is expected to return to productive capacity at a normal rate.

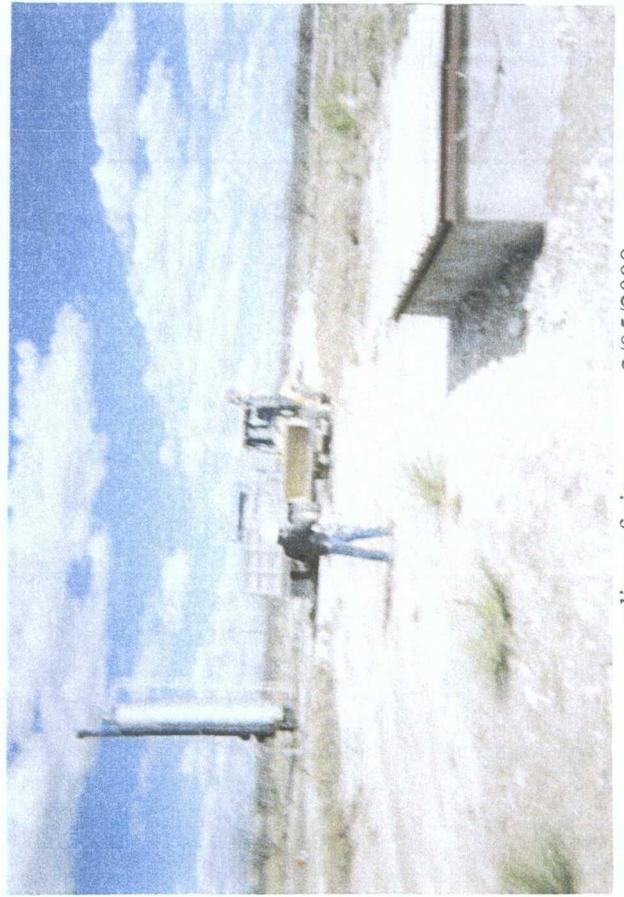
2/05/2008

seeding of site

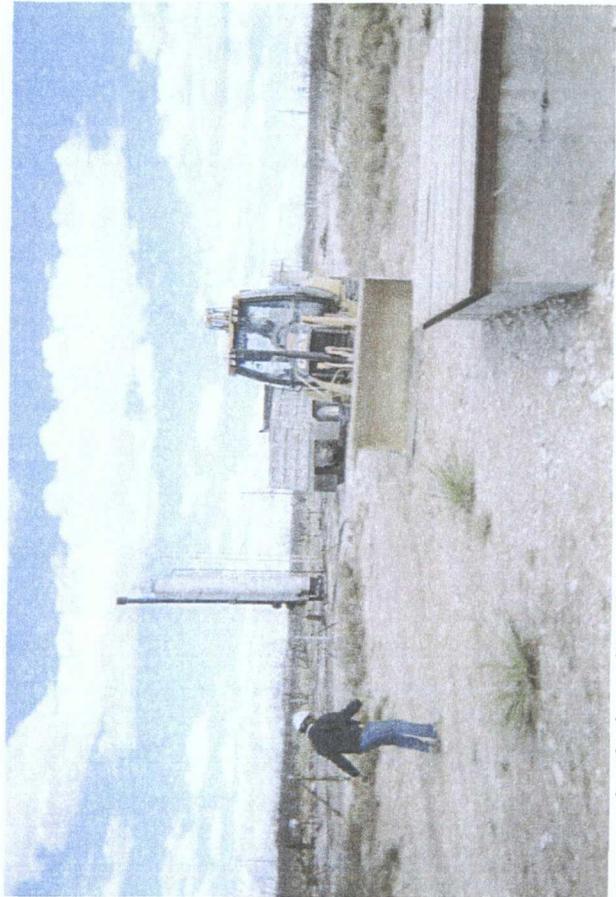
2/05/2008

back dragging site

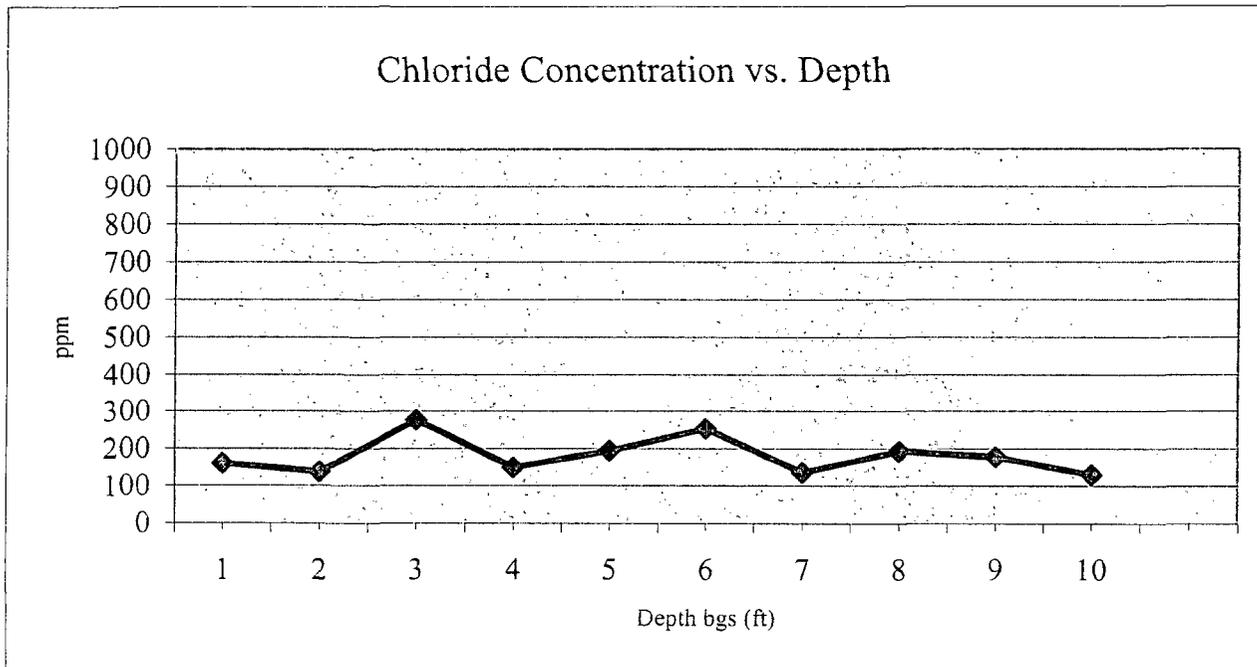
Backhoe samples at junction (source)

Depth bgs (ft)	[Cl ⁻] ppm
1	160
2	137
3	276
4	149
5	194
6	253
7	136
8	192
9	177
10	130
