BD I-32 VENT

**RICE OPERATING COMPANY
JUNCTION BOX FINAL REPORT**

BD Jct. I-32 vent

Unit I, Section 32, T21S, R37E

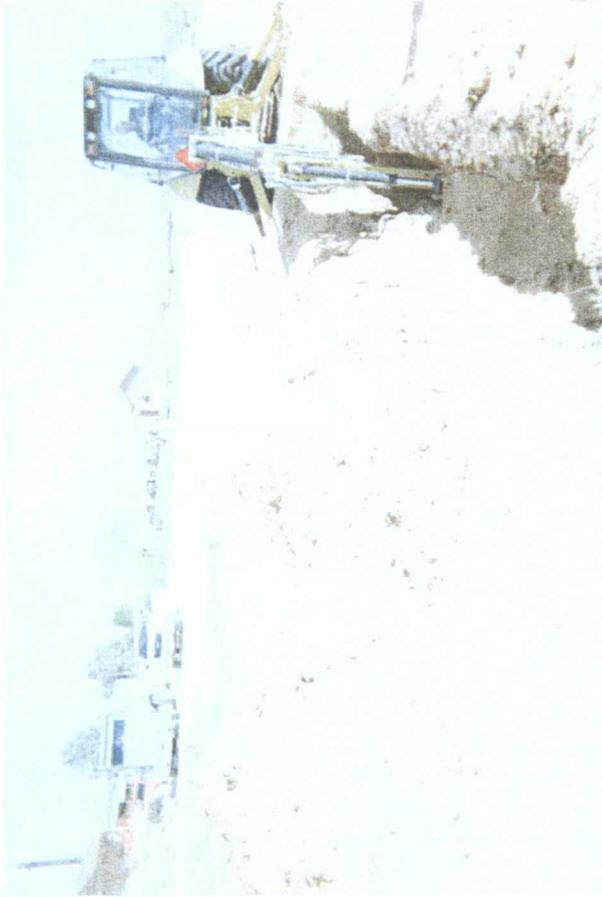
2/25/2008

former junction box site being excavated, facing east

General Description of Remedial Action: This box was eliminated as part of the pipeline replacement/upgrade program. After the box was removed an investigation was conducted using a backhoe to collect soil samples at regular intervals producing a 5x3x9-ft-deep hole. A chloride field test performed on each sample yielded low concentrations similar to that of the background levels. Organic vapors were measured using a PID, which also yielded low concentrations. Commercial laboratory analyses performed on the backfill and the deepest sample from the source (9' bgs) confirmed that the soil was low in chloride and organics. The site was then backfilled and contoured to the surrounding area. On 02/26/2008, the site was seeded with a blend of native vegetation and is expected to return to a productive capacity at a normal rate.

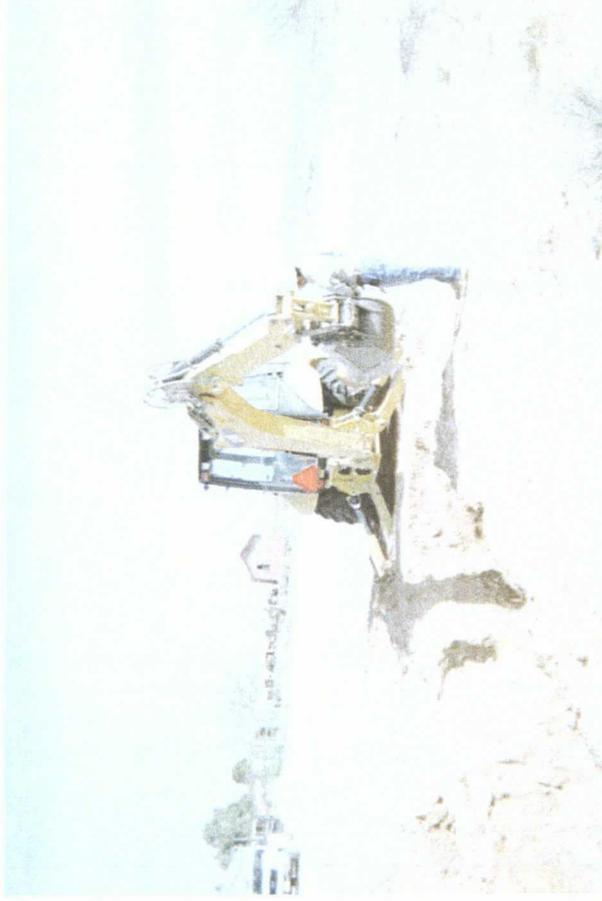
2/25/2008

sampling at 9' bgs, facing east

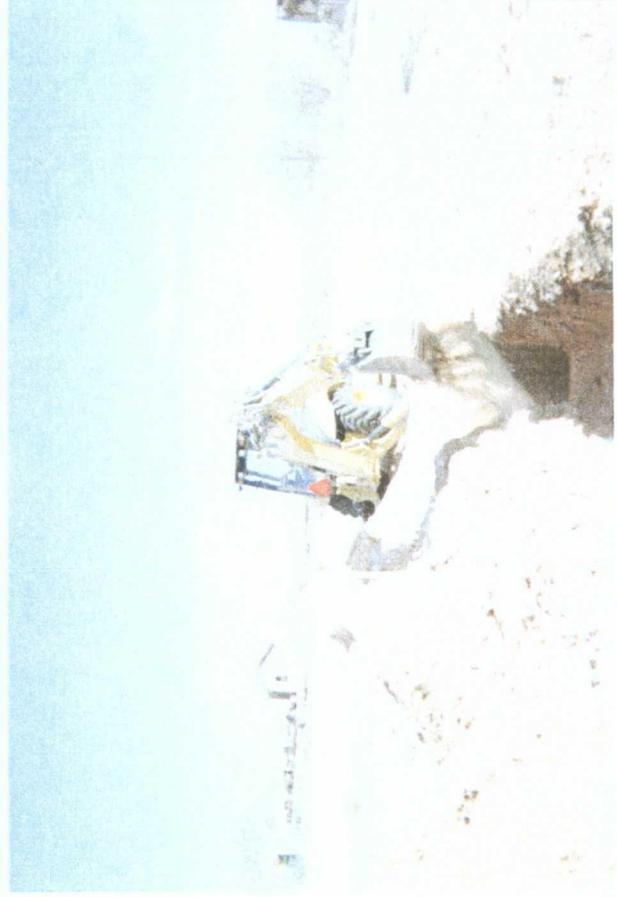
2/25/2008

back filling excavation site, facing east

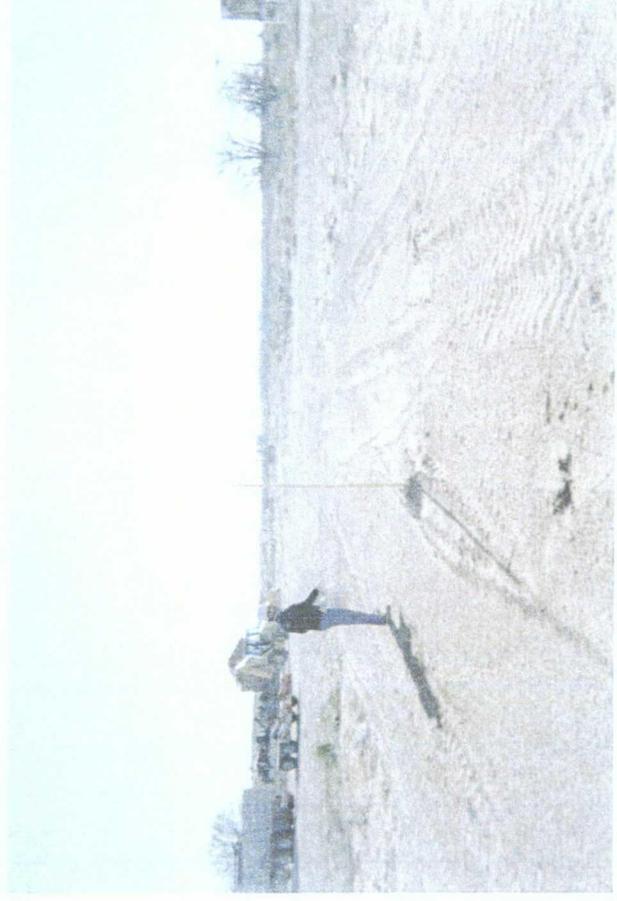
2/26/2008

seeding backfilled site, facing east

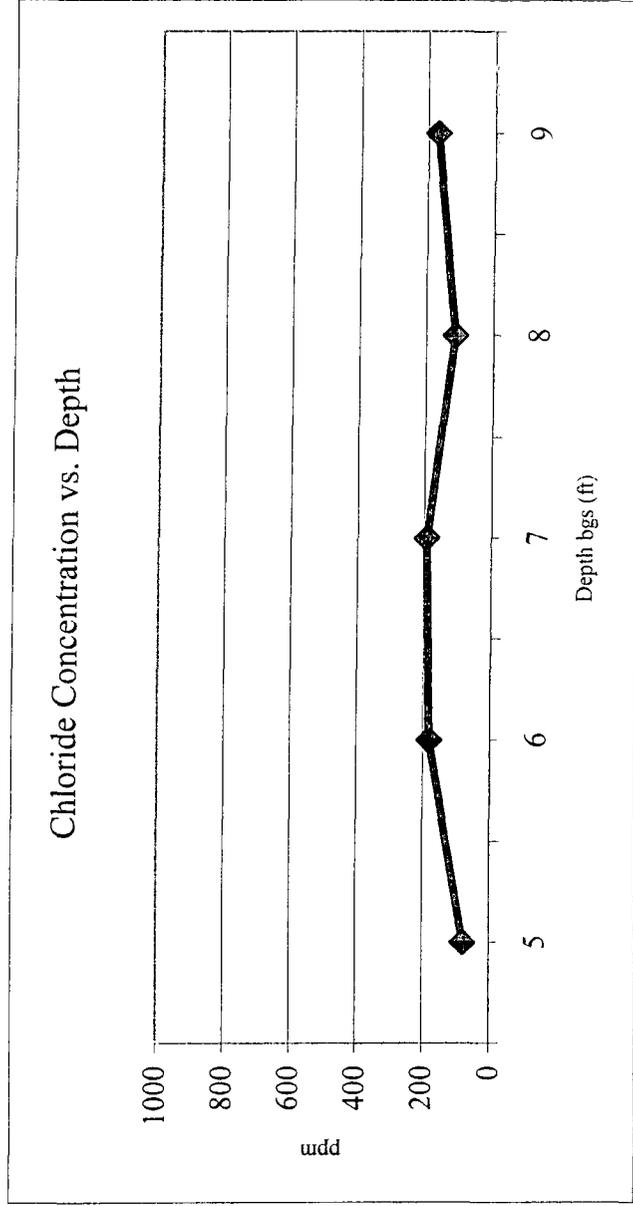
CHLORIDE CONCENTRATION CURVE

Backhoe samples at junction (source)

Depth bgs (ft)	[Cl ⁻] ppm
5	78
6	181
7	193
8	113
9	171

Groundwater = 100 ft

LOCATION	DEPTH	mg/kg
background	1'	114
vertical delineation trench at the junction	5'	78
	6'	181
	7'	193
	8'	113
9'	171	
backfill comp.	n/a	79
