CLOSURE

**RICE OPERATING COMPANY
JUNCTION BOX FINAL REPORT**

BD Jct. K-7-5

Unit K, Section 7, T22S, R37E

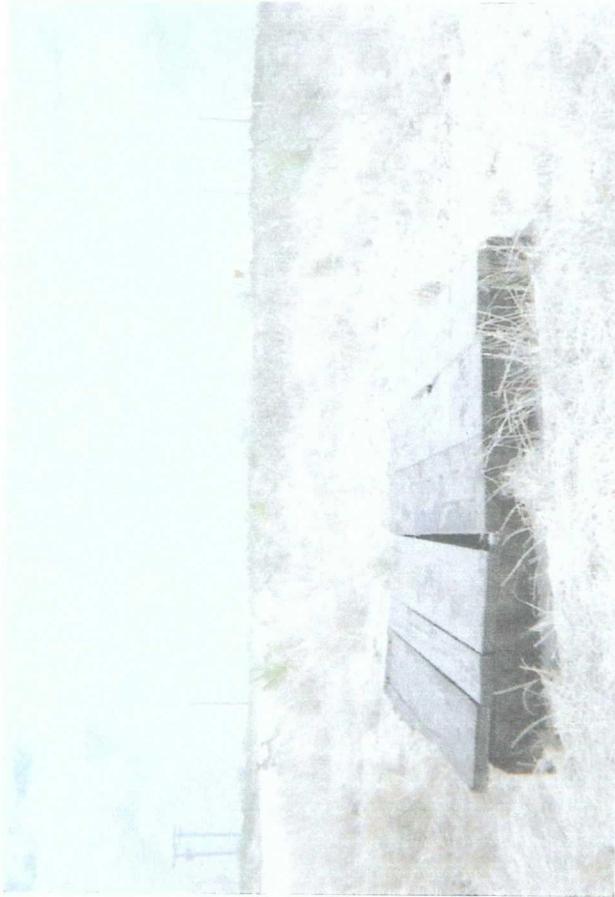
undisturbed junction box

6/25/2008

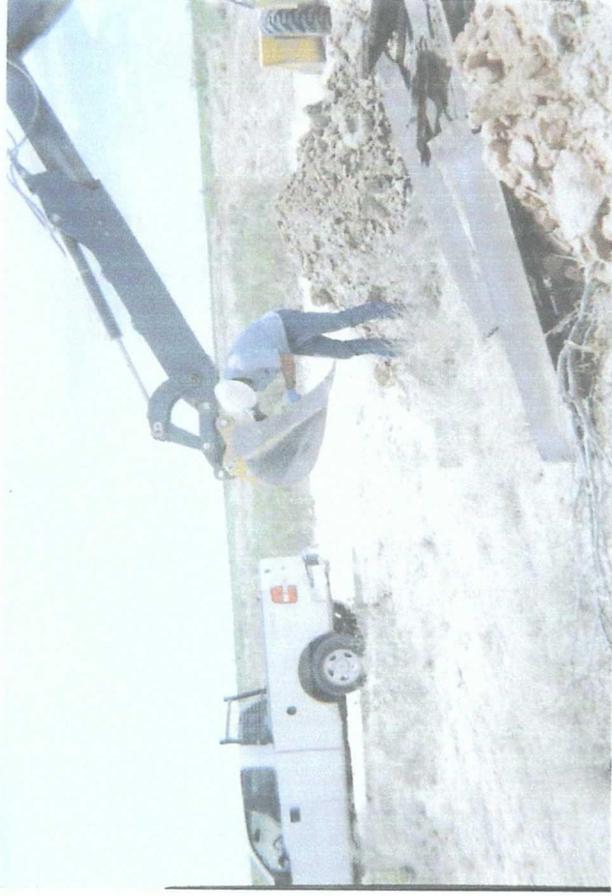
taking a sample

6/30/2008

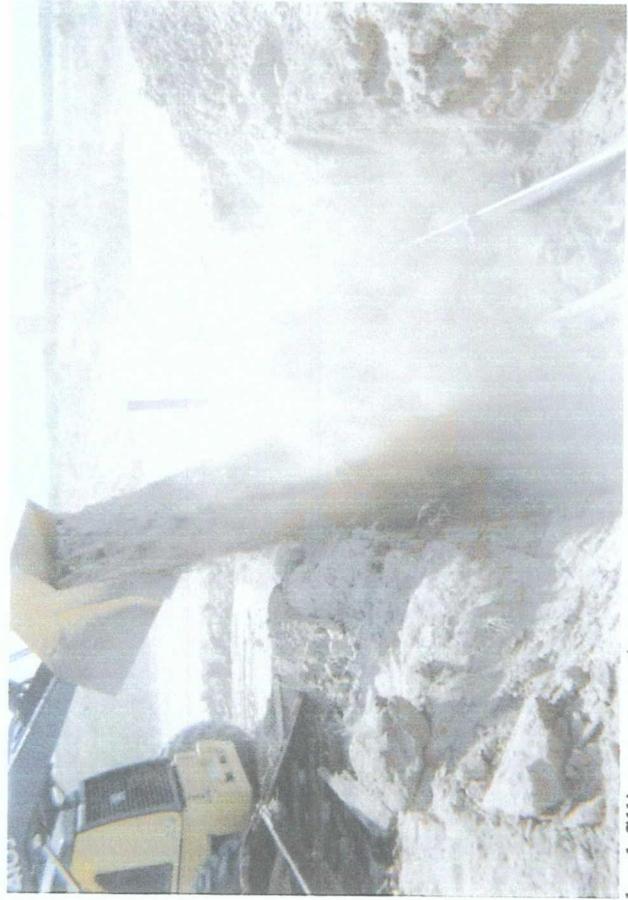
backfilling excavation

6/30/2008

General Description of Remedial Action: This junction was eliminated during the pipeline replacement/upgrade program. After the former box was removed, an investigation was conducted using a backhoe to collect soil samples at regular intervals producing a 5x3x12-ft-deep hole. Chloride field tests were performed on each sample, which yielded low concentrations similar to that of the background. Organic vapors were measured using a PID, which also yielded low concentrations. The deepest sample, 12 ft BGS, was sent to a commercial laboratory for analysis, which confirmed low concentrations of chloride and organics. The excavated soil was blended on-site and returned to the excavation to ground surface and contoured to the surrounding area. On 7/11/2008, the site was seeded with a blend of native vegetation and is expected to return to a productive capacity at a normal rate.

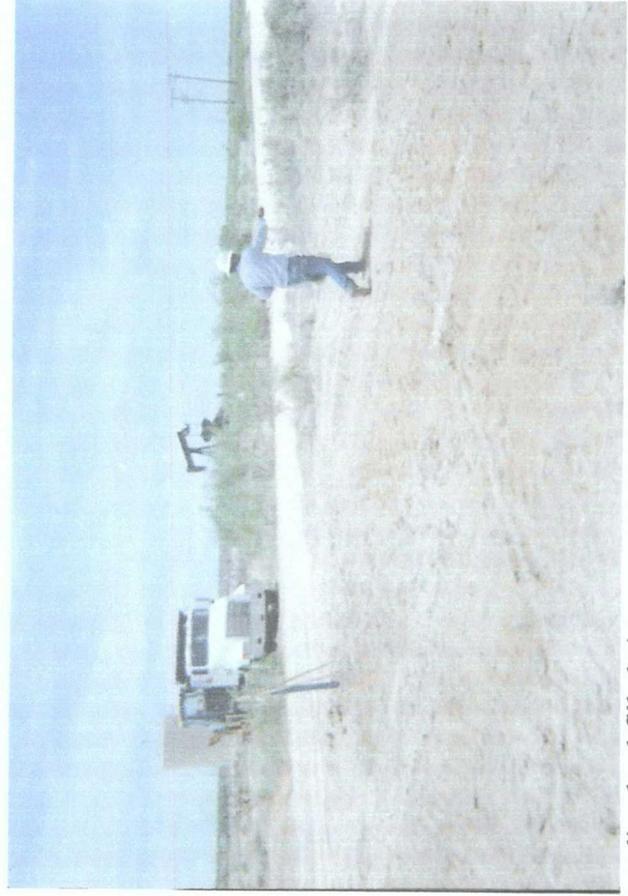
seeding backfilled site

7/11/2008

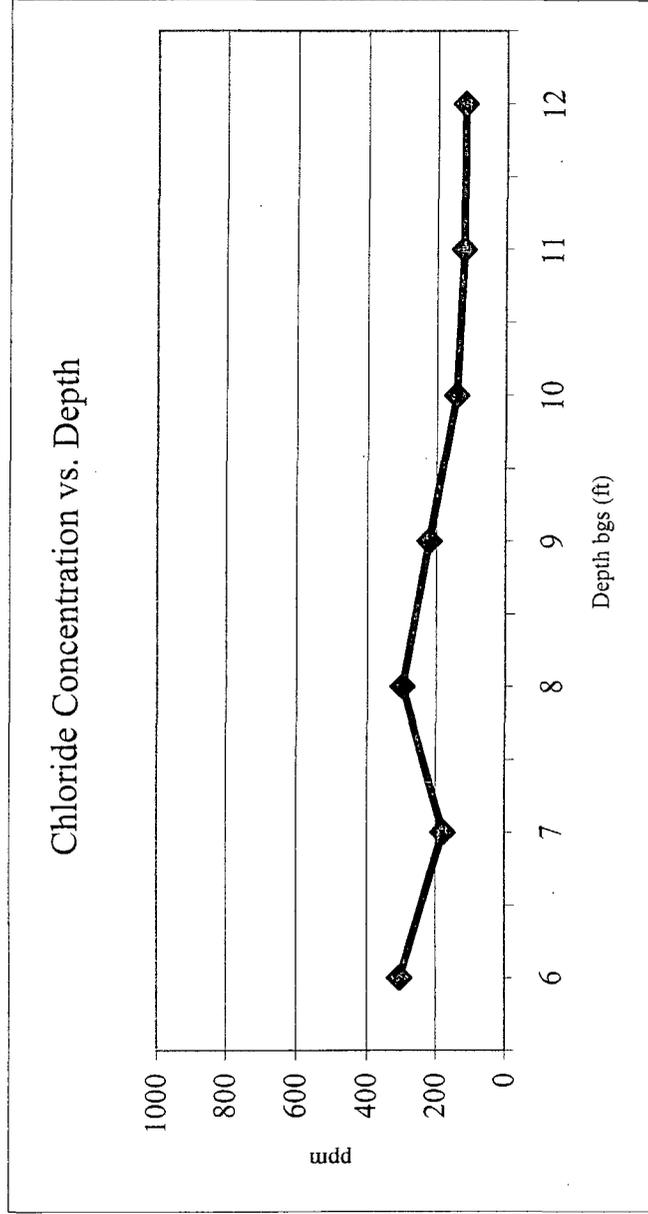
CHLORIDE CONCENTRATION CURVE

Backhoe samples at junction (source)

Depth bgs (ft)	[Cl] ppm
6	305
7	179
8	299
9	221
10	143
11	122
12	120

Groundwater = 126 ft

LOCATION	DEPTH	mg/kg
background	1'	137
vertical delineation trench at the junction (source)	6'	305
	7'	179
	8'	299
	9'	221
	10'	143
	11'	122
	12'	120
