BD Vent M-31

**RICE OPERATING COMPANY
JUNCTION BOX FINAL REPORT**

Unit M, Section 31, T21S, R37E

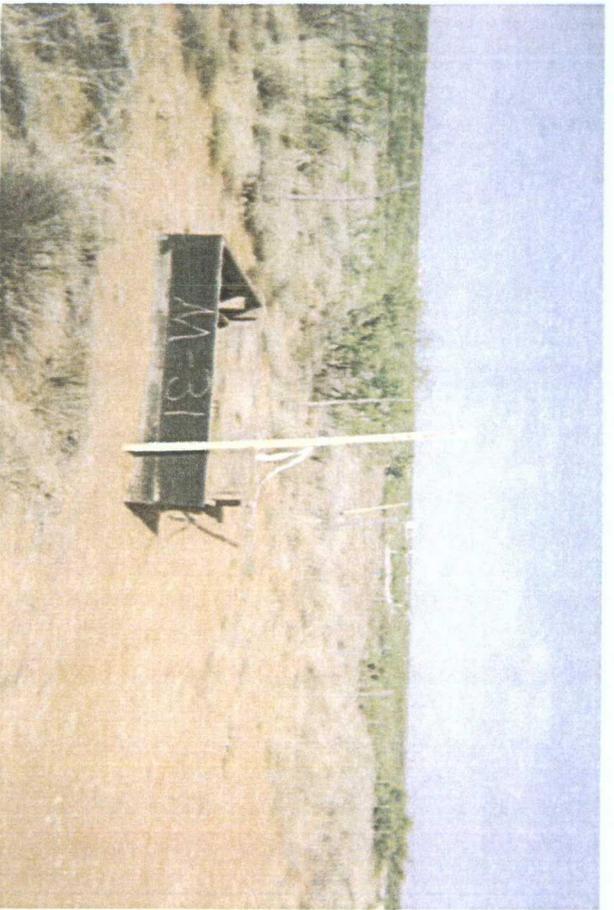
6/25/2008

former junction box, facing west

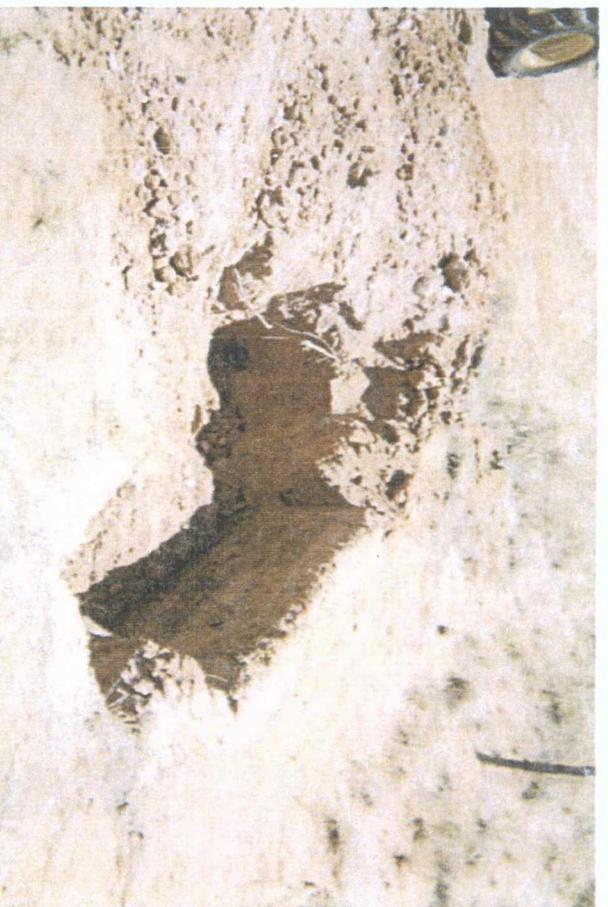
6/25/2008

delineation trench at former junction site

General Description of Remedial Action: This junction was eliminated during the pipeline replacement/upgrade program. After the former junction box was removed, an investigation was conducted using a backhoe to collect soil samples at regular intervals producing a 5x3x13-ft-deep excavation. Field tests were performed on each sample to determine chloride and organic vapor concentrations. Field data suggest the site is low in both chloride and organic vapors with levels similar to that of the background. The deepest sample, 13 ft BGS, was sent to a commercial laboratory for analysis of chloride and TPH, which confirmed low concentrations. The excavated soil was returned to the excavation and clean soil was imported and used as a top cap and to contour the site to the surrounding area. On 7/9/2008, the site was seeded with a blend of native vegetation and is expected to return to a productive capacity at a normal rate.

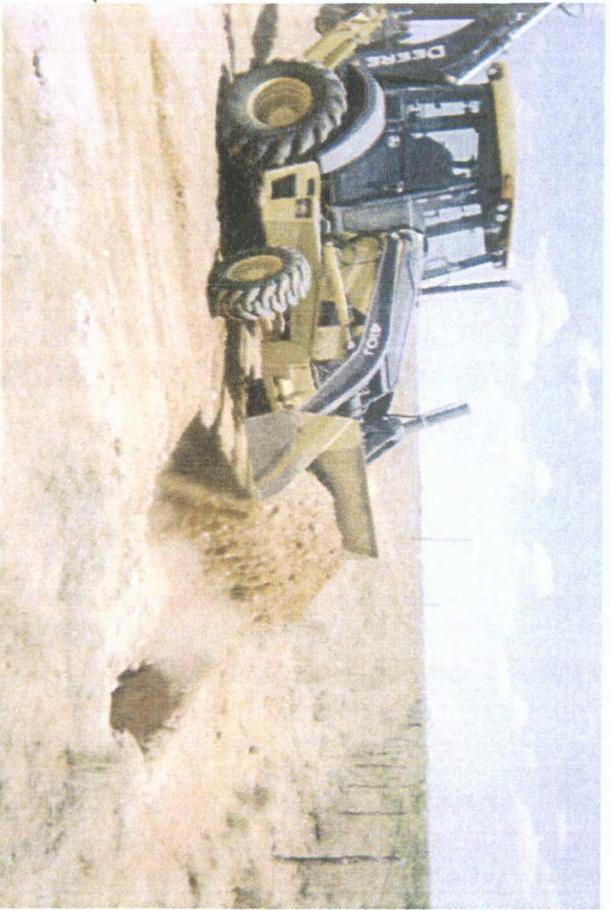
6/25/2008

backfilling excavation

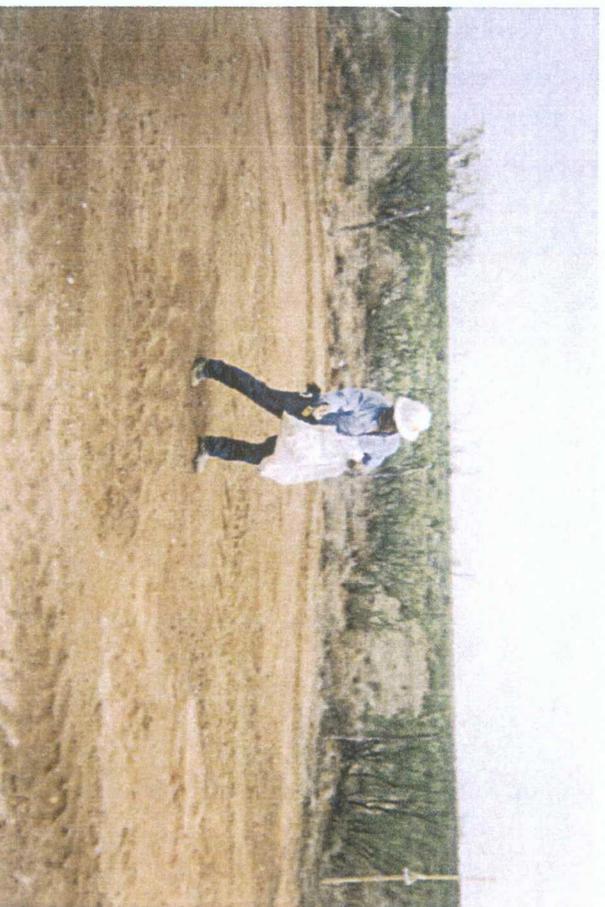
7/9/2008

seeding backfilled site

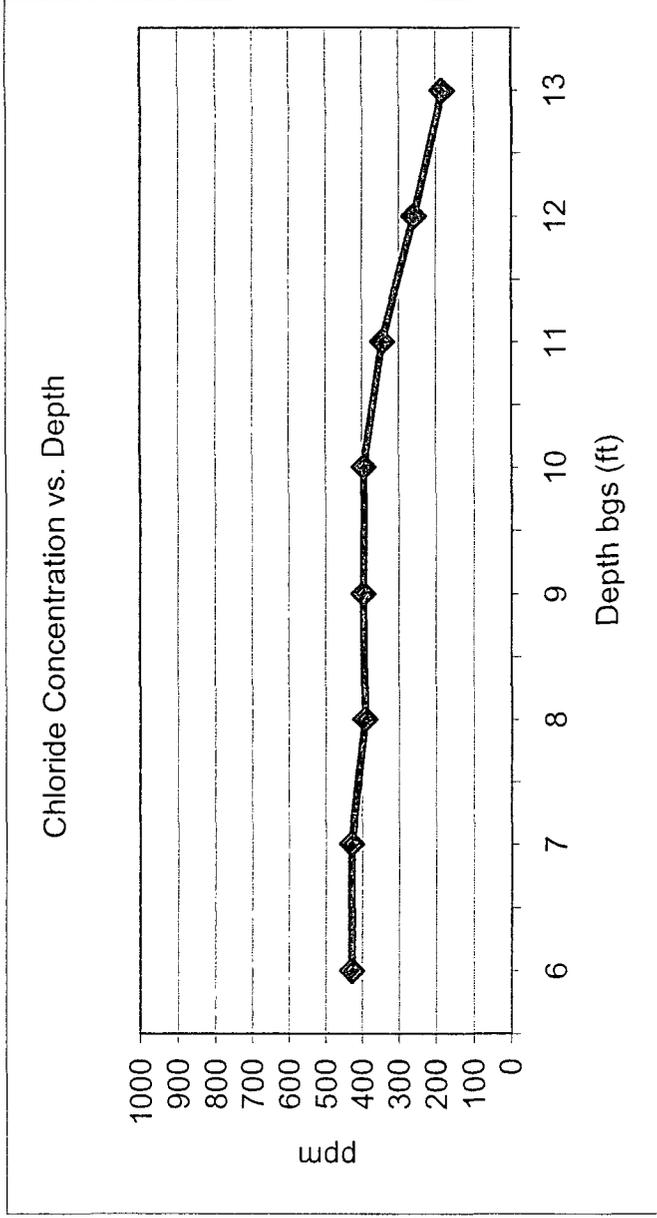
CHLORIDE CONCENTRATION CURVE

Backhoe samples at junction (source)

Depth bgs (ft)	Cl ⁻ ppm
6	428
7	430
8	392
9	396
10	395
11	345
12	260
13	183

Groundwater = 105 ft

LOCATION	DEPTH	mg/kg
background	6"	90
vertical delineation trench at the junction (source)	6'	428
	7'	430
	8'	392
	9'	396
	10'	395
	11'	345
	12'	260
	13'	183
