BD Apache State D 'A' EOL

**RICE OPERATING COMPANY
JUNCTION BOX FINAL REPORT**

Unit L, Section 16, T21S, R37E

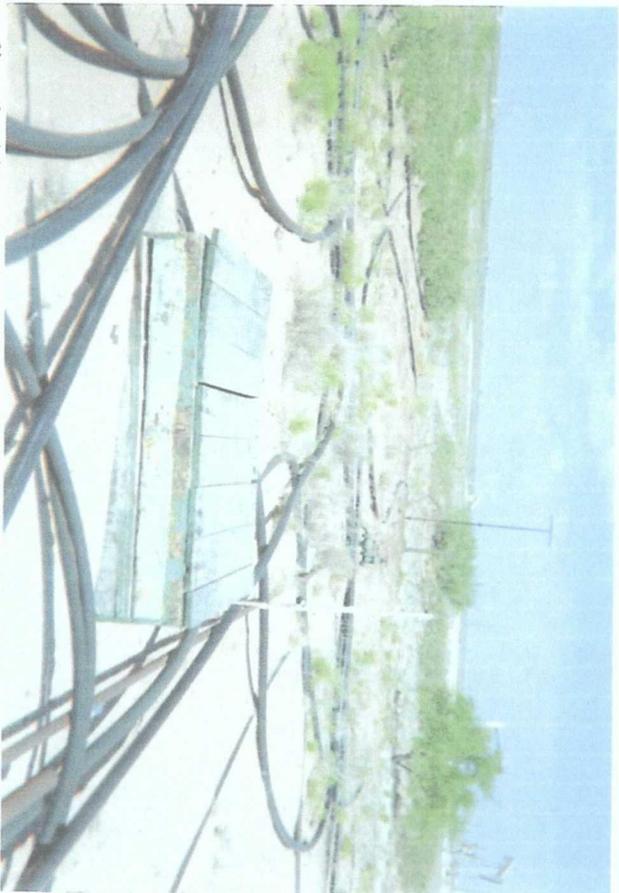
6/17/2008

undisturbed junction box, facing west

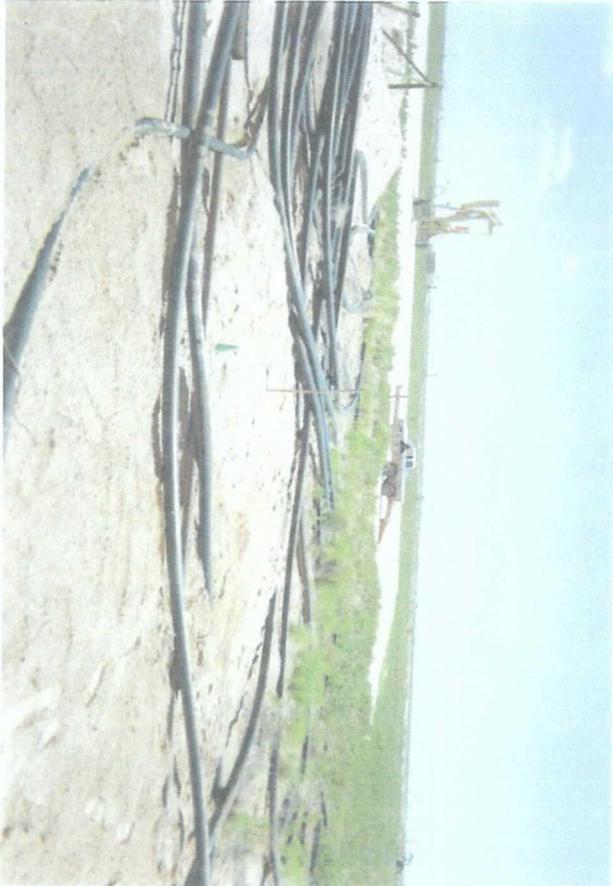
6/26/2008

backfilled excavation, facing south

General Description of Remedial Action: This junction was eliminated during the pipeline replacement/upgrade program. After the old box was removed, an investigation was conducted using a backhoe to collect soil samples at regular intervals producing a 5x3x9-ft-deep excavation. Chloride field tests were performed on each sample, which yielded low concentrations similar to that of the background levels. Organic vapors were measured using a PID, which also yielded low concentrations. The deepest sample was sent to a commercial laboratory for analysis, confirming low concentrations of chloride and TPH. The excavated soil was returned to the excavation and clean, imported blow sand was used as a top cap and to contour to the surrounding area. On 6/26/2008, the site was seeded with a blend of native vegetation and is expected to return to a productive capacity at a normal rate.

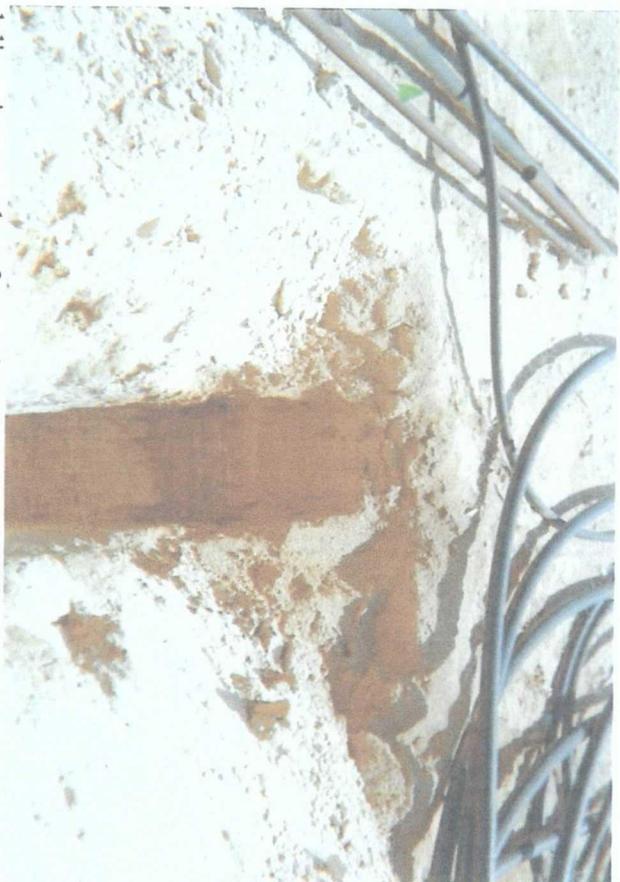
6/26/2008

delineation trench at former junction site, facing east

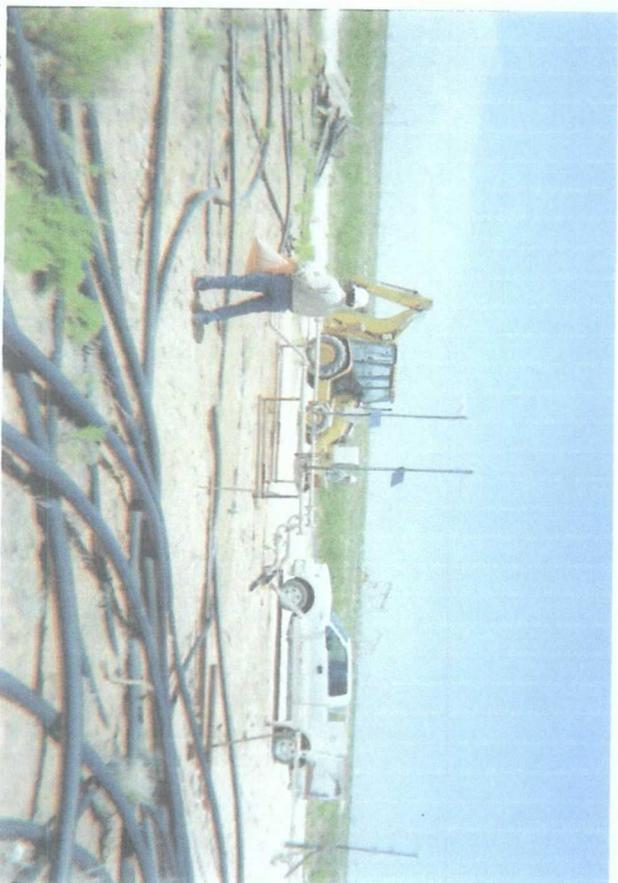
6/26/2008

seeding backfilled site, facing north

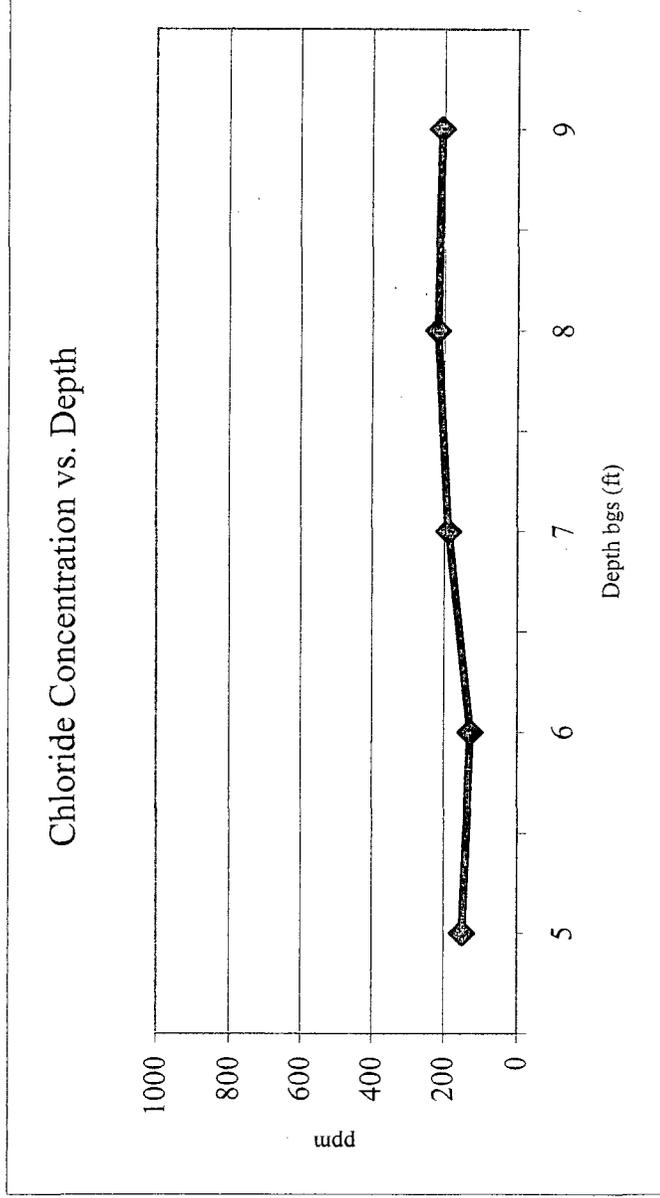
CHLORIDE CONCENTRATION CURVE

Backhoe samples at junction (source)

Depth bgs (ft)	[Cl ⁻] ppm
5	149
6	128
7	188
8	218
9	207

Groundwater = 72 ft

LOCATION	DEPTH	mg/kg
background	6"	89
vertical delineation trench at the junction (source)	5'	149
	6'	128
	7'	188
	8'	218
	9'	207
