**BD Jct B-30-2**  
(2 boxes)

**CLOSURE**

**RICE OPERATING COMPANY  
JUNCTION BOX FINAL REPORT**

Unit B, Section 30, T21S, R37E

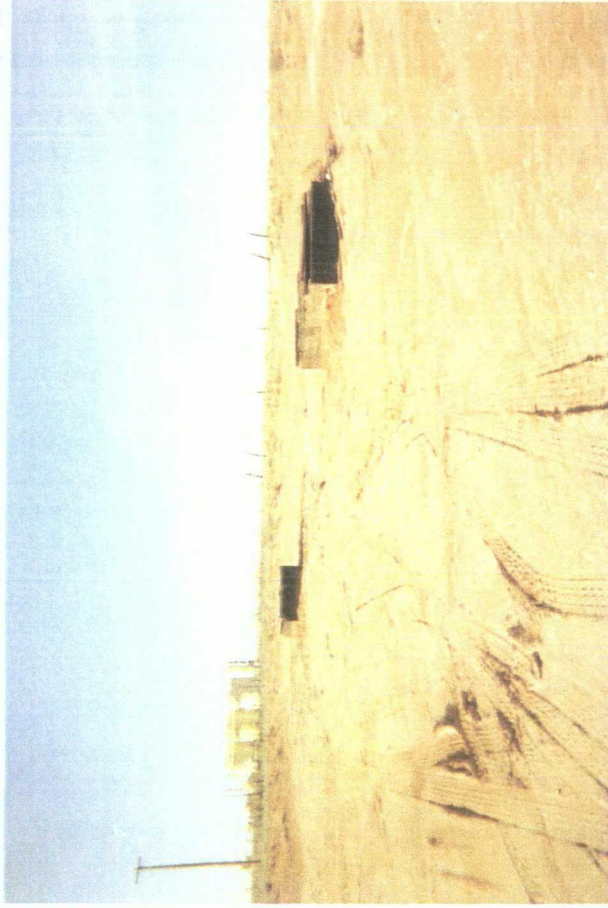
2/26/2004

undisturbed junction box

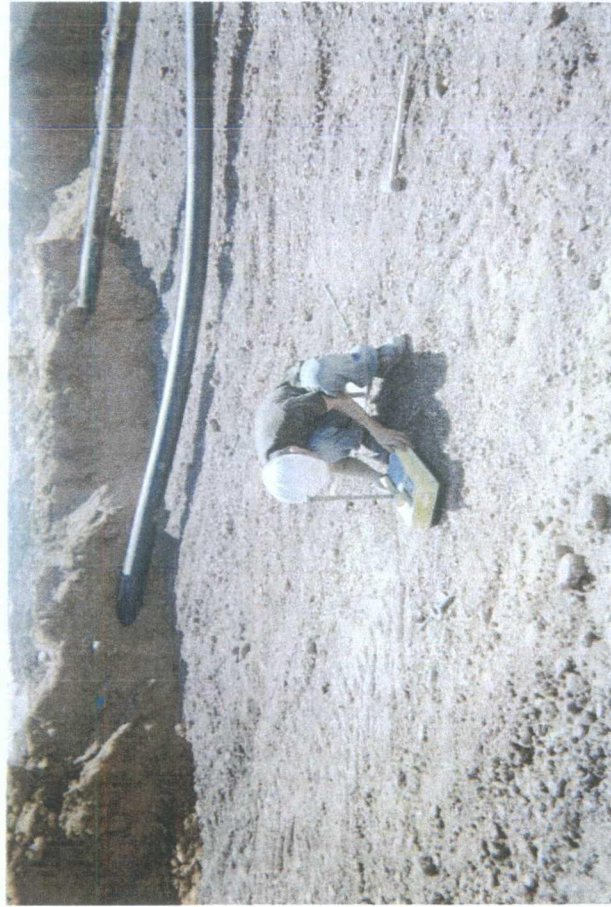
3/17/2008

clay compaction test

| Test No. | Location | Dry Density | | Depth |
|---|---|---|---|---|
| SG 1 | 15' E. & 15' S. of NW Corner of Pad | 94.2 | 16.1 | 5' Below Surface |
| SG 2 | 20' N. & 15' W. of SE Corner of Pad | 93.6 | 14.9 | 5' Below Surface |

Required Compaction: 90% - 95%

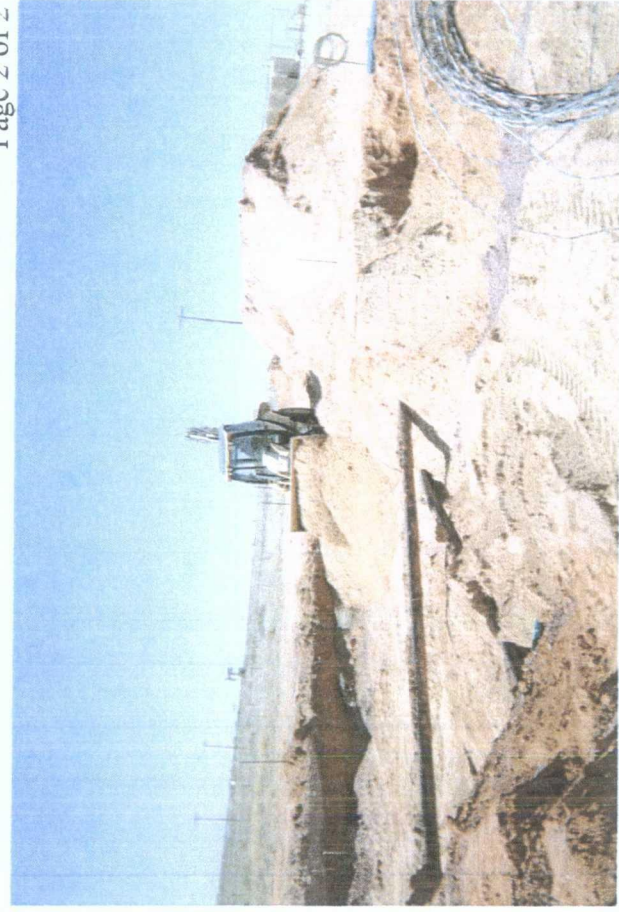
3/19/2008

backfilling excavation, facing northwest

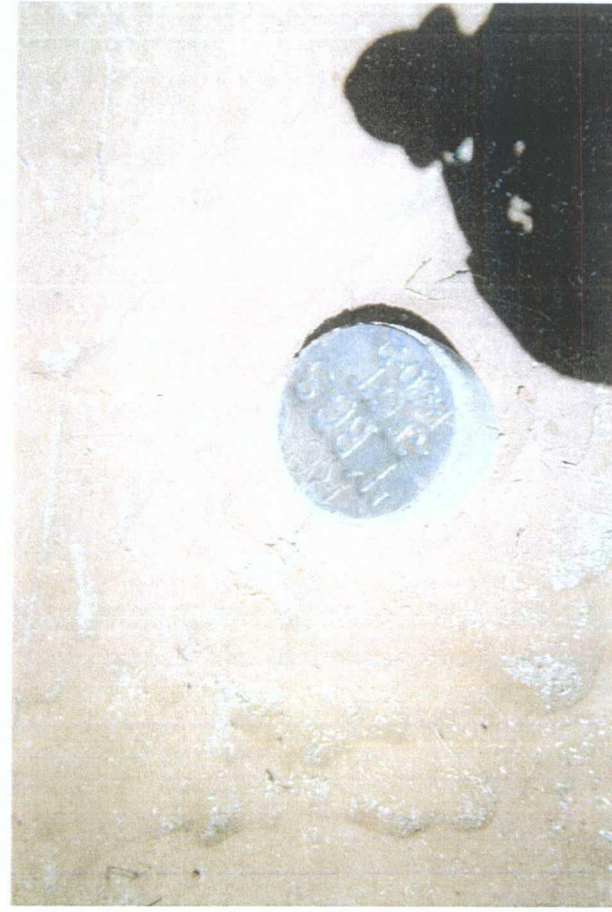
3/24/2008

clay marker

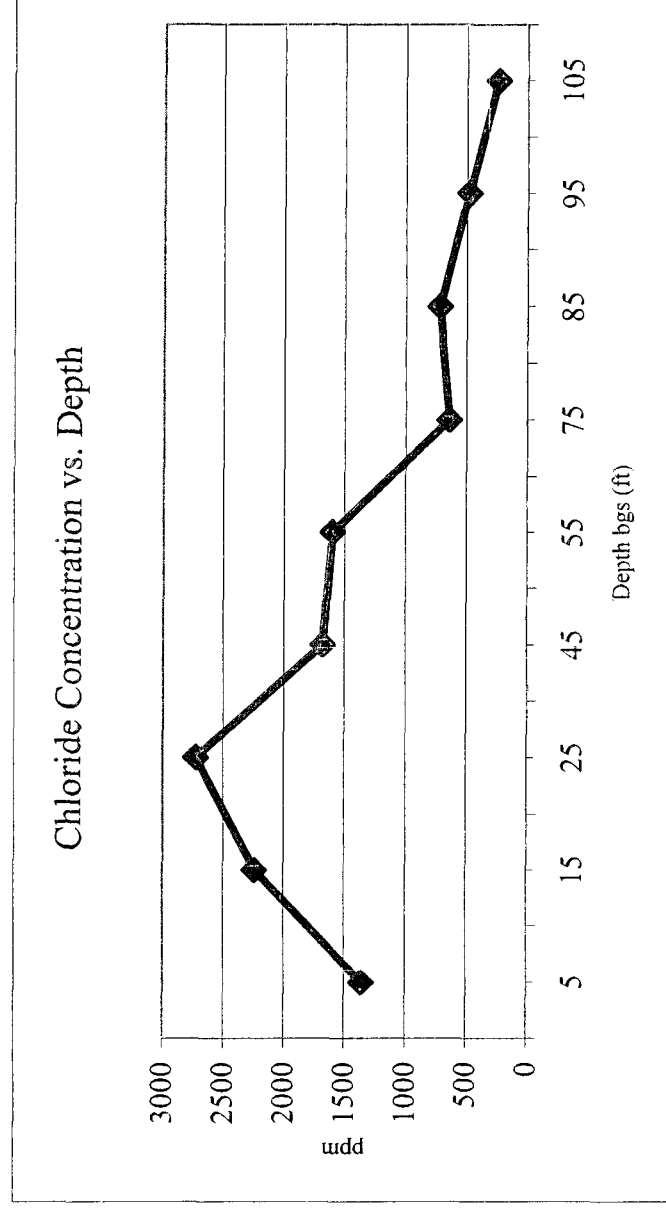
# CHLORIDE CONCENTRATION CURVE

Soil boring samples at 10 ft north of south former junction (source)

Groundwater = >125 ft

**General Description of Remedial Action:** This site contained two boxes that were eliminated during the pipeline replacement/upgrade program. A soil boring completed in 2003 by another firm yielded chloride concentrations that decreased with depth. A concentration of 21.3 mg/kg was reached at a depth of 105 ft BGS. Based on that soil boring data, the site was excavated to 60x45x5-ft-deep in preparation for a clay barrier encompassing both former boxes. At 5-4 ft BGS, a clay barrier was installed with a clay density test performed on 3/17/2008. The excavated soil was blended on site with clean, imported soil and field tested for chloride and organic vapor concentrations. A blended backfill sample was sent to a commercial laboratory for analysis of chloride and TPH which confirmed low concentrations. The blended backfill was used to fill the excavation to ground surface and to contour to the surrounding area. An identification plate was placed on the surface at the former junction site to mark the presence of the clay below. On 3/24/2008, the site was seeded with a blend of native vegetation and is expected to return to productive capacity at a normal rate.
