BD Apache Hawk 'A' EOL

CLOSURE

**RICE OPERATING COMPANY
JUNCTION BOX FINAL REPORT**

Unit A, Section 8, T21S, R37E

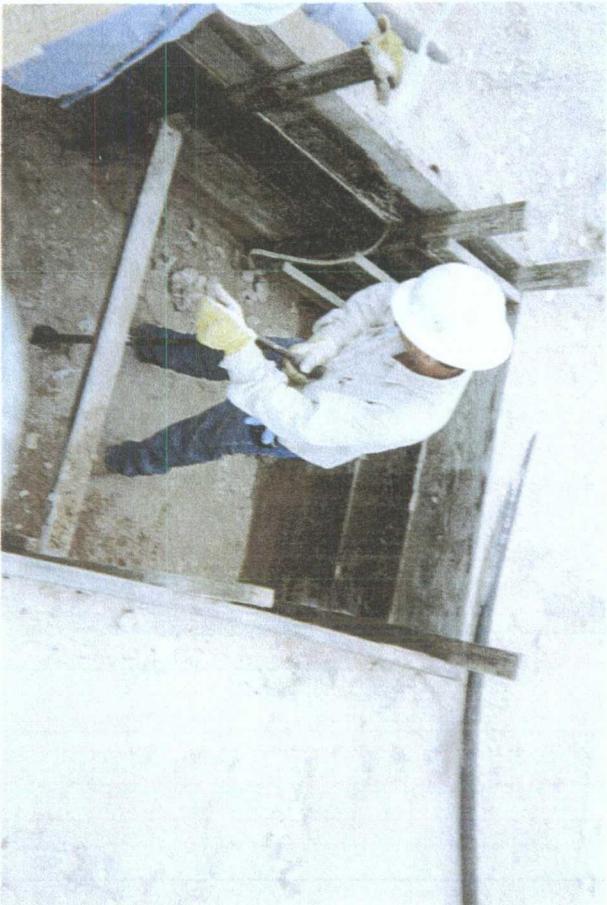
8/14/2008

collecting hand auger samples, facing west

General Description of Remedial Action: This junction was eliminated during the pipeline replacement/upgrade program. After the former box was removed, an investigation was conducted using hand auger to collect soil samples at regular intervals.

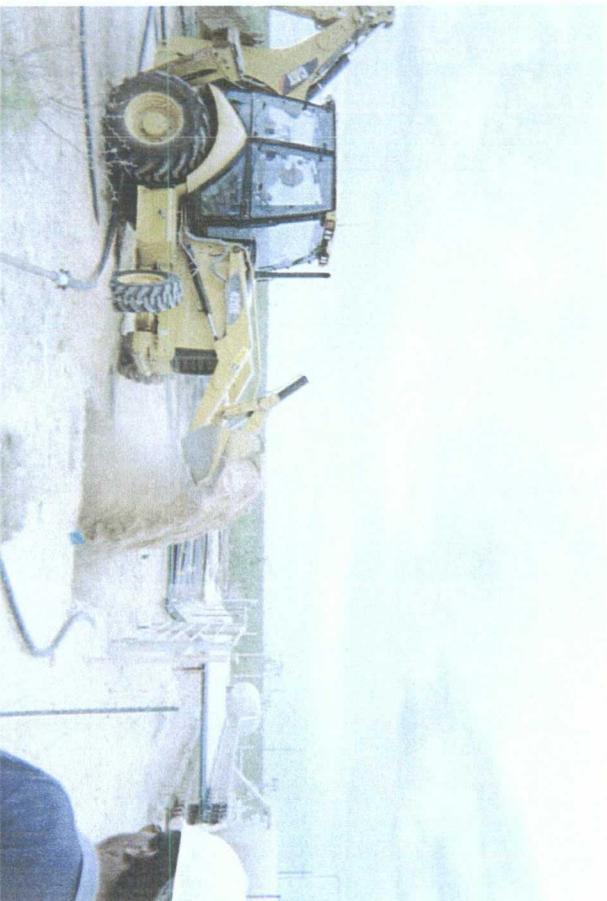
8/14/2008

backfilling the former junction box site, facing south

Field data suggests the site is low in organic vapors, and chloride concentrations in the soil are similar to that of the background. The deepest sample, 7 ft BGS, was sent to a commercial laboratory for analysis of chloride and TPH, which confirmed low concentrations. Clean, imported soil was used to backfill the site and to contour to the surrounding area. On 8/14/2008, the site was seeded with a blend of native vegetation and is expected to return to a productive capacity at a normal rate.

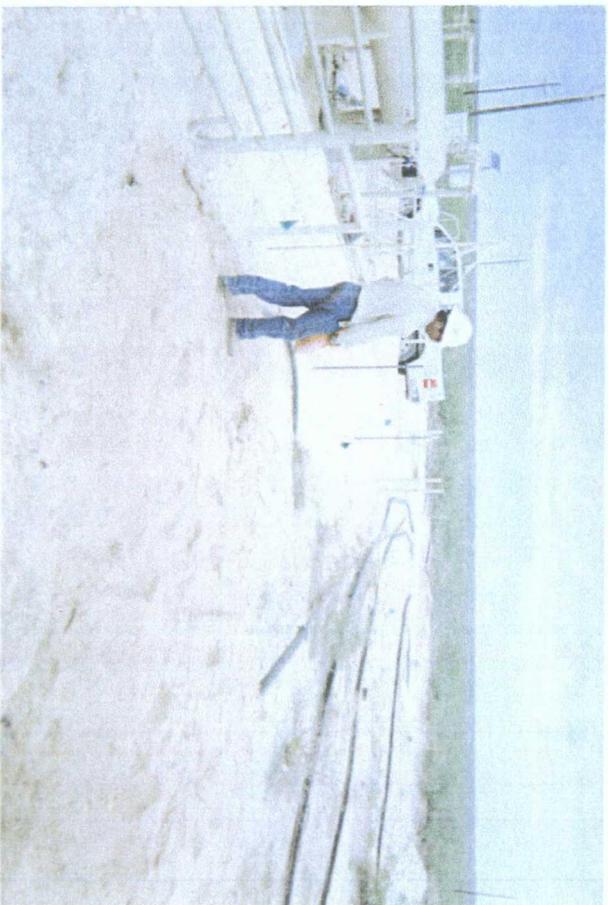
8/14/2008

seeding backfilled site, facing north

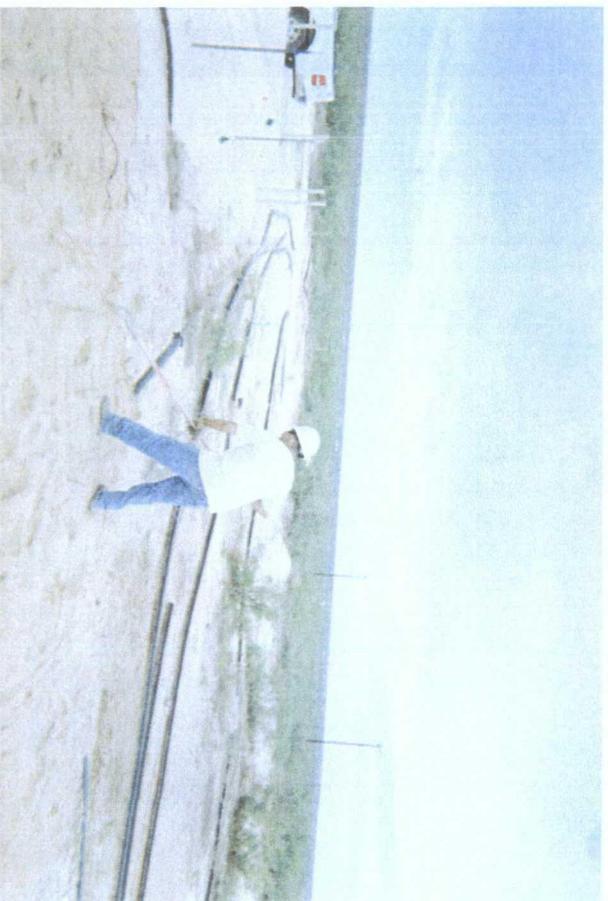
8/14/2008

raking the seeded and backfilled site, facing north

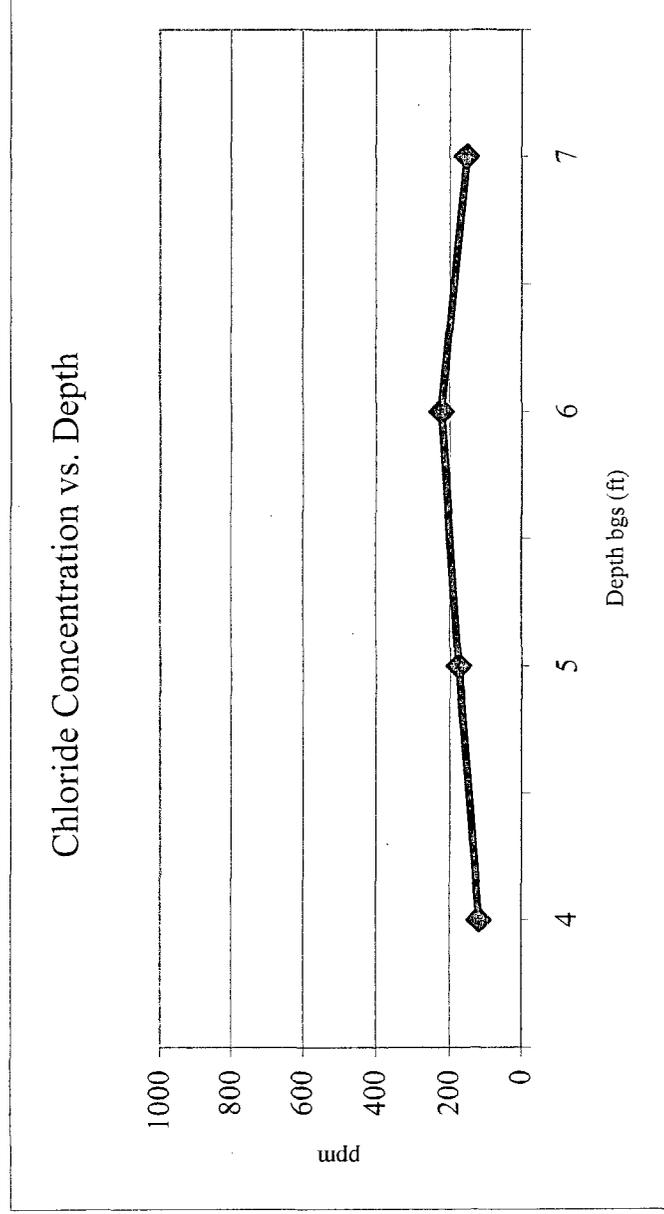
CHLORIDE CONCENTRATION CURVE

Hand auger samples below the junction (source)

Depth bgs (ft)	[Cl] ppm
4	118
5	175
6	223
7	152

Groundwater = 72 ft

LOCATION	DEPTH	mg/kg
background	6"	198
hand auger below the junction (source)	4'	118
	5'	175
	6'	223
	7'	152
