**RICE OPERATING COMPANY
JUNCTION BOX DISCLOSURE* REPORT**

SWD SYSTEM	JUNCTION	UNIT	SECTION	TOWNSHIP	RANGE	COUNTY	BOX DIMENSIONS - FEET		
							Length	Width	Depth
Blinbery-Drinkard (BD)	Jct. J-1-1	J	1	22S	36E	Lea	same location

BD Jct. J-1-1

Unit J, Section 1, T22S, R36E

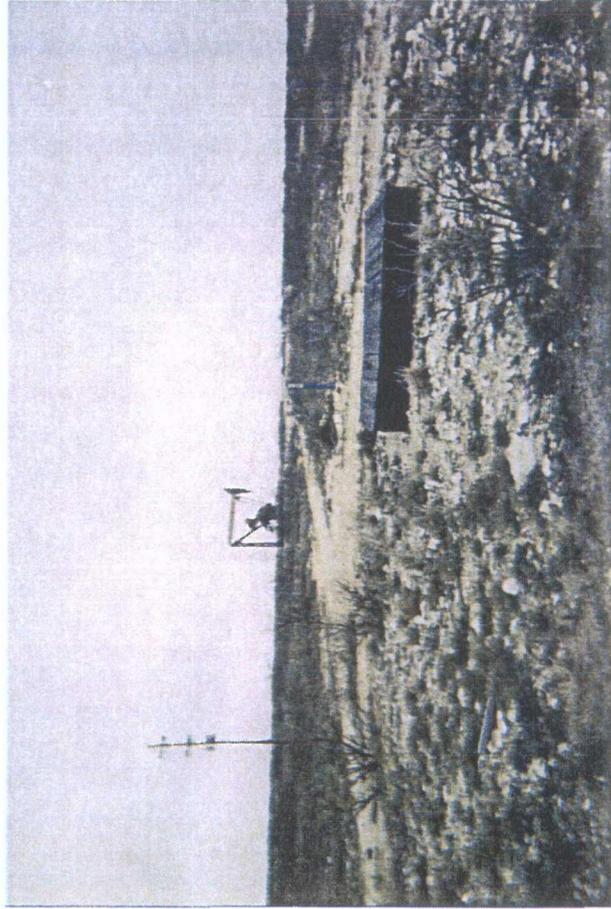
2/8/2005

undisturbed junction box, facing north

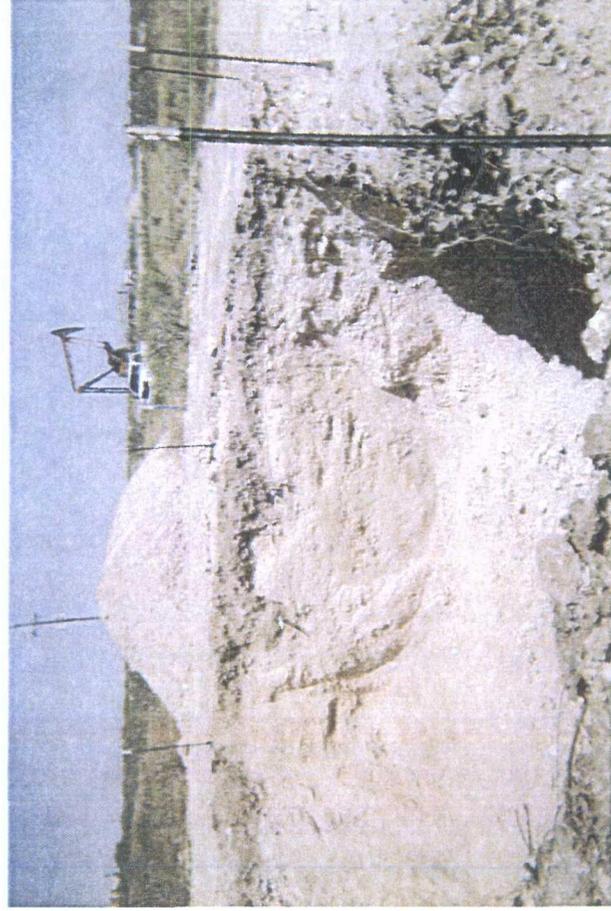
4/18/2008

30x30x12-ft excavation at
former junction site, facing northwest

General Description of Remedial Action: This junction was addressed during the pipeline replacement/upgrade program. After the former junction box was removed an investigation was conducted using a backhoe to collect soil samples at regular intervals producing a 30x30x12-ft-deep excavation. Chloride field tests performed on each sample yielded elevated concentrations that did not relent with depth. Organic vapors were measured using a PID, which yielded low concentrations. Representative composite samples were sent to a commercial laboratory for analysis of chloride and TPH. The excavated soil was blended on site and returned to the excavation up to 6 ft below ground surface (BGS). A 6-ft-deep shelf was excavated extending 5 ft out from the North, East, and West walls to prepare the surface for the clay barrier. At 6-5 ft BGS, a 1-ft-thick clay barrier was installed with a clay density test performed on 05/05/2008. The remaining fill was used to backfill the excavation to ground surface and to contour to the surrounding area. An identification plate was placed on the surface at the former junction site to mark the presence of the clay below. On 5/9/2008, the site was seeded with a blend of native vegetation and is expected to return to a productive capacity at a normal rate. A new, watertight junction box will be built in the same location. To further investigate the depth of chloride presence, two soil borings were initiated on 6/30/2008 and

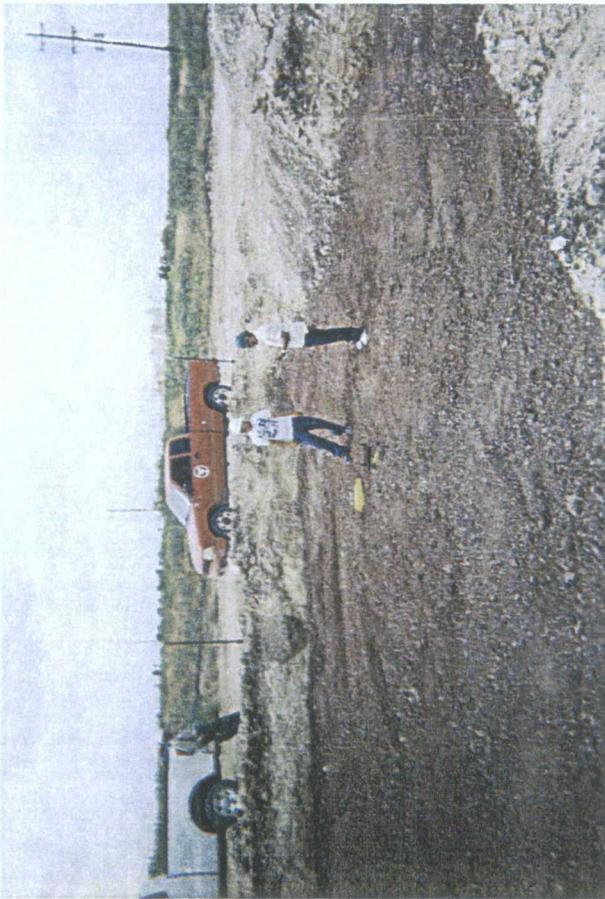
5/5/2008

clay density test

Test No.	Location	Dry Density % Max	% Moisture	Depth
SG 2	BDJC J-1-1 10' E. & 10' S. of NW Corner	92.0	17.0	4' Below FSG

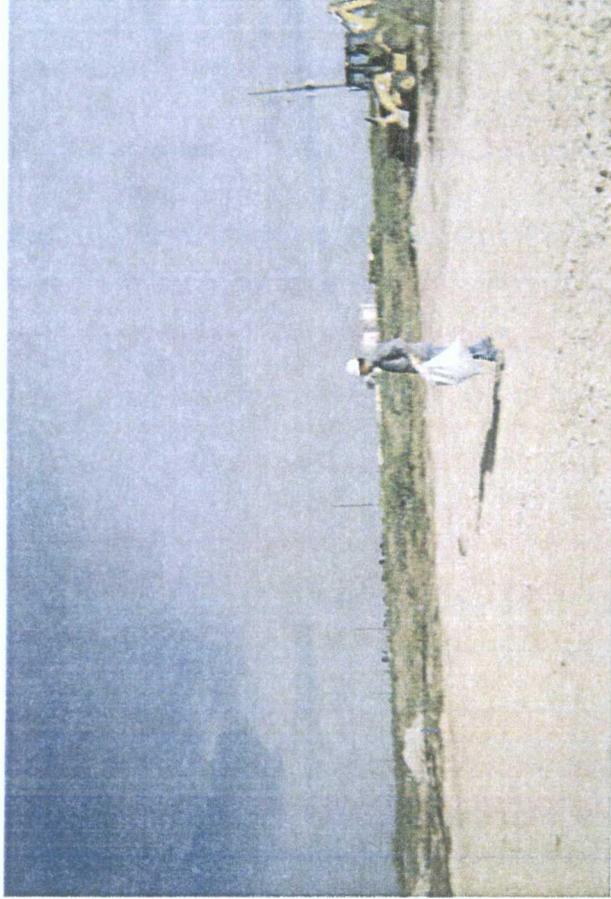
5/9/2008

seeding backfilled site

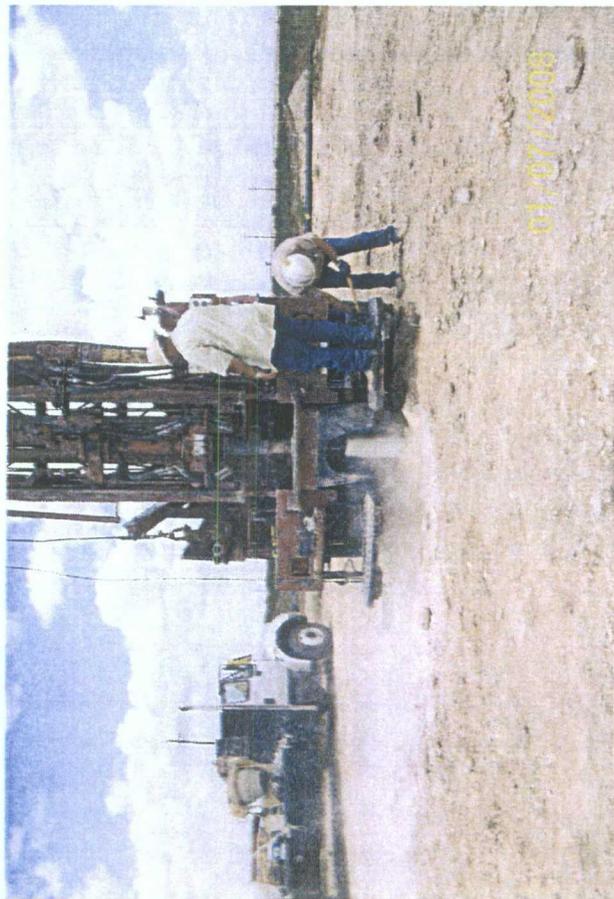
soil boring #2 at 5 ft south of former junction

7/1/2008 at 23 ft west (SB #1) and 5 ft south (SB #2) of the former junction box. SB #1 was advanced to 70 ft BGS and SB #2 was advanced to 90 ft BGS while soil samples were collected every 5 feet and tested for chlorides. The 20 ft and 90 ft samples from SB #2 were analyzed by a commercial laboratory for chloride, yielding elevated concentrations. The entire borehole was plugged with bentonite to the ground surface. NMOCD was notified of potential groundwater impact on 1/5/2009.

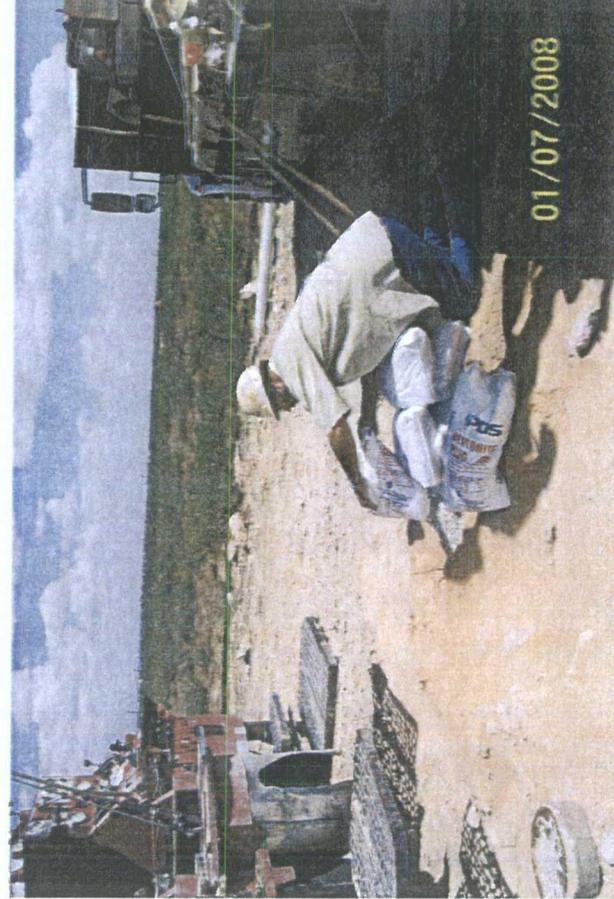
7/11/2008

plugging soil boring #2 with bentonite

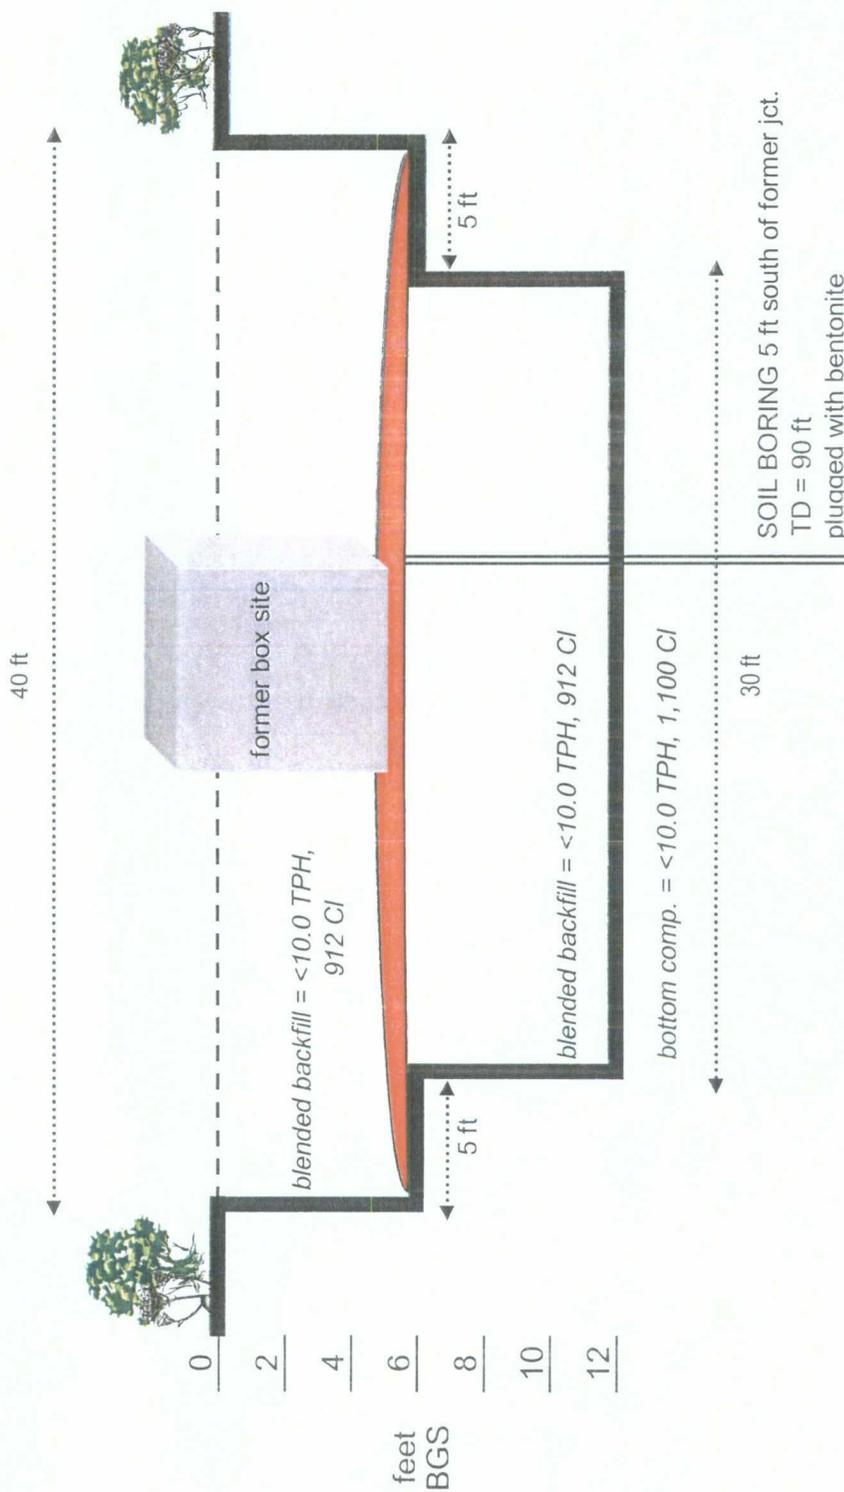
Excavation Cross-Section

BD Jct. J-1-1
Unit 'J', Sec. 1, T22S, R36E

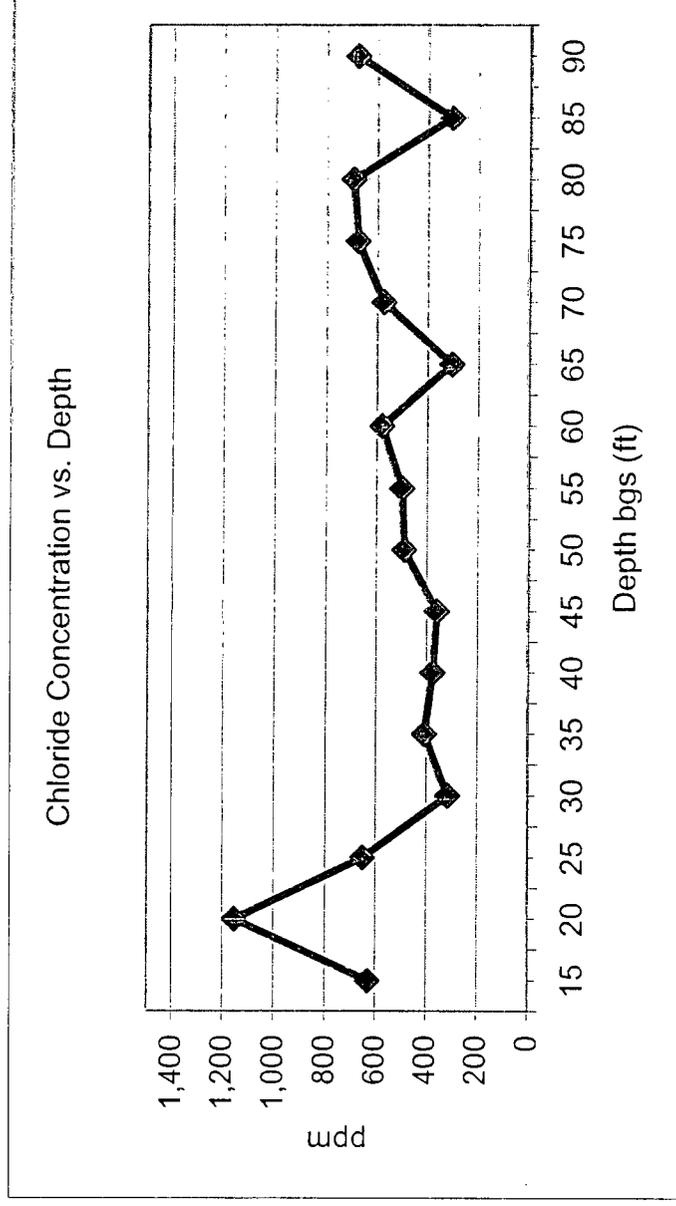
CHLORIDE CONCENTRATION CURVE

SOIL BORING samples at 5 ft south of the junction (source)

Depth bgs. (ft)	Cl ⁻ ppm
15	631
20	1,154
25	652
30	315
35	406
40	373
45	357
50	487
55	496
60	576
65	301
70	570
75	674
80	692
85	301
90	674

Groundwater = 137 ft
