BD Jct N-20

**RICE OPERATING COMPANY
JUNCTION BOX DISCLOSURE* REPORT**

BD Jct. N-20

Unit N, Section 20, T21S, R37E

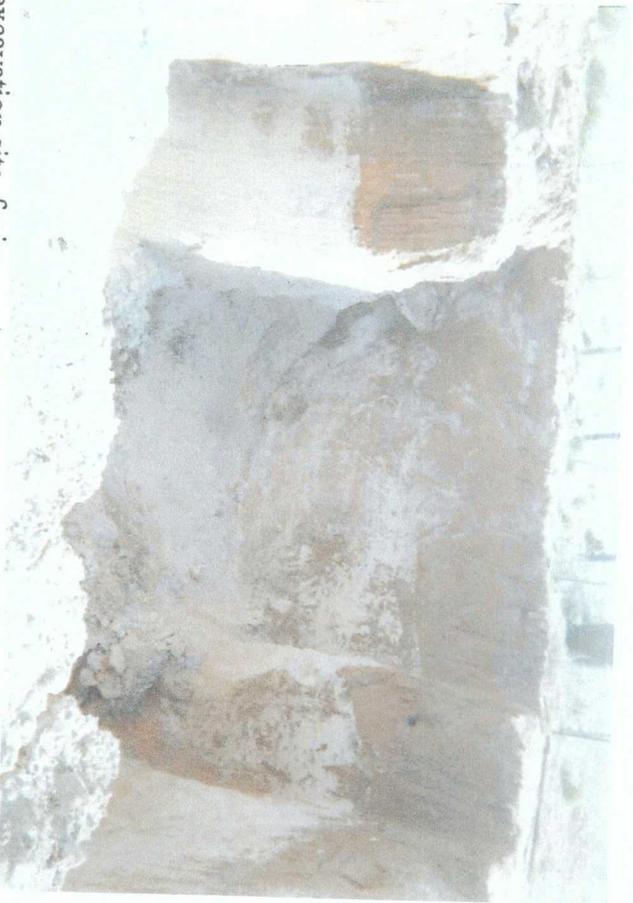
excavation site, facing east

3/14/2007

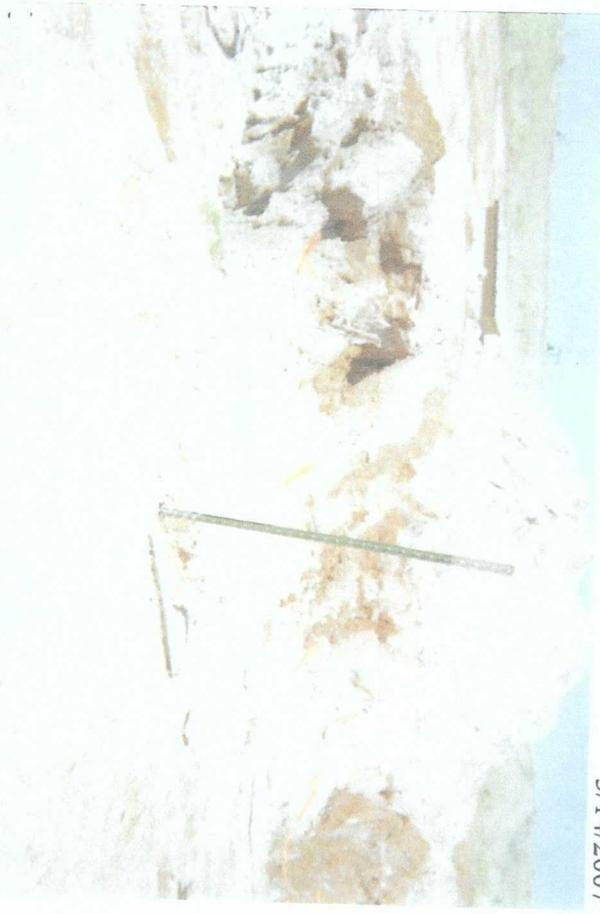
backfilled site up to 6 ft BGS with new, watertight box in background

3/15/2007

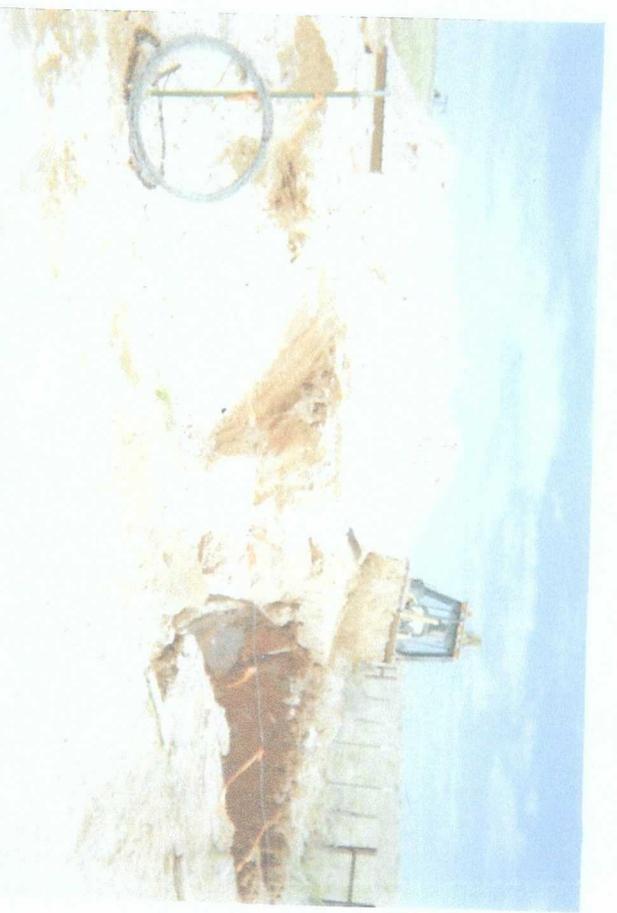
backfilling excavation site up to 6 ft BGS, facing north

3/15/2007

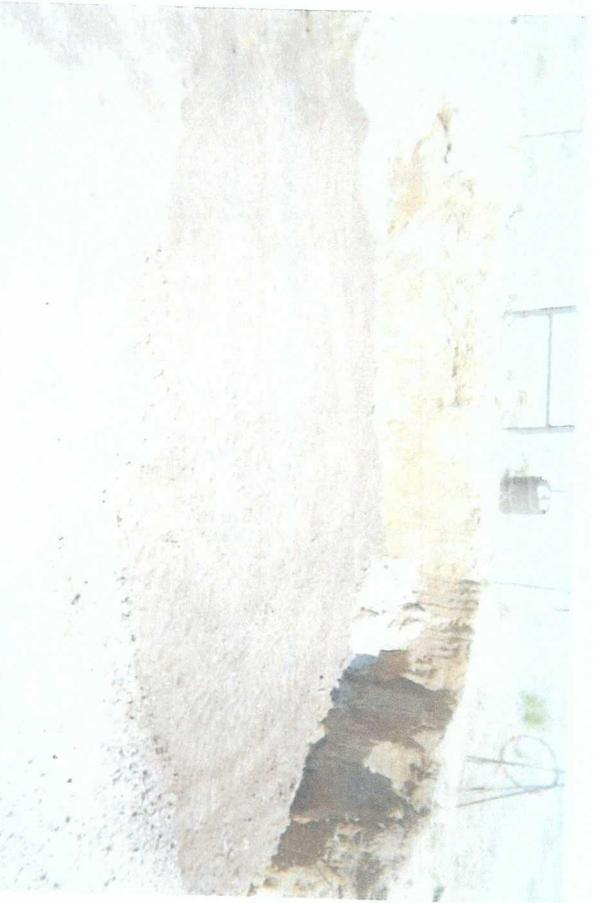
clay barrier, facing east

3/15/2007

General Description of Remedial Action: This junction was addressed under the pipe-line replacement/upgrade program. A new, watertight junction box was installed 25 ft north of the former. After the former box was removed, an investigation was conducted using a backhoe to collect soil samples at regular intervals producing a 25x25x12-ft-deep hole. Each sample was field tested for chlorides and organic vapors. Field chloride tests yielded elevated concentrations of chloride that did not relent with depth. Representative composite samples were sent to a commercial laboratory for analysis. The excavated soil was then blended on site and return to the excavation up to 6 ft below ground surface. At 6-5 ft BGS, a 1-ft-thick clay barrier was installed.

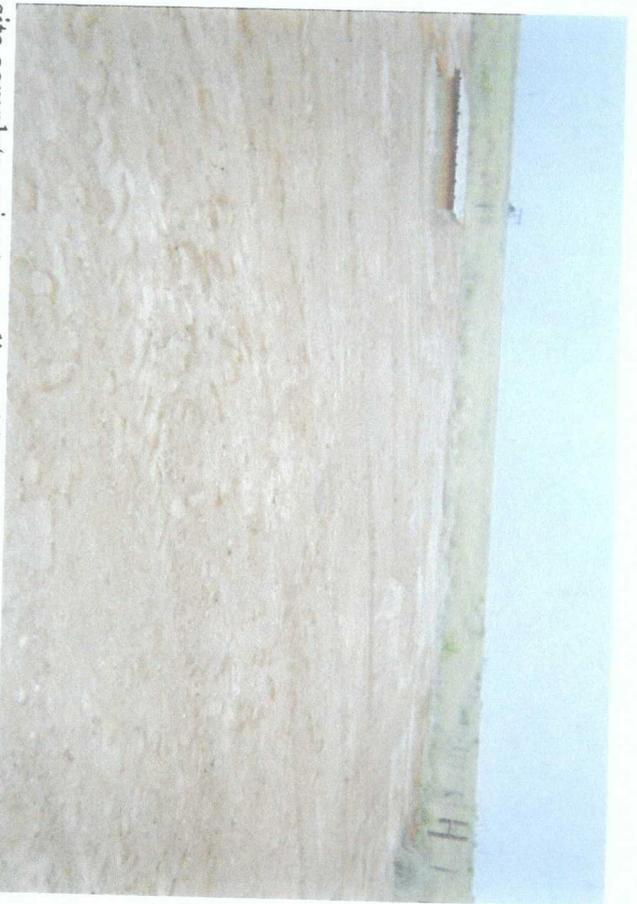
site complete, prior to seeding with new,
watertight box in background, facing north

3/16/2007

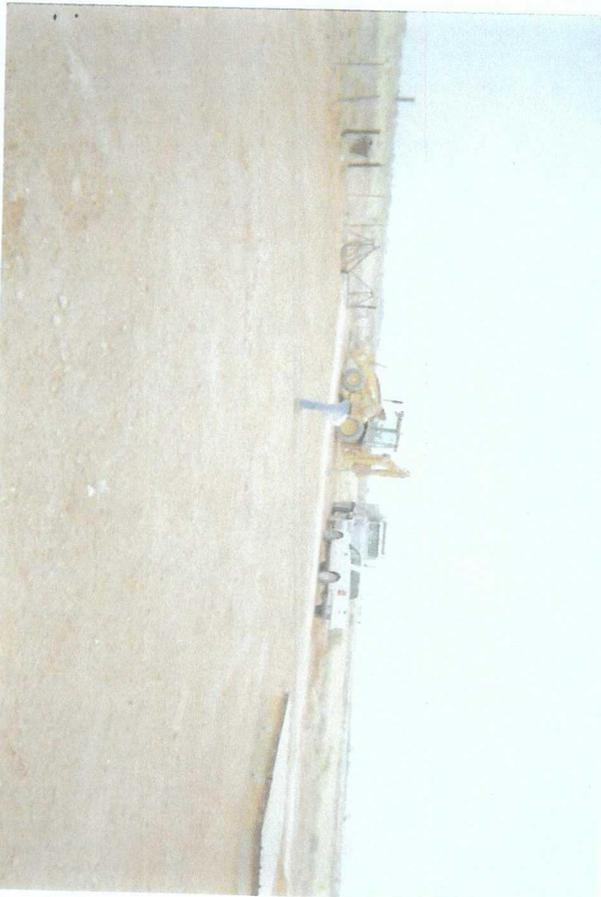
seeding backfilled site, facing south

3/16/2007

The remaining fill was used to backfill the excavation to ground surface and contour to the surrounding area. An identification plate was placed on the surface at the former junction site to mark the presence of the clay below. On 3/16/2007, the site was seeded with a blend of native vegetation and is expected to return to a productive capacity at a normal rate. To further investigate depth of chloride presence, two soil borings were initiated on 4/18/2007 at the former junction box site and 15 ft east of the former box site. Each boring was advanced to 75 ft BGS while soil samples were collected every 5 ft and tested for chloride concentrations. The deepest sample, 75 ft BGS, was sent to a commercial laboratory for analysis. Each bore hole was plugged with bentonite to ground surface. NMOCD was notified of potential groundwater impact on 7/25/2008.

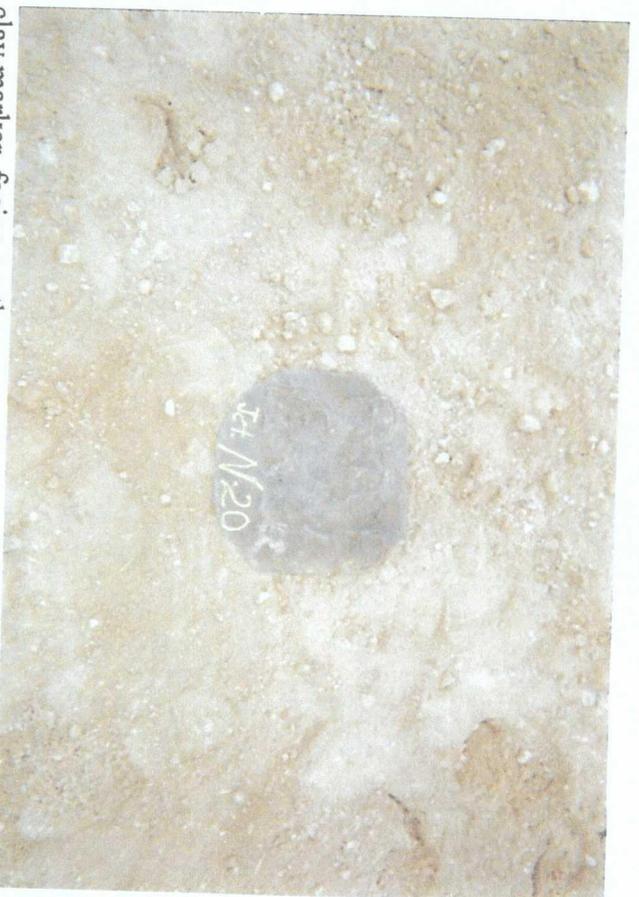
clay marker, facing north

3/16/2007

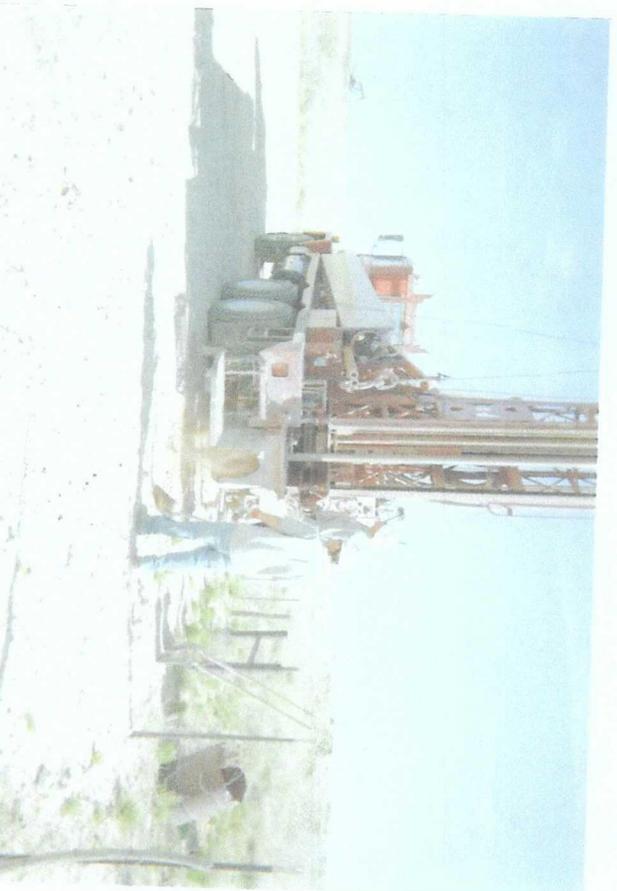
soil boring 15 ft east of former junction box, facing north

4/18/2007

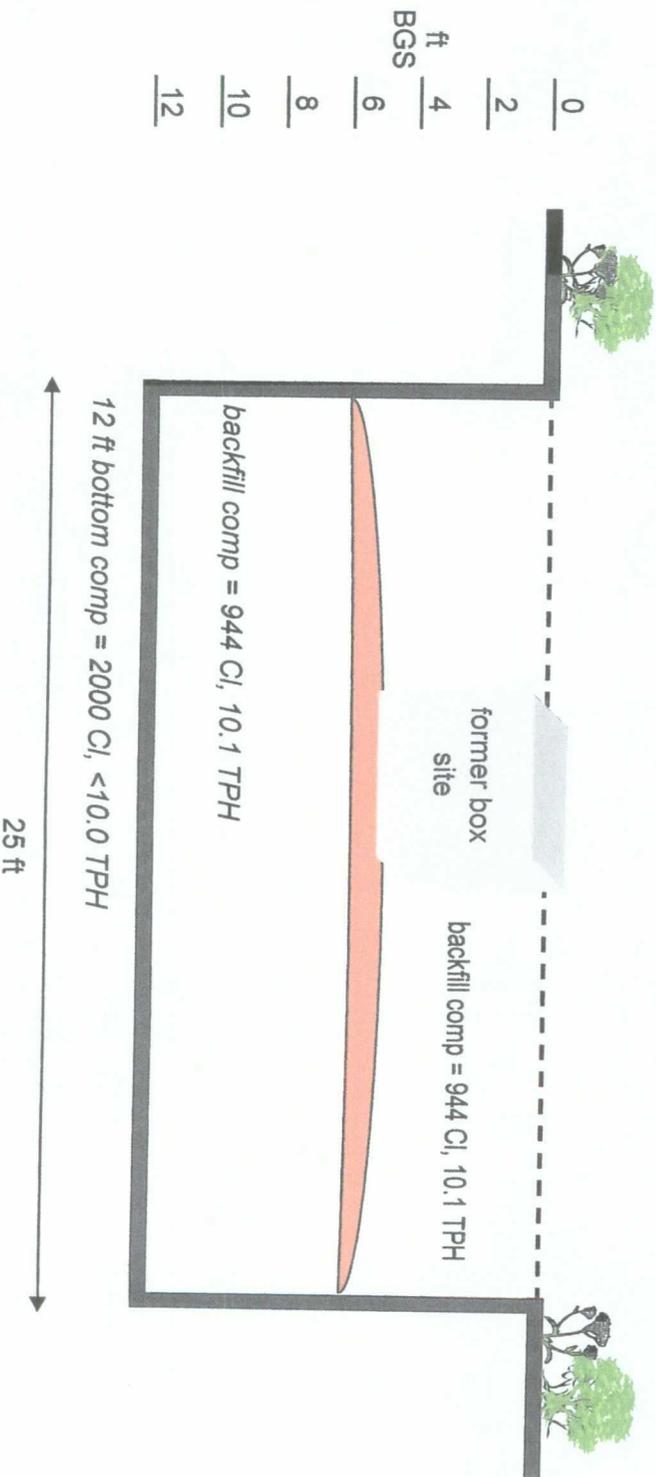
Excavation Cross-Section

W

E

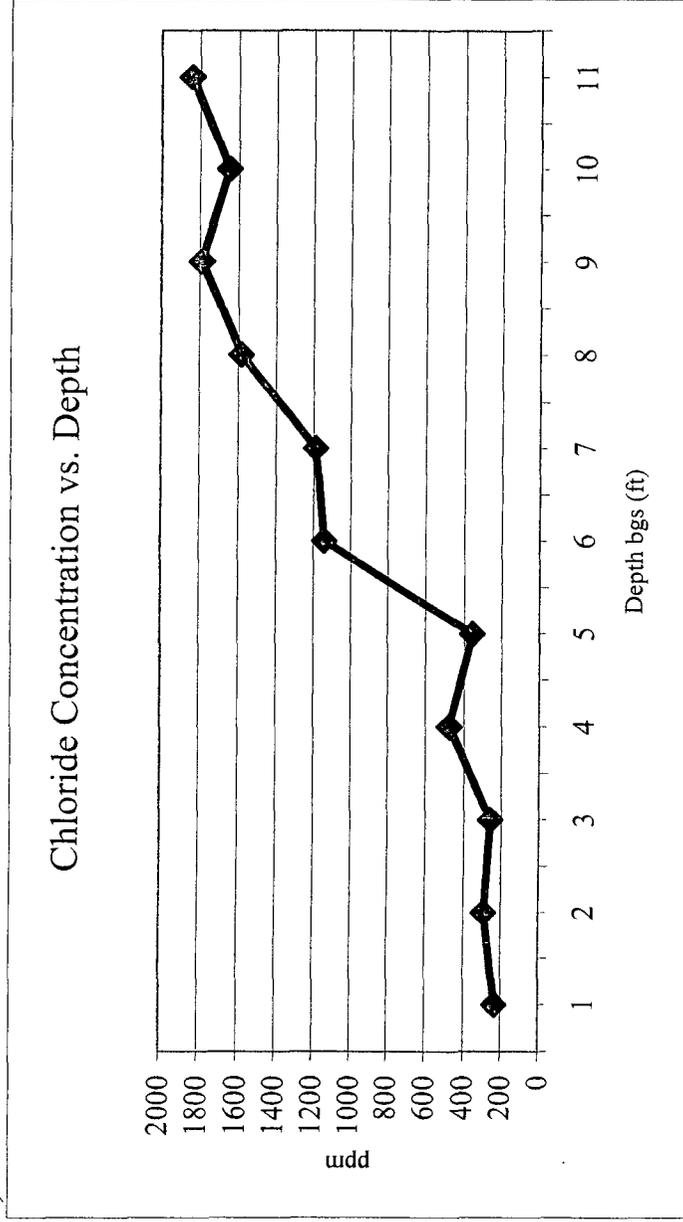
CHLORIDE CONCENTRATION CURVE

Backhoe samples at junction (source)

Depth bgs. (ft)	[Cl] ppm
2	235
3	291
4	259
5	477
6	355
7	1140
8	1188
9	1584
10	1790
11	1650
12	1841

Groundwater = 99 ft
