**RICE OPERATING COMPANY
JUNCTION BOX DISCLOSURE* REPORT**

SWD SYSTEM	JUNCTION	UNIT	SECTION	TOWNSHIP	RANGE	COUNTY	BOX DIMENSIONS - FEET		
							Length	Width	Depth
Blinebry-Drinkard (BD)	Jct. I-4	I	4	22S	37E	Lea	moved 75 ft west

BD Jct. I-4

Unit I, Section 4, T22S, R37E

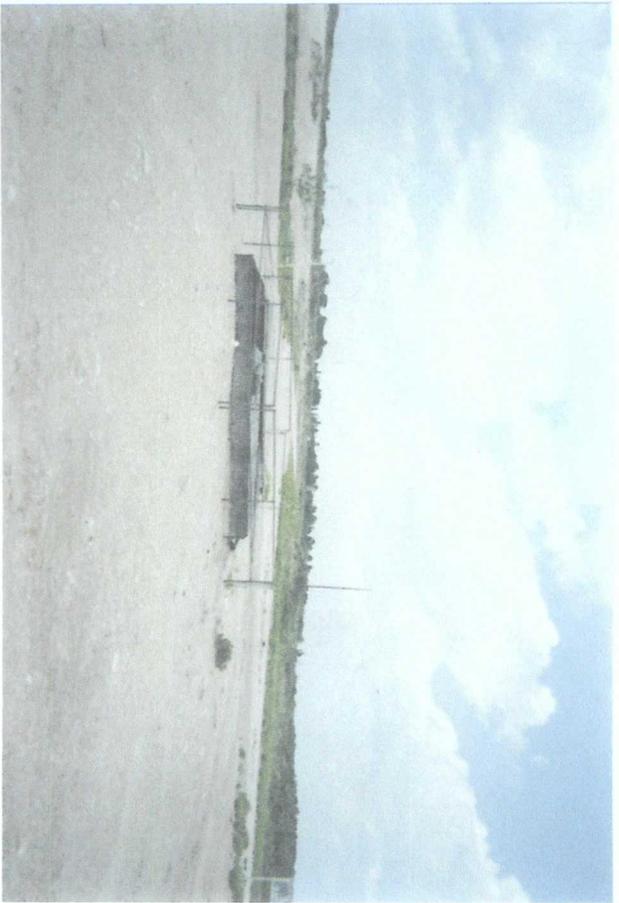
undisturbed junction box, facing north

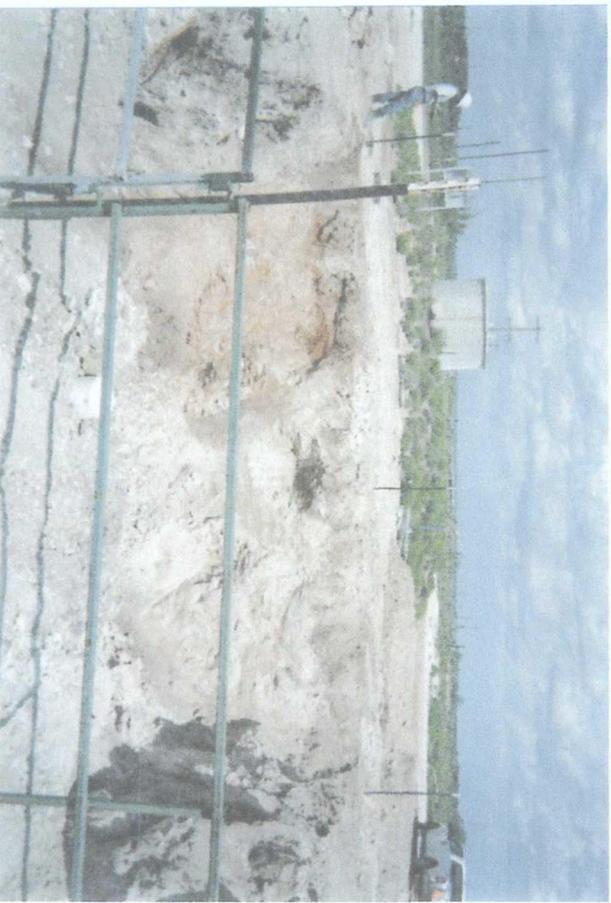
30x30x12-ft-deep excavation, facing east

General Description of Remedial Action: This junction was addressed under the pipeline replacement/upgrade program. A new, watertight junction box was installed 75 ft west of the former. After the former box was removed, an investigation was conducted using a backhoe to collect soil samples at regular intervals producing a 30x30x12-ft-deep hole. Each sample was field tested for chloride concentration. Organic vapors were measured using a PID, which yielded elevated concentrations. Representative composite samples were sent to a commercial laboratory for analysis of chloride, TPH, and BTEX concentrations. The excavated soil was blended on-site and field tested for chloride and TPH, which yielded elevated concentrations. Half of the blended backfill was replaced with clean, imported soil and blended on-site. The 50/50 backfill was returned to the excavation. Clean, imported top soil was used as a top cap and to contour to the surrounding area. On 8/28/2007, the site was seeded with a blend of native vegetation and is expected to return to a productive capacity at a normal rate. NMOCD was notified of potential groundwater impact on 8/7/2008.

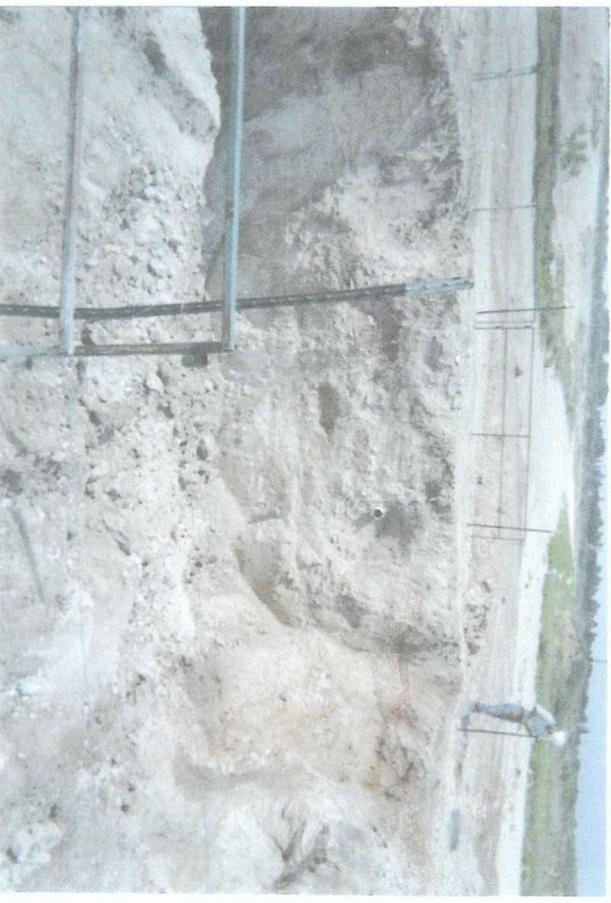
30x30x12-ft-deep excavation, facing north

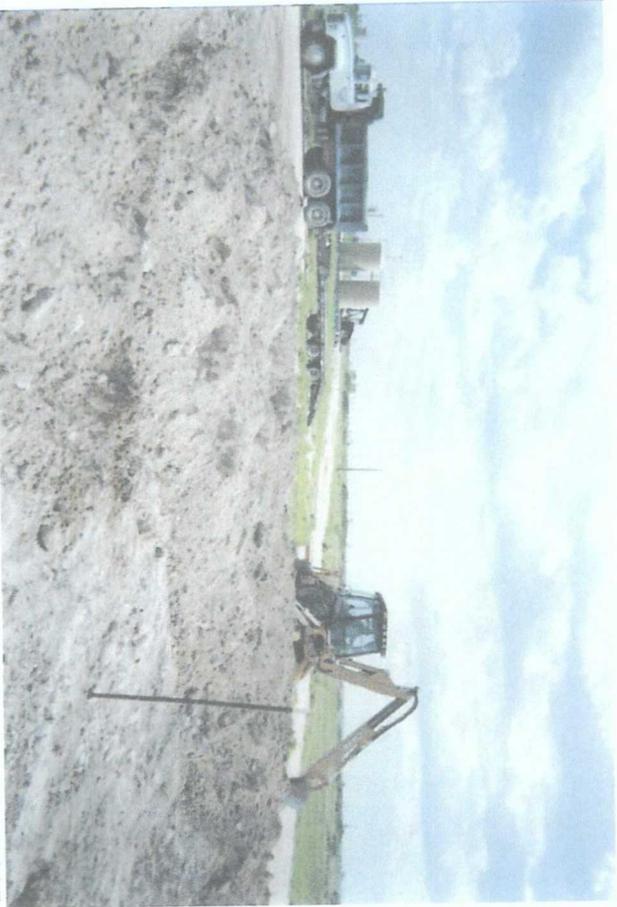
blending excavated soil, facing south

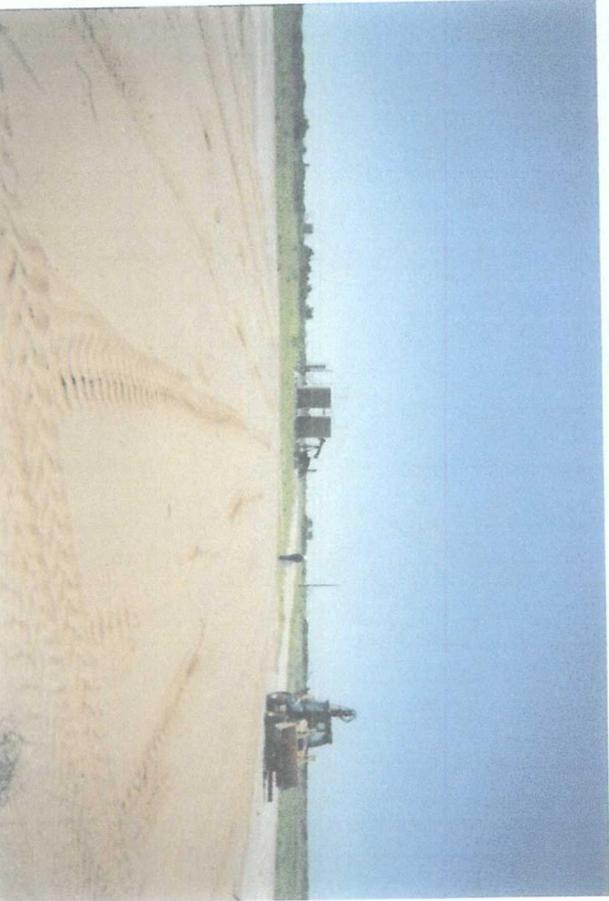
seeding backfilled site, facing south

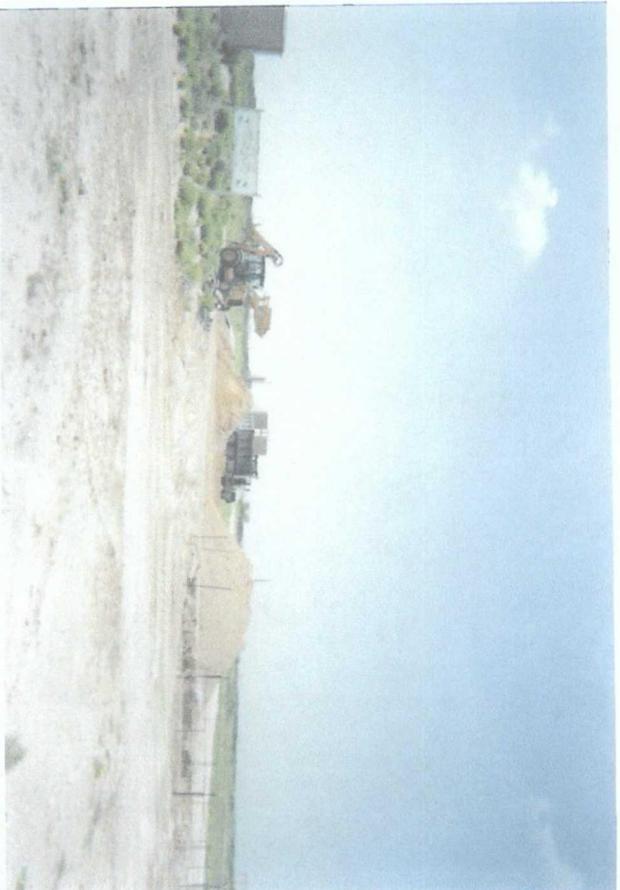
blending clean, imported soil with blended backfill, facing south

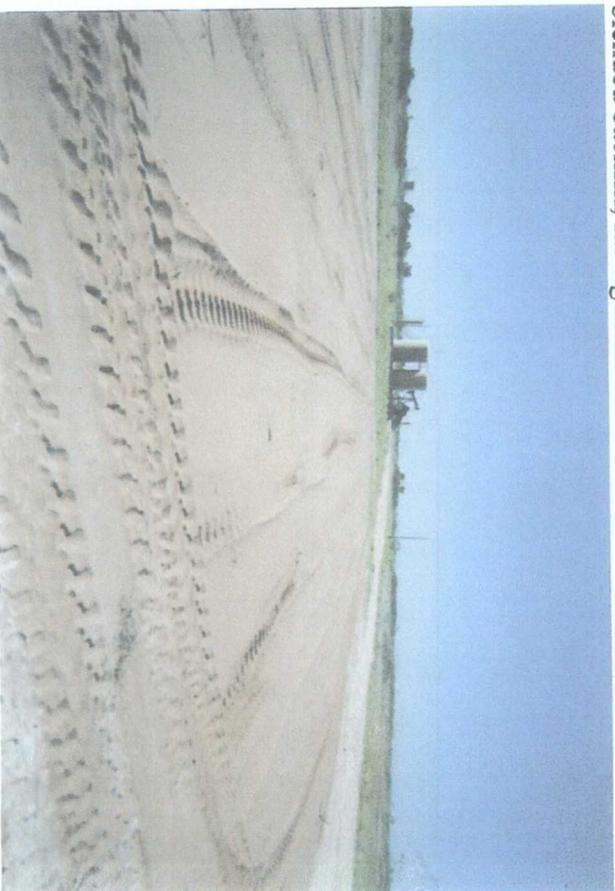
backfilled site, facing south

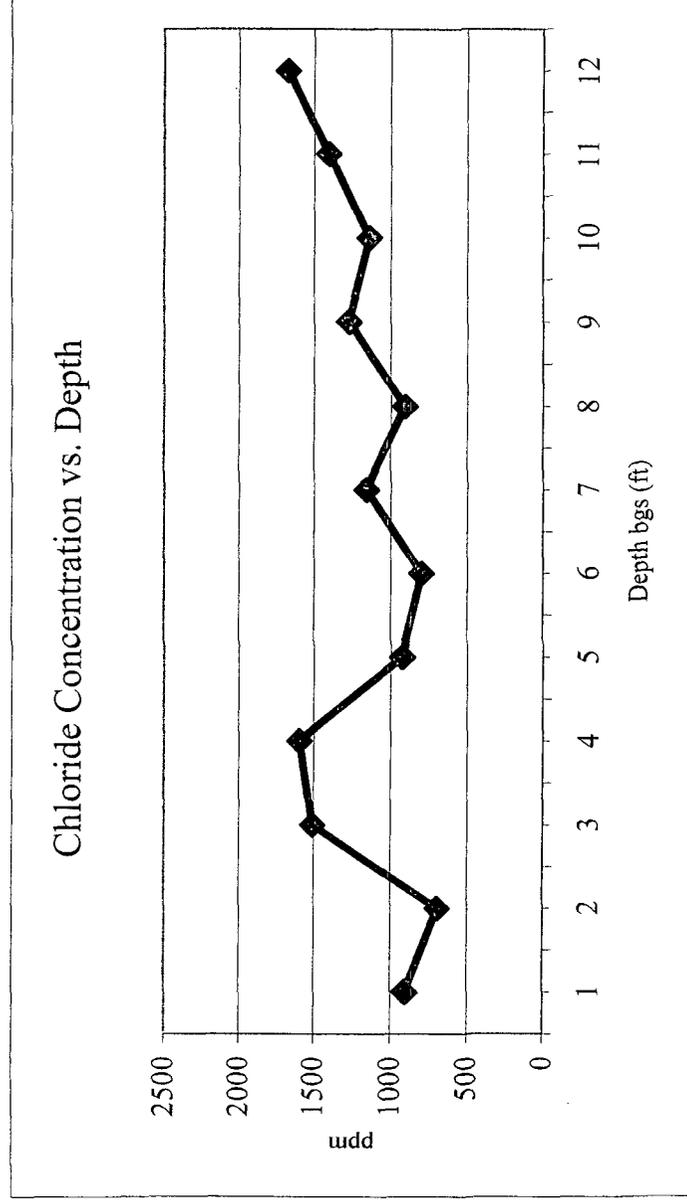
CHLORIDE CONCENTRATION CURVE

Backhoe samples at 15 ft south of junction (source)

Depth bgs (ft)	[Cl ⁻] ppm
1	907
2	697
3	1510
4	1596
5	926
6	803
7	1158
8	909
9	1271
10	1139
11	1403
12	1674

Groundwater = 85 ft
