BD Pogo Manda EOL

**RICE OPERATING COMPANY
JUNCTION BOX DISCLOSURE* REPORT**

Unit C, Section 28, T22S, R37E

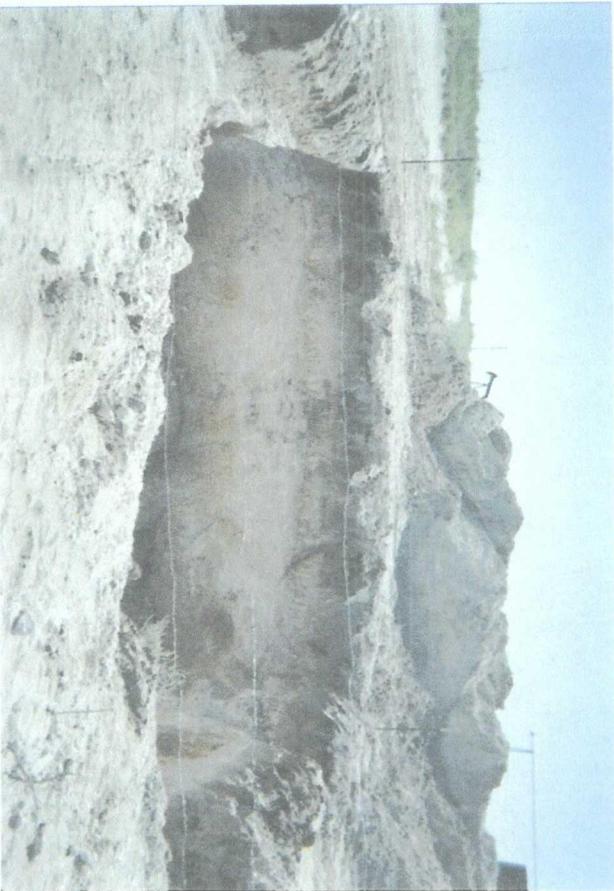
10/26/2007

30x30x12-ft-deep excavation, facing south

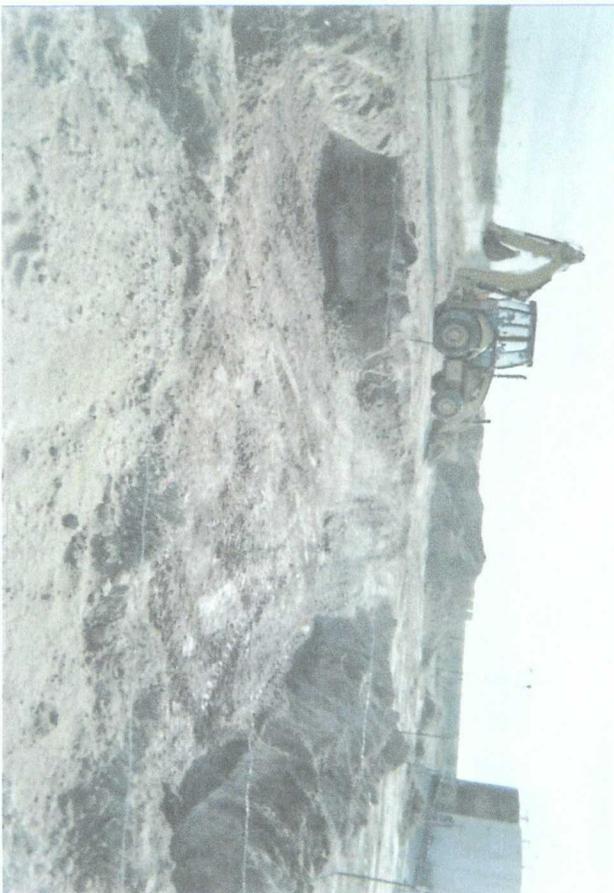
11/27/2007

clay barrier installed, facing south

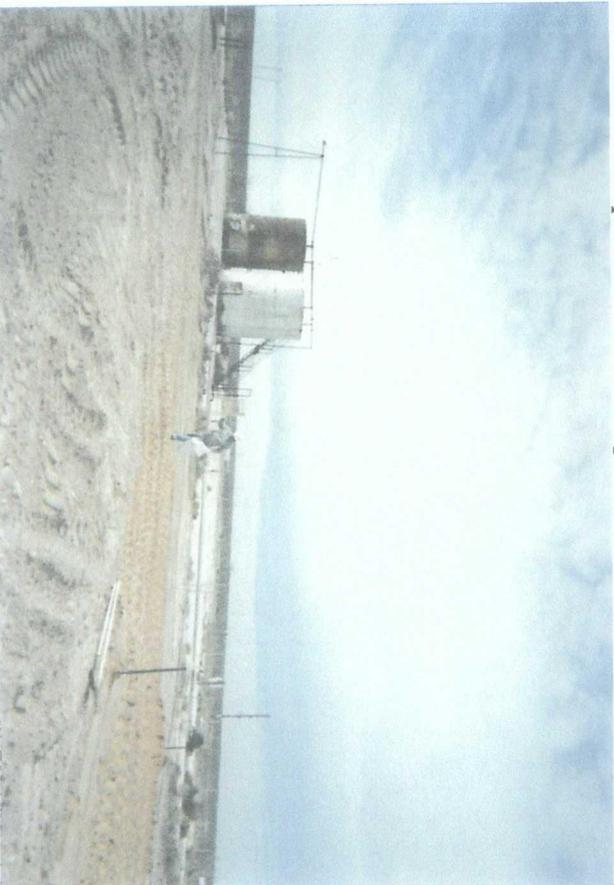
11/28/2007

seeding backfilled site, facing west
