EME D-16 Vent

CLOSURE

**RICE OPERATING COMPANY
JUNCTION BOX FINAL REPORT**

Unit D, Section 16, T20S, R37E

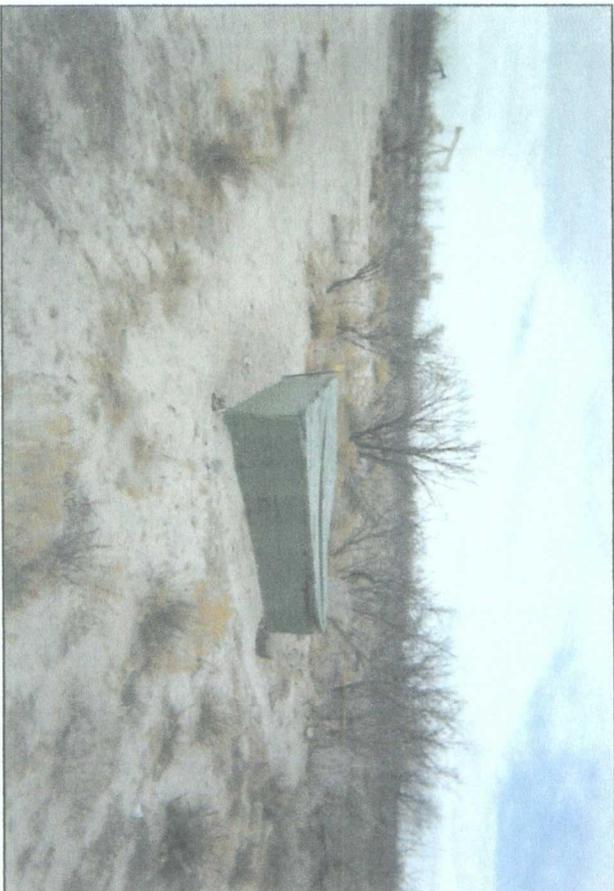
2/2/2006

undisturbed junction box

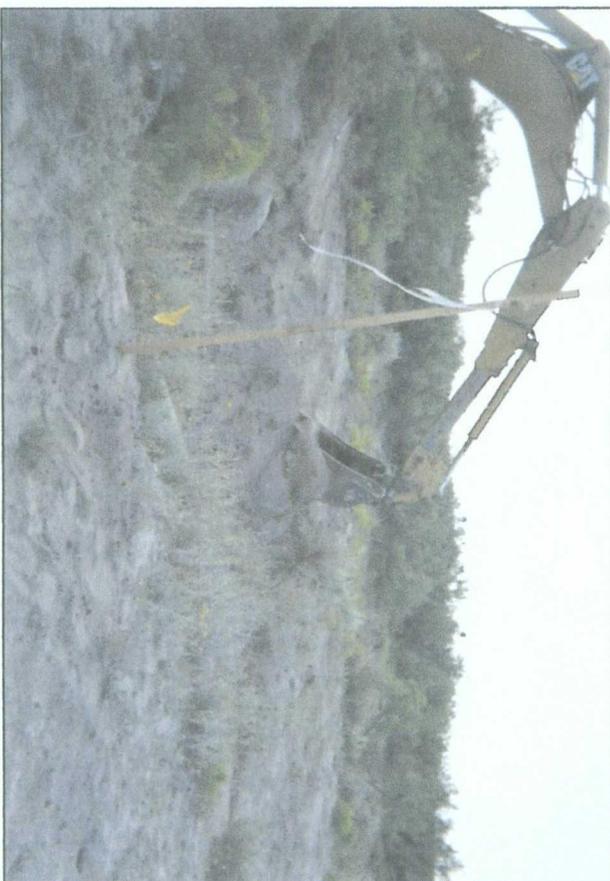
8/21/2007

backfilling former box hole

General Description of Remedial Action: This junction box site was addressed under the pipeline replacement/upgrade program. A new, water-tight junction box was built 45 feet north. An investigation was conducted using a hand auger to collect soil samples at regular intervals. Field chloride test performed on each sample yielded low concentrations of chloride similar to that of the background. Organic vapors were measured using a PID, which also yielded low concentrations. Commercial laboratory analysis confirmed that the samples were low in chloride and organics. The site was then backfilled and seeded with a blend of native vegetation and is expected to return to productive capacity at a normal rate.

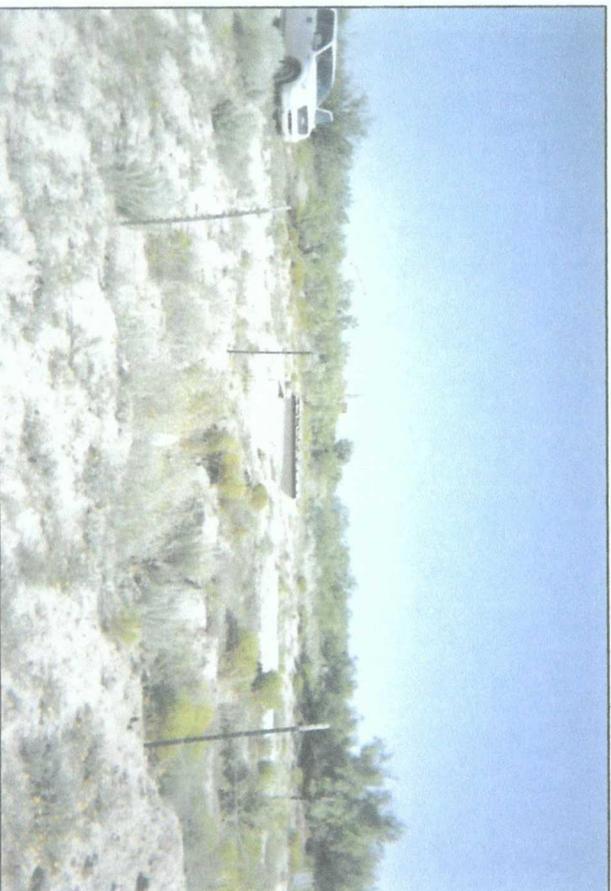
former site (fenced) with old box removed; new box in background 8/6/2007

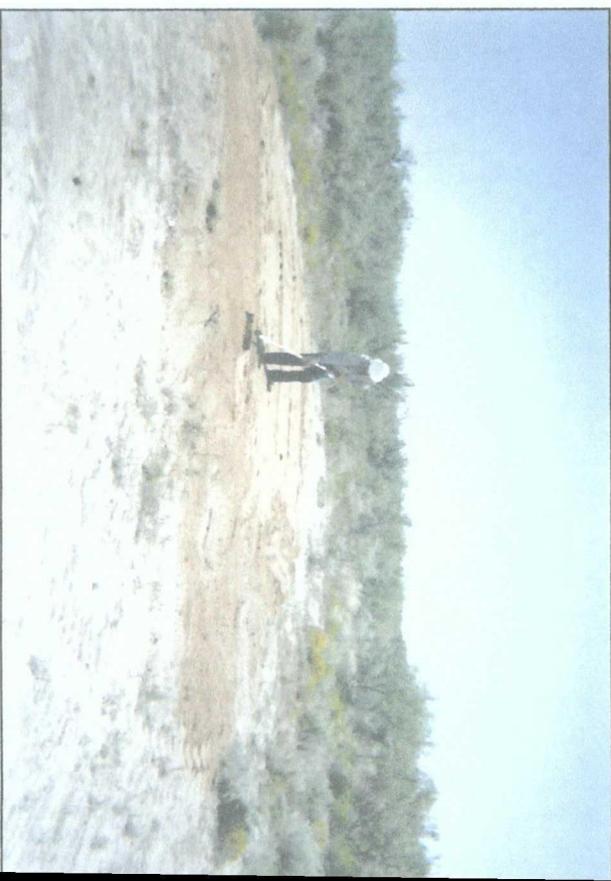
8/21/2007

seeding soil spread on site

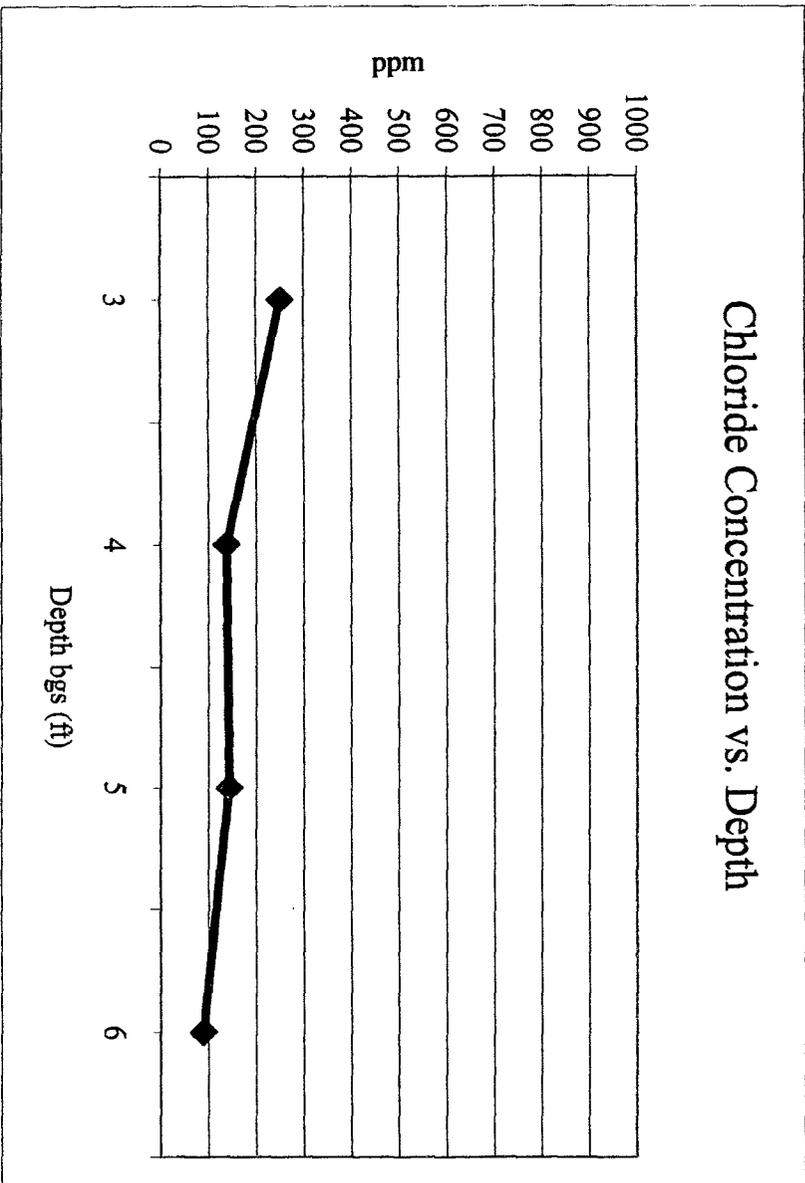
CHLORIDE CONCENTRATION CURVE

Hand auger samples at junction (source)

| Depth bgs (ft) | [Cl ⁻] ppm |
| 3 | 251 |
| 4 | 138 |
| 5 | 143 |
| 6 | 89 |

Groundwater = 20 ft
