CLOSURE

**RICE OPERATING COMPANY
JUNCTION BOX FINAL REPORT**

EME Jct. L-16

Unit L, Section 16, T20S, R37E

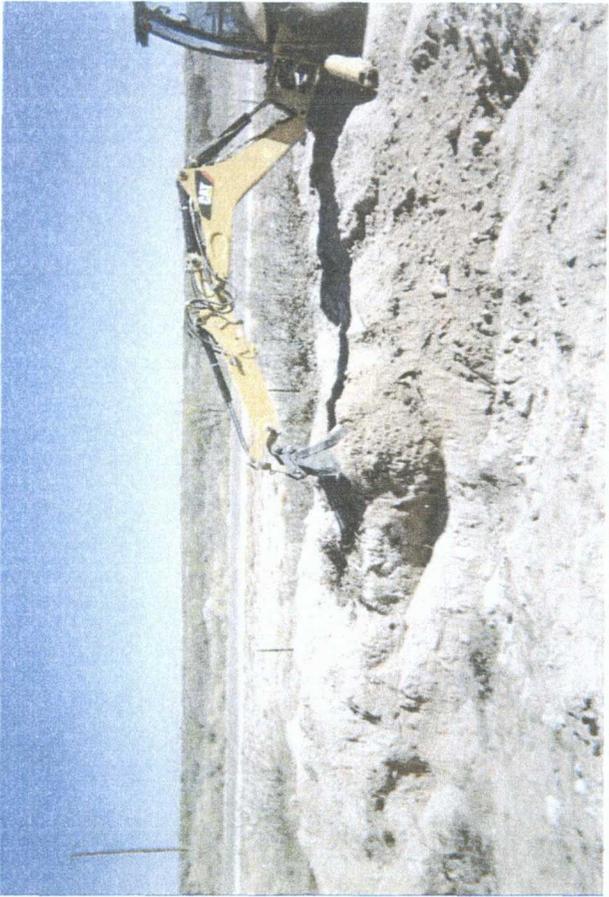
11/19/2007

backfilling of site (W to E)

General Description of Remedial Action: This junction box was eliminated during the pipeline replacement/upgrade project. A hand auger was used to collect samples at regular intervals. Field data suggest that the site is low in organic vapors, and chloride concentrations in the soil are similar to that of the background soil sample. The deepest sample (16' bgs) was sent to a commercial laboratory for analysis, which confirmed that the site is low in chloride and organics. On 11/19/2007, site was backfilled and contoured to the surrounding area. On 11/20/2007 the disturbed area was seeded with a blend of native vegetation and is expected to return to productive capacity at a normal rate.

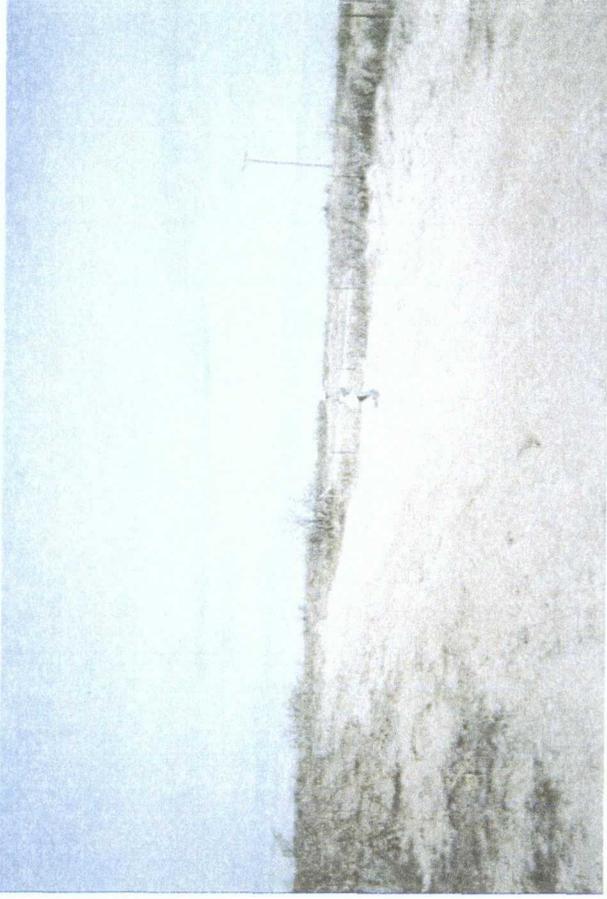
11/20/2007

seeding backfilled site (SW to NE)

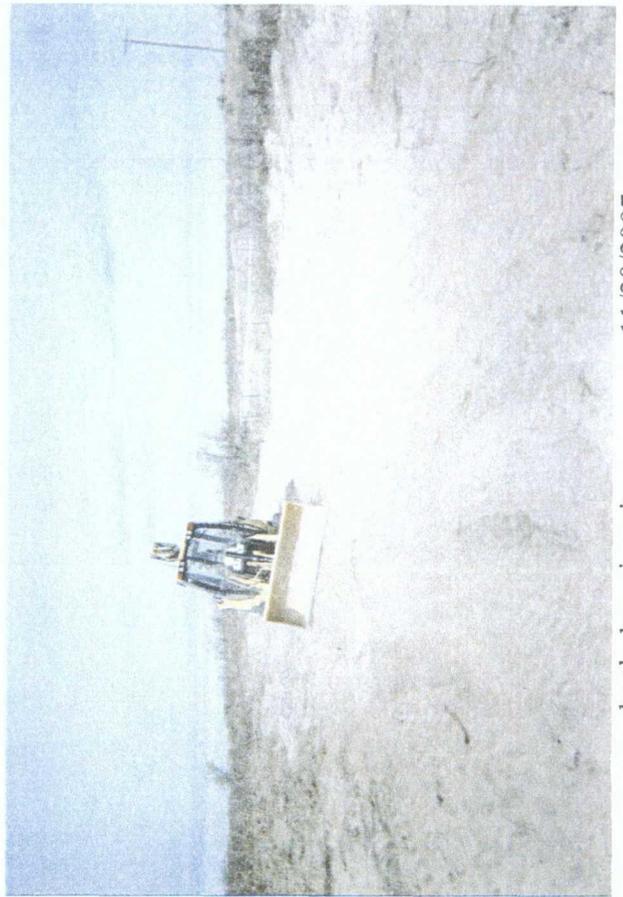
11/20/2007

back dragging site

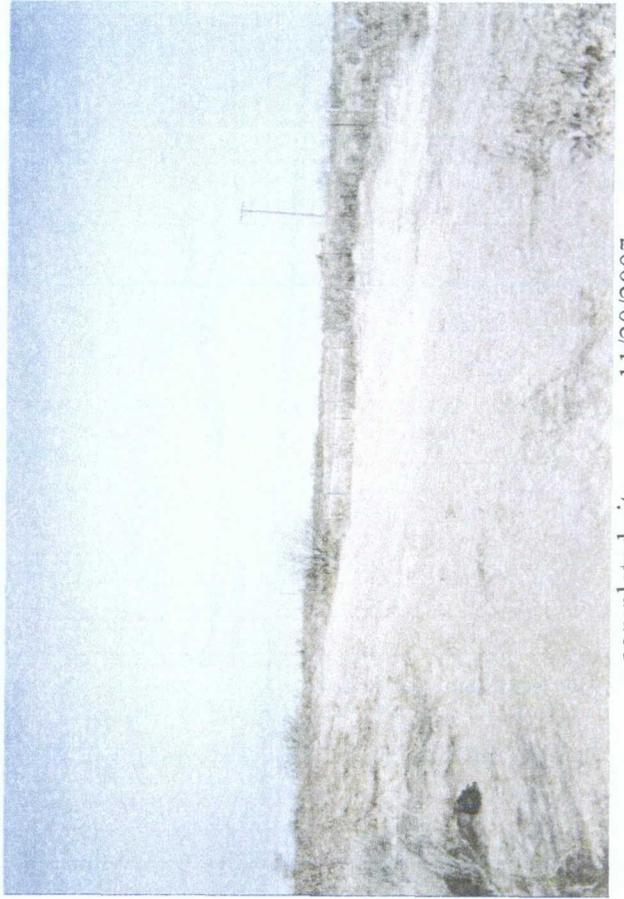
11/20/2007

completed site

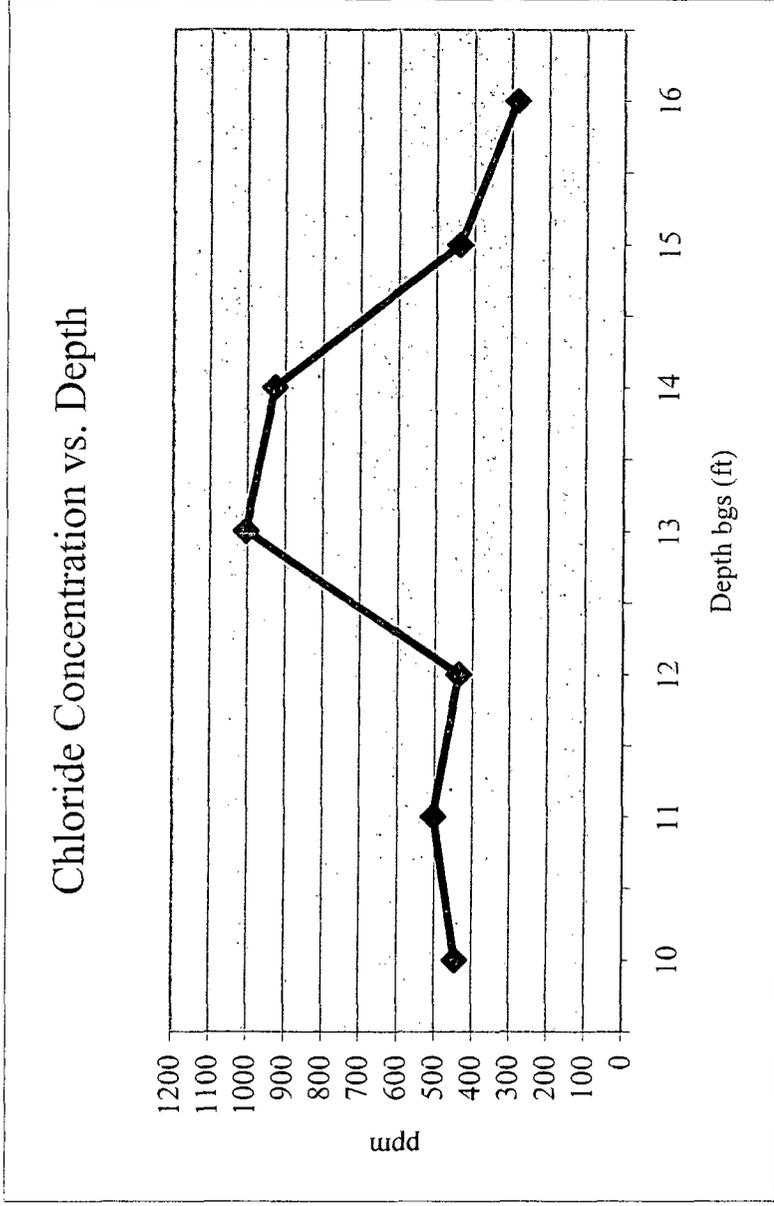
CHLORIDE CONCENTRATION CURVE

Hand auger samples at junction (source)

Depth: bgs (ft)	[Cl ⁻] ppm
10	445
11	504
12	436
13	1004
14	927
15	438
16	284

Groundwater = 20 ft

LOCATION	DEPTH	mg/kg
background	6"	209
hand auger below junction (source)	10'	445
	11'	504
	12'	436
	13'	1004
	14'	927
	15'	438
16'	284	
backfill comp.	n/a	155
