EME Hendrix Reeves EOL

CLOSURE

**RICE OPERATING COMPANY
JUNCTION BOX FINAL REPORT**

Unit D, Section 29, T20S, R37E

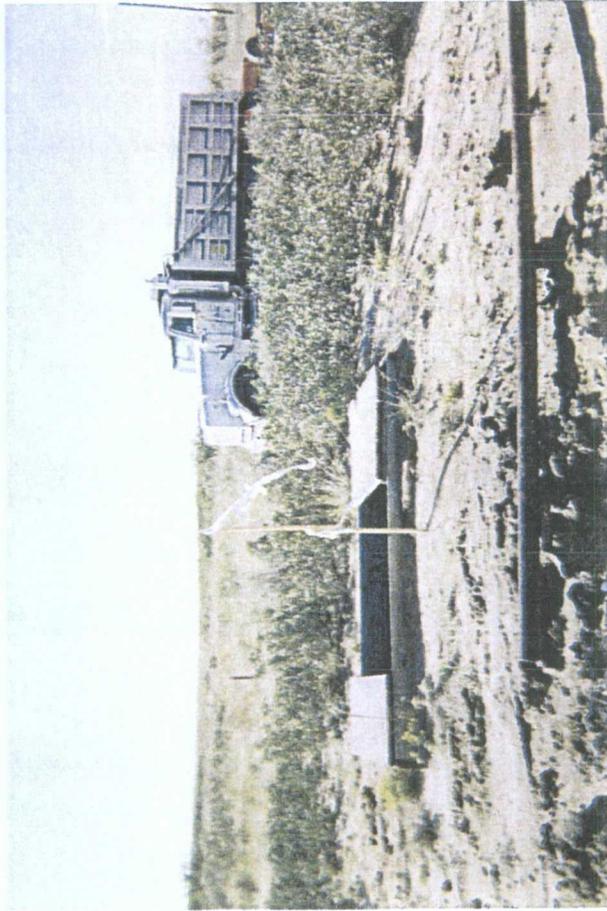
10/7/2008

former junction box, facing south

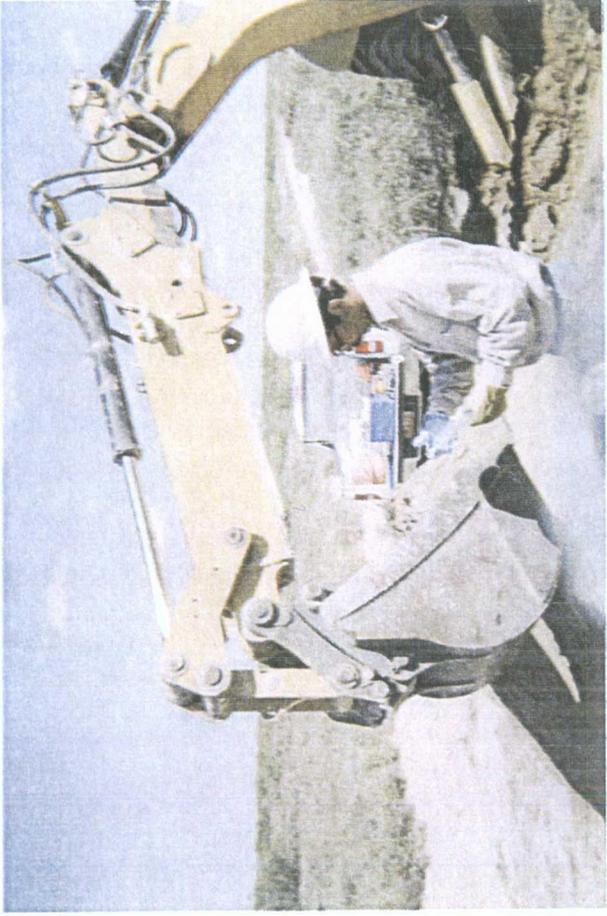
10/7/2008

taking a soil sample, facing southwest

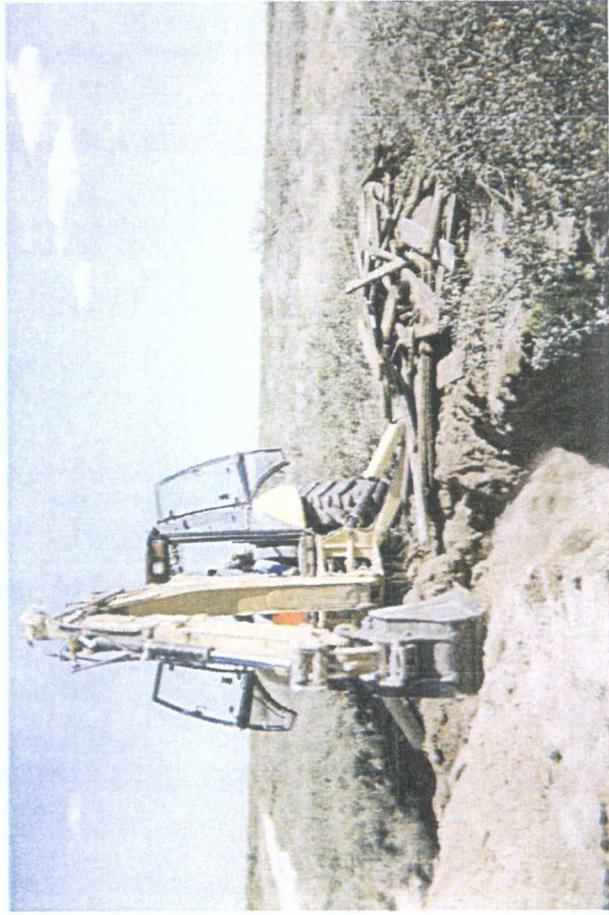
10/7/2008

backfilling 5x3x12-ft-deep excavation

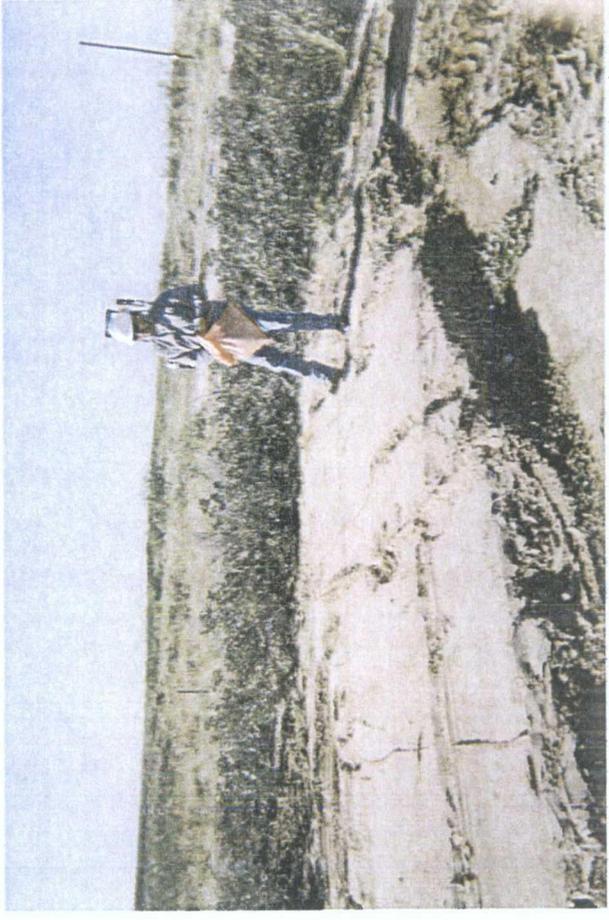
10/10/2008

seeding backfilled site, facing south

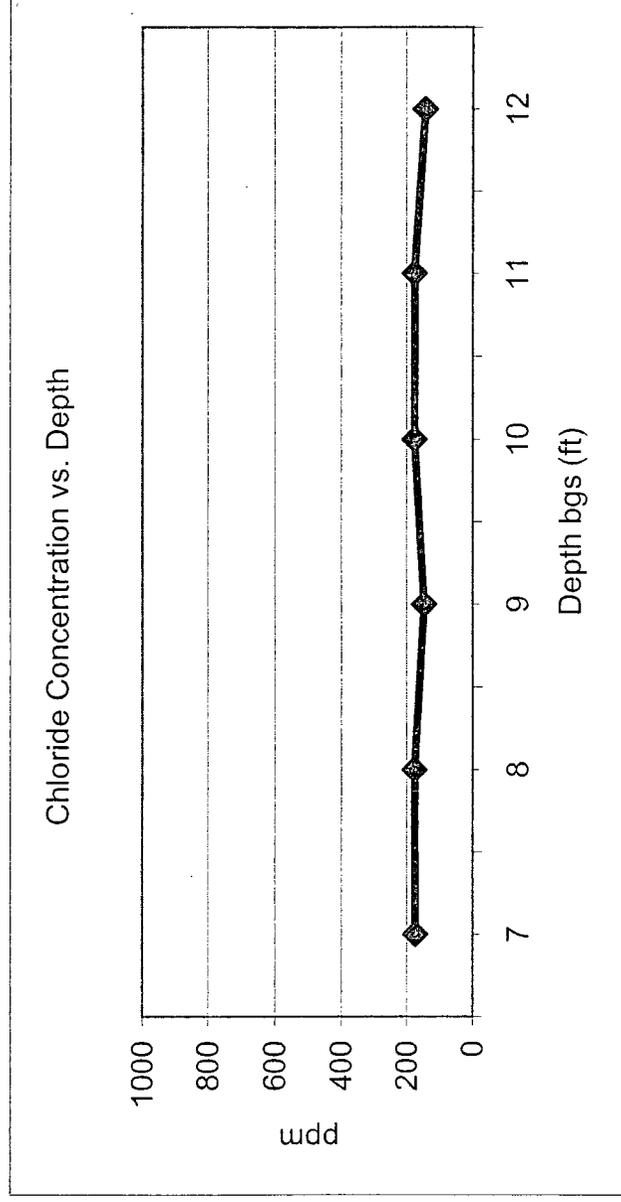
Backhoe samples at junction (source)

Depth bgs (ft)	Cl ⁻ ppm
7	174
8	176
9	147
10	176
11	176
12	143

Groundwater = 73 ft
