# EME Duke Eunice Plant EOL

# CLOSURE

**RICE OPERATING COMPANY  
JUNCTION BOX FINAL REPORT**

Unit G, Section 5, T21S, R36E

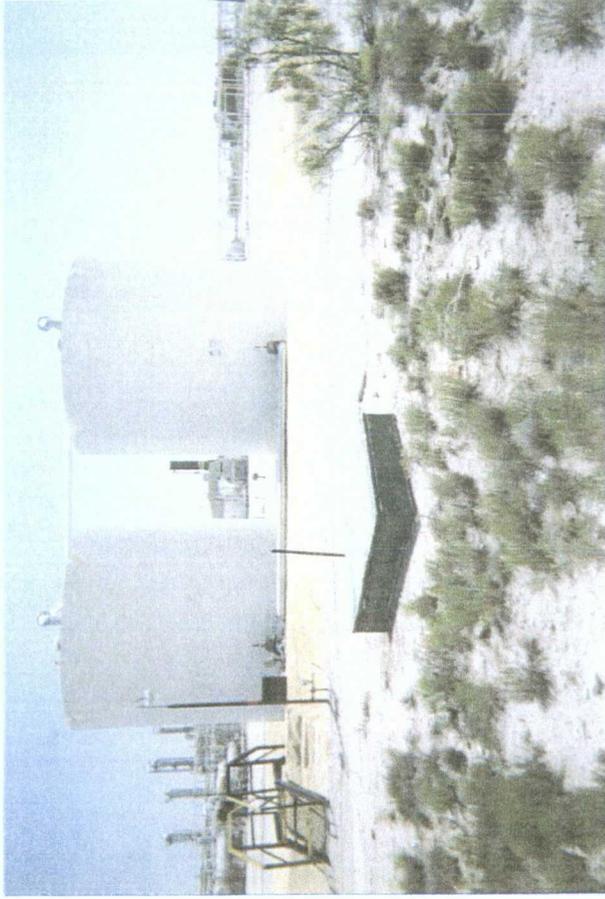
8/21/2007

undisturbed junction box

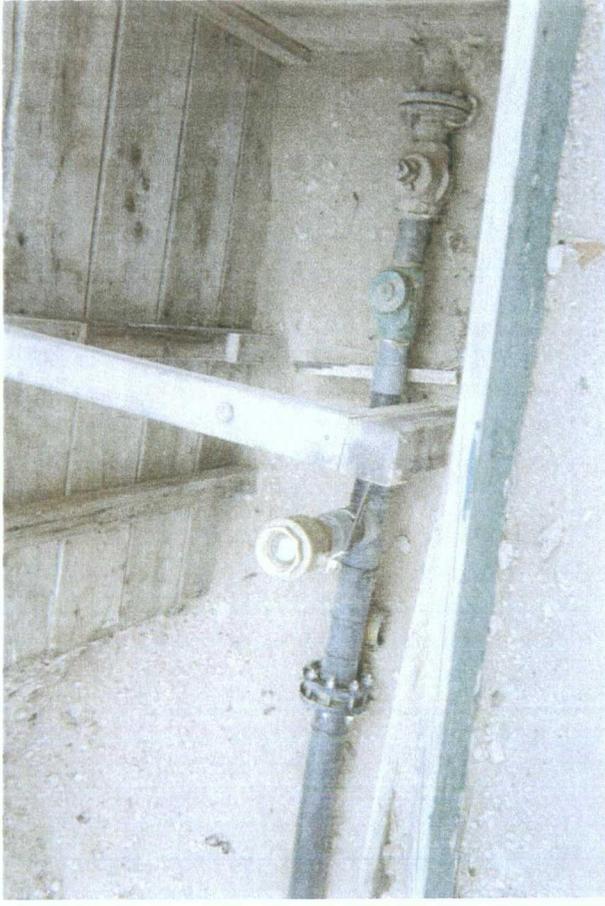
5/29/2008

plumbing at former junction box

General Description of Remedial Action: This junction was addressed during the pipeline replacement/upgrade program. A new, watertight junction box was built 15 ft northwest of the former. After the former box was removed, an investigation was conducted using hand auger to collect soil samples at regular intervals. Field data suggests the site is low in organic vapors, and chloride concentrations in the soil are similar to that of the background. The deepest sample, 7 ft BGS, was sent to a commercial laboratory for analysis of chloride and TPH, confirming low concentrations. The excavated soil was returned to the excavation and contoured to the surrounding area. On 7/10/2008, the site was seeded with a blend of native vegetation and is expected to return to a productive capacity at a normal rate.

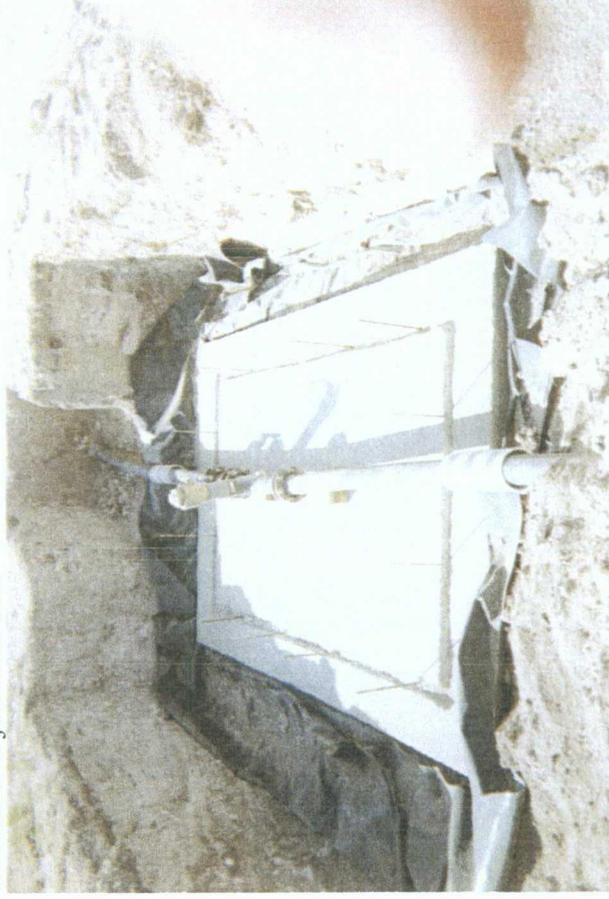
6/9/2008

plumbing at new junction box

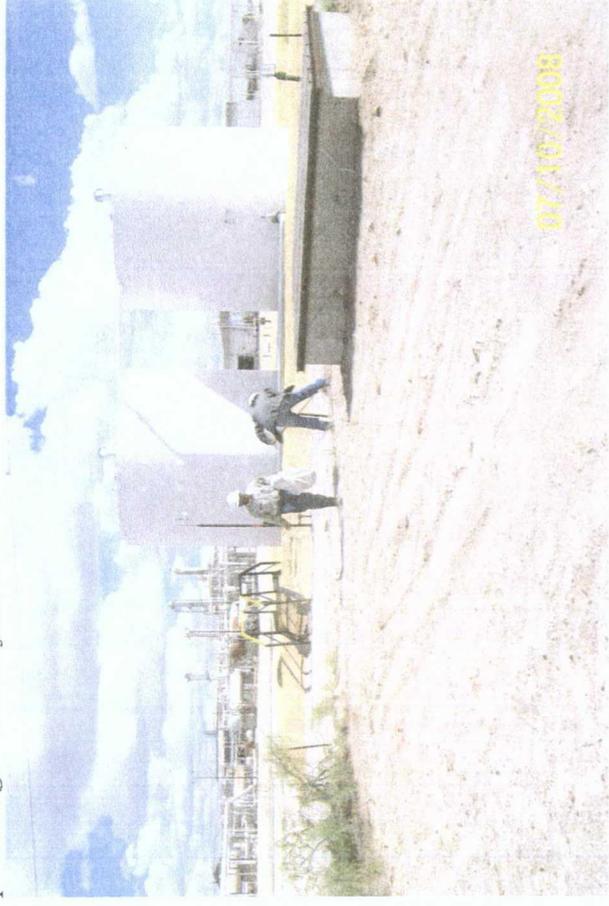
07/10/2008

seeding backfilled site with new, watertight junction box on right

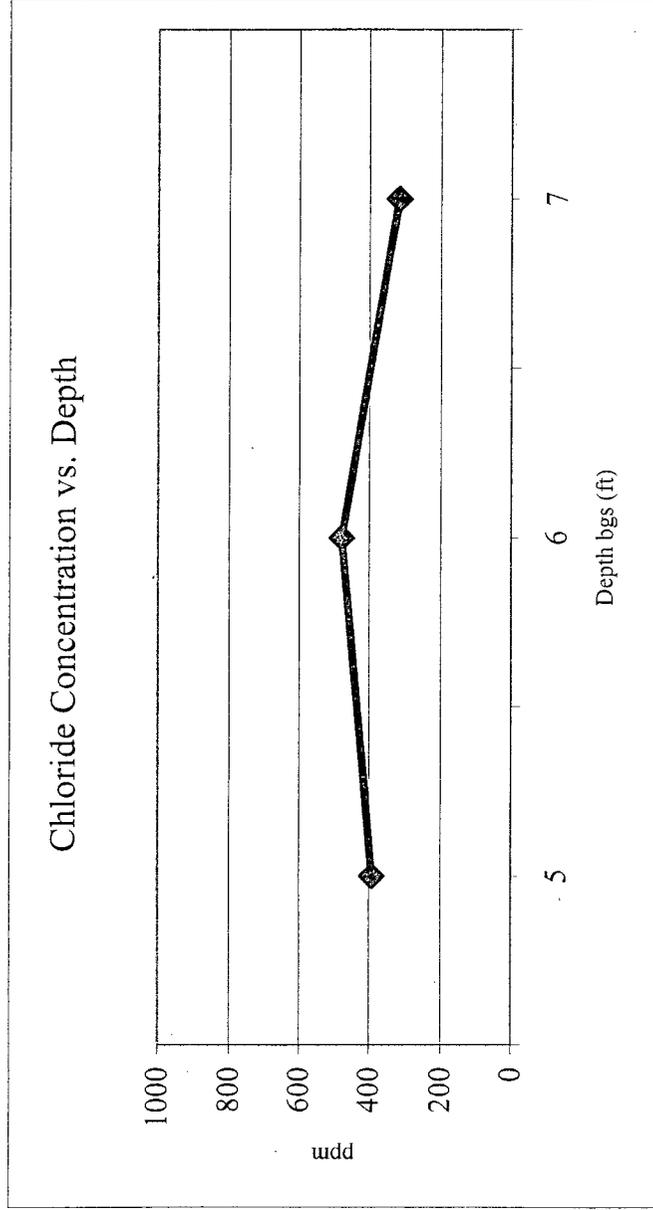
# CHLORIDE CONCENTRATION CURVE

Backhoe samples at junction (source)

Depth bgs (ft)	[G] ppm
5	392
6	479
7	317

Groundwater = 184 ft

LOCATION	DEPTH	mg/kg
background	1'	198
hand auger at the junction (source)	5'	392
	6'	479
	7'	317
