EME Jct I-1

**RICE OPERATING COMPANY  
JUNCTION BOX FINAL REPORT**

Unit I, Section 1, T20S, R37E

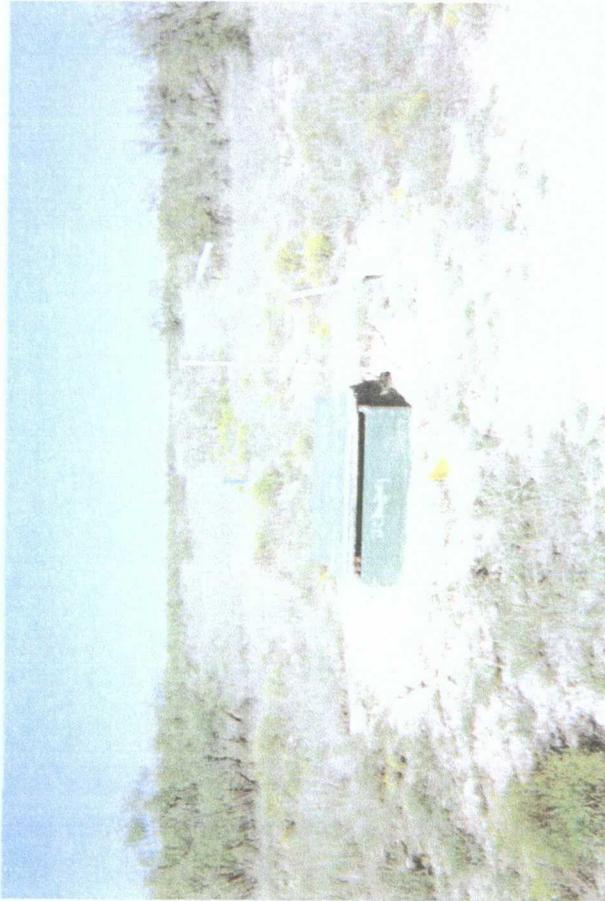
9/18/2008

undisturbed junction box

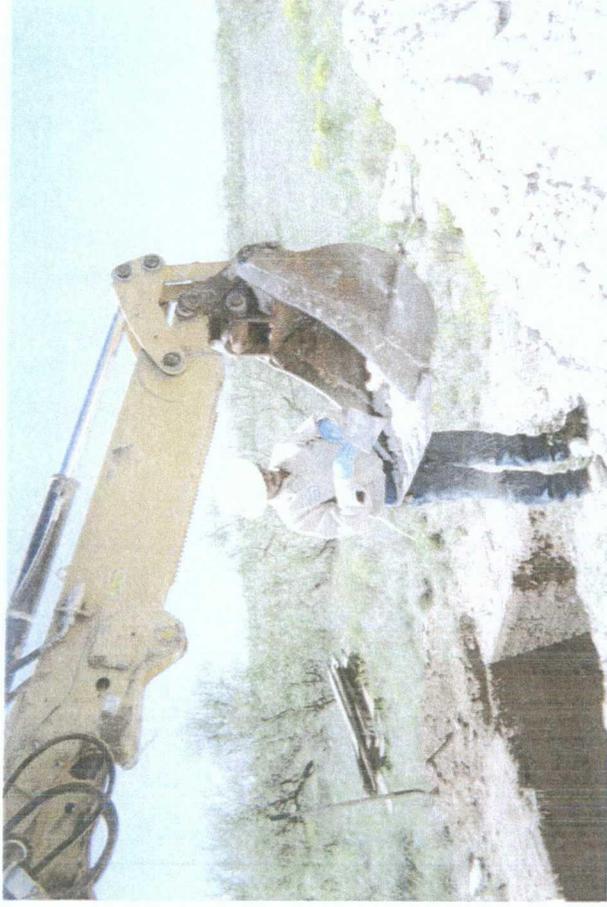
9/18/2008

collecting a soil sample

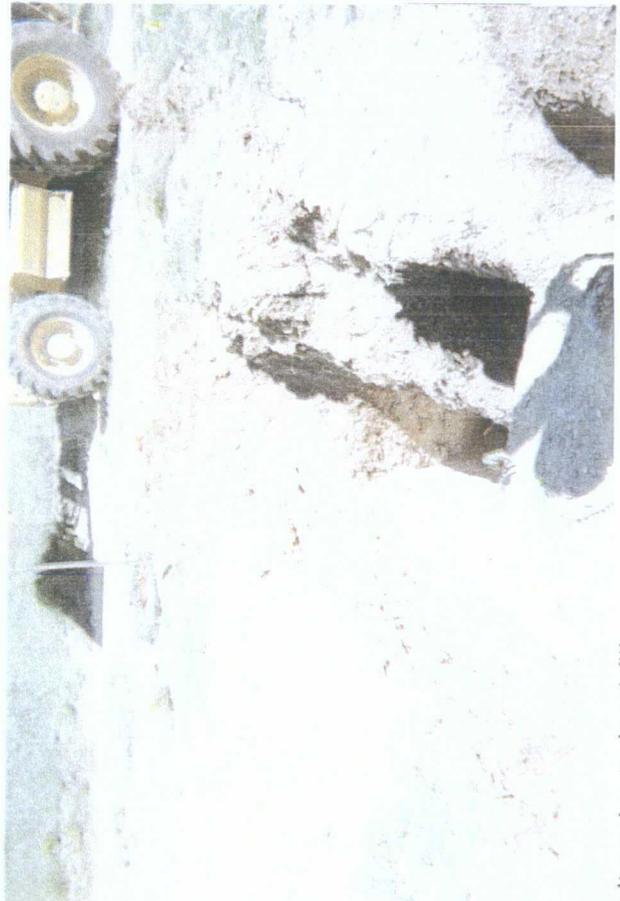
9/18/2008

site prior to backfill

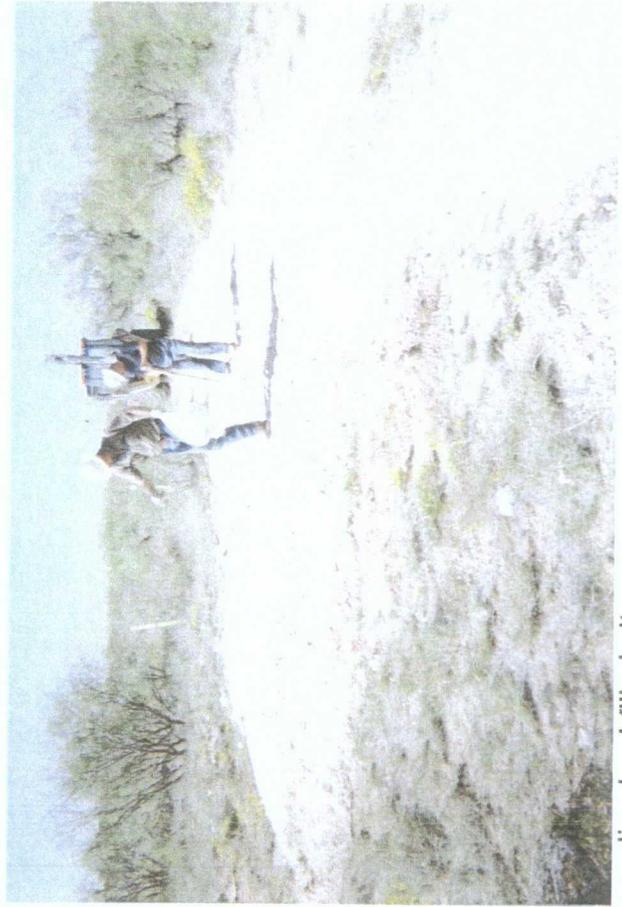
9/29/2008

seeding backfilled site

**General Description of Remedial Action:** This junction was eliminated during the pipeline replacement/upgrade program. After the former junction box was removed, an investigation was conducted using a backhoe to collect soil samples at regular intervals producing a 5x3x15-ft-deep excavation. Chloride field tests performed on each sample yielded generally low concentrations that decreased with depth. Organic vapors were measured using a PID, which also yielded low concentrations. The deepest sample, 15 ft BGS, was analyzed by a commercial laboratory for chloride and TPH, which confirmed low concentrations. The excavated soil was returned to the excavation and clean blow sand was used as a top cap and to contour the site to the surrounding area. On 9/29/2008, the site was seeded with a blend of native vegetation and is expected to return to a productive capacity at a normal rate.

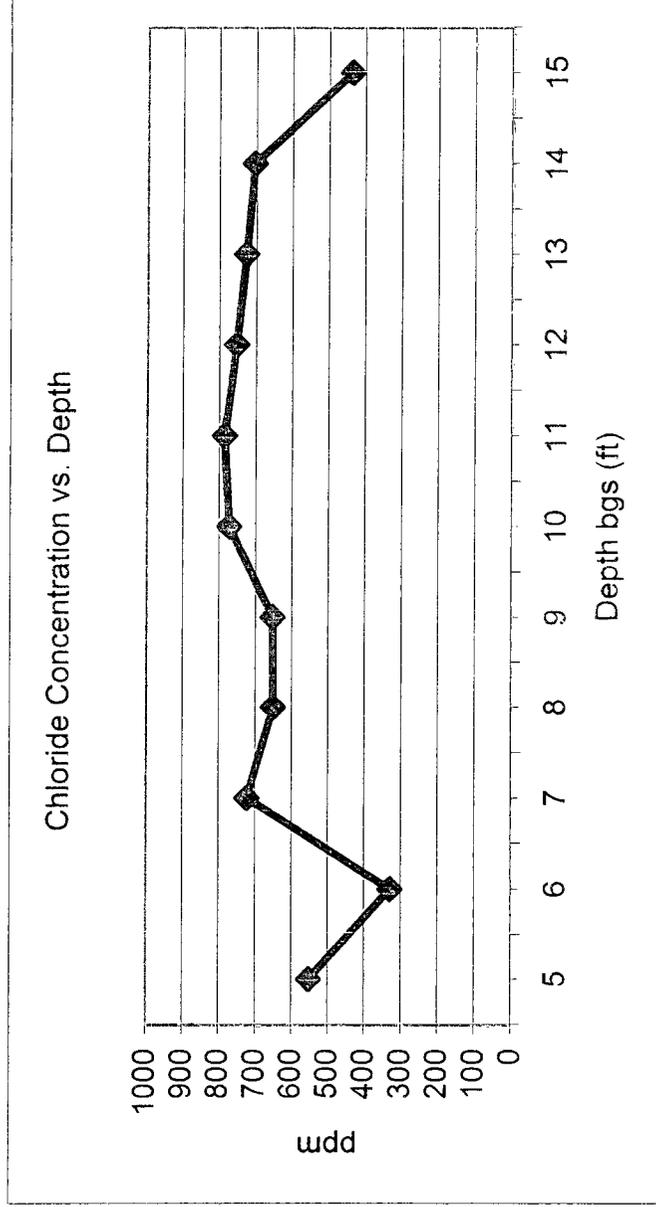
# CHLORIDE CONCENTRATION CURVE

Backhoe samples at the junction (source)

Depth: bgs. (ft)	[Cl <sup>-</sup> ] ppm
5	552
6	329
7	722
8	651
9	652
10	772
11	785
12	753
13	727
14	704
15	436

Groundwater = 55 ft

LOCATION	DEPTH	mg/kg
background	6"	173
vertical delineation trench at the junction (source)	5'	552
	6'	329
	7'	722
	8'	651
	9'	652
	10'	772
	11'	785
	12'	753
	13'	727
	14'	704
15'	436
