**EME** (Finley) **Ida White Boot**

**1R427-255**

**RICE OPERATING COMPANY  
JUNCTION BOX FINAL REPORT**

## EME Ida White boot

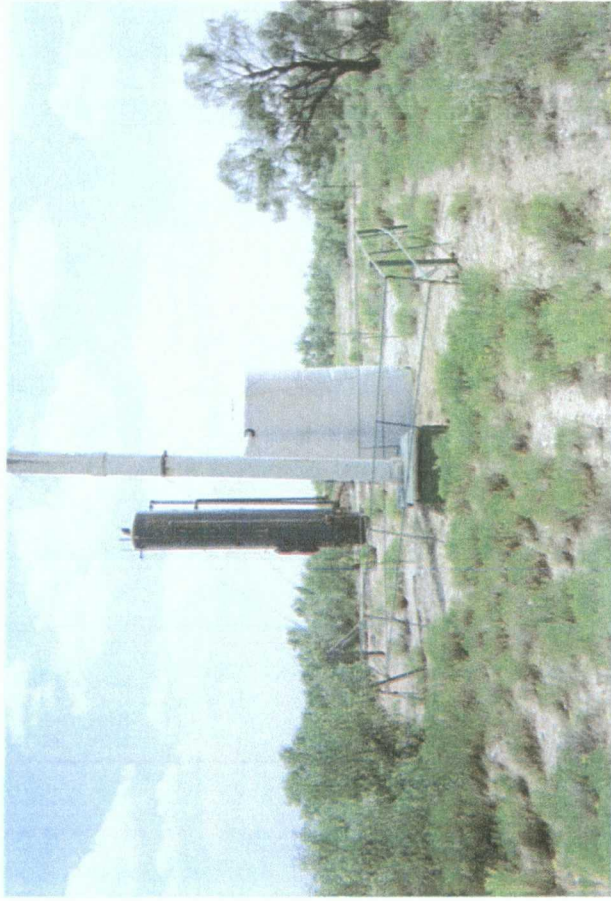
8/15/2007

undisturbed junction box

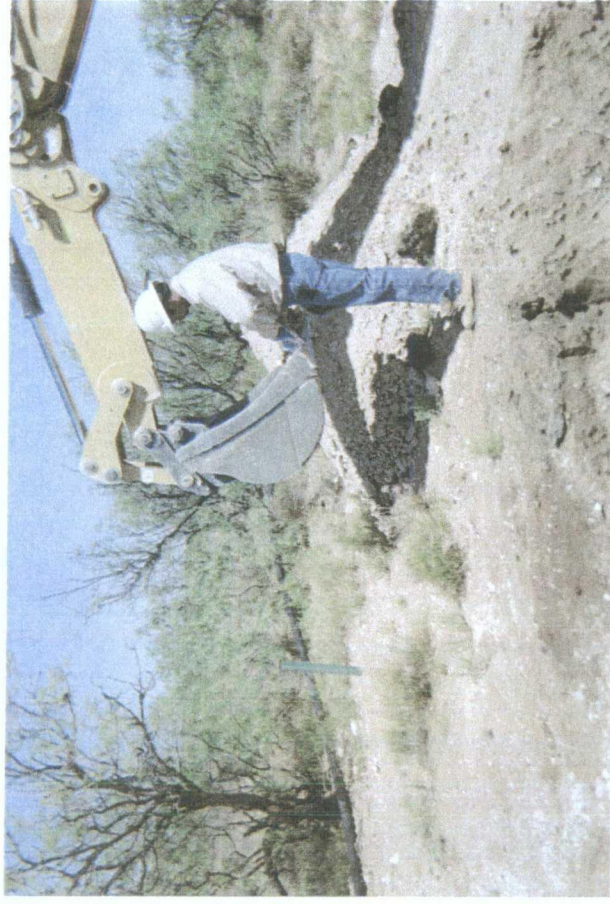
6/11/2008

collecting a soil sample

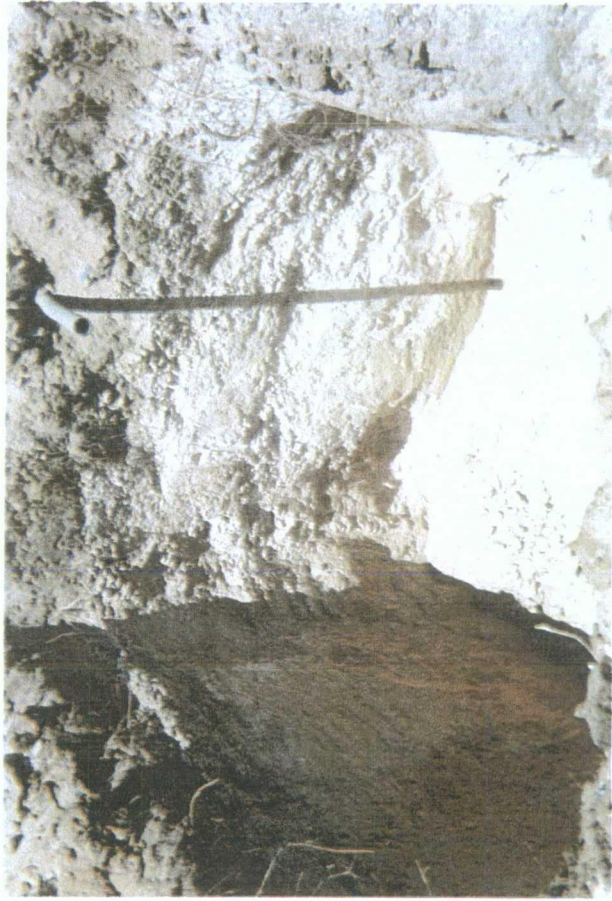
6/12/2008

10x10x12-ft-deep excavation

**General Description of Remedial Action:** This junction was addressed during the pipeline replacement/upgrade program. After the former junction box was removed, an investigation was conducted using a backhoe to collect soil samples at regular intervals producing a 10x10x12-ft-deep excavation. Chloride field tests performed on each sample yielded generally low concentrations. Organic vapors were measured using a PID, which also yielded low concentrations. Representative composite samples were sent to a commercial laboratory for analysis of chloride and TPH, which confirmed low concentrations. The excavated soil was blended on-site and returned to the excavation up to 5'6" below ground surface (BGS). A 5'6" deep shelf was excavated extending 5 ft out from the north, south, east, and west walls to prepare the surface for a clay barrier. At 5'6" to 4'6" a 1-ft-thick clay barrier was installed with a clay density test performed on 7/1/2008. The excavation was then backfilled and a new, watertight junction box was built in place of the former.

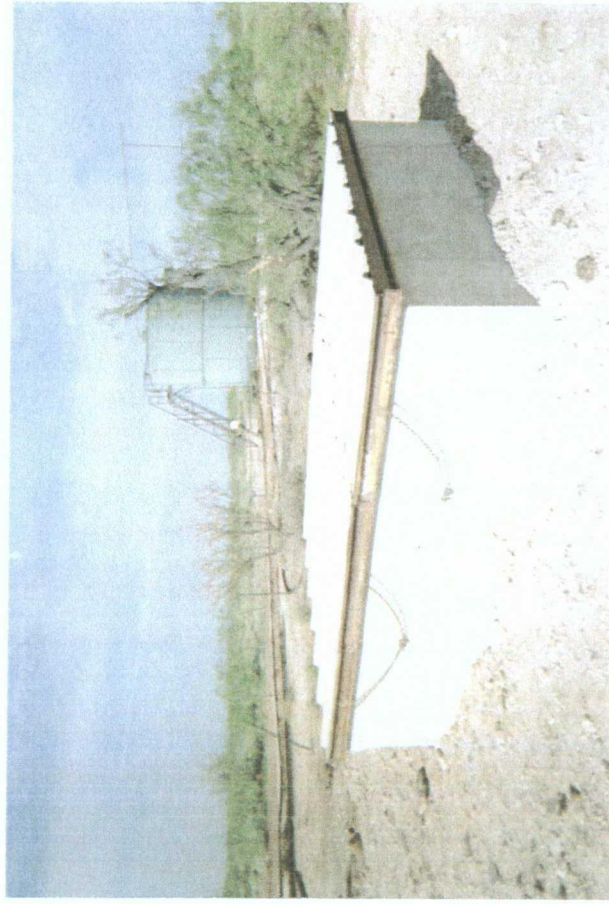
8/27/2008

new, watertight junction box
