**RICE OPERATING COMPANY  
JUNCTION BOX FINAL REPORT**

## EME Jct. A-19-2

Unit A, Section 19, T21S, R36E

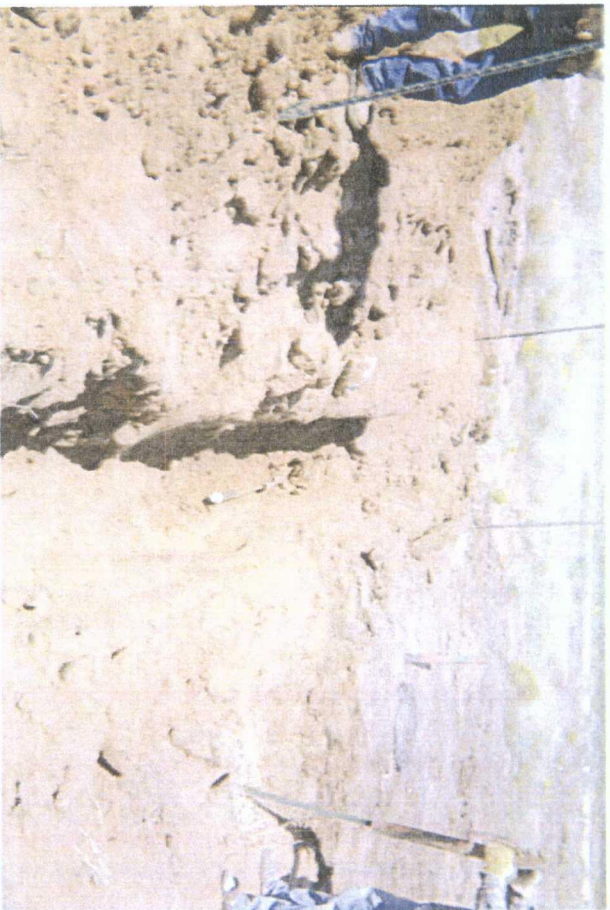
former junction box site

9/31/2008

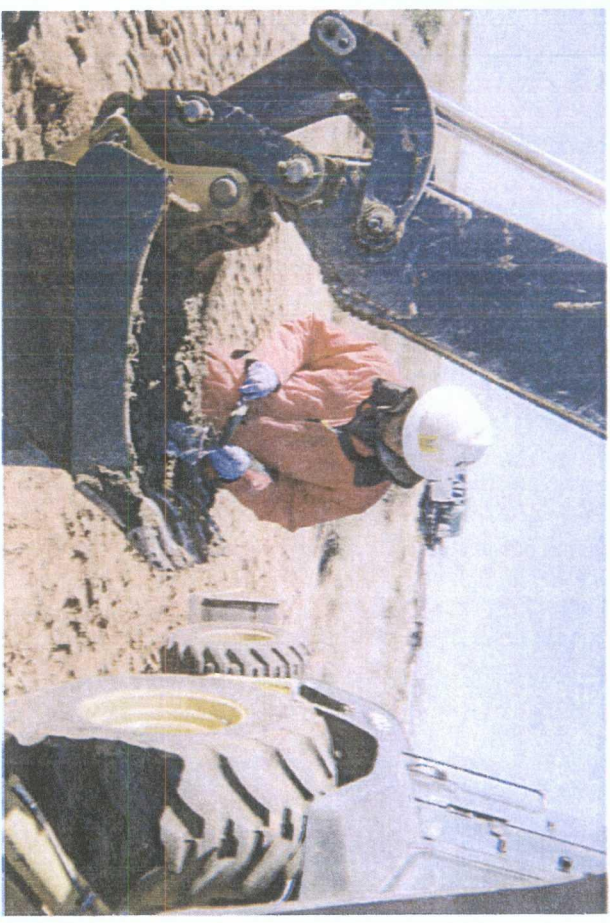
collecting a soil sample

10/28/2008

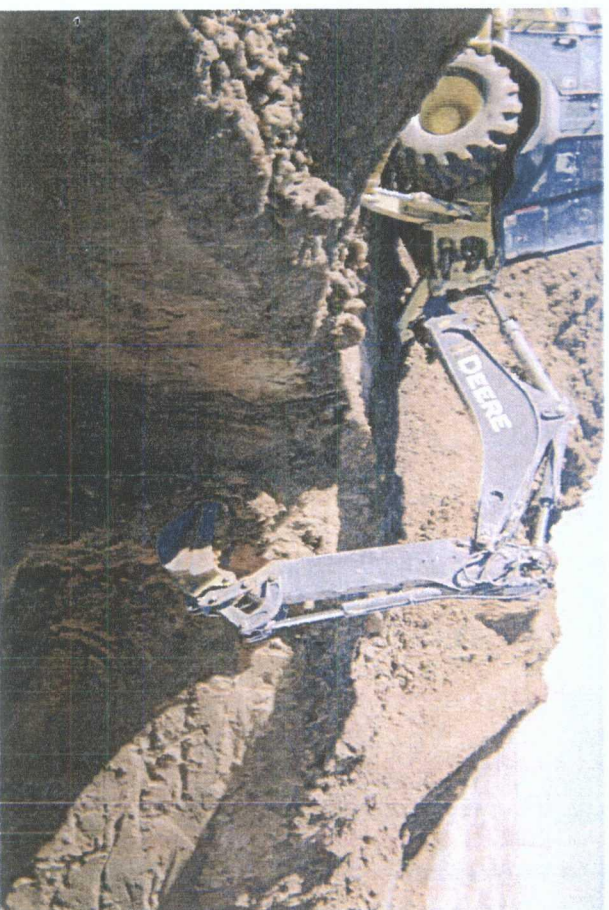
squaring up the excavation

10/28/2008

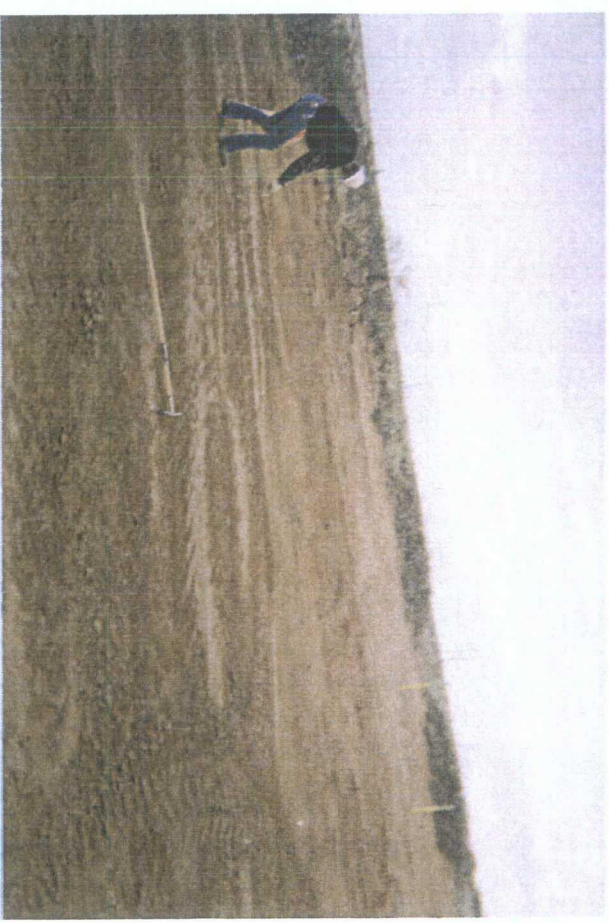
seeding backfilled site

11/10/2008
