EME Chesapeake Turner EOL

1R427-268

**RICE OPERATING COMPANY
JUNCTION BOX FINAL REPORT**

Unit O, Section 6, T20S, R38E

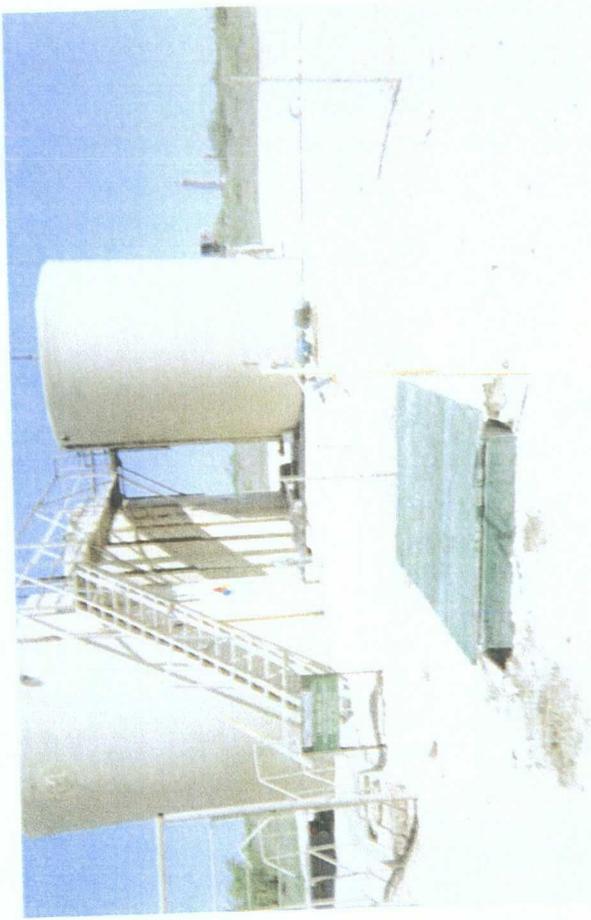
9/16/2008

undisturbed junction box, facing east

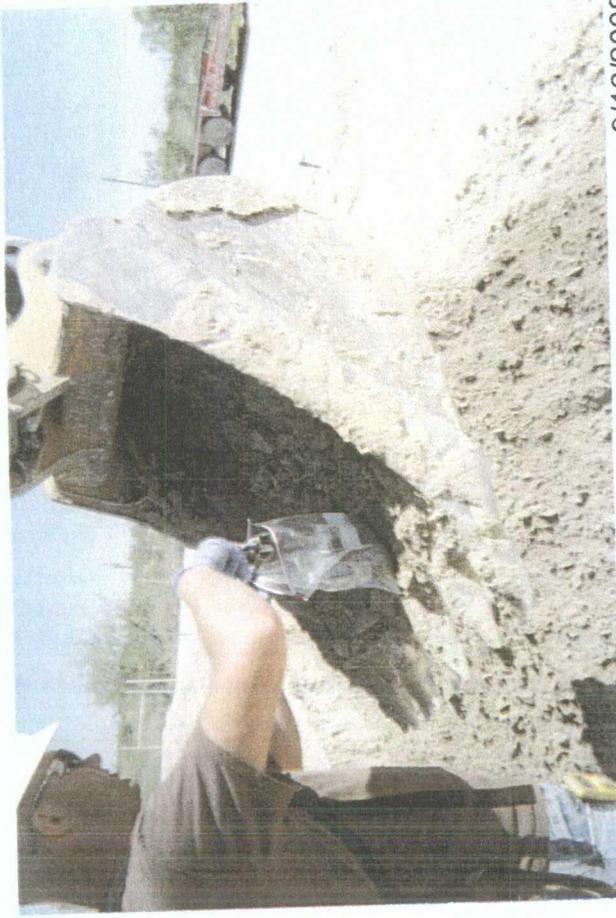
9/16/2008

collecting a soil sample, facing east

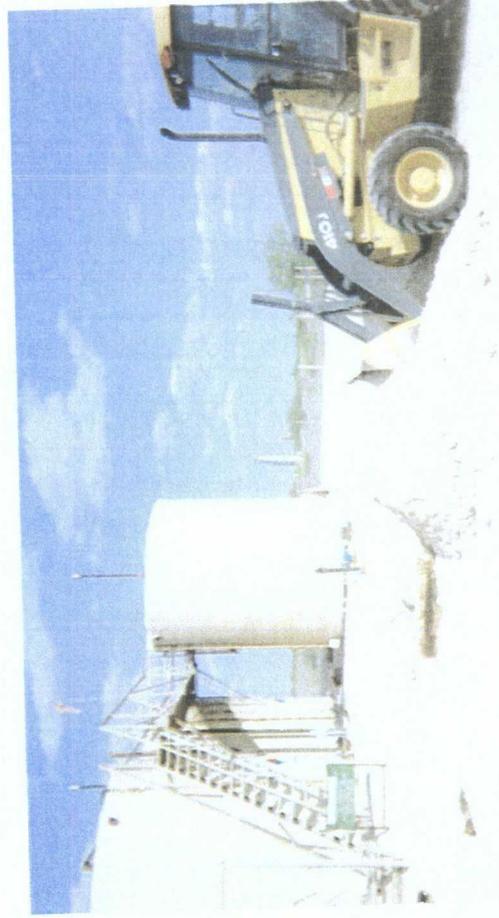
9/26/2008

backfilling with clean, imported caliche, facing east

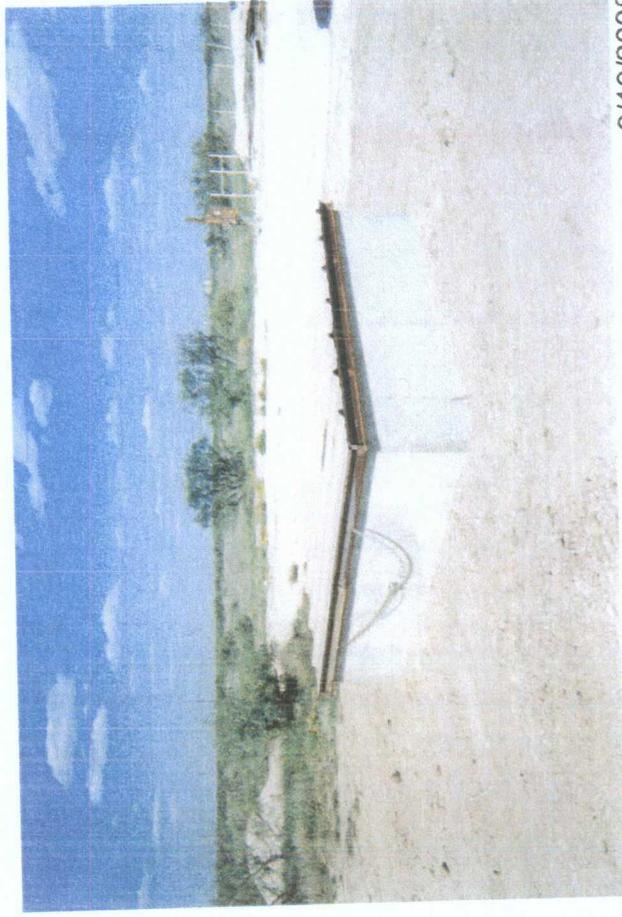
9/19/2008

new, watertight junction box
