EMIE Jct HI-36 Vent

**RICE OPERATING COMPANY
JUNCTION BOX DISCLOSURE* REPORT**

EME Jct. H-36 vent

Unit H, Section 36, T20S, R36E

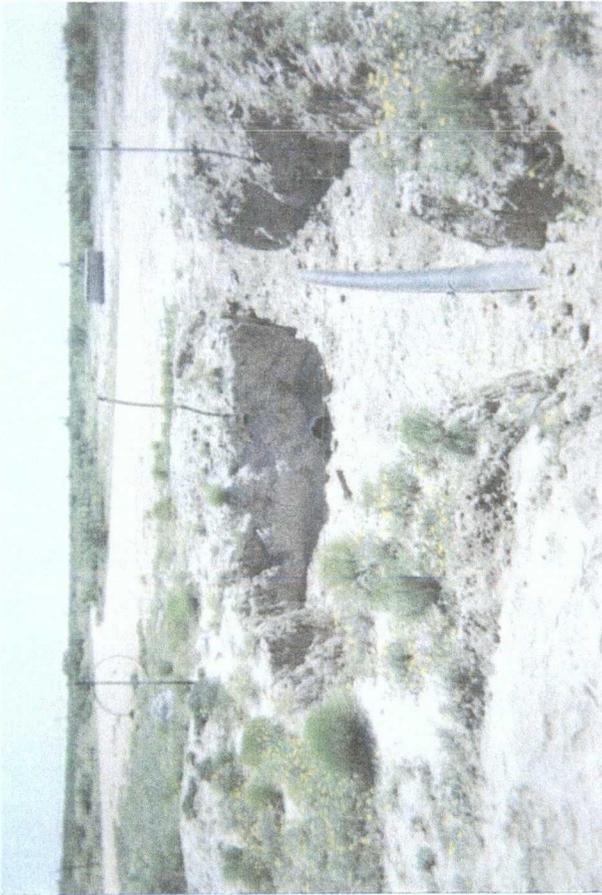
7/18/2007

former junction box site in foreground and new, watertight box in background

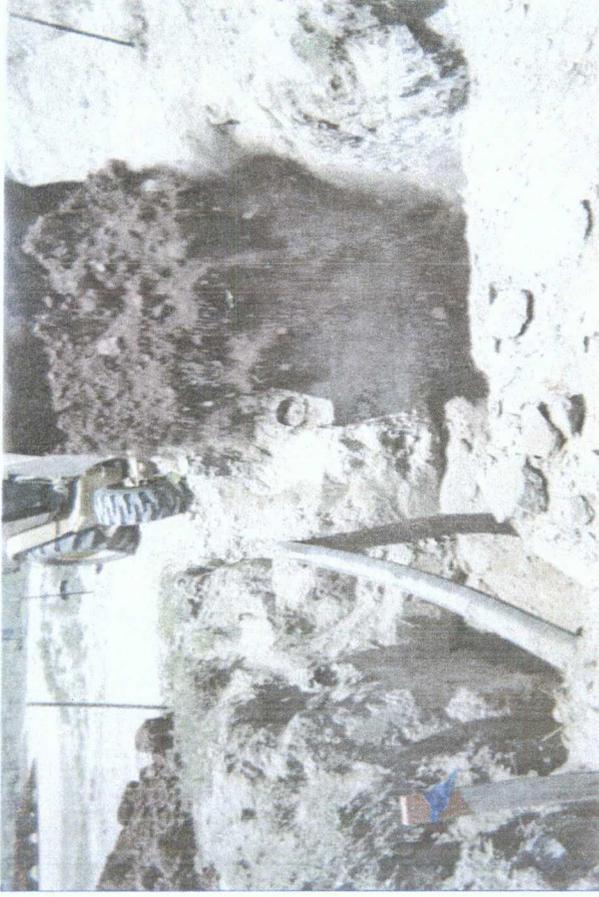
6/25/2007

clay barrier being installed

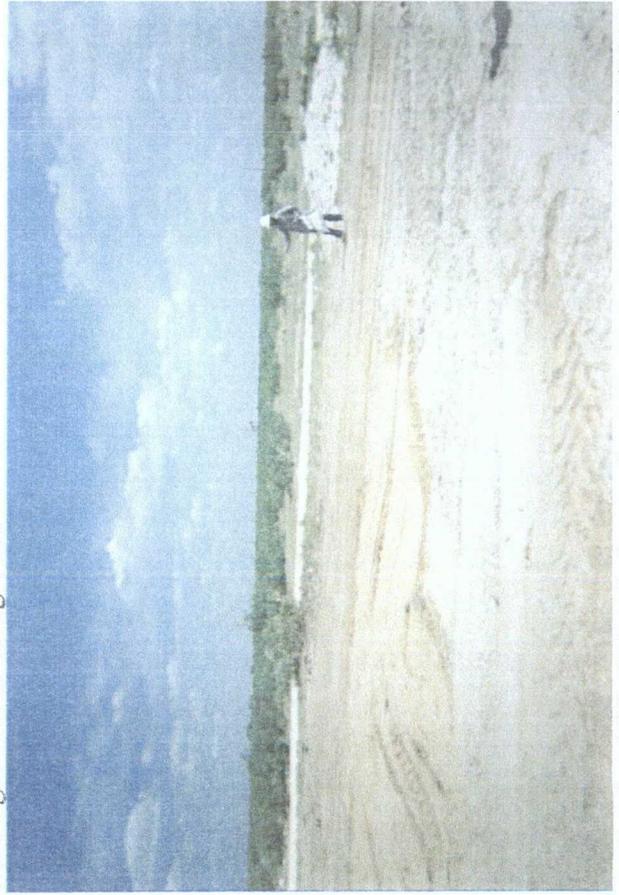
7/13/2007

seeding backfilled site, facing north

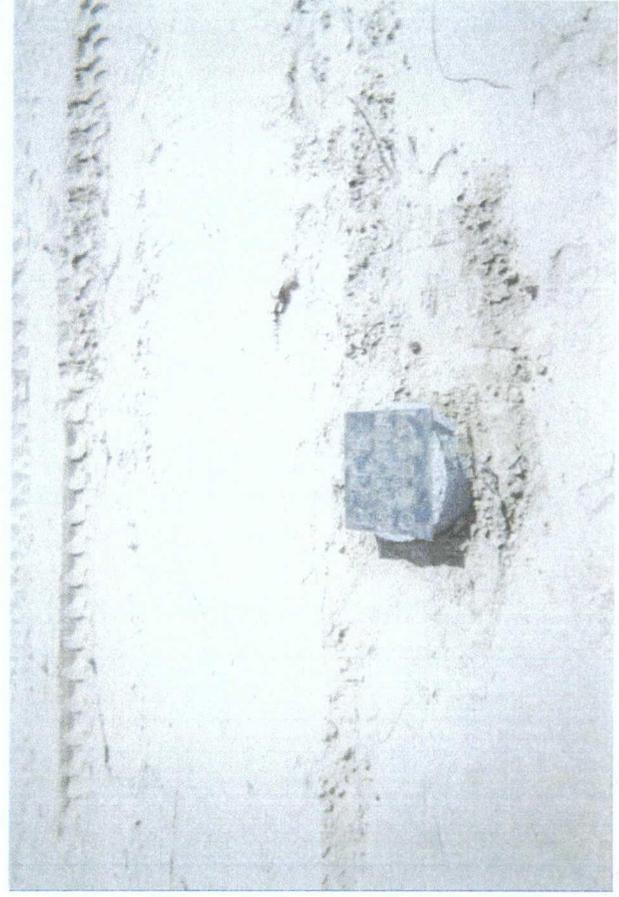
7/16/2007

clay marker

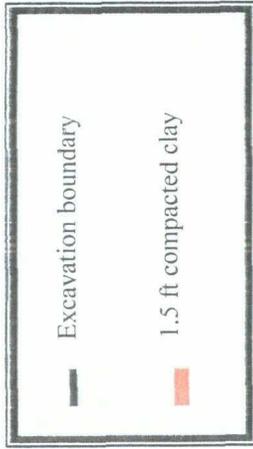
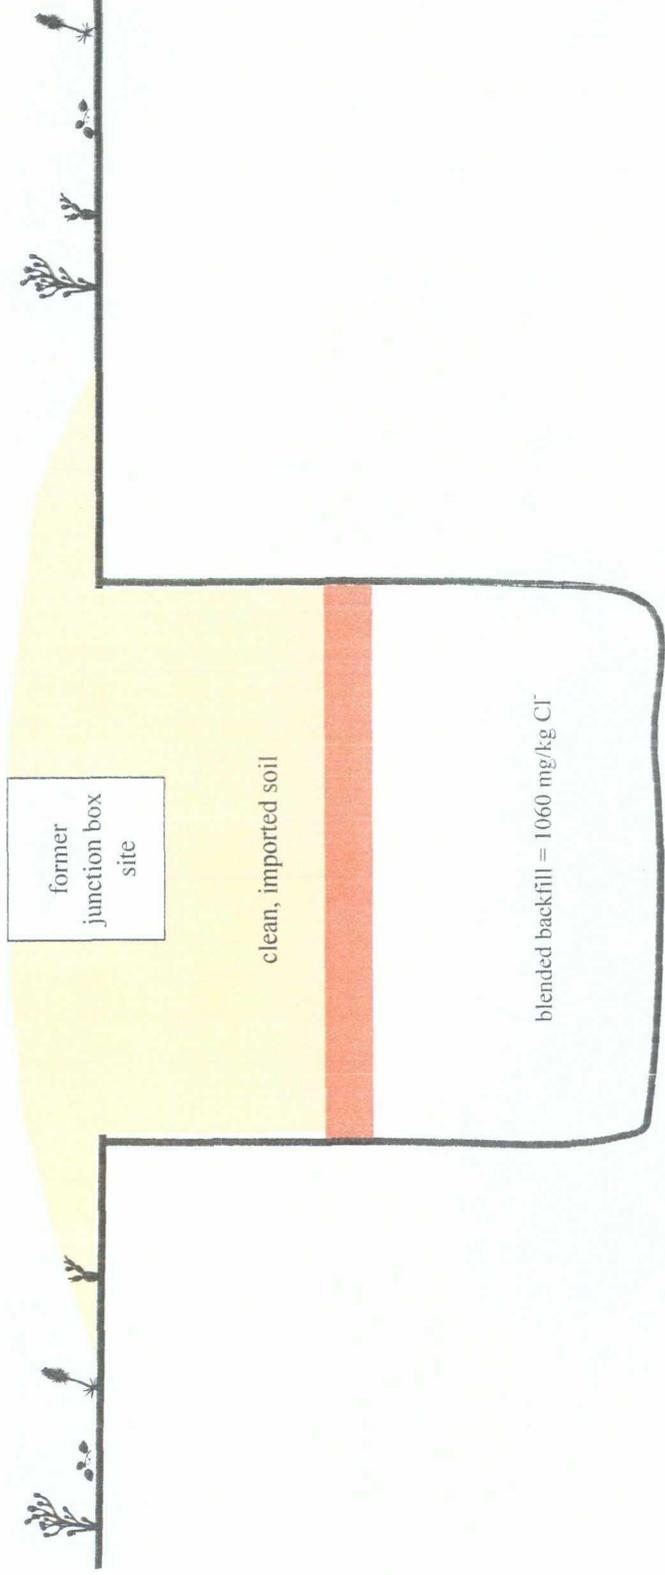
Excavation Cross-Section

10 x 10 x 12-ft-deep

10 ft

surface	0
ft BGS	1
	2
	3
	4
	5
	6
	7
	8
	9
	10
	11
	12

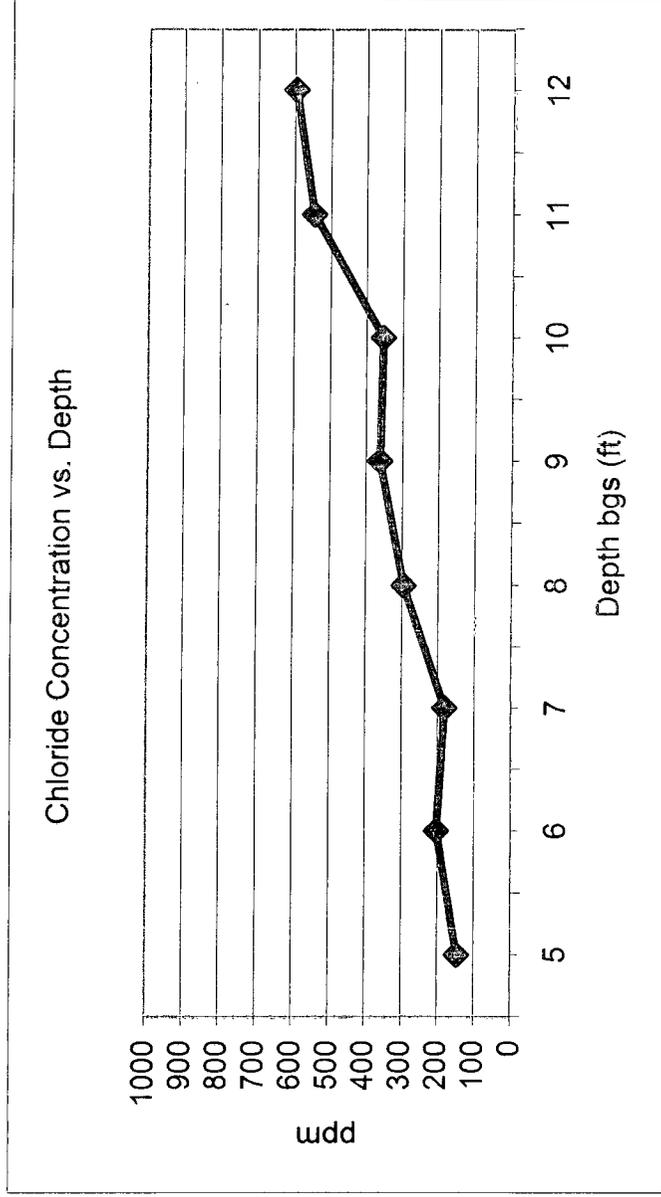
CHLORIDE CONCENTRATION CURVE

Backhoe samples at 5 ft north of the junction (source)

Depth bgs (ft)	[Cl] ppm
5	146
6	203
7	181
8	295
9	362
10	354
11	545
12	596

Groundwater = 123 ft
