EME Jct P-27

**RICE OPERATING COMPANY
JUNCTION BOX DISCLOSURE* REPORT**

EME Jct. P-27

Unit P, Section 27, T19S, R36E

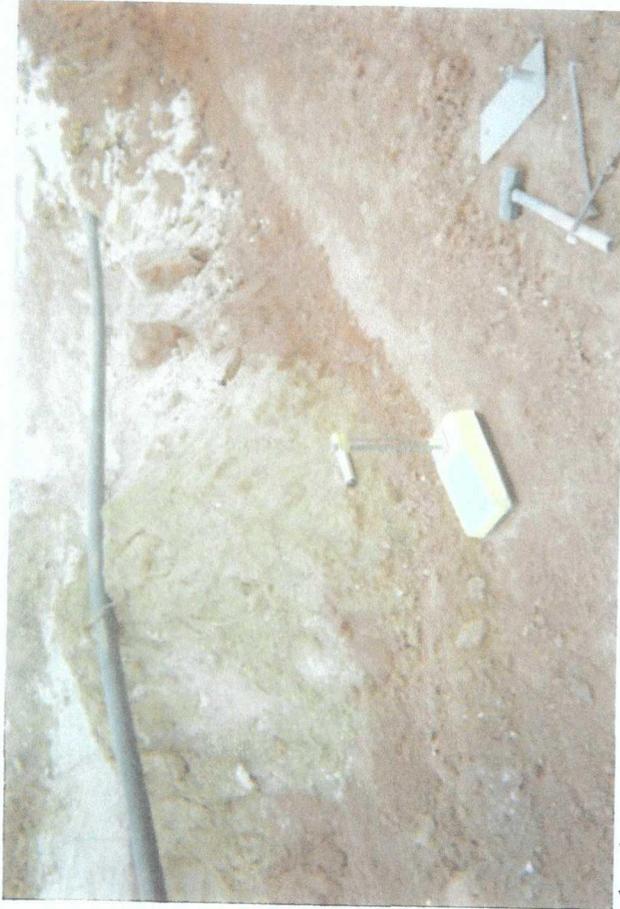
1/04/2008

clay layer compaction test

Test No.	Location	Dry Density % Max	% Moisture	Depth
SG 16	EME Jct. P-27 - 20' W. of Electrical Pole	95.5	17.4	5' Below FSG

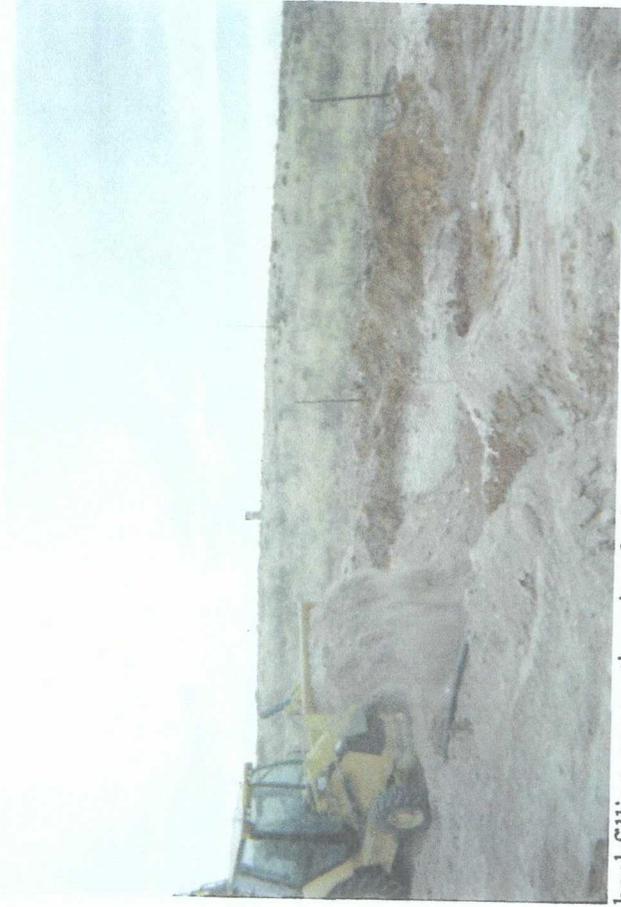
1/04/2008

backfilling excavation site, facing southwest

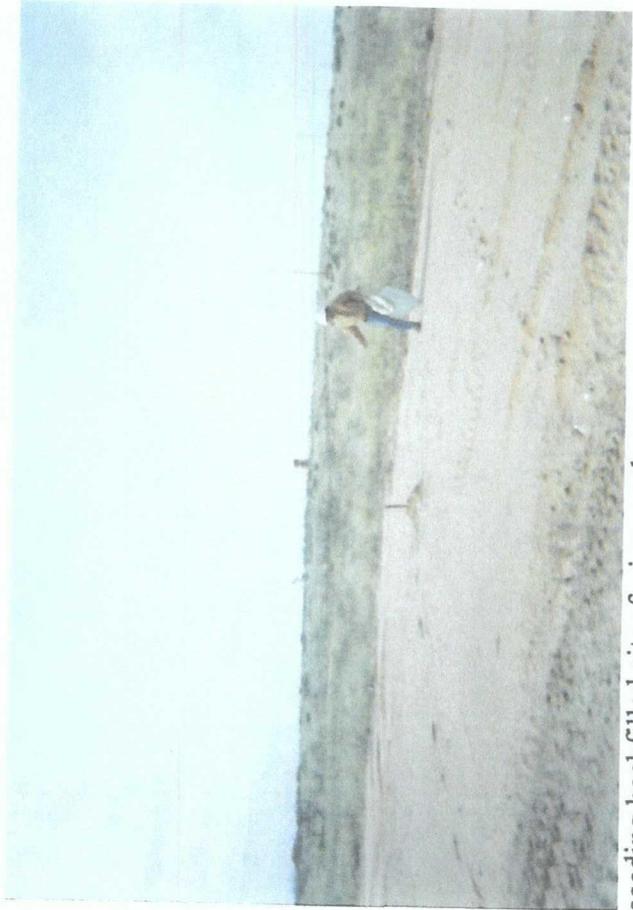
1/08/2008

seeding backfilled site, facing southwest

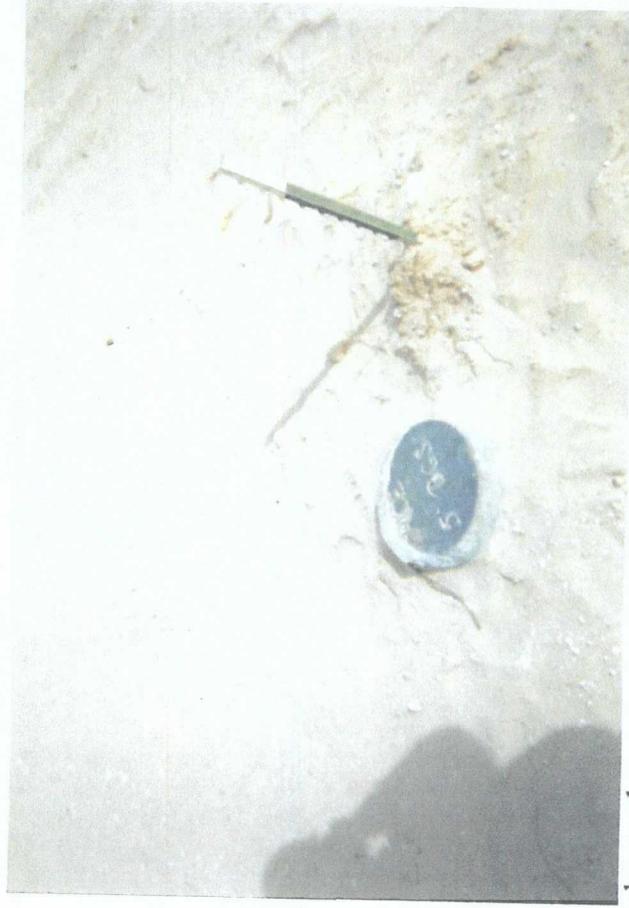
1/08/2008

clay marker

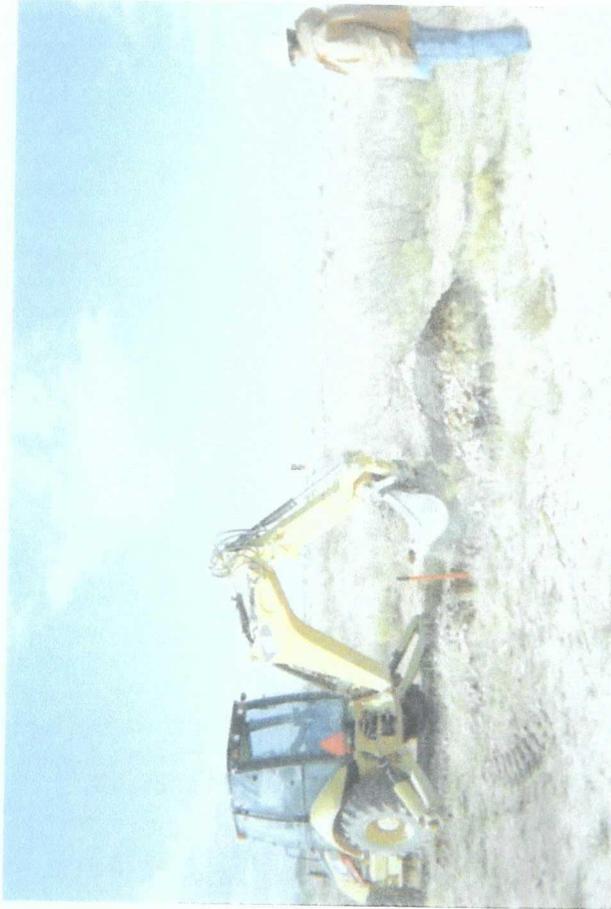
12/12/2007

vertical being excavated, facing southwest

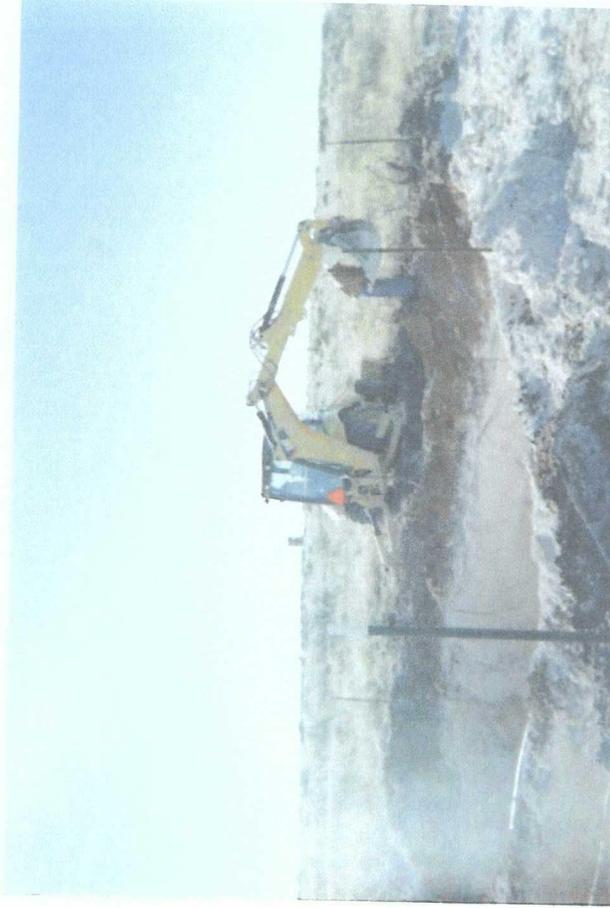
12/26/2007

soil sample being taken 15' west, facing southwest

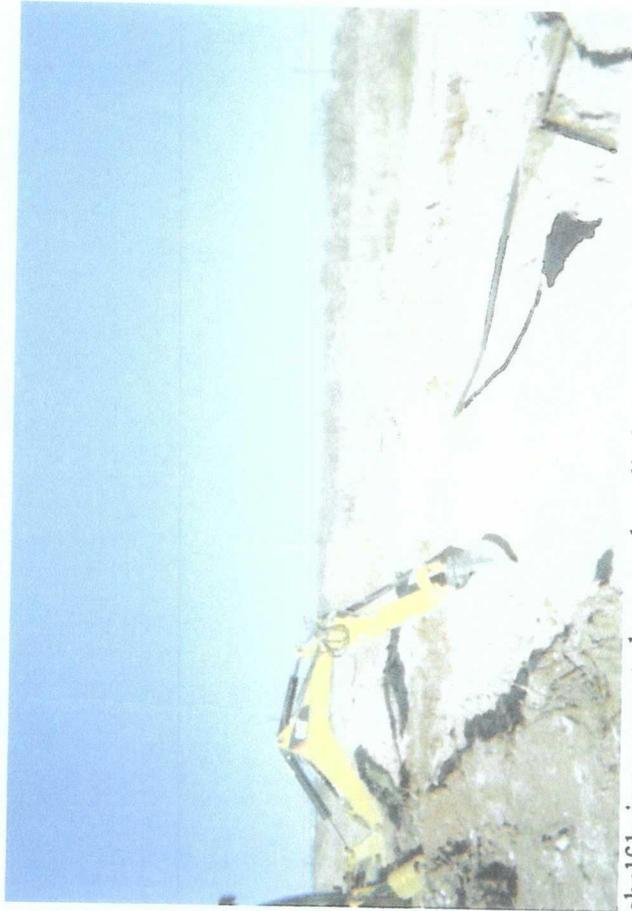
12/31/2007

shelf being excavated on north wall, facing northeast

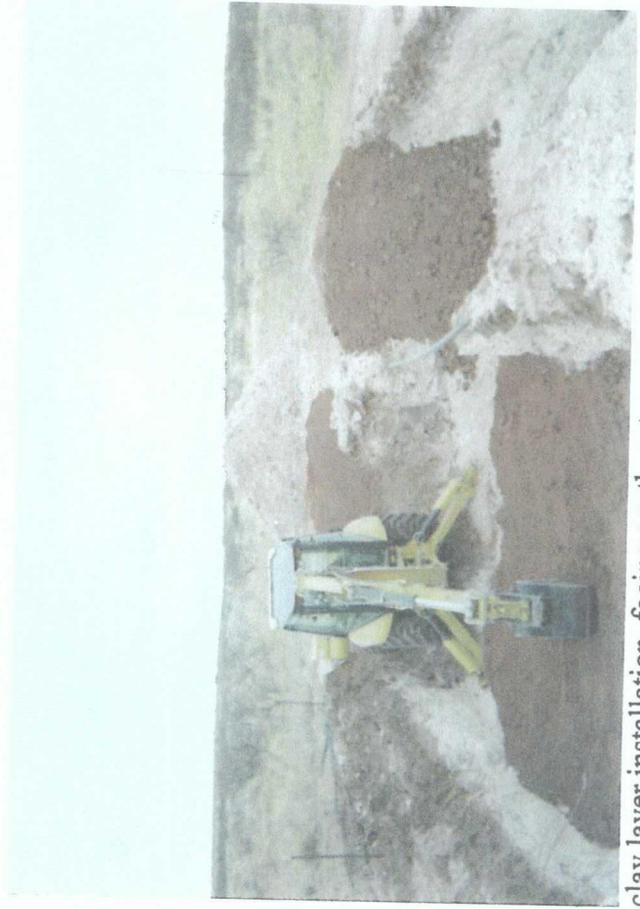
1/04/2008

clay layer installation, facing southeast

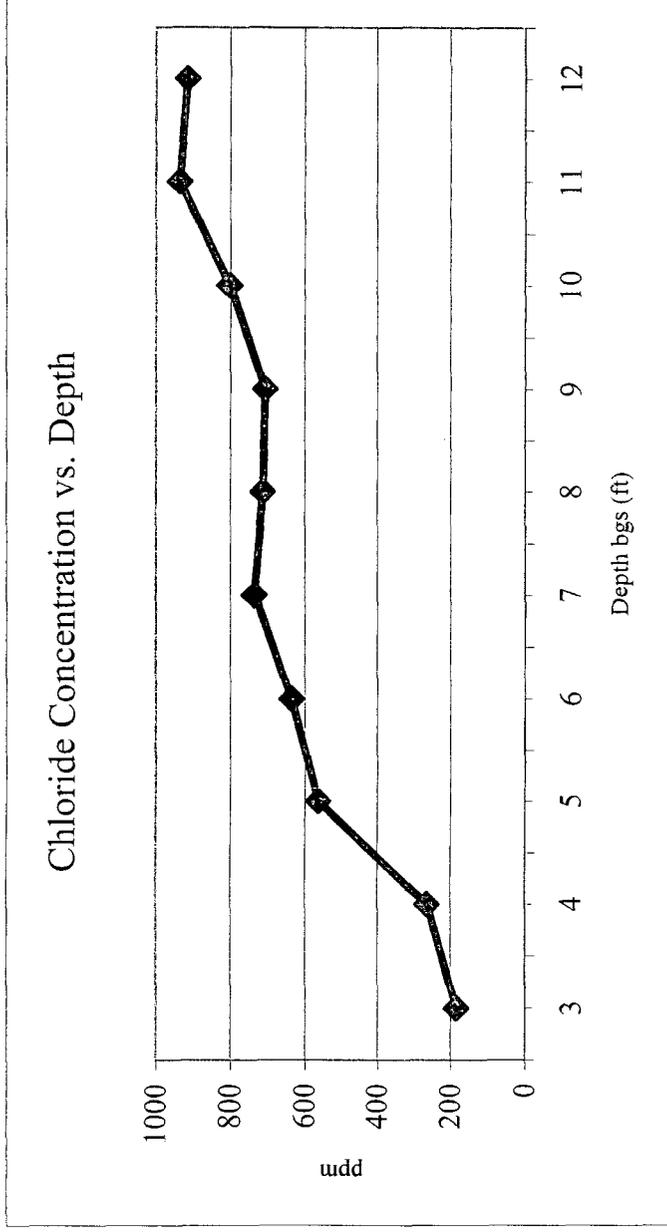
CHLORIDE CONCENTRATION CURVE

Backhoe samples at junction (source)

Depth bgs (ft)	[Cl ⁻] ppm
3	184
4	264
5	563
6	636
7	737
8	714
9	708
10	801
11	934
12	914

Groundwater = 28 ft

LOCATION	DEPTH	mg/kg
4-wall comp.	n/a	682
bottom comp.	12'	745
backfill comp.	n/a	538
vertical delineation trench at the former junction site	3'	184
	4'	264
	5'	563
	6'	636
	7'	737
	8'	714
	9'	708
	10'	801
	11'	934
	12'	914
