**RICE OPERATING COMPANY  
JUNCTION BOX DISCLOSURE\* REPORT**

SWD SYSTEM	JUNCTION	UNIT	SECTION	TOWNSHIP	RANGE	COUNTY	BOX DIMENSIONS - FEET		
							Length	Width	Depth
Eunice Monument Eumont (EME)	Jct. C-8 vent	C	8	20S	37E	Lea	moved 50 ft north

# EME Jct. C-8 vent

Unit C, Section 8, T20S, R37E

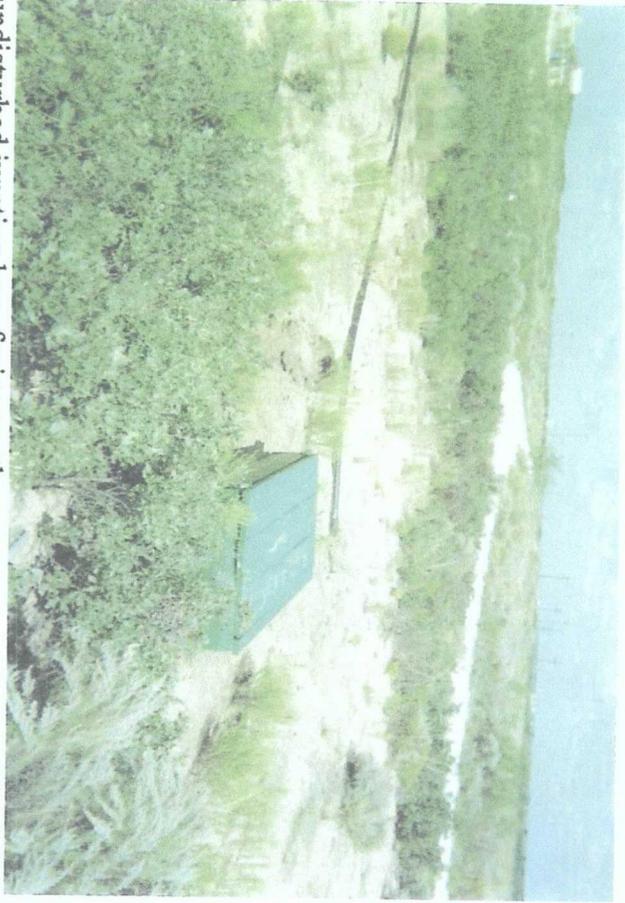
9/24/2004

undisturbed junction box, facing north

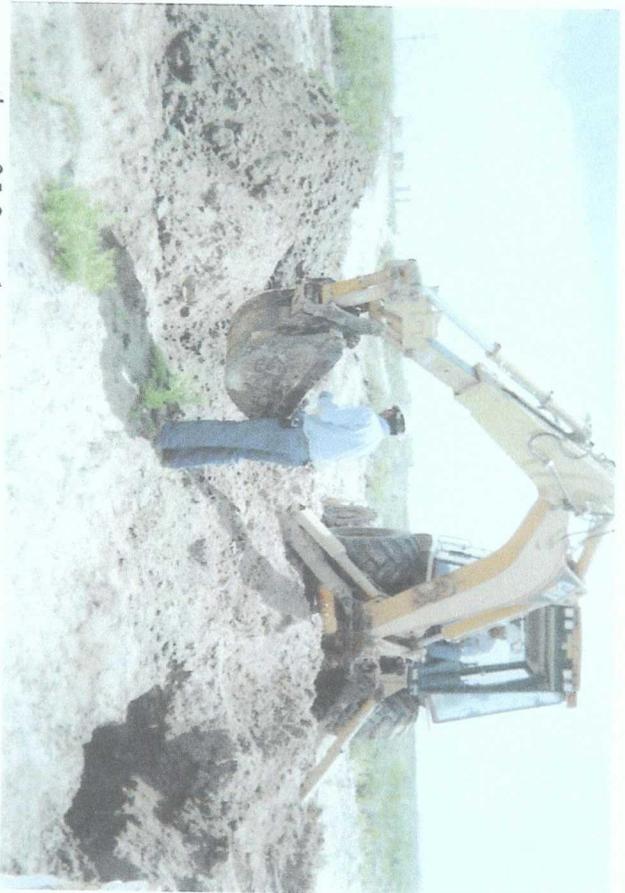
9/18/2006

excavation of 5 ft south vertical

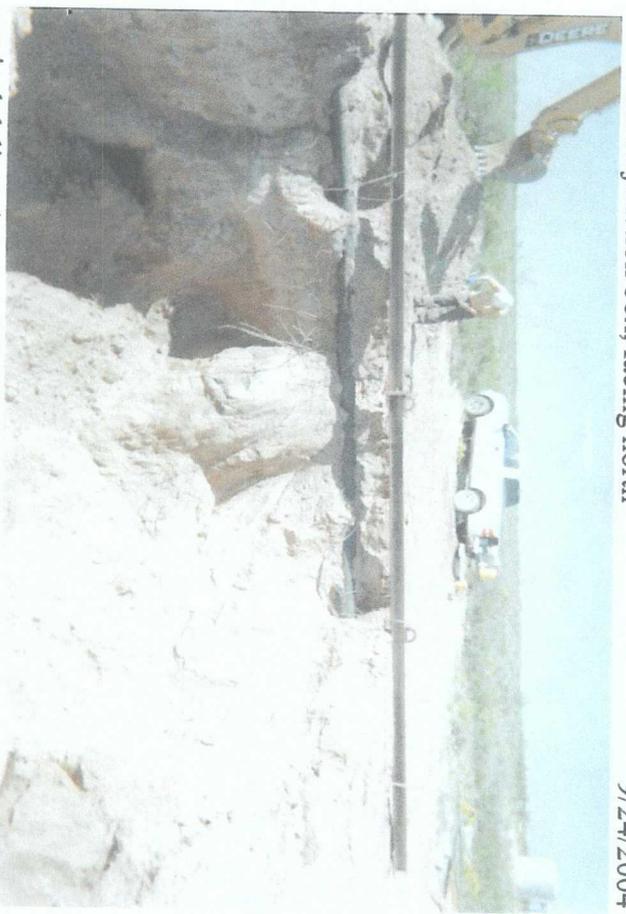
9/20/2006

vertical delineation trench 10 ft south of junction (source)

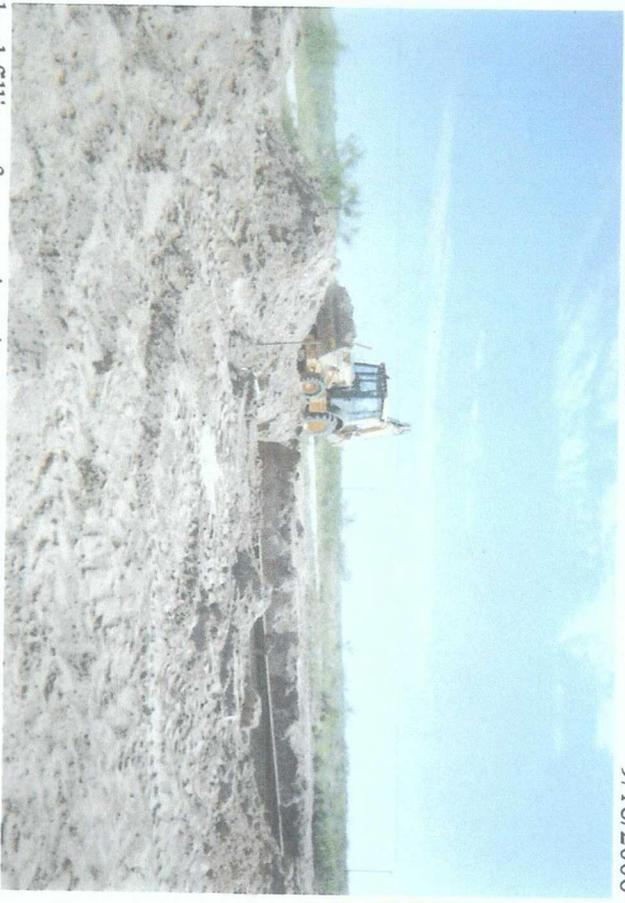
10/12/2006

backfilling of excavation site

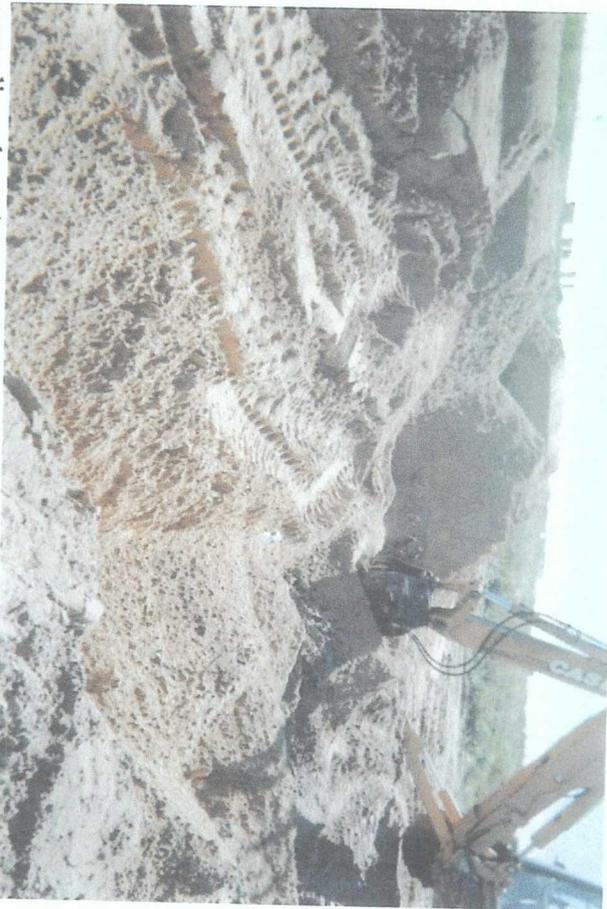
10/19/2006

spreading clean, imported top soil

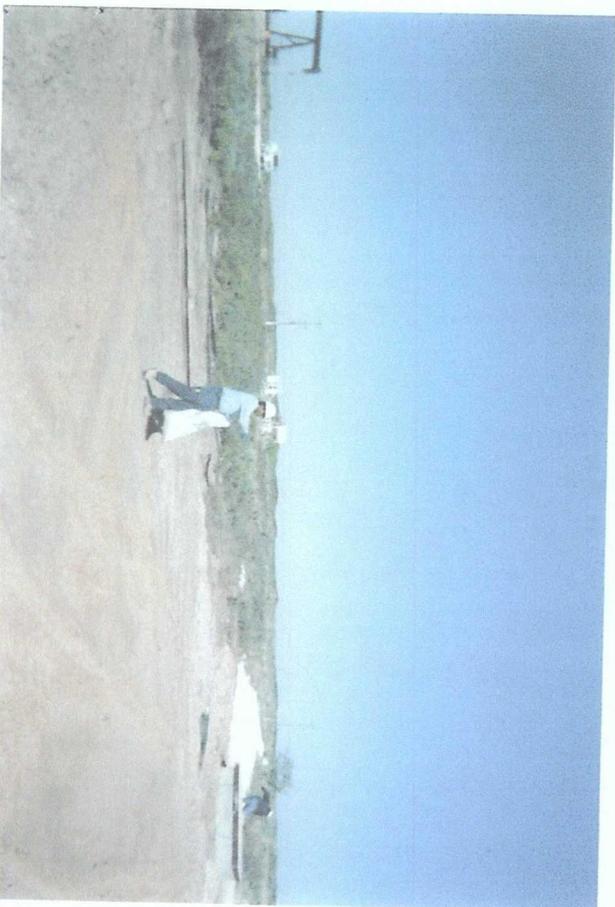
10/25/2006

seeding backfilled site

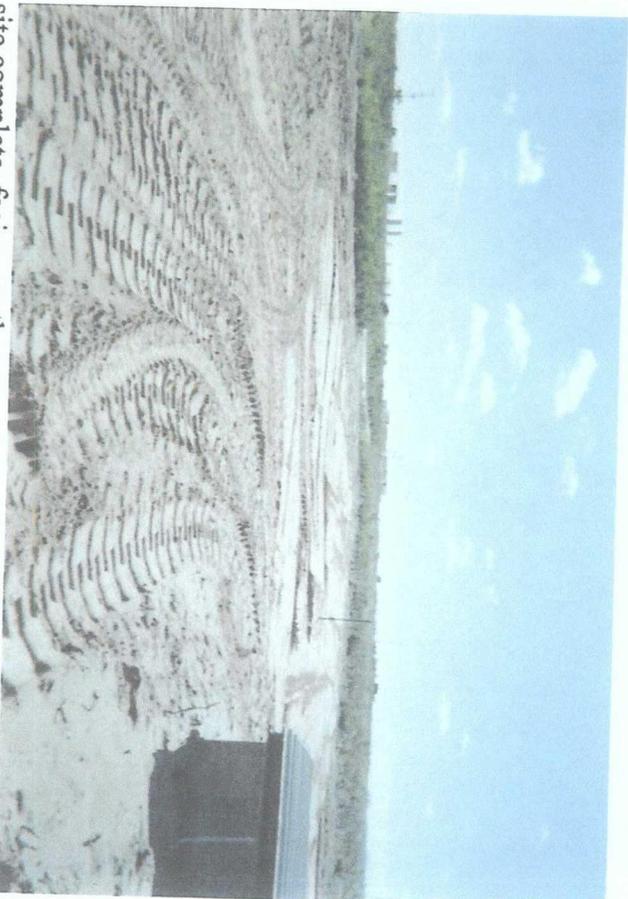
10/19/2006

site complete, facing south

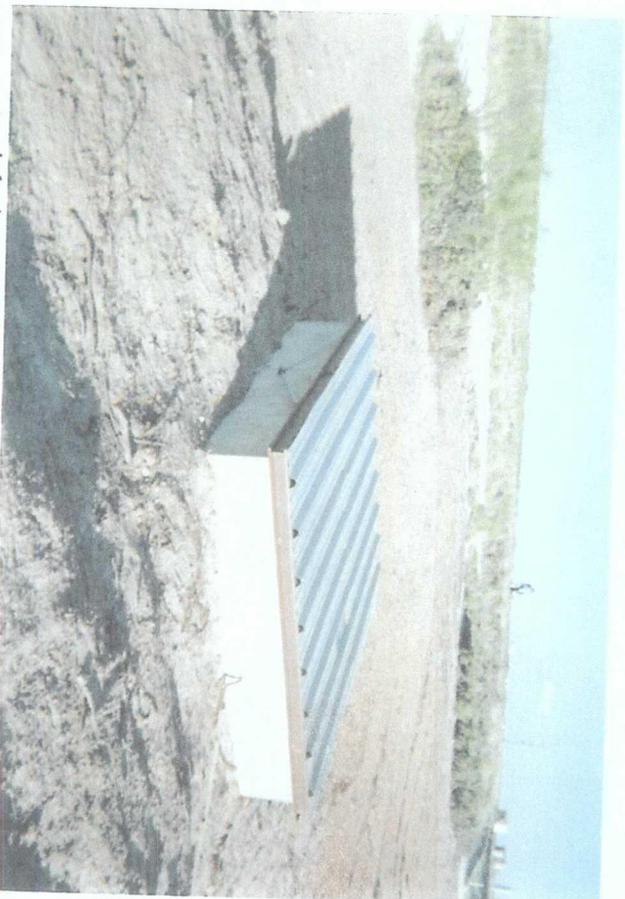
10/30/2006

new, watertight junction box

General Description of Remedial Action: This junction was addressed under the pipeline replacement/upgrade program. A new, watertight junction box was installed 50 ft north of the former. After the former box was removed, an investigation was conducted using a backhoe to collect soil samples at regular intervals producing a 30x30x12-ft-deep hole. Each sample was field tested for chloride concentrations and organic vapors. Representative composite samples were collected from the excavation bottom, walls, and excavated soil for laboratory confirmation of chloride, TPH, and BTEX concentrations. The excavated soil was then blended on-site and returned to the excavation up to the ground surface. Clean, imported soil was used to top cap the location. On 10/25/2008, the site was seeded with a blend of native vegetation and is expected to return to a productive capacity at a normal rate. NMOCD was notified of potential groundwater impact on 7/31/2008.

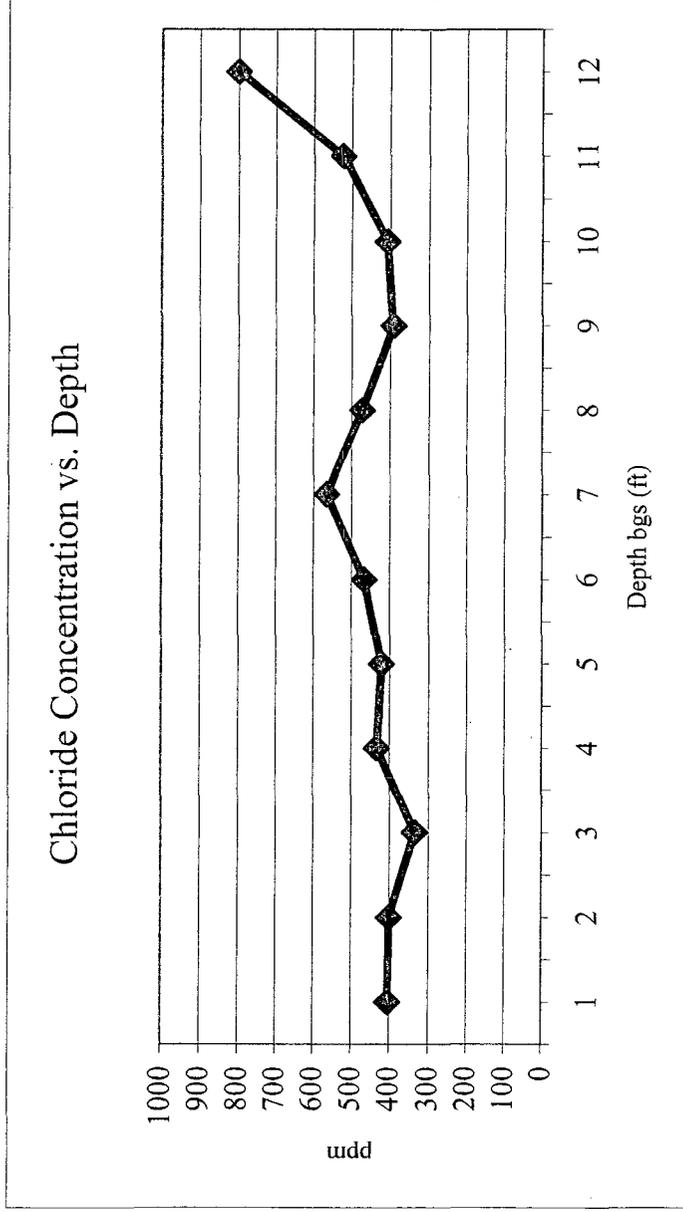
# CHLORIDE CONCENTRATION CURVE

Backhoe samples at 15 ft south of the junction (source)

Depth bgs (ft)	[Cl] ppm
1	404
2	401
3	336
4	433
5	422
6	466
7	566
8	472
9	392
10	407
11	523
12	800

Groundwater = 40 ft

LOCATION	DEPTH	mg/kg
4-wall comp.	n/a	374
bottom comp.	12'	594
backfill comp.	n/a	555
vertical delineation trench 15 ft south of the junction (source)	1'	404
	2'	401
	3'	336
	4'	433
	5'	422
	6'	466
	7'	566
	8'	472
	9'	392
	10'	407
11'	523	
12'	800
