RE: Investigation and Characterization Plan Report & **Termination Request**  
Rice Operating Company – Vacuum SWD System  
VAC Jct. M-5 Unit M Sec 5 T18S R35E  
**NMOCD Case Number - 1R425-38**

On behalf of Rice Operating Company (ROC), Texerra submits this ICP Report and Termination Request for your consideration. ROC has completed the work outlined in the Investigation and Characterization Plan for this project. The site location is shown in Figure 1. The key findings of this work may be summarized as follows:

**Rice Operating Company – VAC M-5**

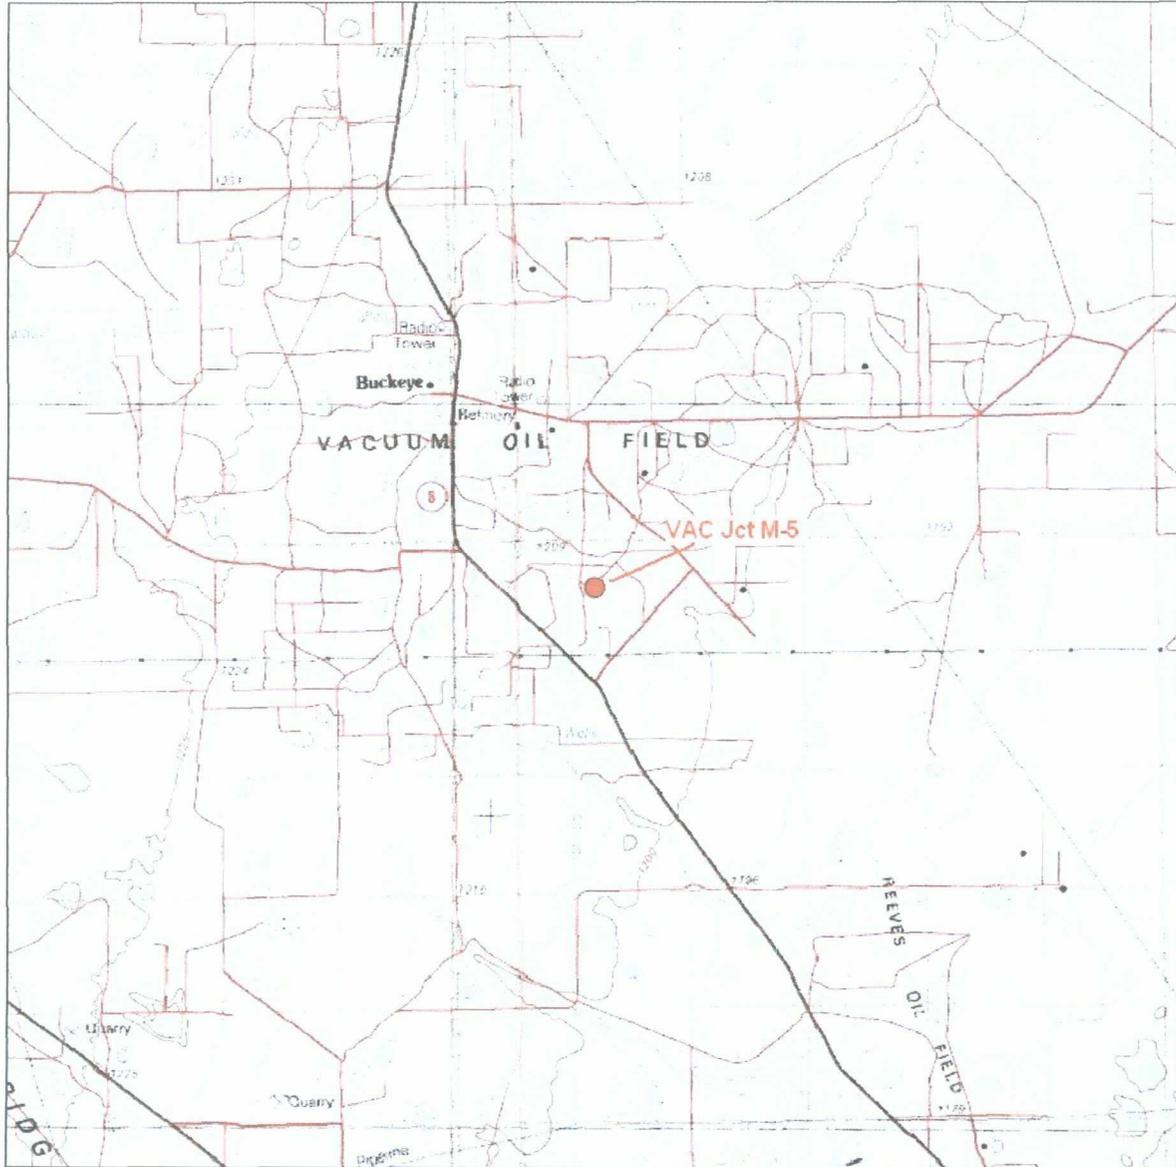
Soil Boring Log

**Identification:** Average of SB-1 through SB-5  
**Location:** See map.  
**Date:** 2/2/2009  
**Driller:** Harrison & Cooper, Inc. (Ken Cooper supervising)  
**Drill method:** Air rotary  
**Logged by:** L. Peter Galusky, Jr., Texerra  
**Total depth:** 50 ft below ground surface  
**Screened interval:** n/a (no well installed)  
**Pipe diameter:** "

<u>Depth (ft below ground surface)</u>	<u>Field Chloride Test (ppm)</u>	<u>Lab Chloride Test (ppm)</u>	<u>Field Avg Soil Chloride Conc (ppm)</u>
-5	585		1,201
-10	784		1,201
-15	1,244		1,201
-20	1,450		1,201
-25	1,315	912	1,201
-30	1,313		1,201
-35	1,354		1,201
-40	1,324		1,201
-45	1,438		1,201
-50	1,207	1,540	1,201
avg	1,201

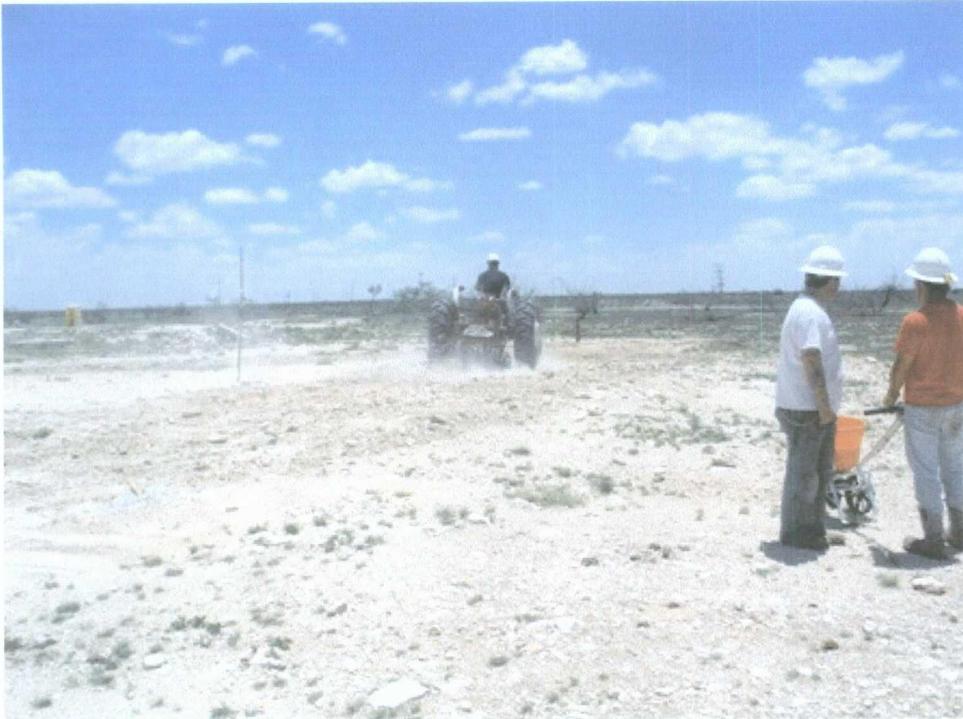
Figure 6 – Reseeding of VAC M-5 June, 2009.

ROC installed a one-foot thick compacted clay barrier beneath the affected area upon removal of the former junction box, as documented in the Junction Box Disclosure Report of August 17<sup>th</sup>, 2007 (Figure 5). Further, ROC prepared the soil and reseeded with a natural vegetation mix in June, 2009 (Figures 6 & 7).
