**Below-Grade Tank
Closure Final Report**

XTO Energy, Inc.

1RP-09-10-2312

Eunice Monument South Unit – Satellite 5
Unit M (SW/4, SW/4), Section 4, T21S, R36E
Lea County, NM

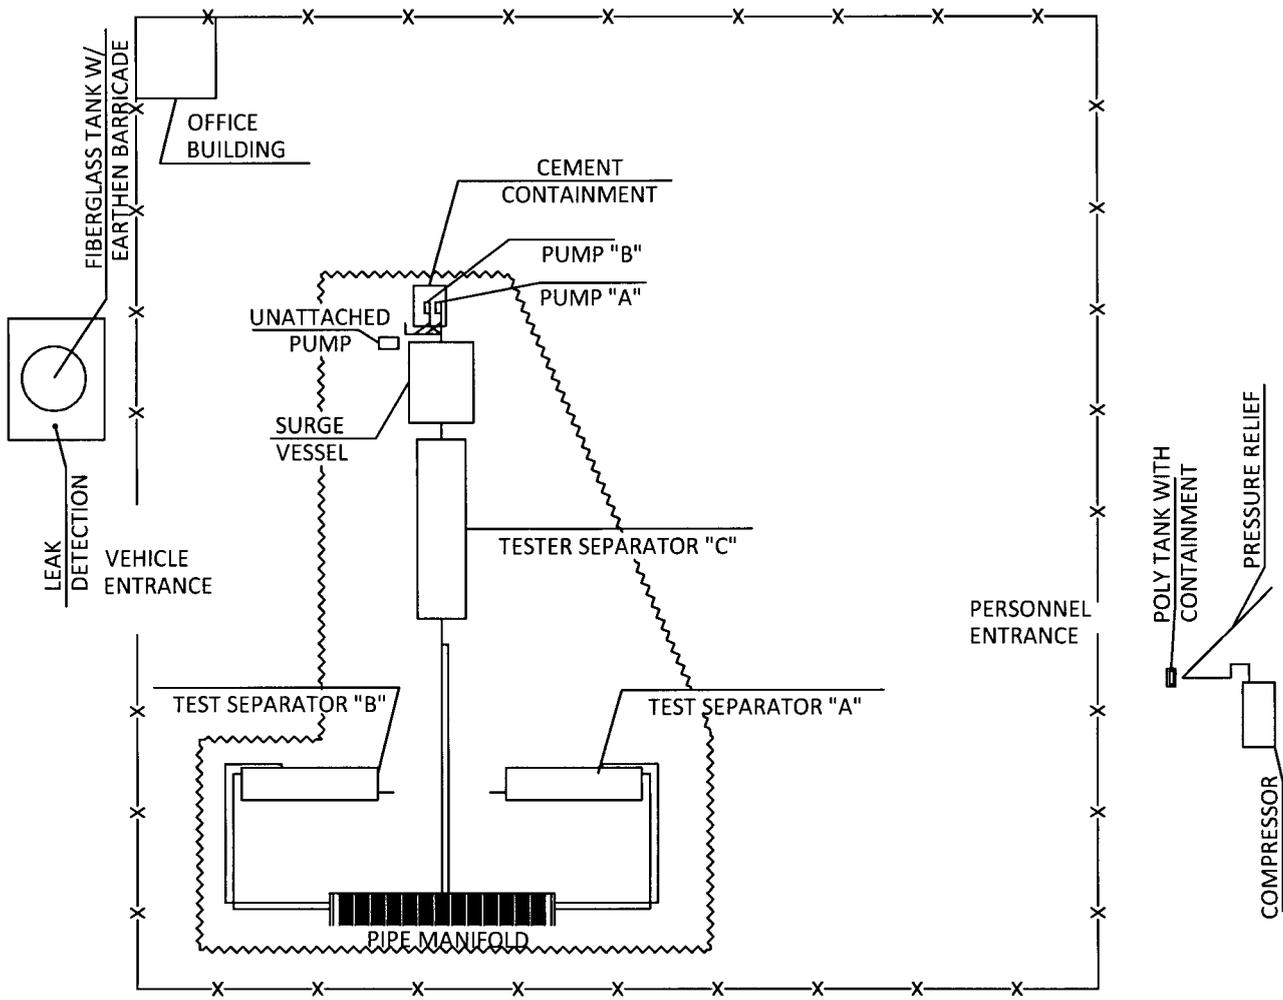
Figure 3 - Site Drawing

The Site has a geodetic location of N32 N32° 30' 7.56", W103° 16' 27.36", and is located in rural Lea County, about 1 mile northwest of Oil Center, New Mexico. The nearest producing well is EMSU #258, API # 30-025-21251. The approximately 0.7 acre Site contains the 90 barrel nominal capacity below-grade fiberglass tank, and ancillary production equipment. The Facility is covered with crushed caliche rock and is relatively flat (Figures 2 and 3).

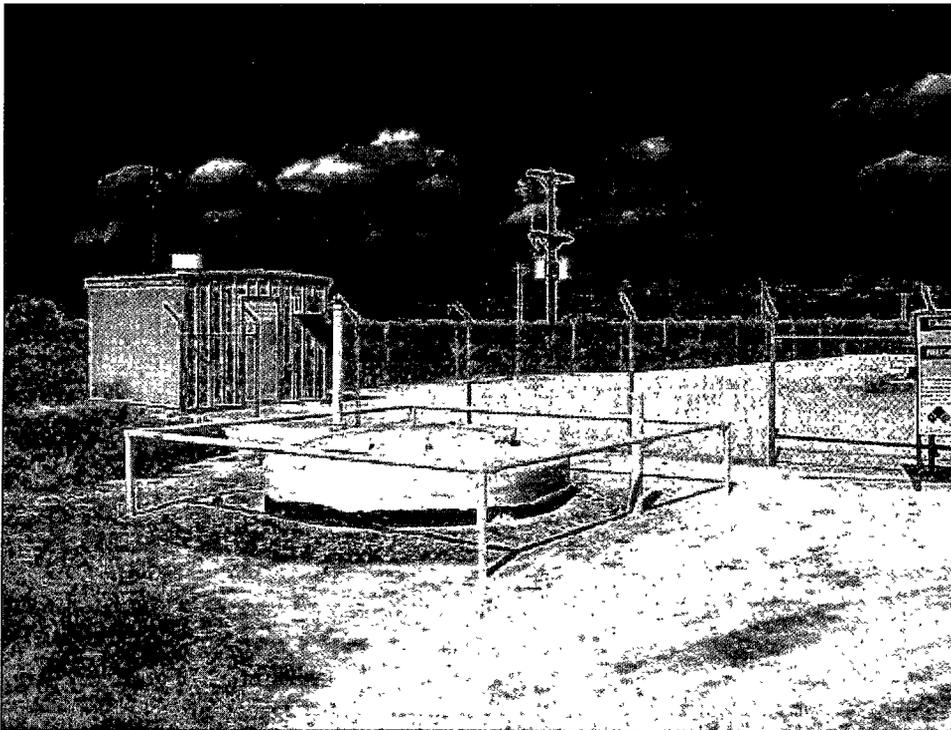
Below-grade tank prior to closure.

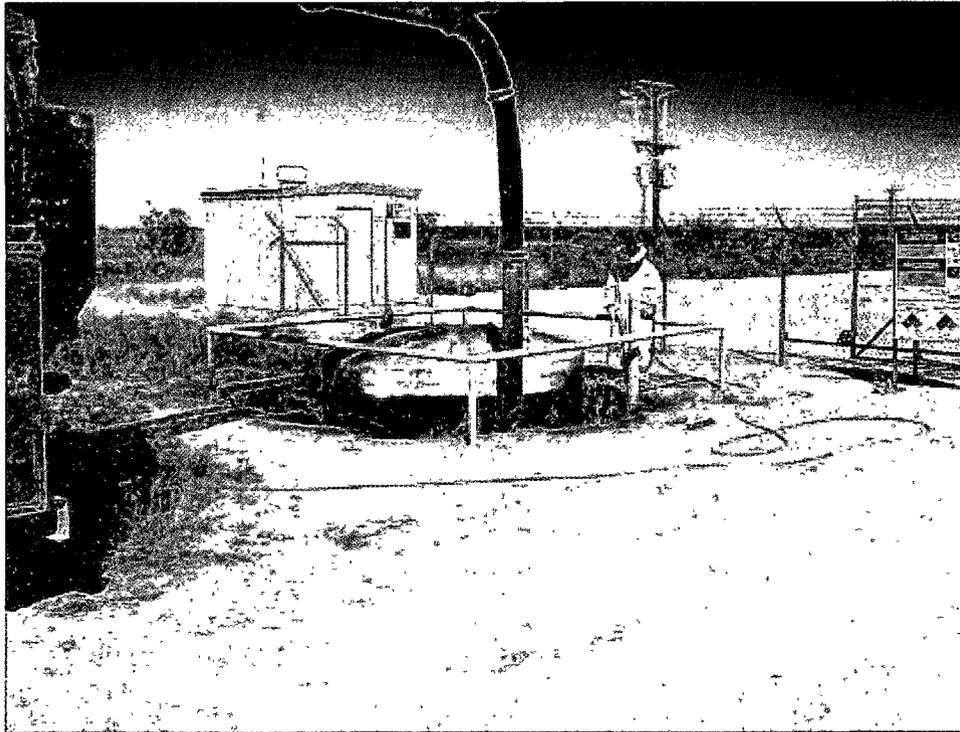
HydroVac excavation in progress.

On October 14, 2009, XTO used a HydroVac truck to excavate around the tank, and a backhoe to remove the tank.

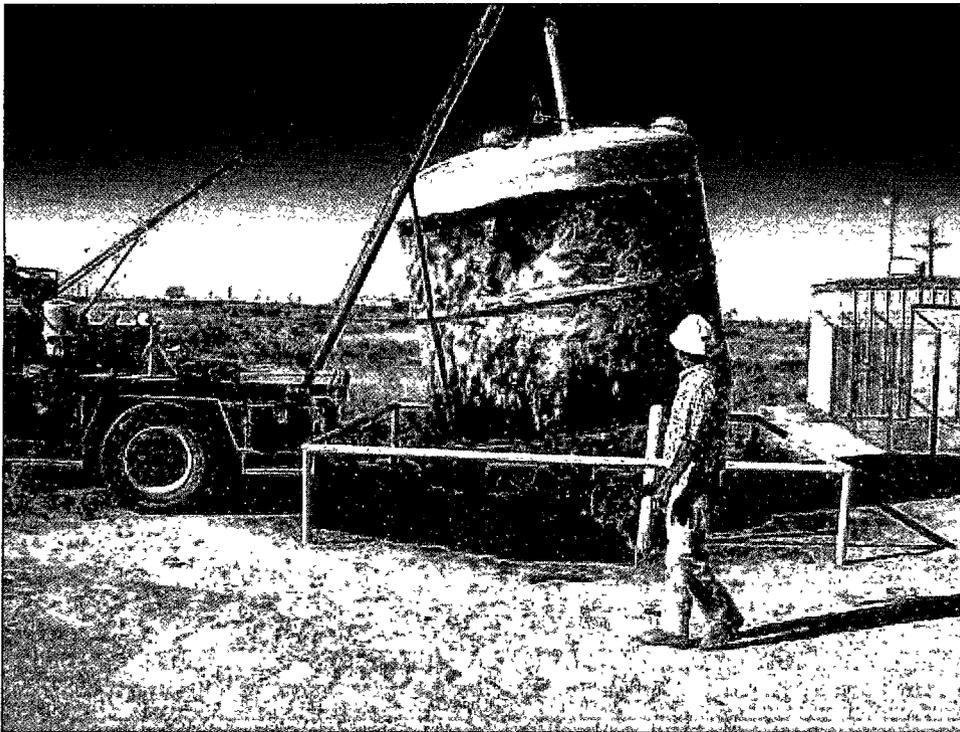
Tank being removed from its hold.
